**INDEPENDENT ASSESSMENT ON EARTHQUAKE PERFORMANCE
OF
617 to 625 Colombo Street**

**FOR
Royal Commission of Inquiry into building failure
caused by the Canterbury Earthquakes**

**Report prepared by Peter C Smith and Jonathan W Devine
OF
Spencer Holmes Ltd**

November 2011

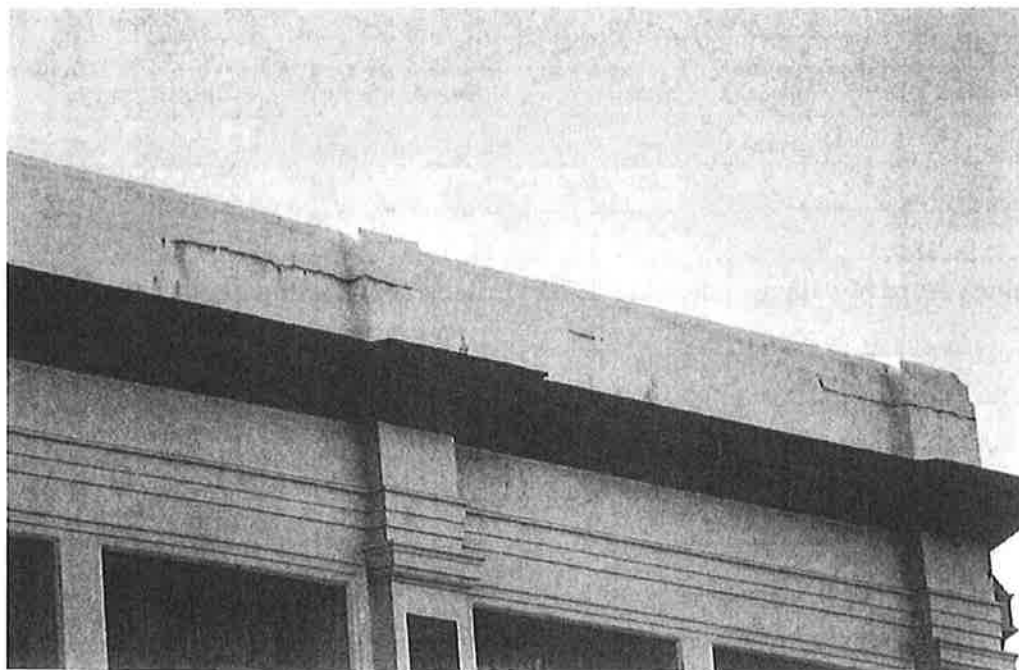
The Christchurch City Council undertook a Seismic Risk Building-Survey on the 28th November, 1991. The building was assessed as a building classification A earthquake risk building with a score of 15. The assessment noted a cracked parapet (horizontally), numerous horizontal crack through columns and that a significant proportion of the ground floor elevation was plate glass with little shear resistance. The Building Classification A required immediate action.

A Hazardous Appendage-Survey was undertaken by the Christchurch City Council on the 19th May, 1992. The survey identified that the two storey office building had horizontal cracking in the parapets. The Christchurch City Council appear to have communicated the likely earthquake prone nature of the building to the owner when work was undertaken on the building and recommended that the owner obtain an engineers assessment of the building. The Christchurch City Council appear not to have followed up on the recommendation.

Parapet damage prior to Canterbury earthquake sequence

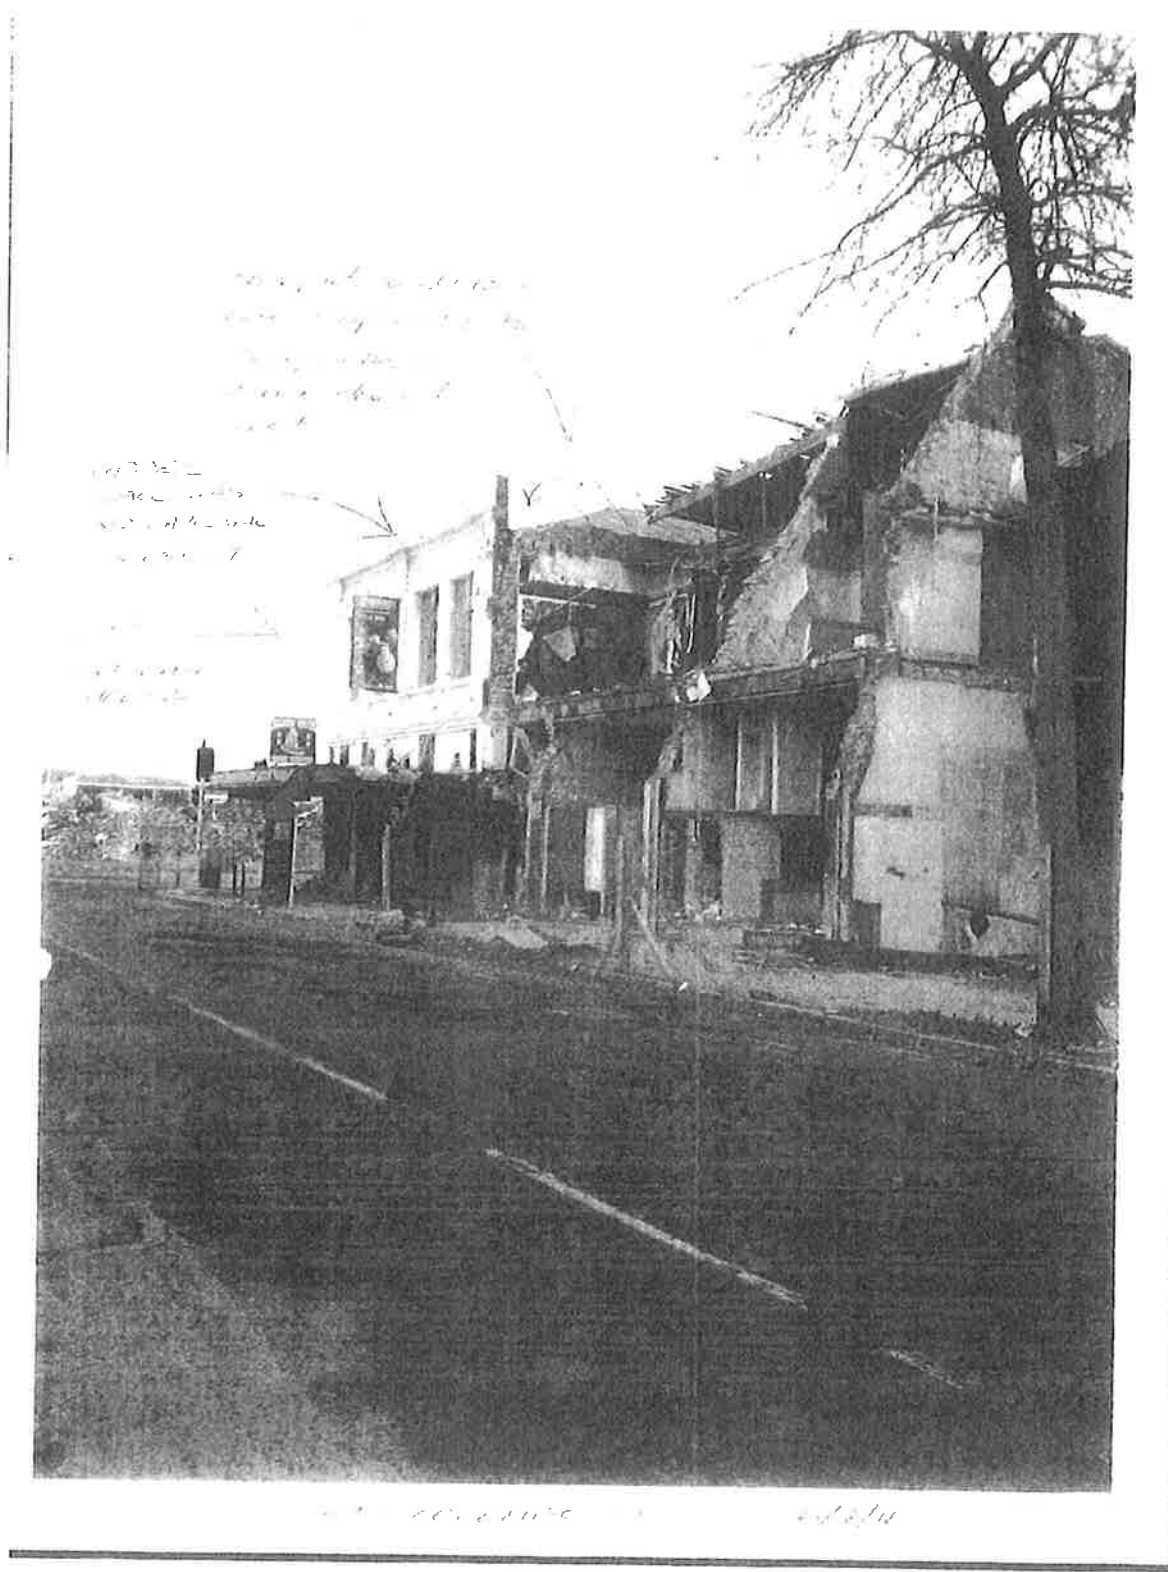
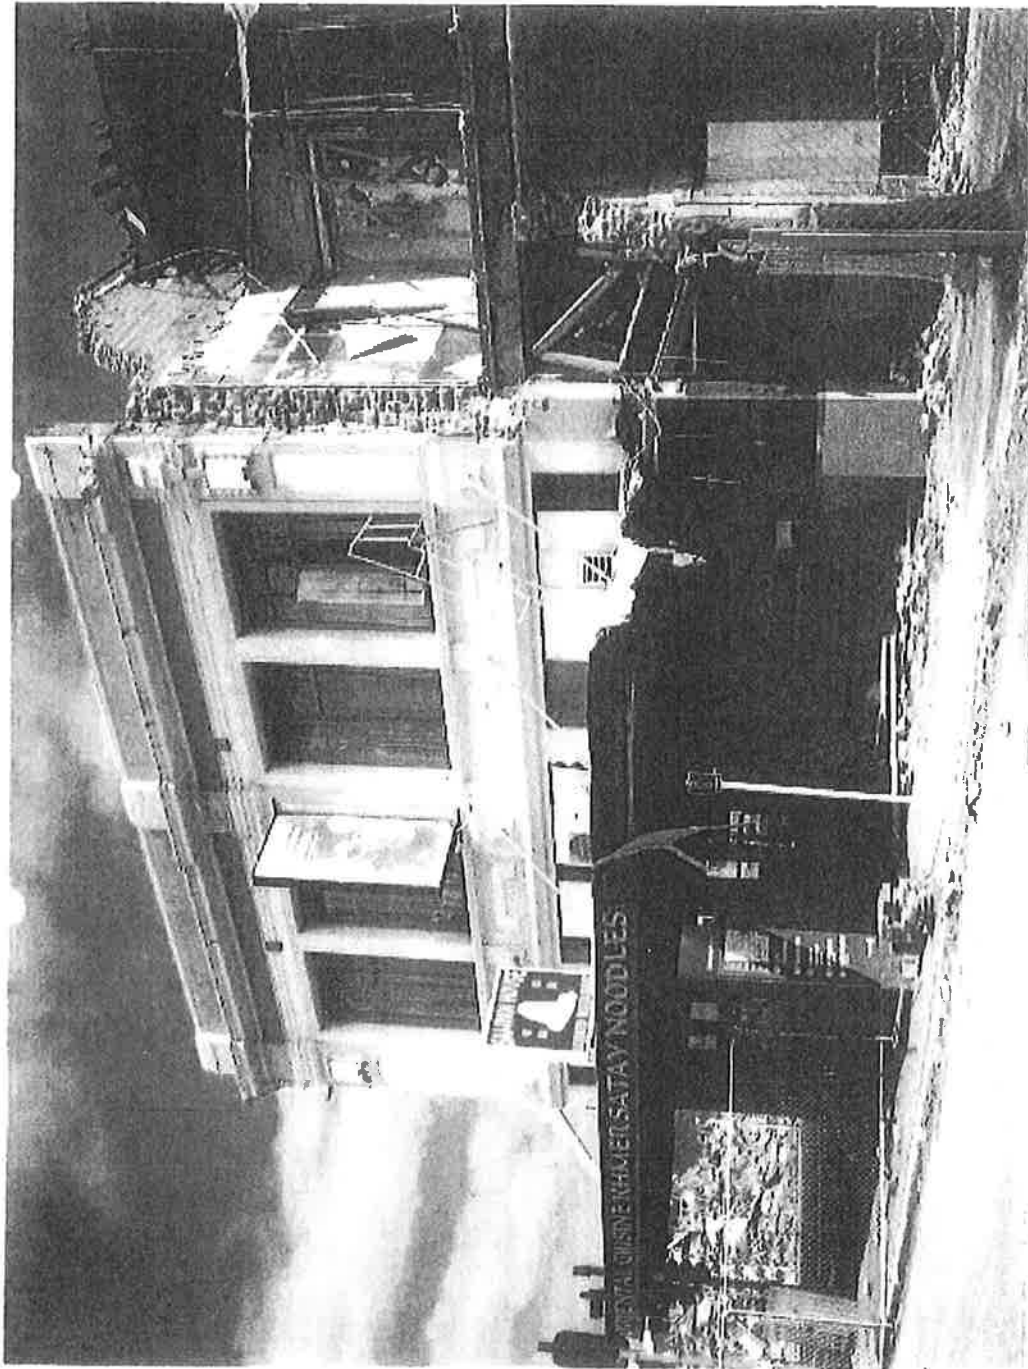
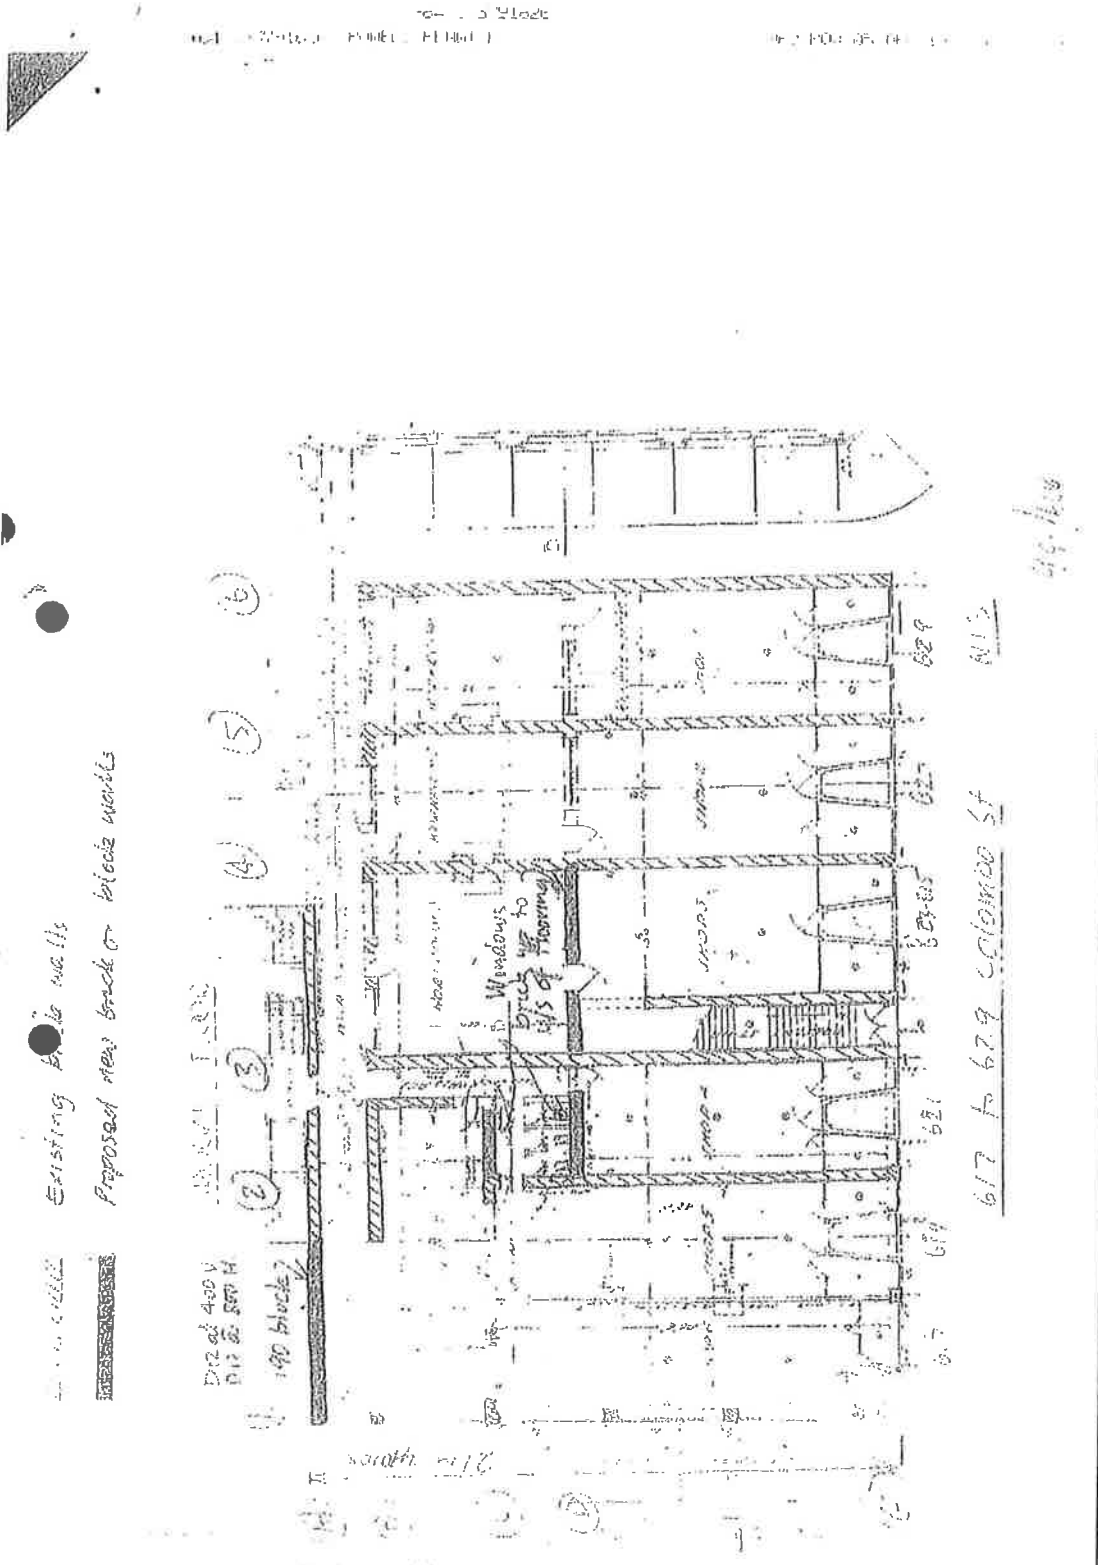
As a result of the 22nd February, 2011 earthquake, the front façade of the buildings 623 to 629 Colombo Street collapsed into Colombo Street. The roof partially collapsed and the brick party walls and internal walls were damaged. The Rapid Assessment-Level 1 undertaken on the building 625 Colombo Street on 26th February, 2011 recommended demolition. (NOTE: This relates to building 623 to 625 Colombo Street).

The failure of the Colombo Street façade to the buildings at the sites 623 and 629 Colombo Street appears to have been an outward rotation of the first floor facades and parapet about the first floor support. (Refer photos appendix 3)

The front façades of the buildings 623 to 629 Colombo Street collapsed into Colombo Street as a result of the 22nd February, 2011 earthquake. The roof partially collapsed and brick party walls and internal walls were damaged. It is significant that end buildings of a series of interconnected

Photographic record of damage following 22nd February 2011 earthquake
