**IN THE MATTER OF ROYAL COMMISSION OF INQUIRY INTO BUILDING
FAILURE CAUSED BY CANTERBURY EARTHQUAKES**

**STATEMENT OF EVIDENCE OF STEPHEN JAMES MCCARTHY IN RELATION TO 617
- 625 COLOMBO STREET**

DATE OF HEARING: WEEK BEGINNING 12 DECEMBER 2011

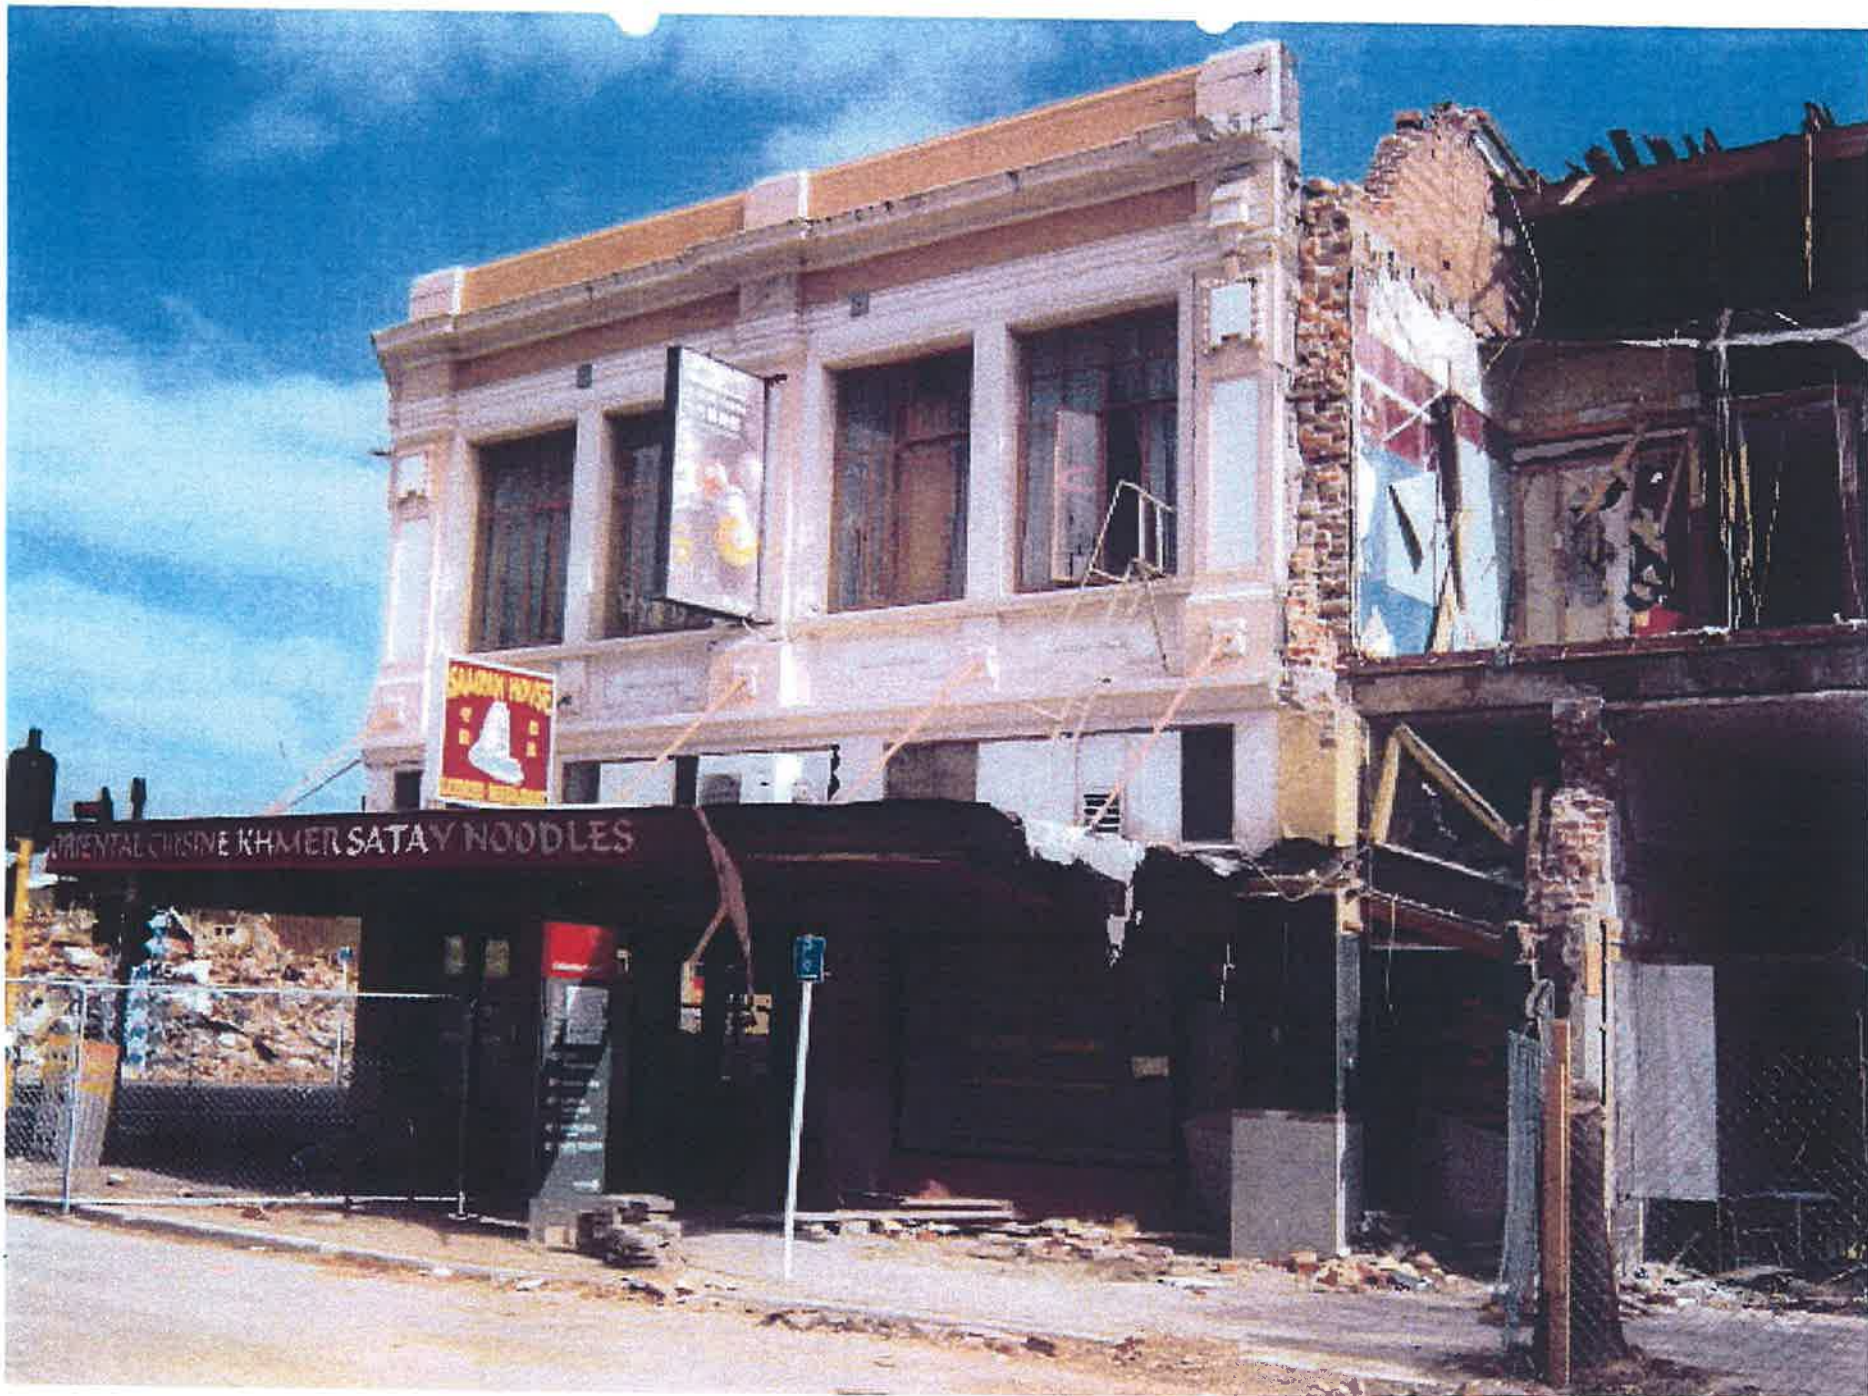
"J"

16. I also attach a photograph taken of the building after the 22 February earthquake. (**Annexure "J"**). The photograph shows the part of 617 Colombo Street which has collapsed. It is likely that this part of the building was actually referred to as 623 Colombo Street, and this correlates with the rapid assessment forms completed, as the front façade of what is referred to as 623 Colombo Street has collapsed onto the street, while Sampan House has minimal damage.
