**IN THE MATTER OF ROYAL COMMISSION OF INQUIRY INTO BUILDING  
FAILURE CAUSED BY CANTERBURY EARTHQUAKES**

**STATEMENT OF EVIDENCE OF STEPHEN JAMES MCCARTHY IN RELATION TO  
382 COLOMBO STREET**

**DATE OF HEARING: WEEK BEGINNING 12 DECEMBER 2011**

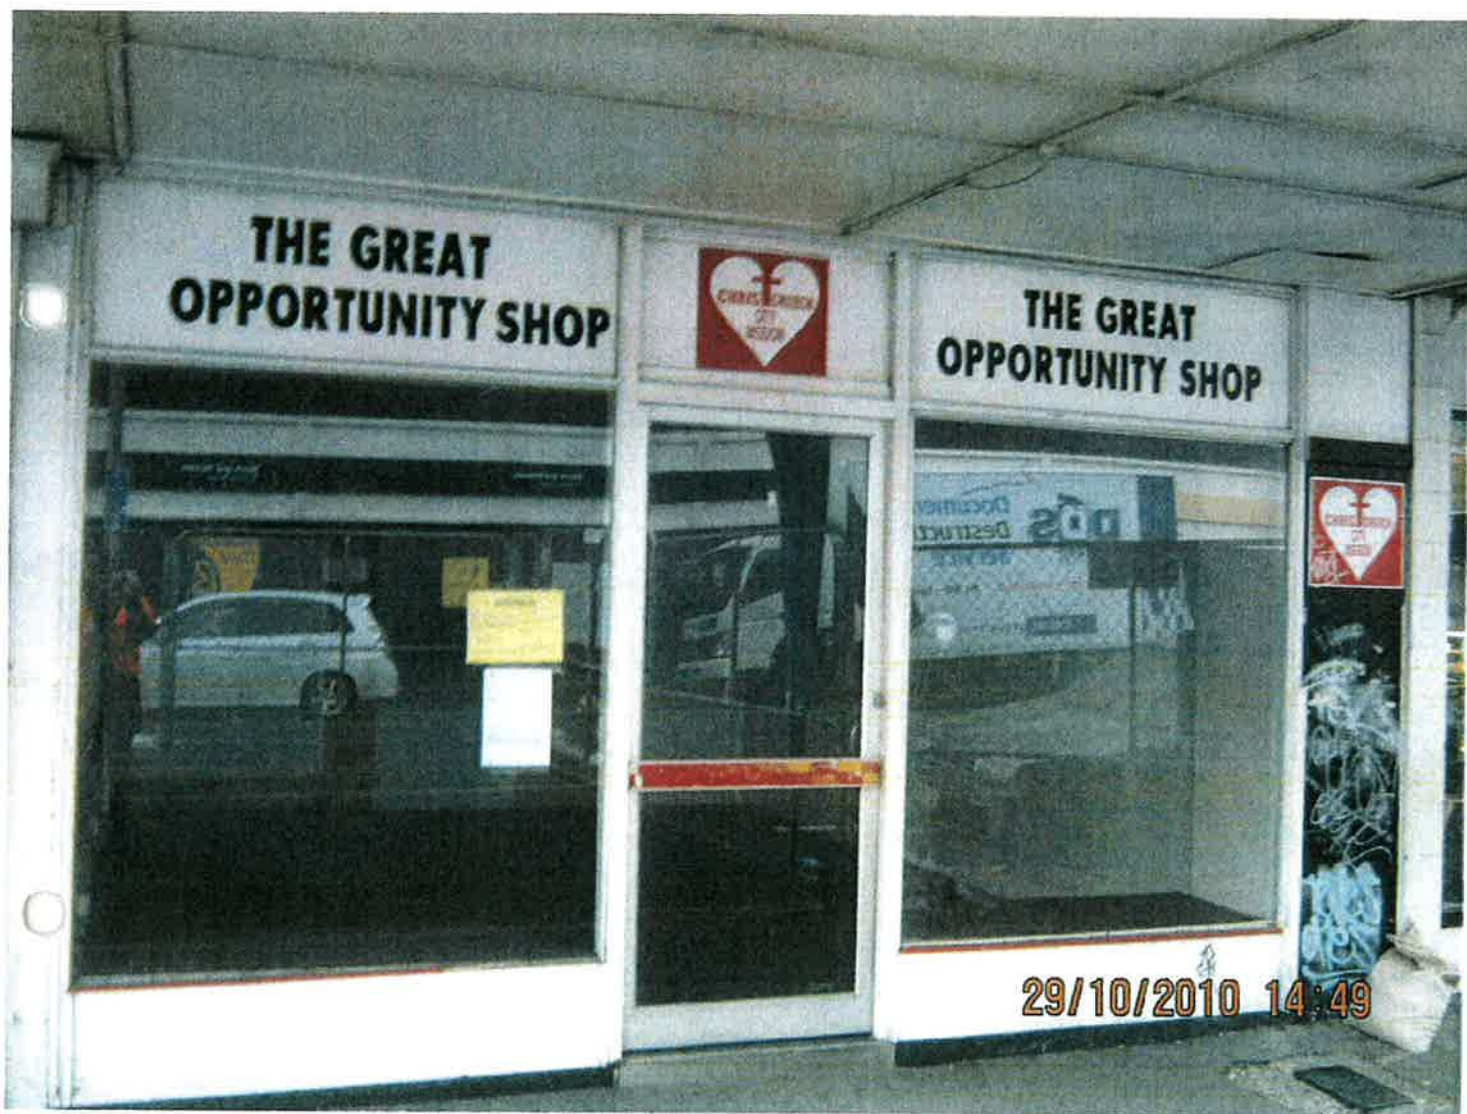
"C"

8. The section 124(1)(c) notice was affixed to the building. I attach a photograph taken on 29 October 2010 which shows the Building Act notice affixed to the building (**Annexure "C"**). A copy of the notice, along with a cover letter dated 29 October 2010, was posted to the owner, Boi Fong Yan, at the owner's last known address, in this case the address recorded by the Council for rating purposes.
