CTV BUILDING

CTV BUILDING COLLAPSE INVESTIGATION FOR DEPARTMENT OF BUILDING AND HOUSING 5TH DECEMBER 2011

CTV BUILDING COLLAPSE REPORT

Report Issue Date: 7 December 2011

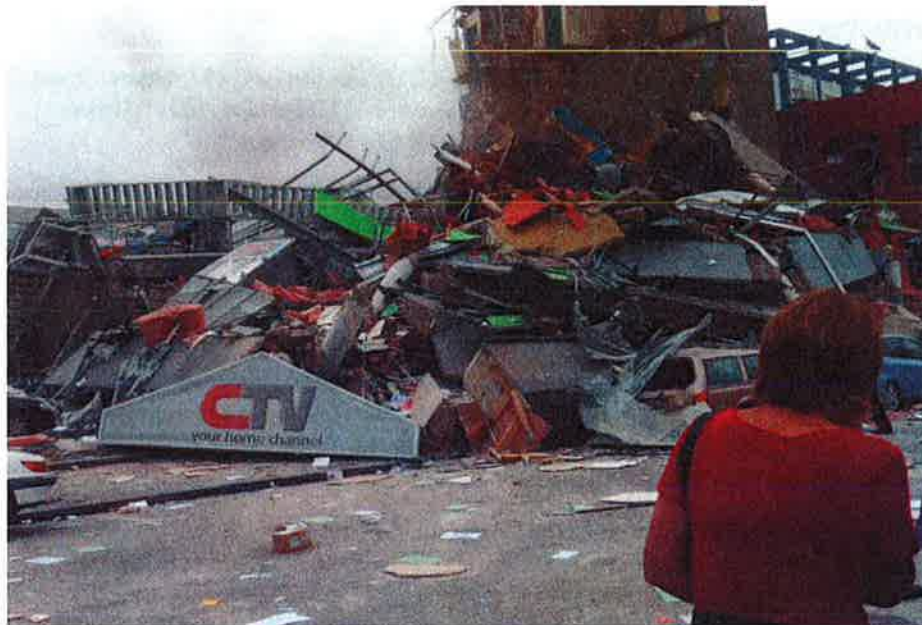
Figure 1 - The CTV Building seen from the corner of Cashel and Madras Streets immediately after the collapse, and prior to debris being shifted and removed. The escape stair on the collapsed South Wall can be seen laying on top of the rubble. Fractured Line F columns and precast concrete Spandrel Panels have fallen onto cars parked in Madras Street. A portion of floor slab from in front of the lift doors at Level 5 hangs precariously from the North Core in the distance (MSN).

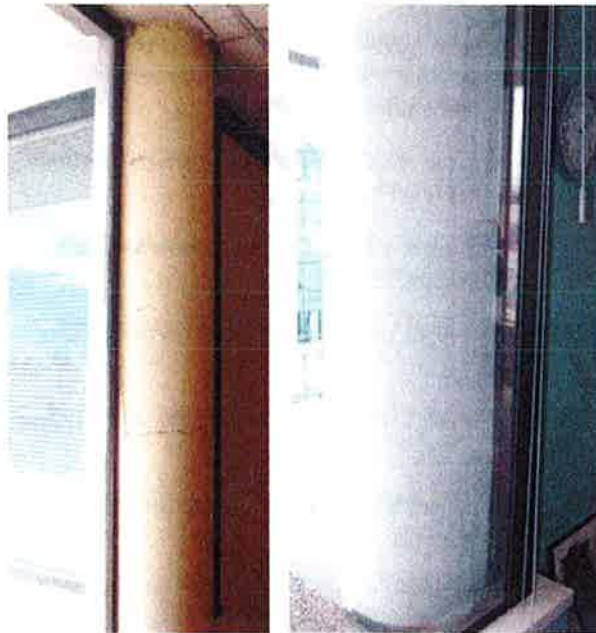
Figure 15 - Level 6 400mm diameter columns (Left to right) a) Column 4 D/E outside lift; b) Column on Line 1/A-B with hairline horizontal cracking.

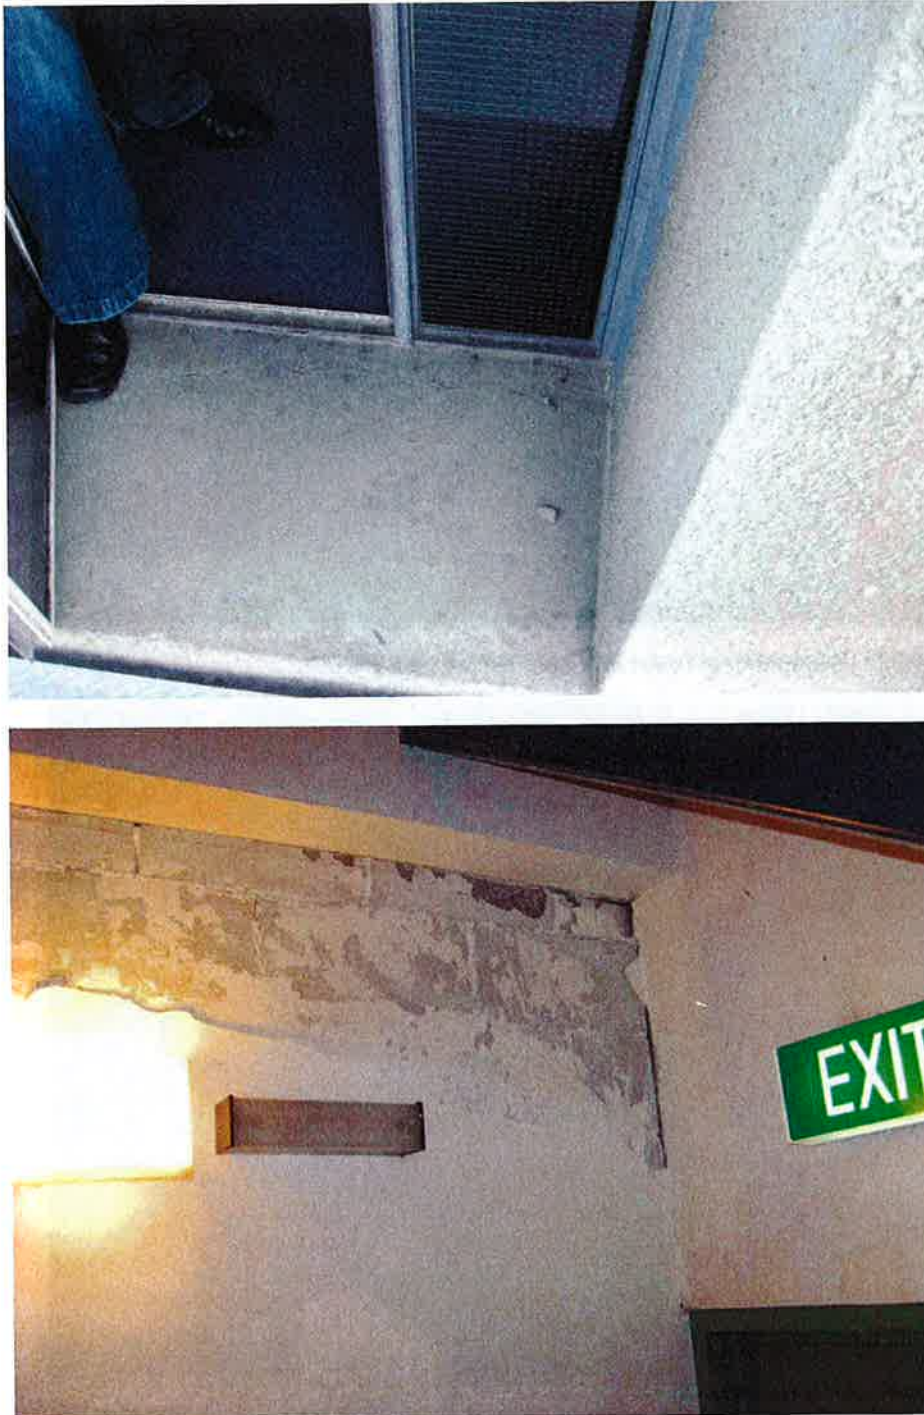
Figure 16 - (Top to bottom) (a) Fine cracking in floor at junction with South Wall; (b) Spalling of plaster finishes on internal masonry in-fill wall on Line 4 in front of stair well.

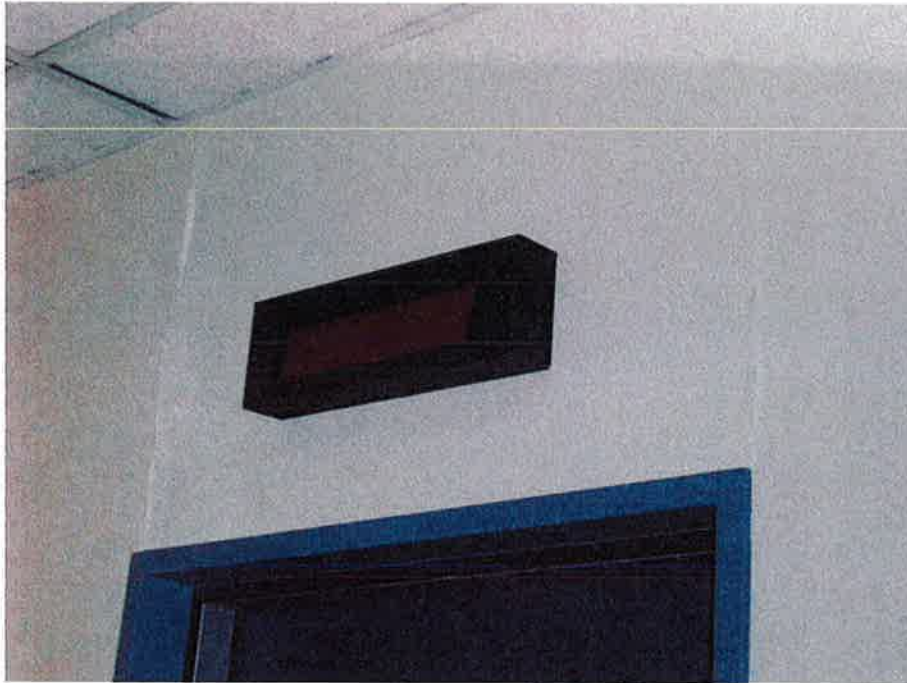
Figure 17 - Damage to wall Linings after 4 September 2010 Earthquake.

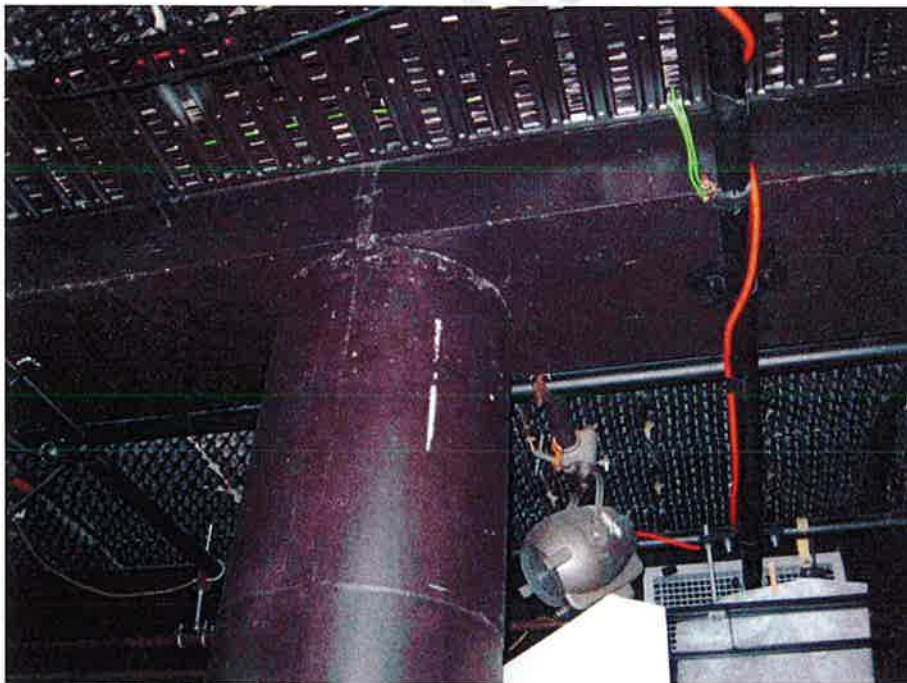
Figure 18 - Level 1 Line 2 or 3 400mm diameter column and beam after 4 September 2010 Earthquake. No visible cracking evident. A horizontal circumferential formwork mark can be seen approximately 600 mm down from the underside of the beam.

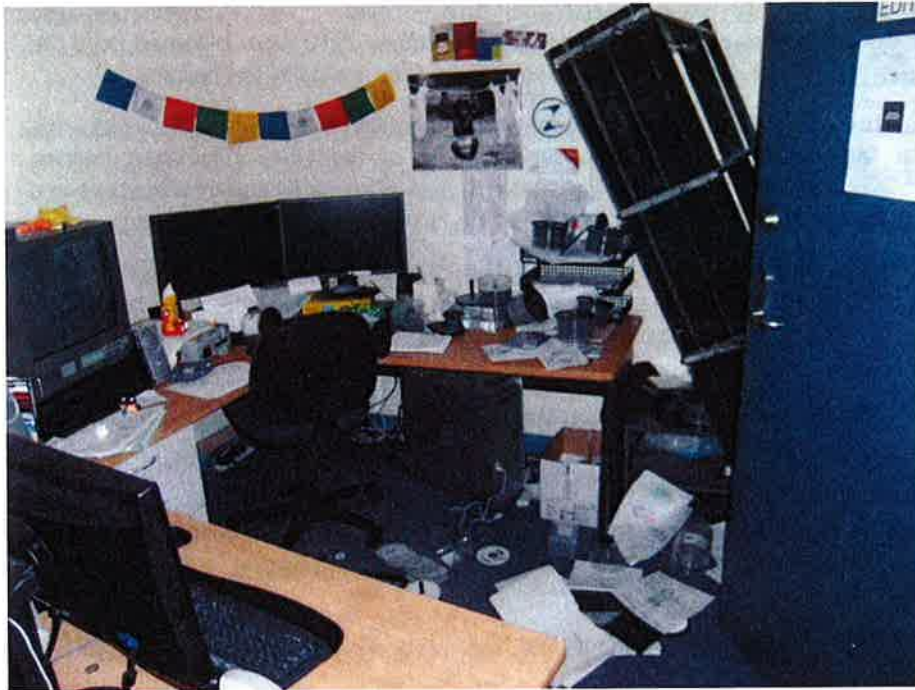
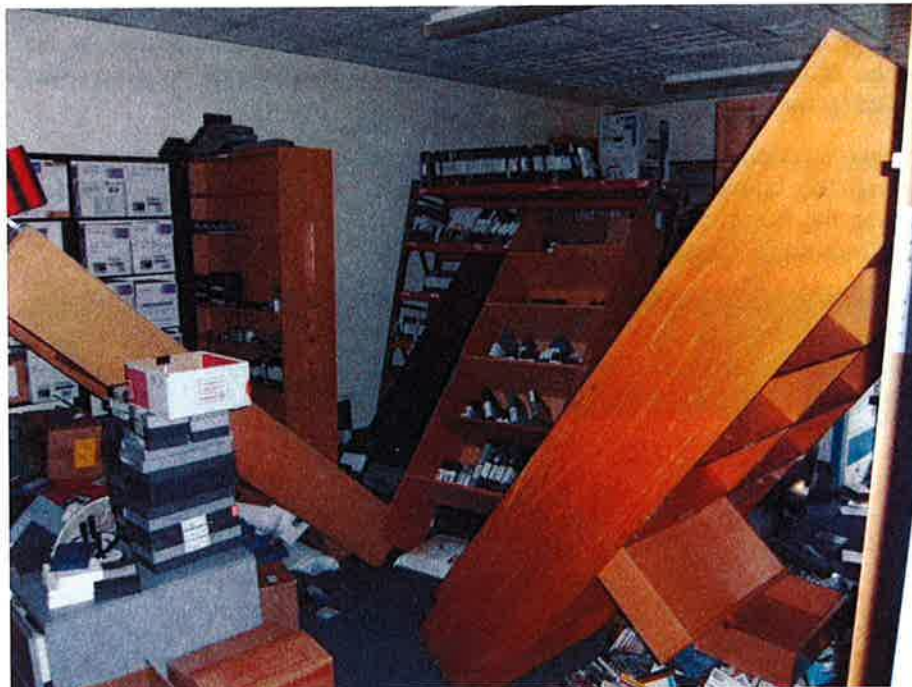
Figure 19 - Damage to office furniture on Level 2 after the 4 September 2010 Earthquake.

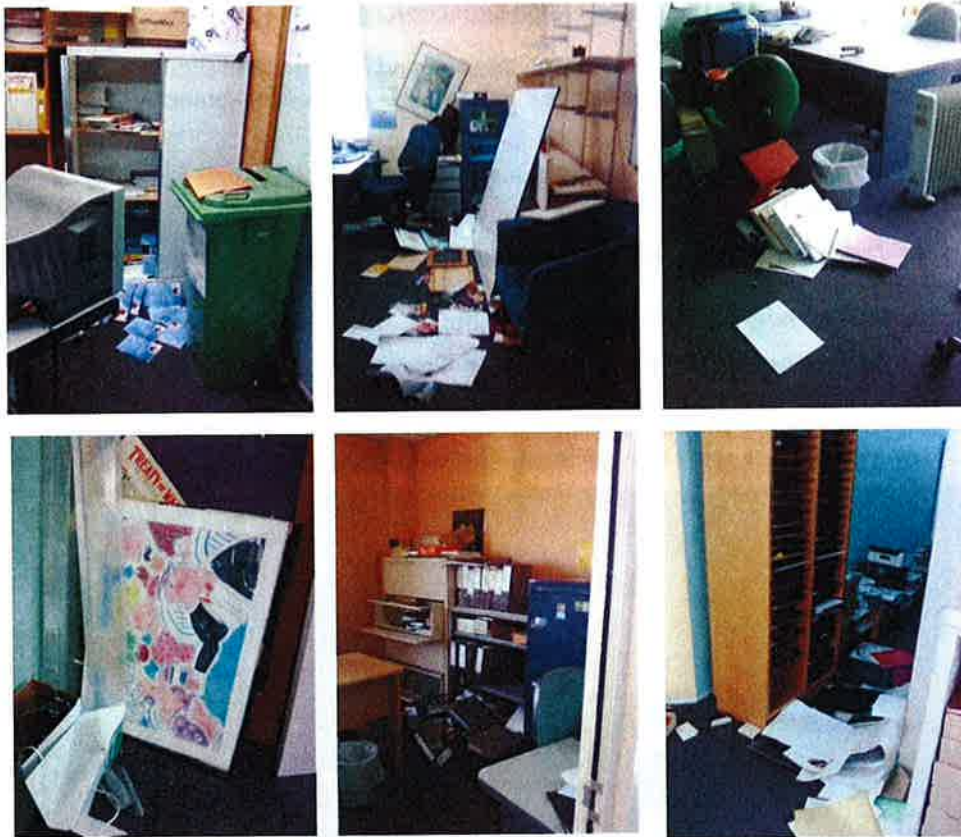
Figure 20 - Damage after 26 December, 2010 aftershock on Level 6 of CTV Building (clockwise from top left) a) Cabinet door had opened but hadn't fallen over though not attached to the wall (Line 3/B-C); b) As it was except that the filing cabinet had been stood back up (Line 2/A-B); c) Oil heater had been righted. Two filing cabinets had fallen to the floor; (Line 1/B-C) d) The cubby-hole unit had not emptied of papers in the earthquake on 4th September. However in December it had fallen against the corridor wall towards Cashel Street. It had been righted before the photo was taken. (Line 2/B-C) e) The shelves and filing cabinets had gone down, but had been righted before the photo was taken (Line 4/A-B). f) The painting had fallen from the wall. (Line 1/A-B).

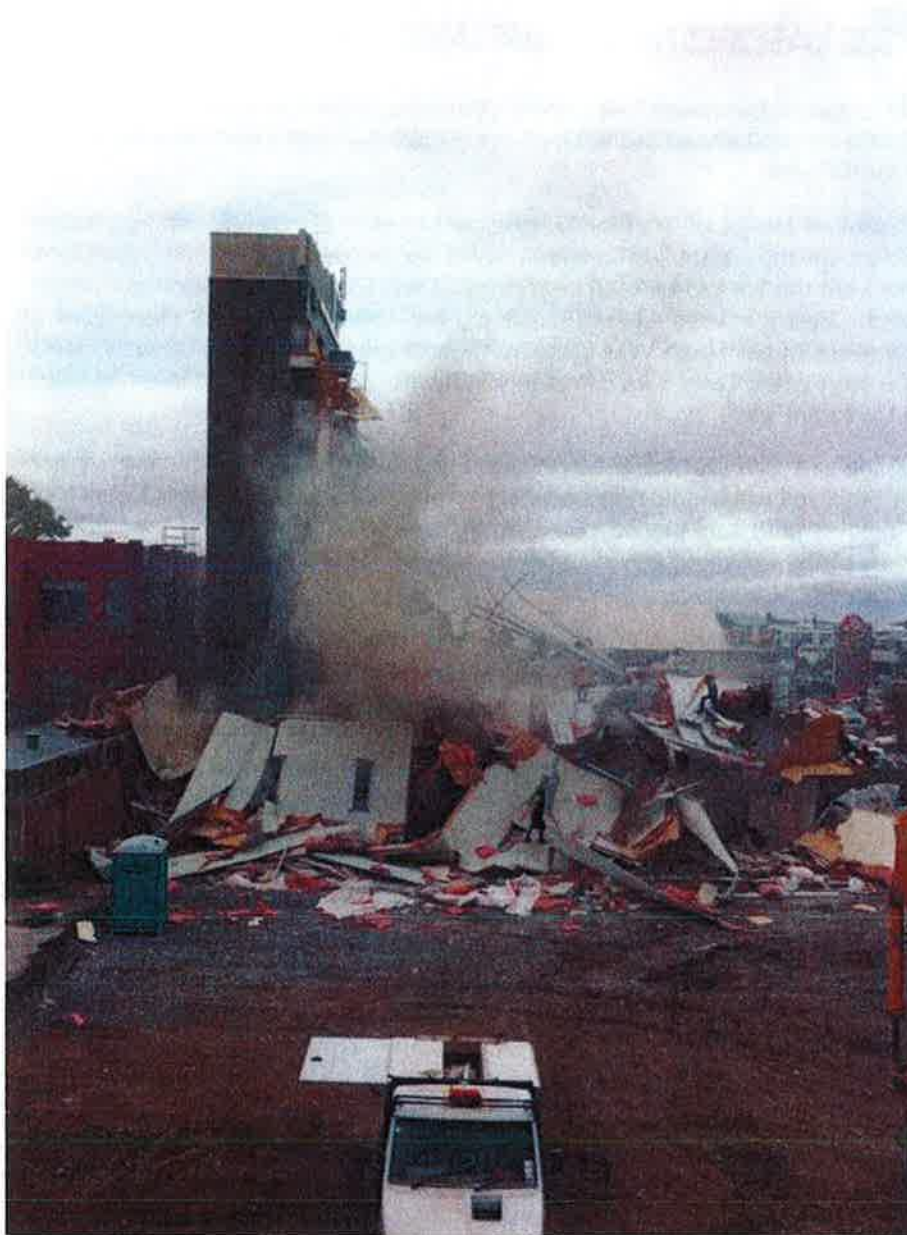
Figure 22 - View of all of the west wall on Line A from Les Mills immediately after collapse before debris removal commenced. No signs of liquefaction can be seen on the vacant site. Smoke from the fire can be seen beginning to arise. Some of the upper light weight external panels between Levels 4 and 6 have fallen northwards, possibly as a consequence of the South Wall falling northwards onto them. Large diagonal cracks can be seen in the Level 2 to 3 masonry infill wall at the right hand end that has fallen onto the vacant site. Roof steelwork can be seen in mid-picture.

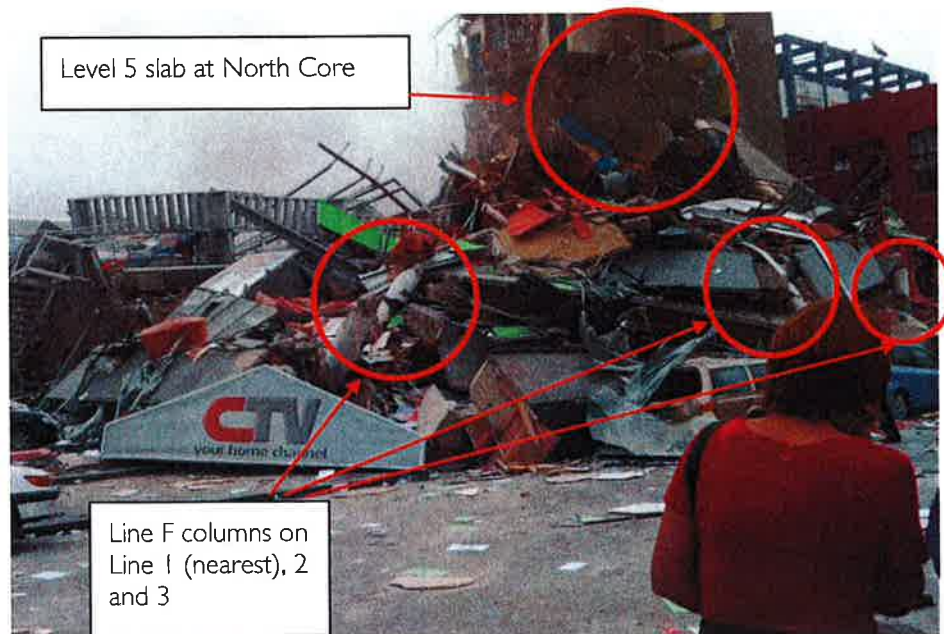
Figure 24 - Corner of Cashel and Madras Streets looking towards North Core. Fractured columns and fallen Spandrel Panels are visible (MSN photo).

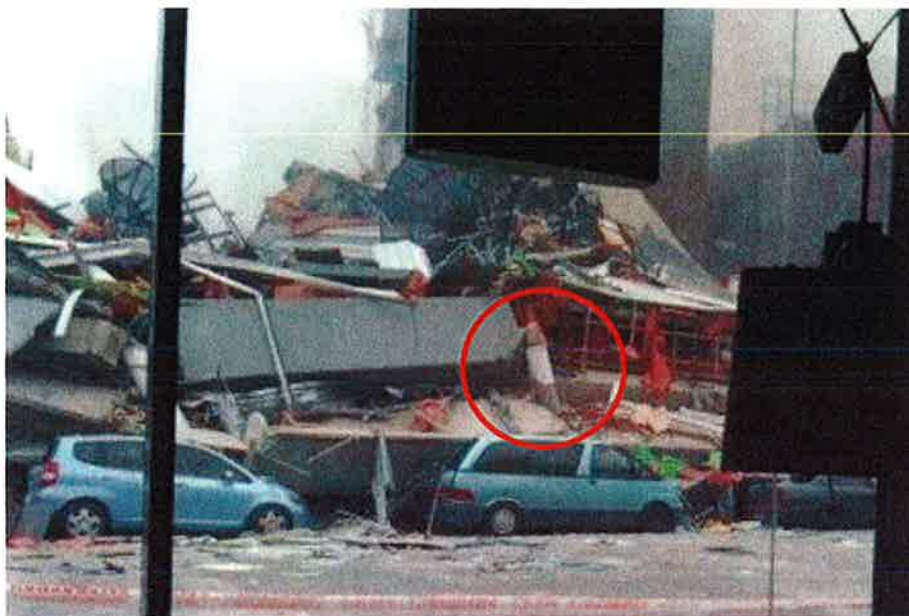
Figure 25 – View from looking west across Madras Street. A Line F/3 column is highlighted showing conical fracture in the painted portion above unpainted portion which had been enclosed by Spandrel Panels.

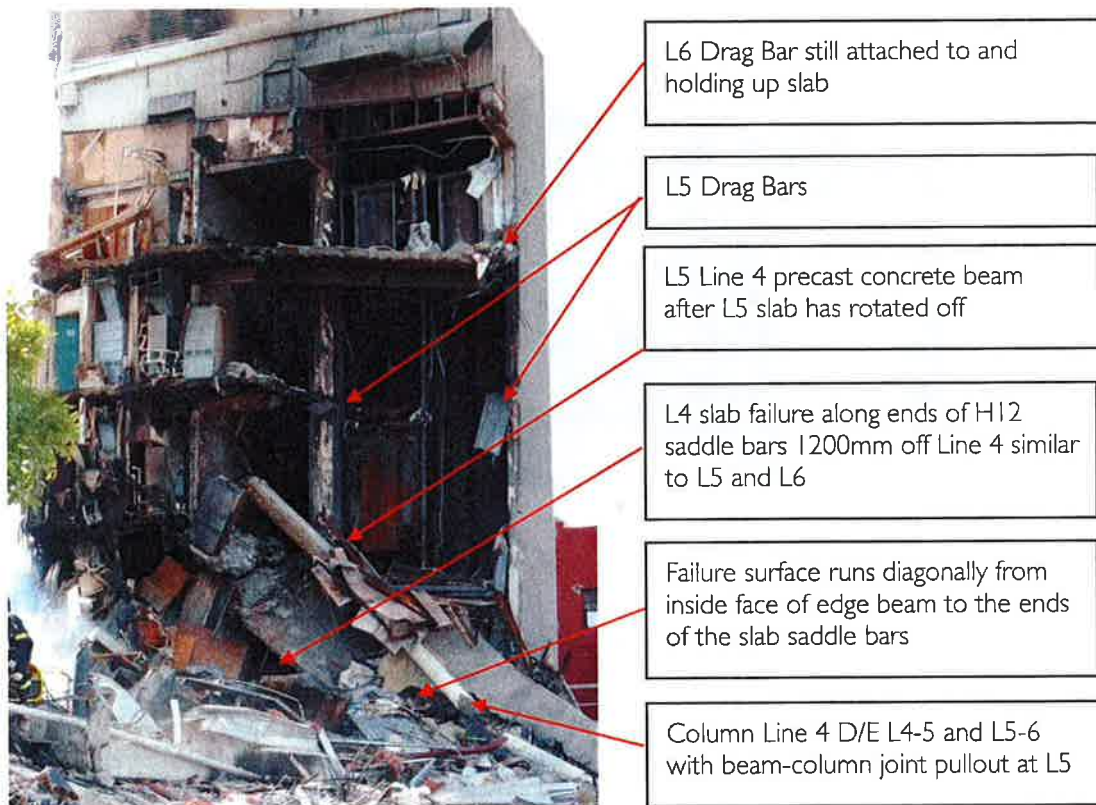
Figure 29 - Failure of slab adjacent to North Core.

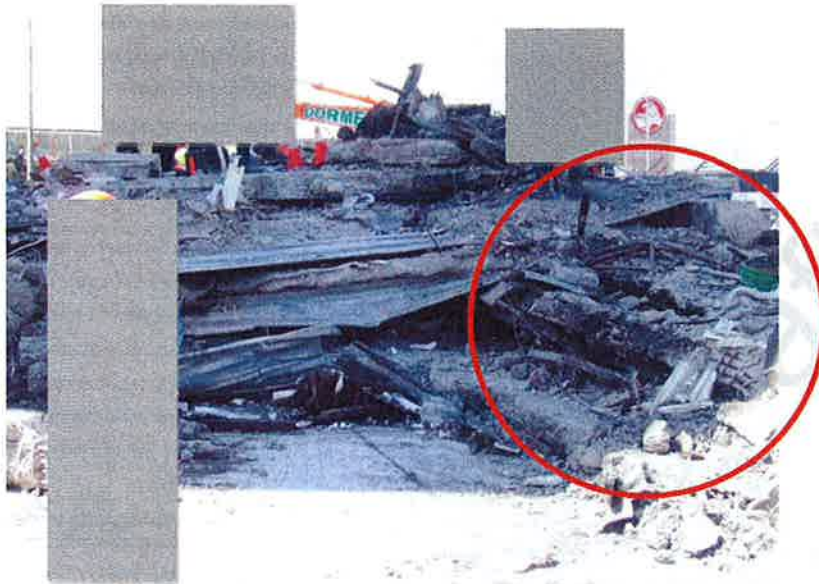
Figure 31 - Line 2 beams highlighted laying rotated northwards. This indicates that the Line 2 columns collapsed prior to the slabs breaking away from the Line 1 South Wall and frame.

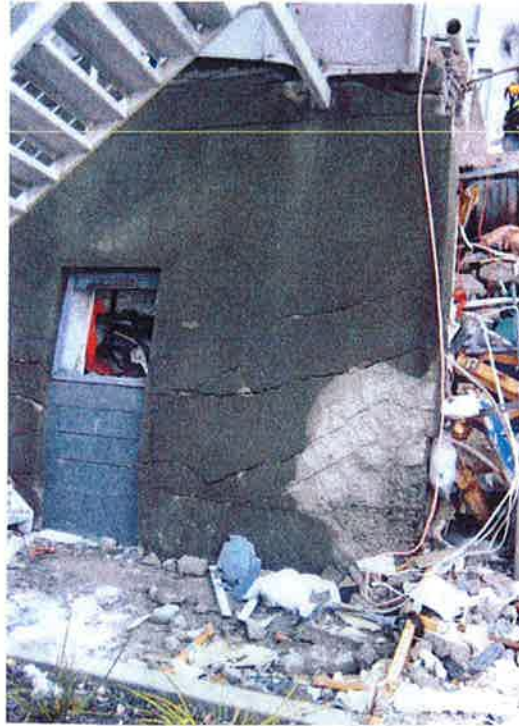
Figure 33 - Fan-like flexural cracking on the South Wall in conjunction with compressive spalling of the concrete at the wall east end. This indicates that the South Wall suffered flexural damage prior to the collapse of the floor slabs.

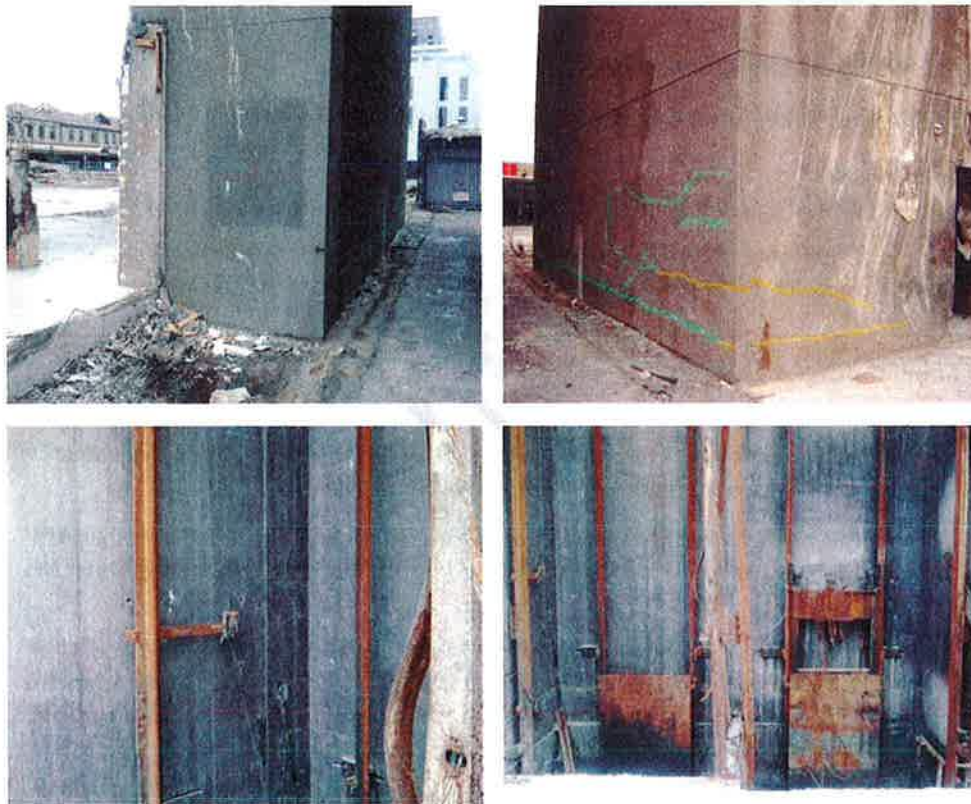
Figure 34 - North Core cracking (clockwise from top left) (a) No obvious cracking on Line D/E wall; (b) Horizontal flexural cracking on west and north west face of Line 5 wall and north end of Line C wall at Line C/5; (c) Fine two-way diagonal cracking on the inside faces of Level 1 to 2 Line 5; (d) and D walls in North Core.

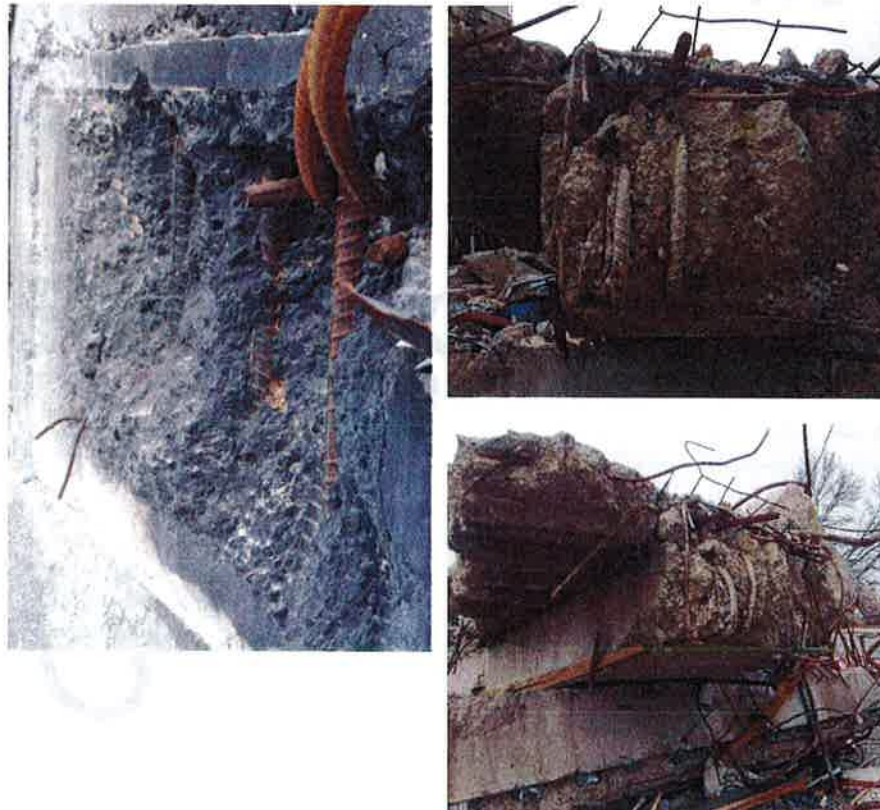
Figure 36 - Precast shell beam (Item E14) from northern face Grid 4, west side of North Core (DENG B23 Dwg S18). (clockwise from top right) (a) to (b) Fractured slab outstand remnant at east end from which slab concrete cores were extracted. The bottom H24 bars from shell beam have been turned back into the concrete infill rather than embedded in shear wall as specified (DENG Detail 5 Dwg S19). Notice the bar imprint on wall at the connection seen in (c) at Level 4 and at Level 3.. This meant that these beams would not have performed as intended.

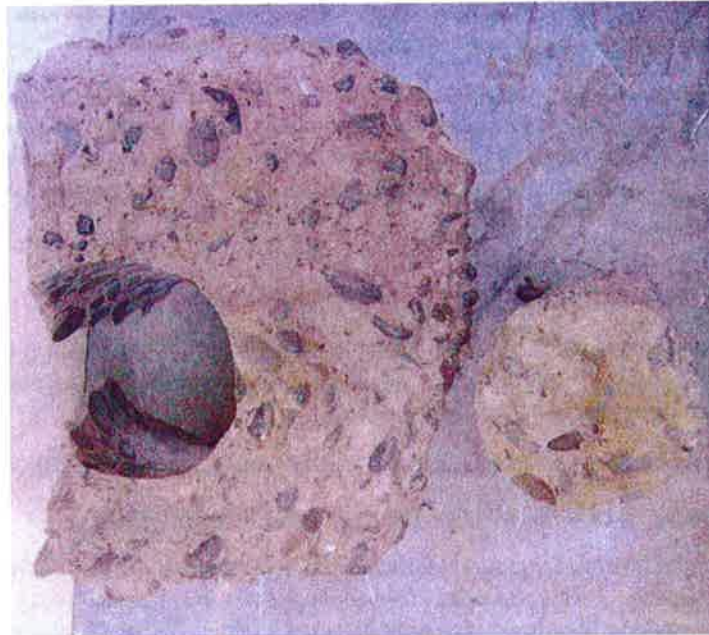
Figure 45 - Concrete from column on Line 4-D/E (C18) showing discolouration from silt.

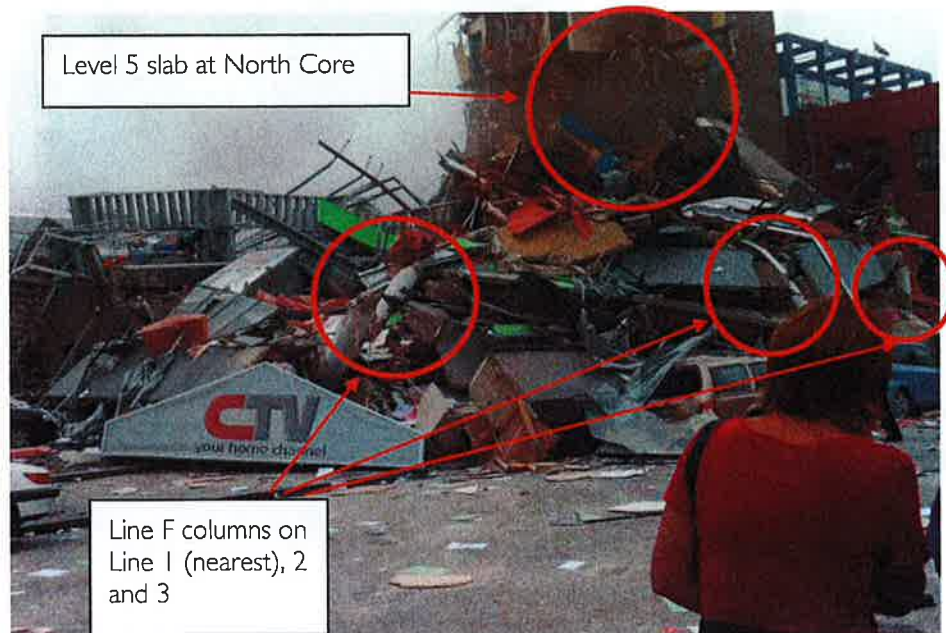
Figure 66 - Corner of Cashel and Madras Streets looking towards North Core. Fractured columns and fallen Spandrel Panels are visible (MSN photo).

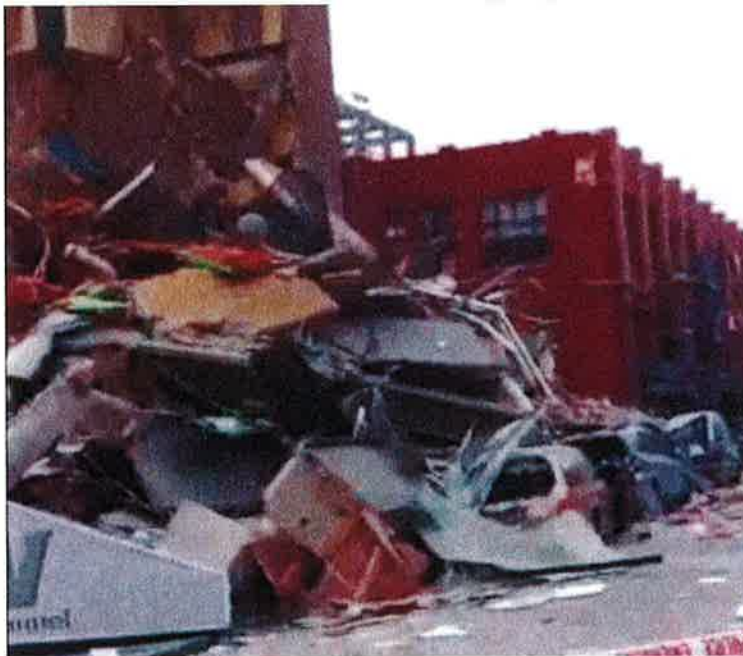
Figure 67 – View from southeast corner of CTV Building along Madras Street. This shows Line F Spandrel Panels fallen onto cars parked in the street indicating a tilt to the east during collapse.

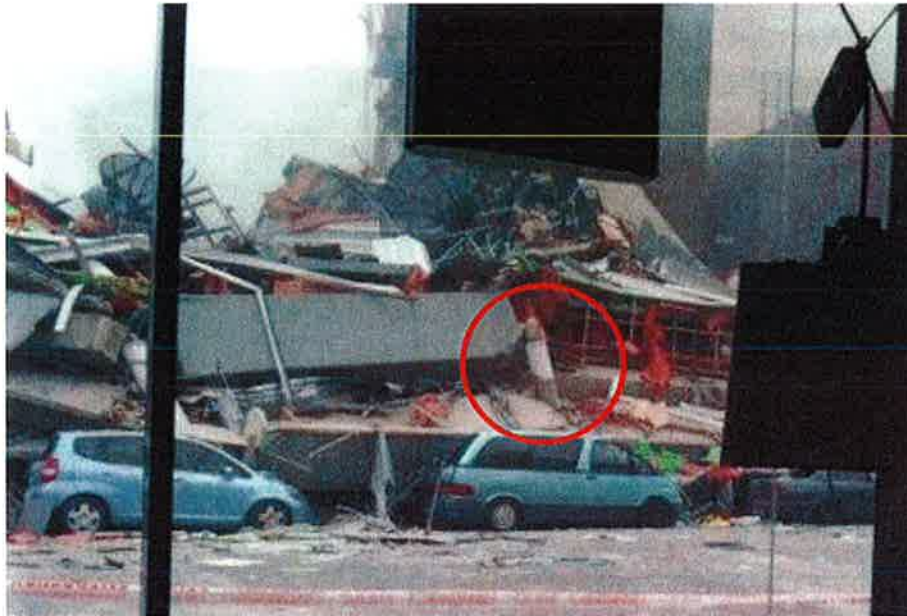
Figure 68 – View from looking west across Madras Street. A Line F/3 column is highlighted showing conical fracture in the painted portion above unpainted portion which had been enclosed by Spandrel Panels.

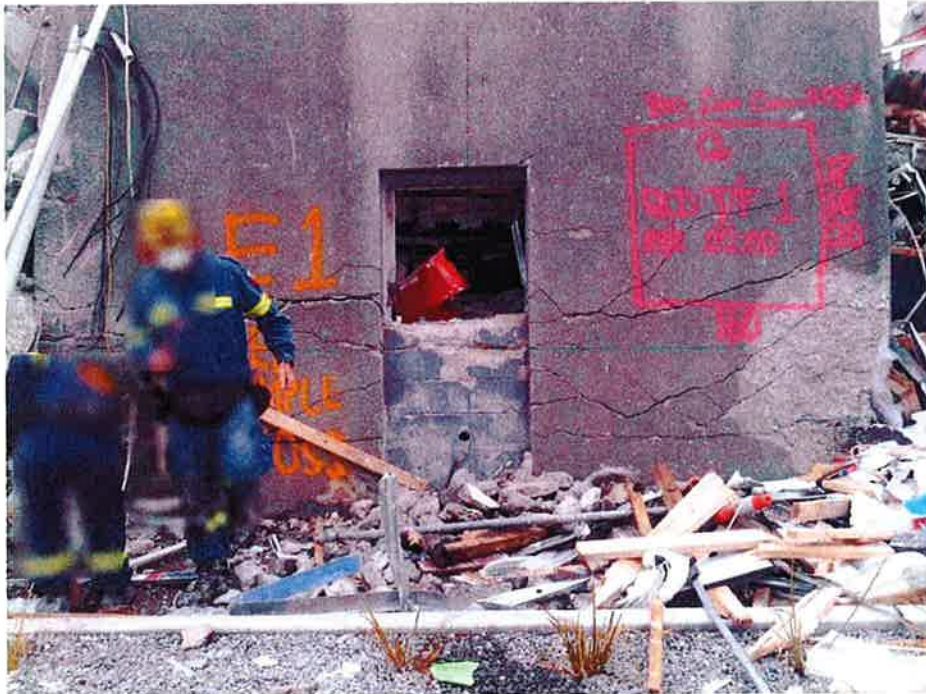
Figure 82 - Line 1 South Wall at Level 1 showing masonry in-fill at door opening, in-plane flexural fan-like cracking and spalling of concrete at right (east) end. A portion of profile slab can be seen end on through the opening

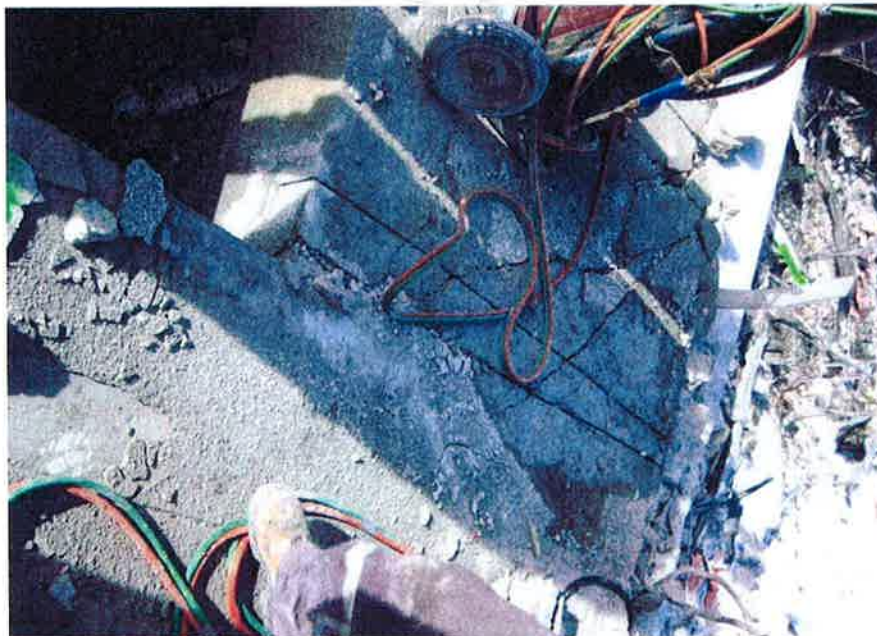
Figure 83 – Line 1 South wall at Level 4 showing severe diagonal cracking in east panel.

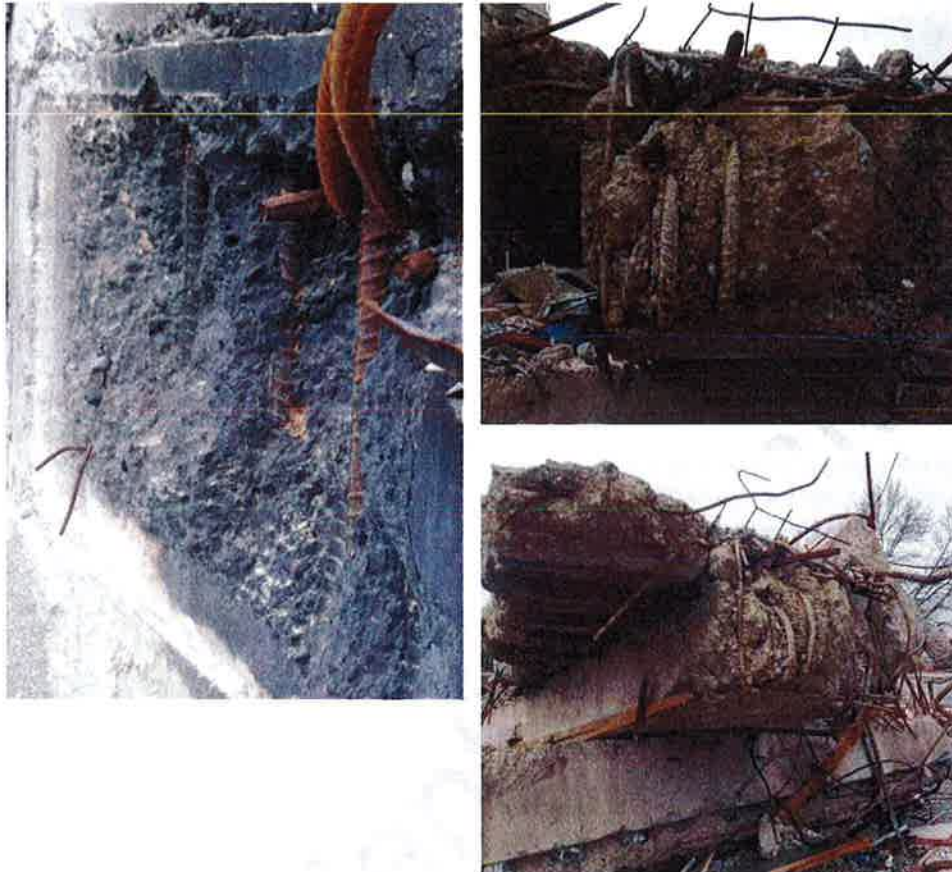
Figure 94 - Precast shell beam (Item E14) from northern face Grid 4, west side of North Core (DENG B23 Dwg S18). (clockwise from top right) (a) to (b) Fractured slab outstand remnant at east end from which slab concrete cores were extracted. The bottom H24 bars from shell beam have been turned back into the concrete infill rather than embedded in shear wall as specified (DENG Detail 5 Dwg S19). Notice the bar imprint on wall at the connection seen in (c) at Level 4 and at Level 3.. This meant that these beams would not have performed as intended.

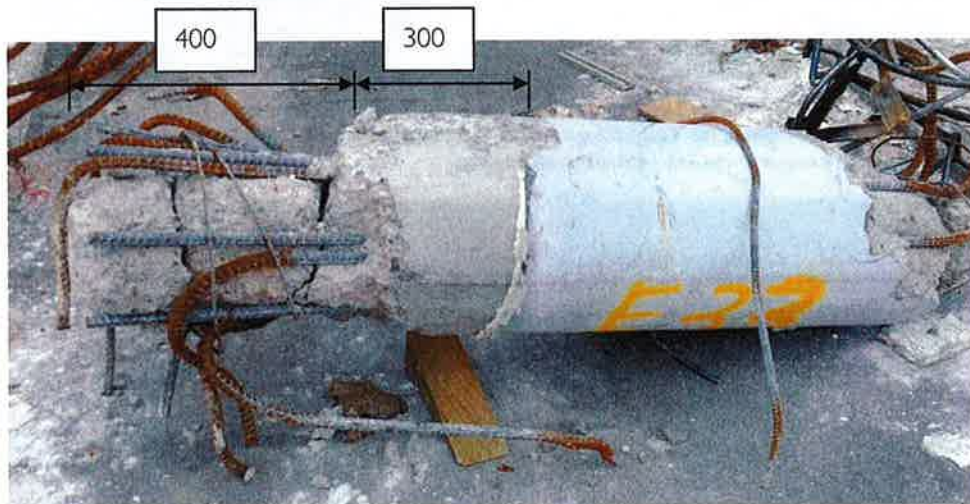
Figure 95 - 400 Diameter Exterior Column Item E33. (DENG C5 or C11, Dwg S15). Left end is bottom of column at floor level with concrete spalling over lapped vertical reinforcing. Horizontal cracking in core confined by R6 spiral which had fractured. The unpainted portion was protected by Spandrel Panels.. Right-hand end fracture occurred below beam-column joint.

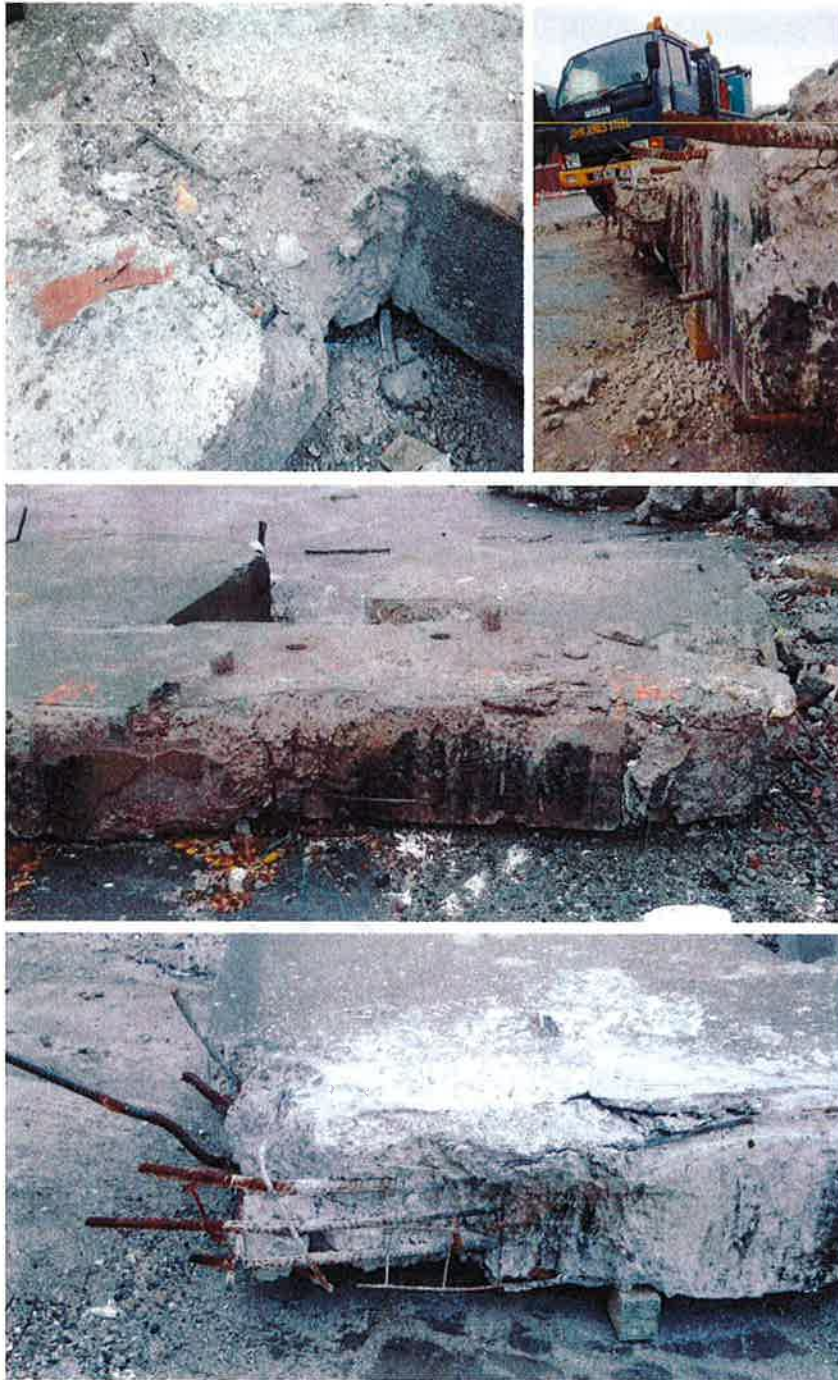
Figure 101 - Line 1 South Wall Level 5 to Level 6 (Item E5) (clockwise from top left) (a) Crumbly concrete at door edge of west pier able to be dislodged by boot; (b) Smooth and charred construction joint on top west surface looking east; (c) Charred construction joint above west pier. Door sill on left; (d); Top east corner with fractured top 3-H24 bars. Floor 664 mesh exposed.

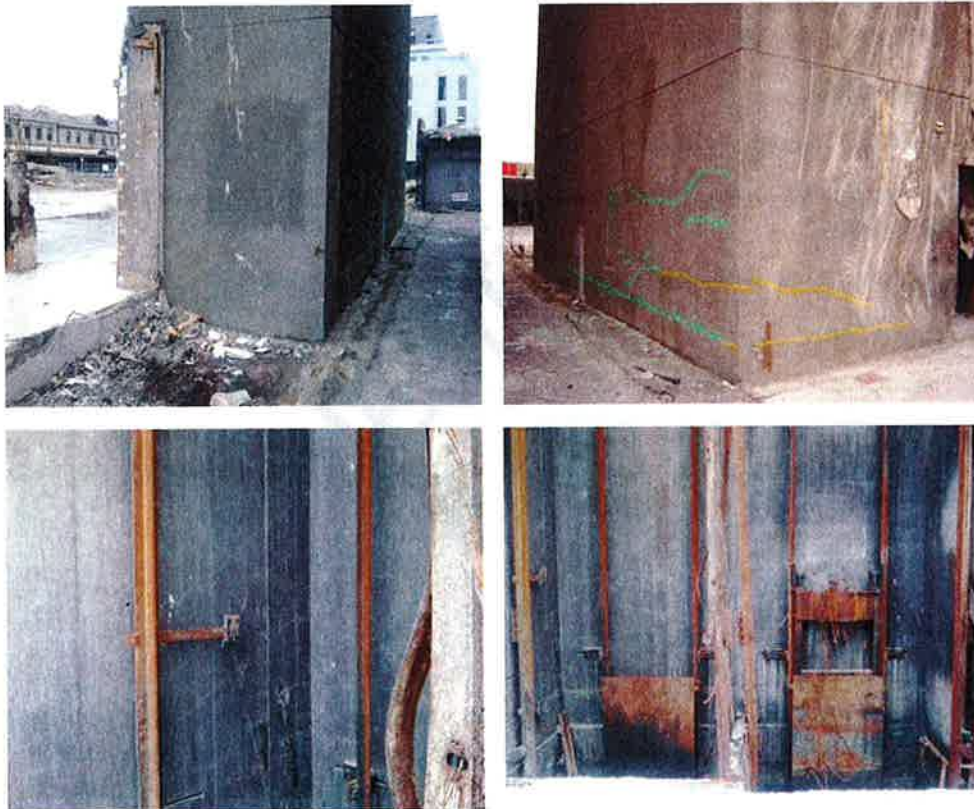
Figure 102 - North Core cracking (clockwise from top left) (a) No obvious cracking on Line D/E wall; (b) Horizontal flexural cracking on west and north west face of Line 5 wall and north end of Line C wall at Line C/5; (c) Fine two-way diagonal cracking on the inside faces of Level 1 to 2 Line 5; (d) and D walls in North Core.

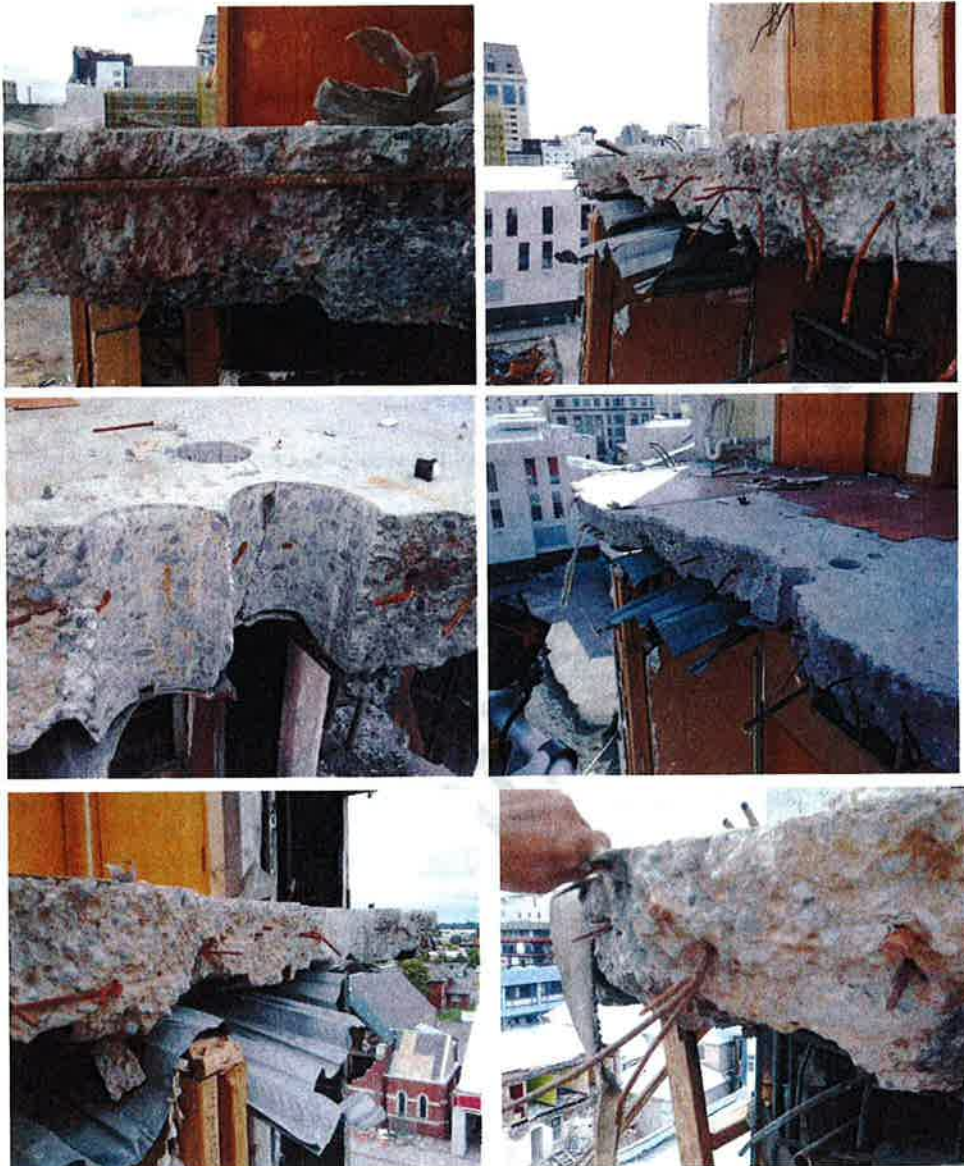
Figure 103 - Line 4 Core Wall Slab Remnant at Level 6 amenity area (clockwise from top left) (a) Slab edge on stairwell wall looking west with H12 saddle bar exposed and ends of mesh below it; (b) Vertical concrete fracture surface with reinforcing mesh fractured; (c) Slab looking west with cores cut in floor for amenities; (d) Fractured mesh angled downwards; (e) Fractured slab edge looking east. Torn metal decking aligned approximately with concrete fracture edge; mesh at varying height within slab; (f) Cores for amenities at fracture edge can be seen and are a small proportion of the total fracture surface length.

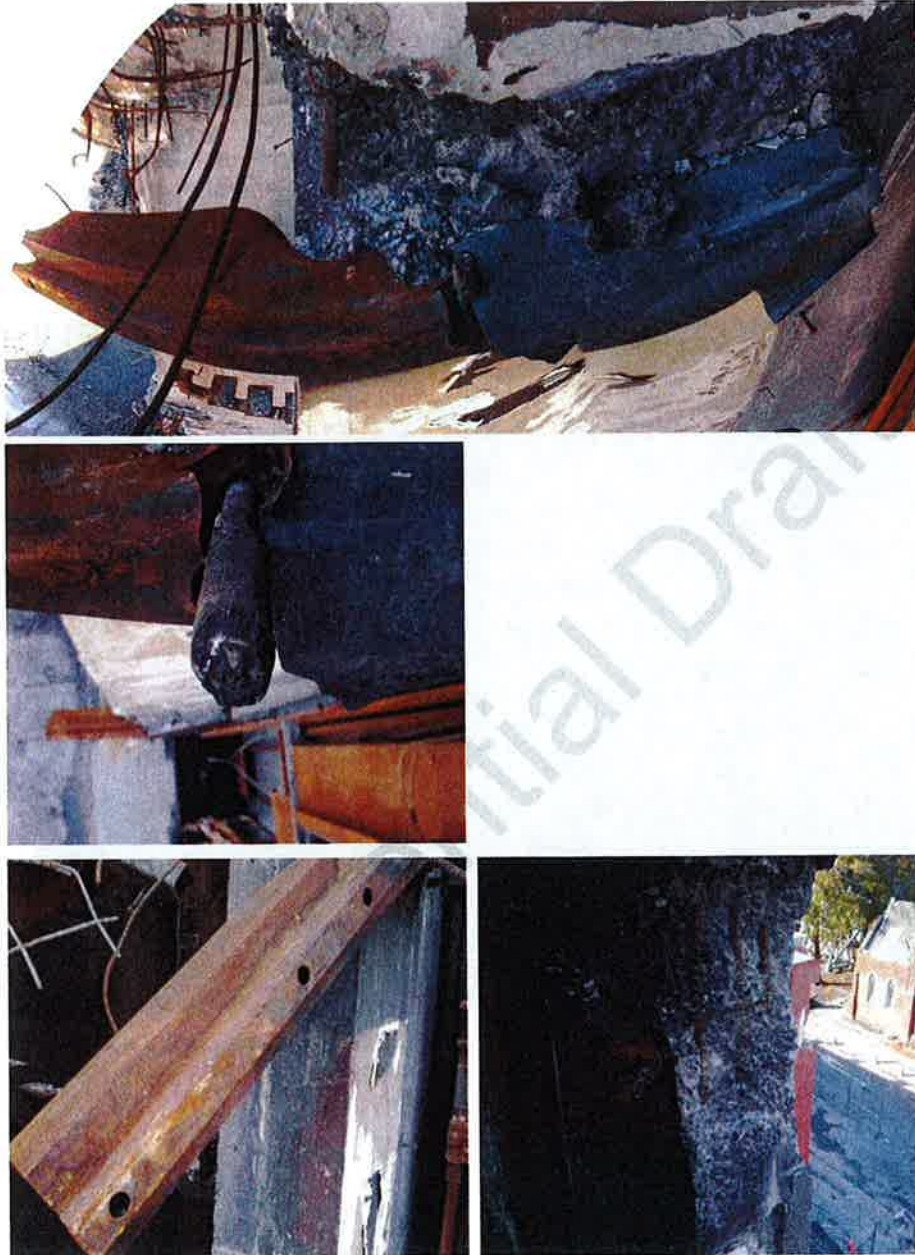
Figure 104 - Level 5 Lift Well Wing Walls Grid D and D/E (anti-clockwise from top) (a) the Drag Bar consisted of a 150x150x10 L steel angle with a 51 x 3.2 SHS welded to it; 4-M24 anchors were epoxied into the wall and 6-M20 threaded anchor rods 350 mm long were epoxied into the slab at the profiled metal deck rib. 3-M20 threaded rods remained upright on the Grid D Drag Bar. The 51x3.2 SHS had fractured in bending and tension at the bolt hole adjacent to last bolt into wall and twisted with the slab; This shows that the slab that had been fixed to the Drag Bar had rotated downwards as the column on Line 4 D/E collapsed, (b) Epoxy grout can be seen around the threaded anchor rod that had been in the slab; (c) The drag Bar is bent downwards and holes where 3-M20 threaded anchor rods had been can be seen; d) On Wall D/E a 150x75x10 L steel Drag Bar was still fixed into the wall D/E with 5-M24 threaded rod anchors. The end of the Drag Bar had been gas cut during deconstruction.

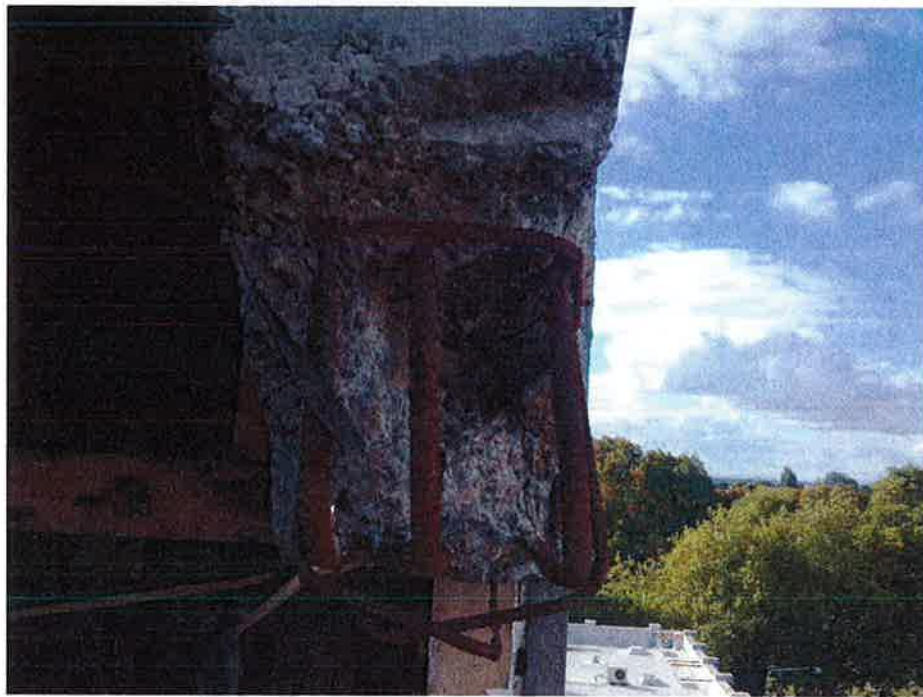
Figure 105 - Lift Well Wing Wall D/E: Column D/E 4 Connection (DENG Dwg S14); 3 x 20 to 24 mm diameter holes can be seen where reinforcing bars from column have pulled out. The drawing shows that 4-H20 bars were required to be bent in to the wall.
