CTV BUILDING

CTV BUILDING COLLAPSE INVESTIGATION FOR DEPARTMENT OF BUILDING AND HOUSING 5TH DECEMBER 2011

CTV BUILDING COLLAPSE REPORT

Report Issue Date: 7 December 2011

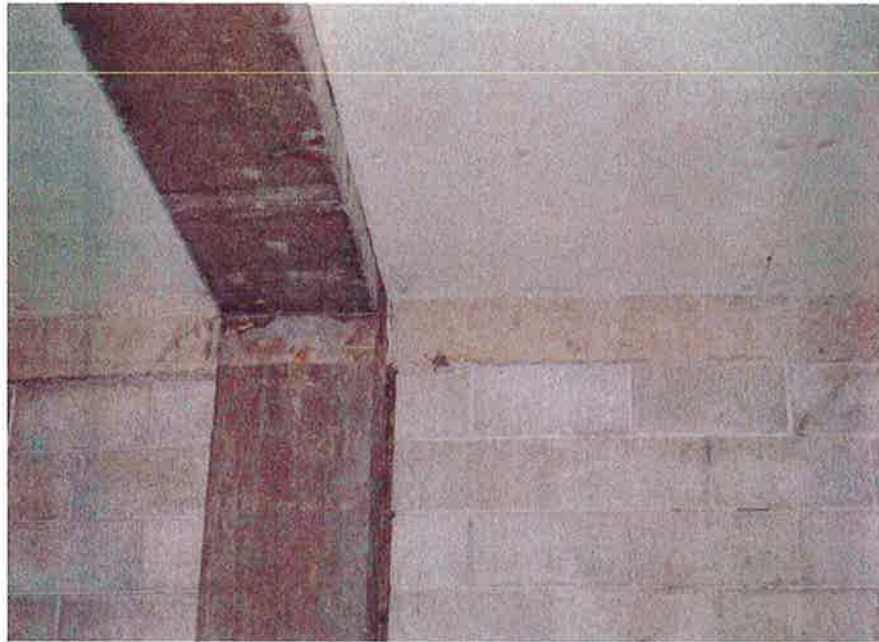
Figure 118 - Line A infill masonry wall adjacent to column with no obvious cracking after the 4 September earthquake. Flexible sealant is visible between masonry and column.

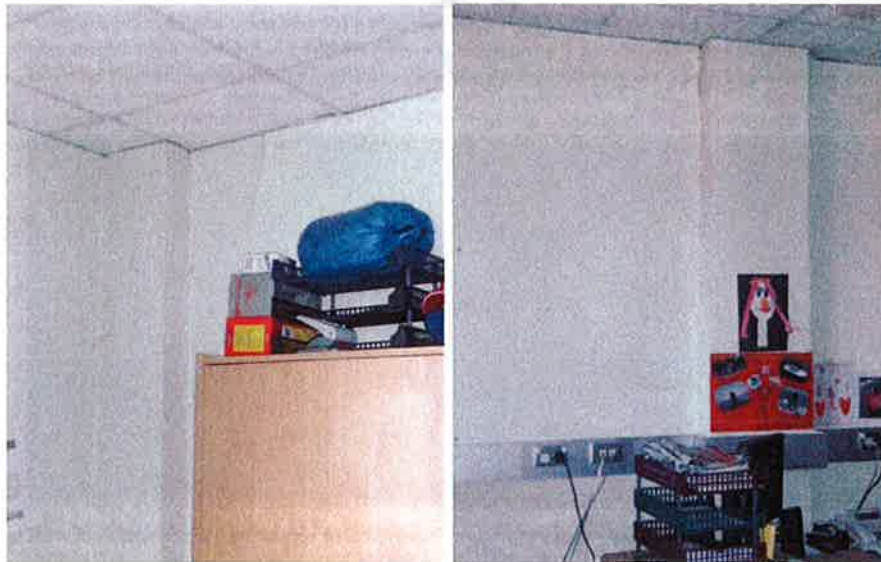
Figure 119 - Inside of the west wall at Level 2 after the 4 September 2010 Earthquake shows some damage to the linings.

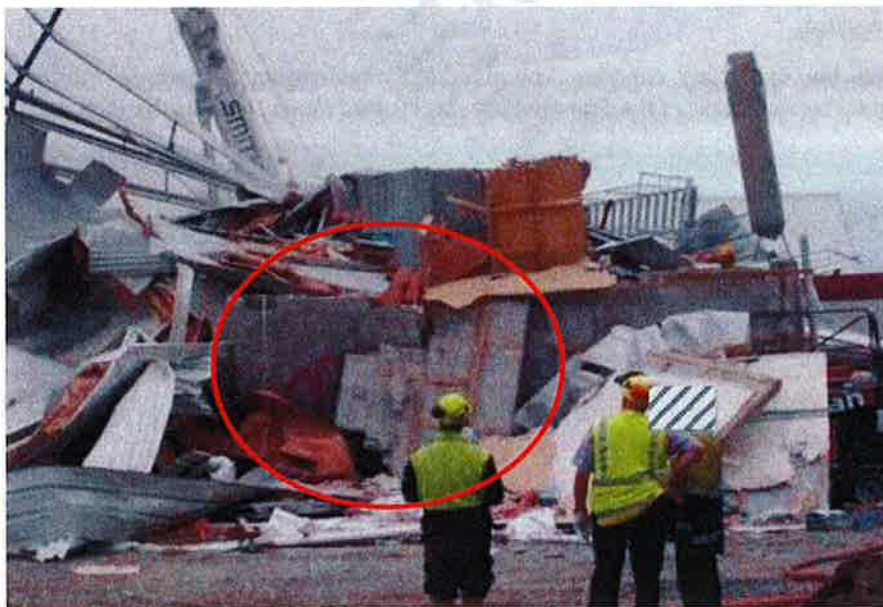
Figure 121 - West wall shortly after collapse. The corner Grid 1/A column is still standing and the wall panels have broken free in panel sections in places. The edges of the panel section are square consistent with the design drawings. Diagonal fracture of the masonry infill that has fallen outwards from level 2 is highlighted. This indicates that the infill masonry above Level 2 fully developed its shear capacity prior to the collapse and therefore affected the response of the structure to the Aftershock.

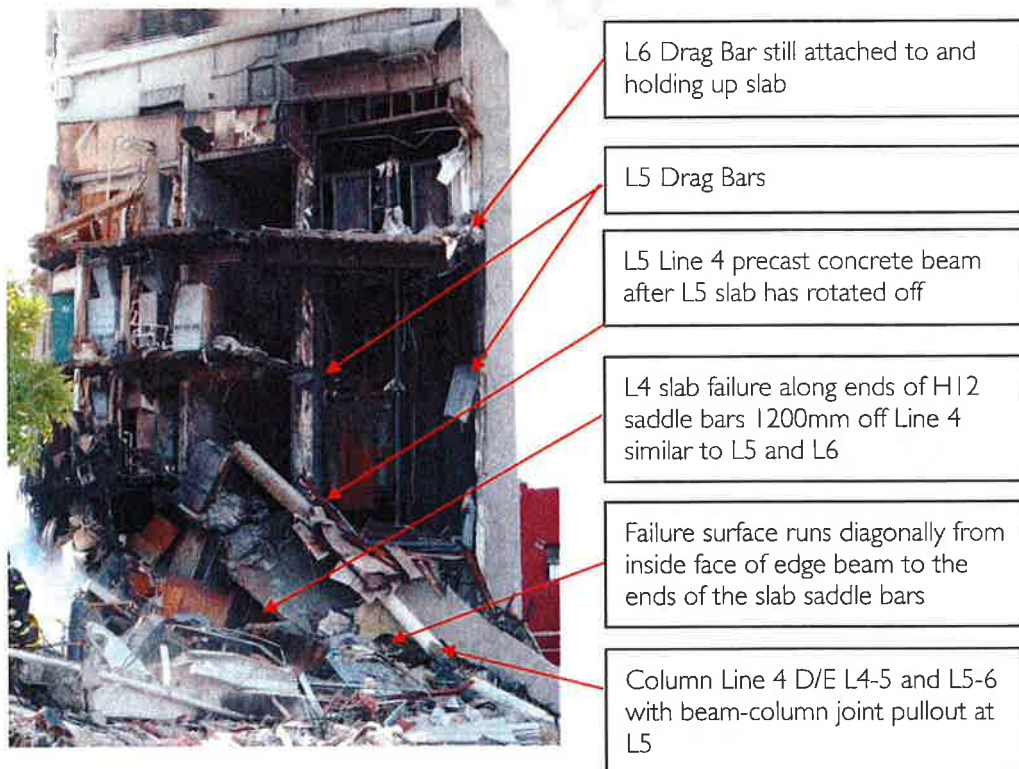
Figure 128 - Failure of slab adjacent to North Core.
