I, **PAUL ARTHUR CAMPBELL** of Auckland, Structural Engineer, state:

601/601A Colombo Street

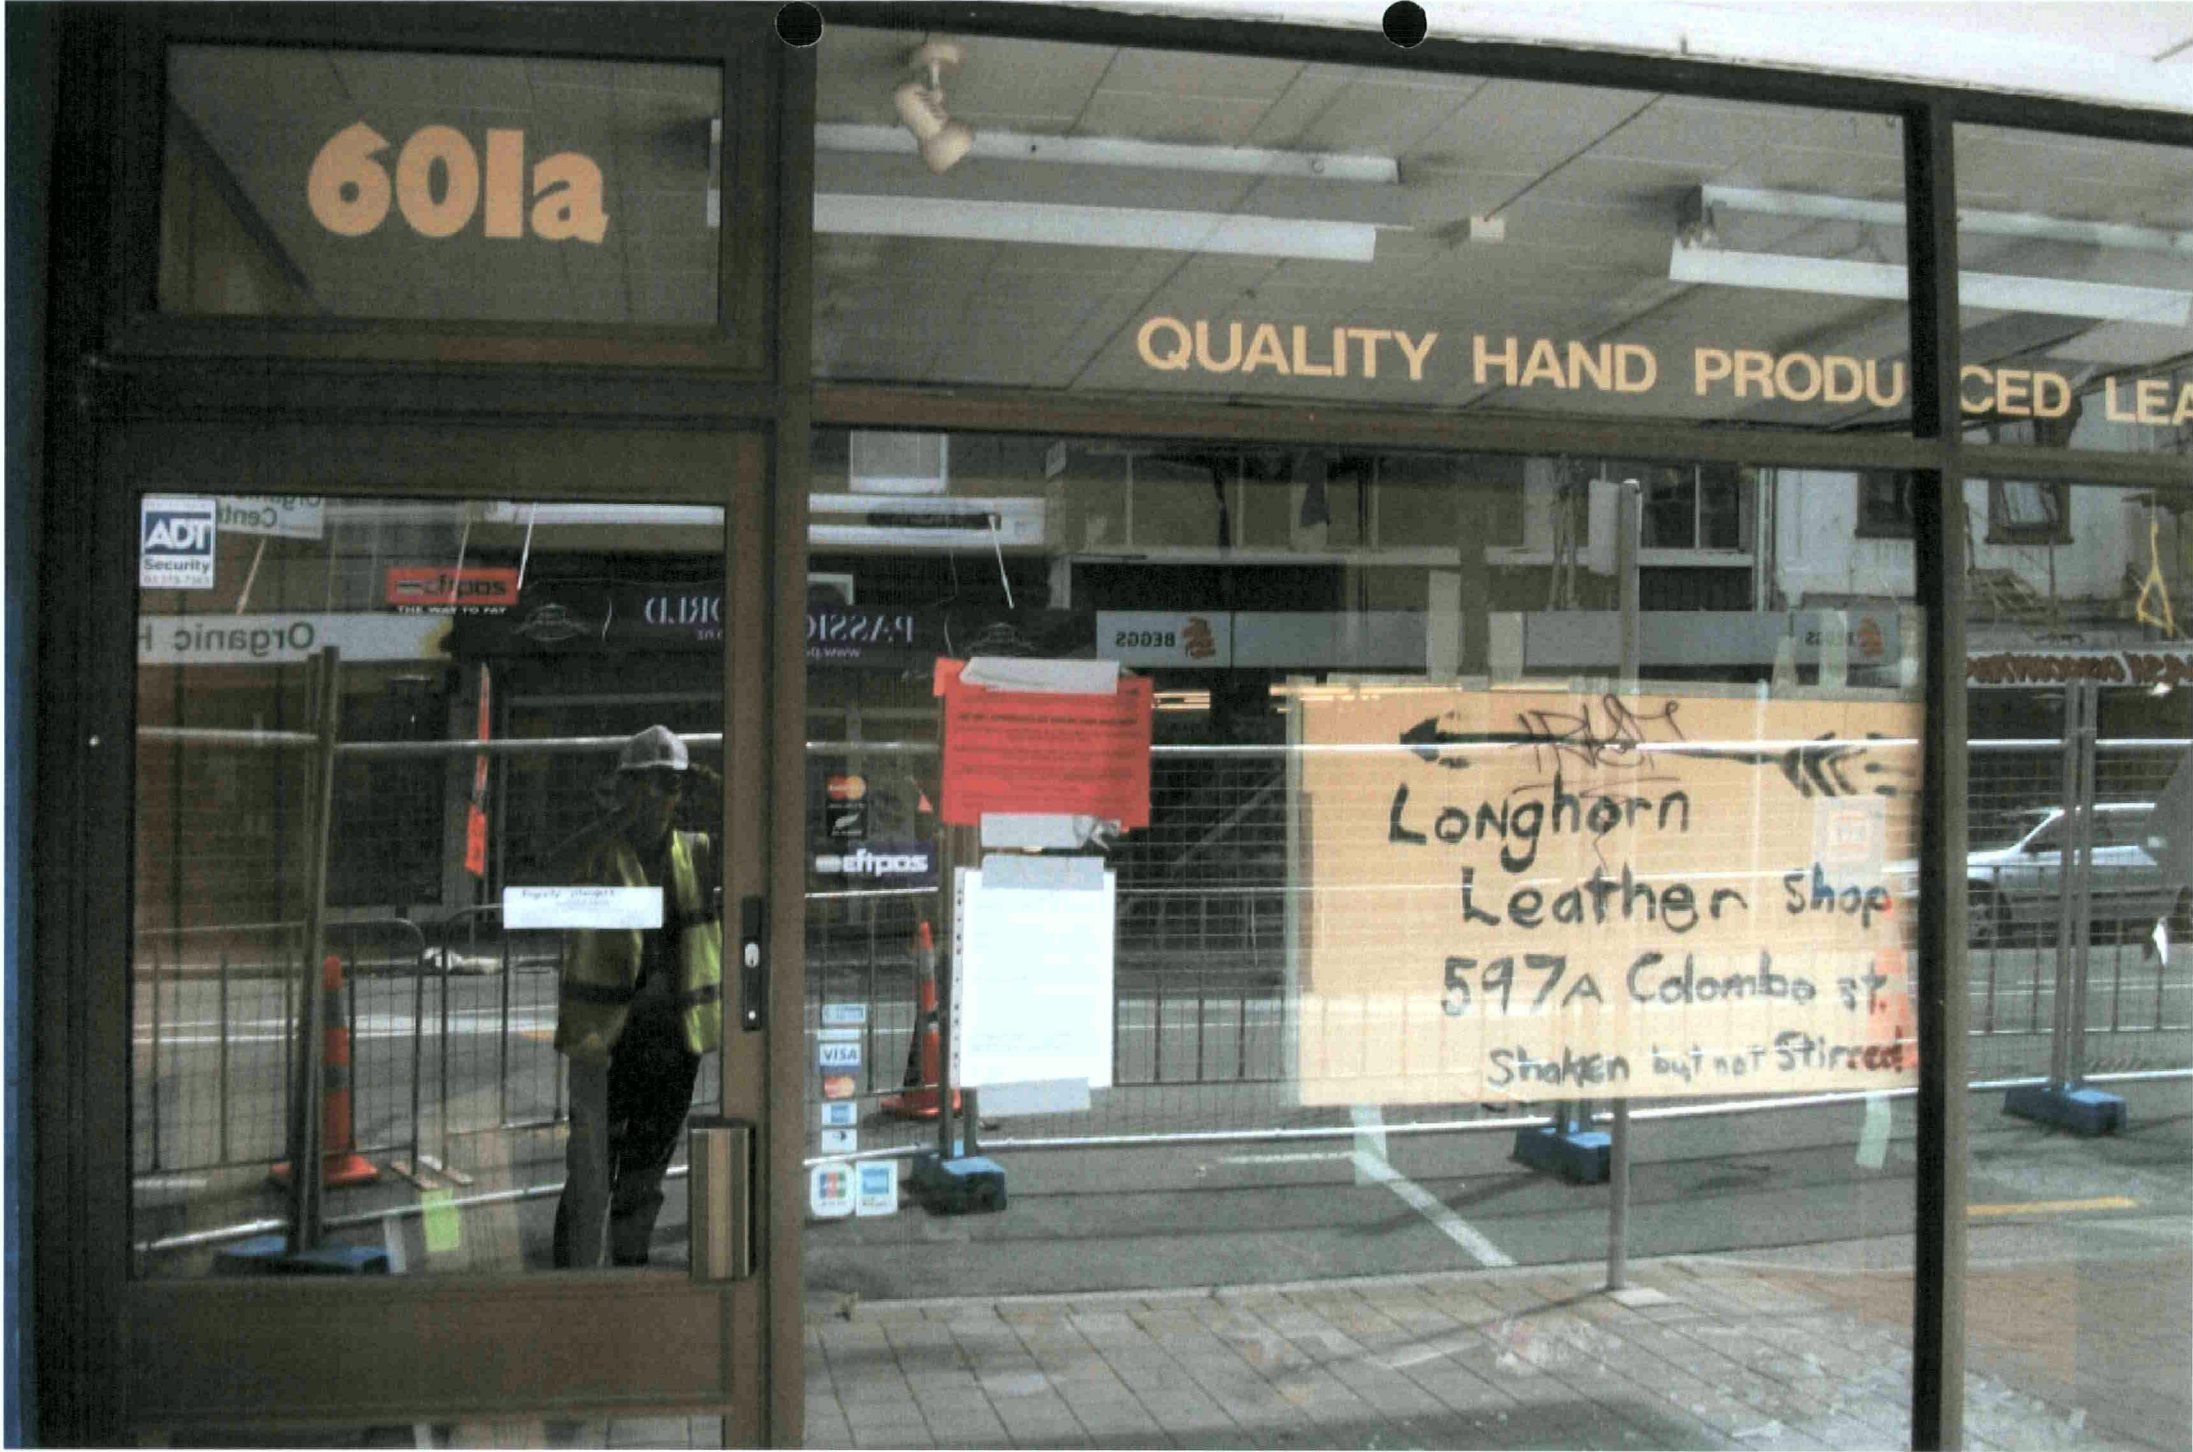
13. I recommended that the existing cordons remain. I refer [**annexure**] to a photograph I took at the time of one of my inspections on 31 January or 14 February (I am the figure in the photograph). Two rows of cordon are visible in front of 601 and 601A. The outer row is the pedestrian lane in the road, and the inner row is the fencing preventing entry to the footpath area. This inner row of cordon extended approximately to the boundary of number 601 to the left of the photograph, and to the right of the photograph preventing access to Mollett Street.

15. From my external visual inspection I considered that the existing cordoning was adequate pending a structural evaluation and any recommended remedial works. It was adequate in my view because all of Mollett Street below the worst affected area of the building was cordoned. The cordoning along the Colombo Street frontage extended to about the edge of the car parking lane, recognizing that the parapet was damaged and could fail.

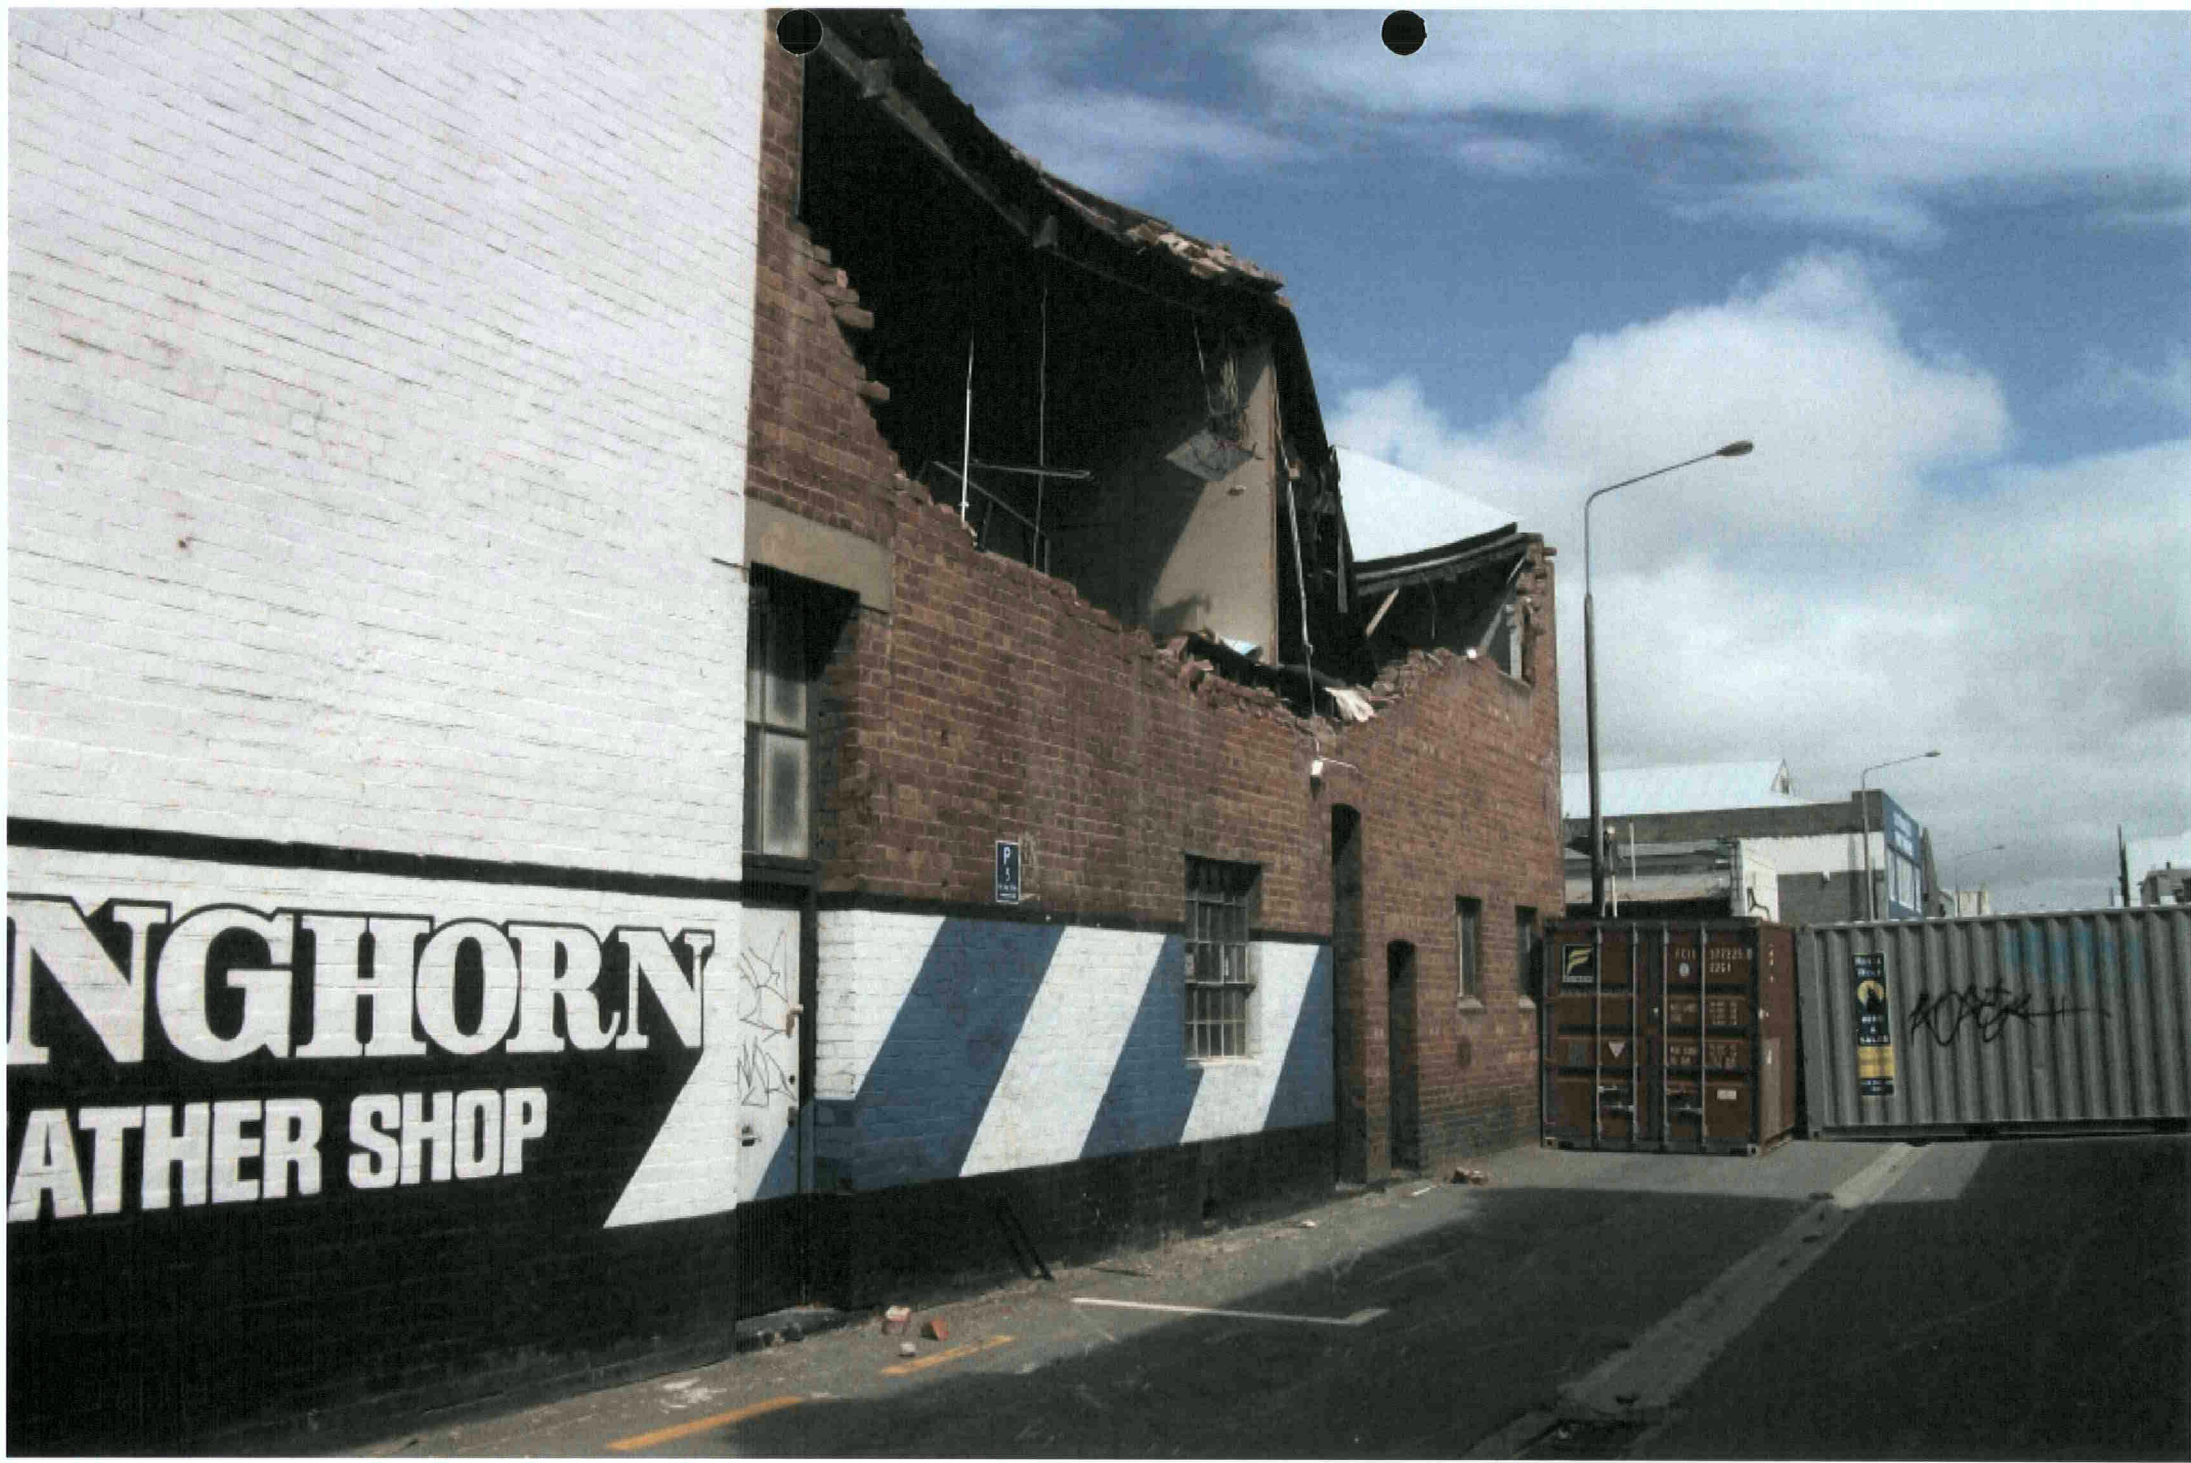
14. Cordoning of the building against access being gained from the west end of Mollett Street had been effected by shipping containers. I have located a photograph on the Council file which shows this [**annexure**]. I may have taken this photograph at the time of one of my inspections.
