**Brief of evidence of Richard George Seville relating to 593 Colombo
Street for hearing week commencing 12 December 2011**

Project Name 593 Colombo St

Project Name 593 Colombo Street
 Project No: 105380.71
 S.R. No: I
 Date: 4 October 2010
 Reviewed By: Paul Roberts

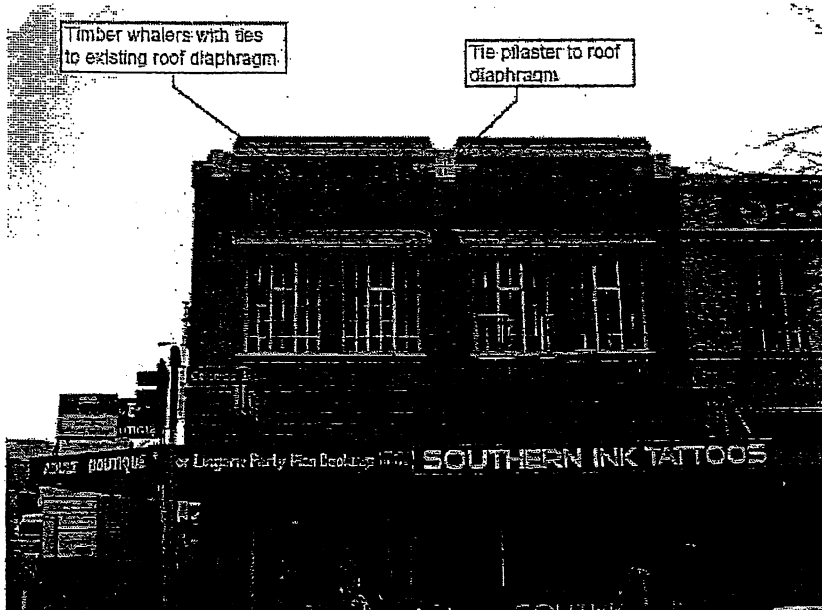
1. On the east wall, HCG observed a 10-20mm gap between the timber framed floor and brick façade. This displacement was also observed from outside. See Figure 1 for a suggested temporary strengthening scheme.
2. At the south wall, a 10-20mm gap was observed between the timber framed floor and brick façade. See Figure 2 for a suggested temporary strengthening scheme.
3. At the West wall, above the 1st floor ceiling, the brick wall appears to be leaning outwards. See Figure 3 for a suggested temporary strengthening scheme. The top of this wall may require removal depending on further investigation.
4. At the North side, no gaps between the floors and brick walls was observed. The façade appears to be in good condition.
