re MAURICE KENNEDY LTD, 593A Colombo Street

SEISMIC RISK BUILDINGS - SURVEY

Project Name 593 Colombo St
 Project No: 105380.71
 S.R. No: 001
 Date: 24 September 2010
 Reviewed By: Alistair Boys

SITE REPORT

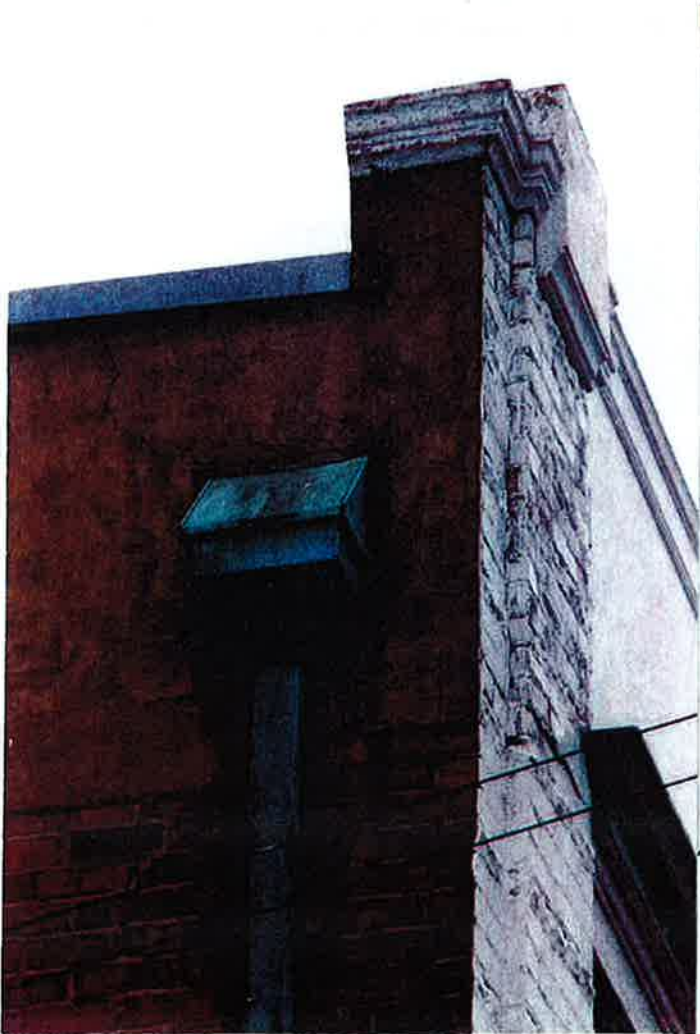
GRACKS DOWN
FROM CAP, THROUGH
MORTAR TO FRONT
ELEVATION

CRACK IN HEAVY PARAPET.

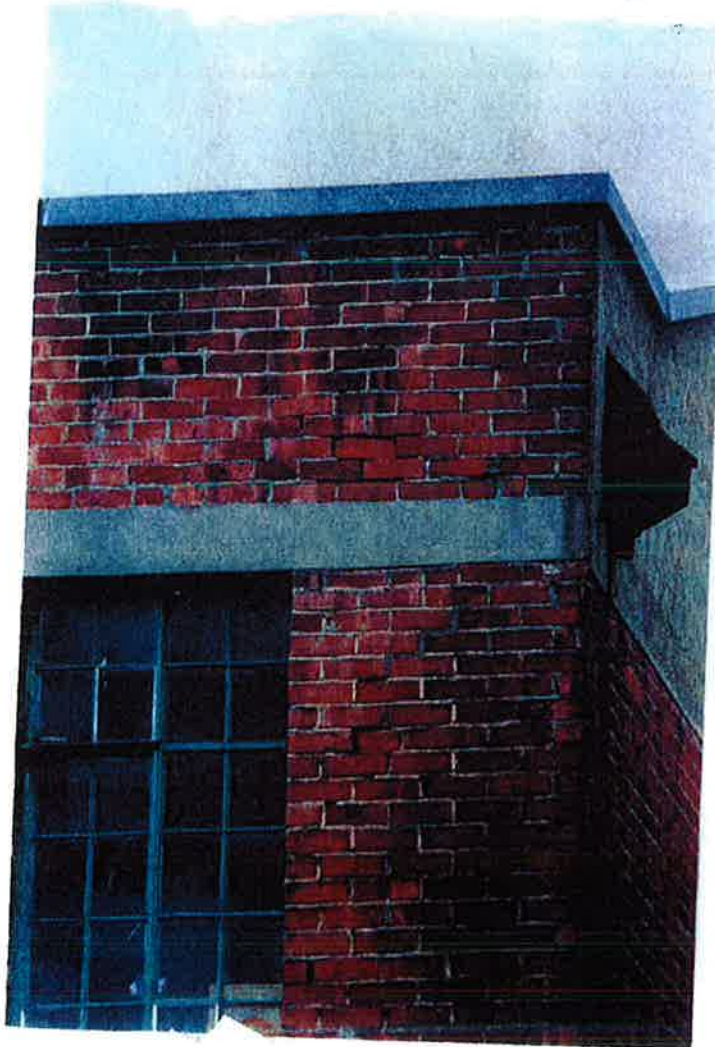
MORTAR
DETERIORATION
AT REAR OF
BUILDING

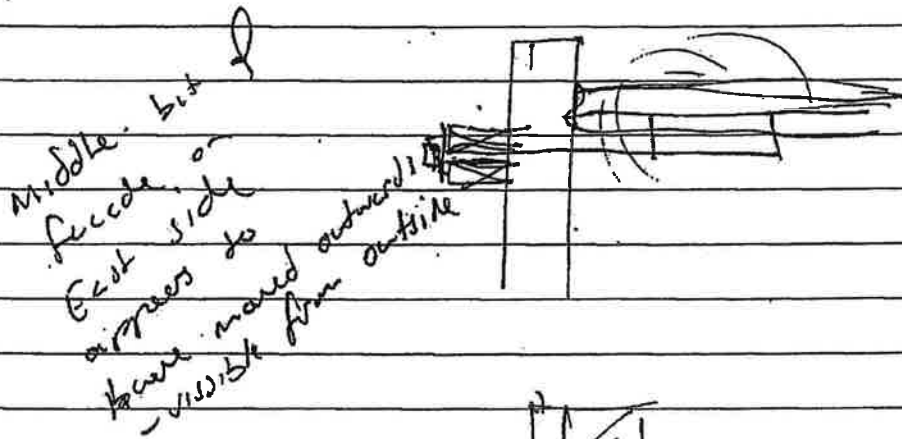
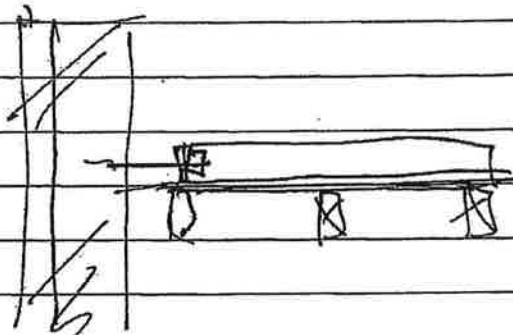
South & East facade appear to have
moved away. From 1st floor a roof
display $\approx 10-20m$ in some places,

visible from 1st floor inside

→ Western end wall - top appears to have
moved out

⇒ CHERRY PICKER & INSPECT FROM ROOF OR REMOVE LATH & PLASTER TO INSPECT TIES BETWEEN ROOF & WALL (POTENTIALLY L2 FLOOR TIES)
