**INDEPENDENT ASSESSMENT ON EARTHQUAKE PERFORMANCE
OF
593 Colombo Street**

**FOR
Royal Commission of Inquiry into building failure
caused by the Canterbury Earthquakes**

**Report prepared by Peter C Smith and Jonathan W Devine
OF
Spencer Holmes Ltd**

November 2011

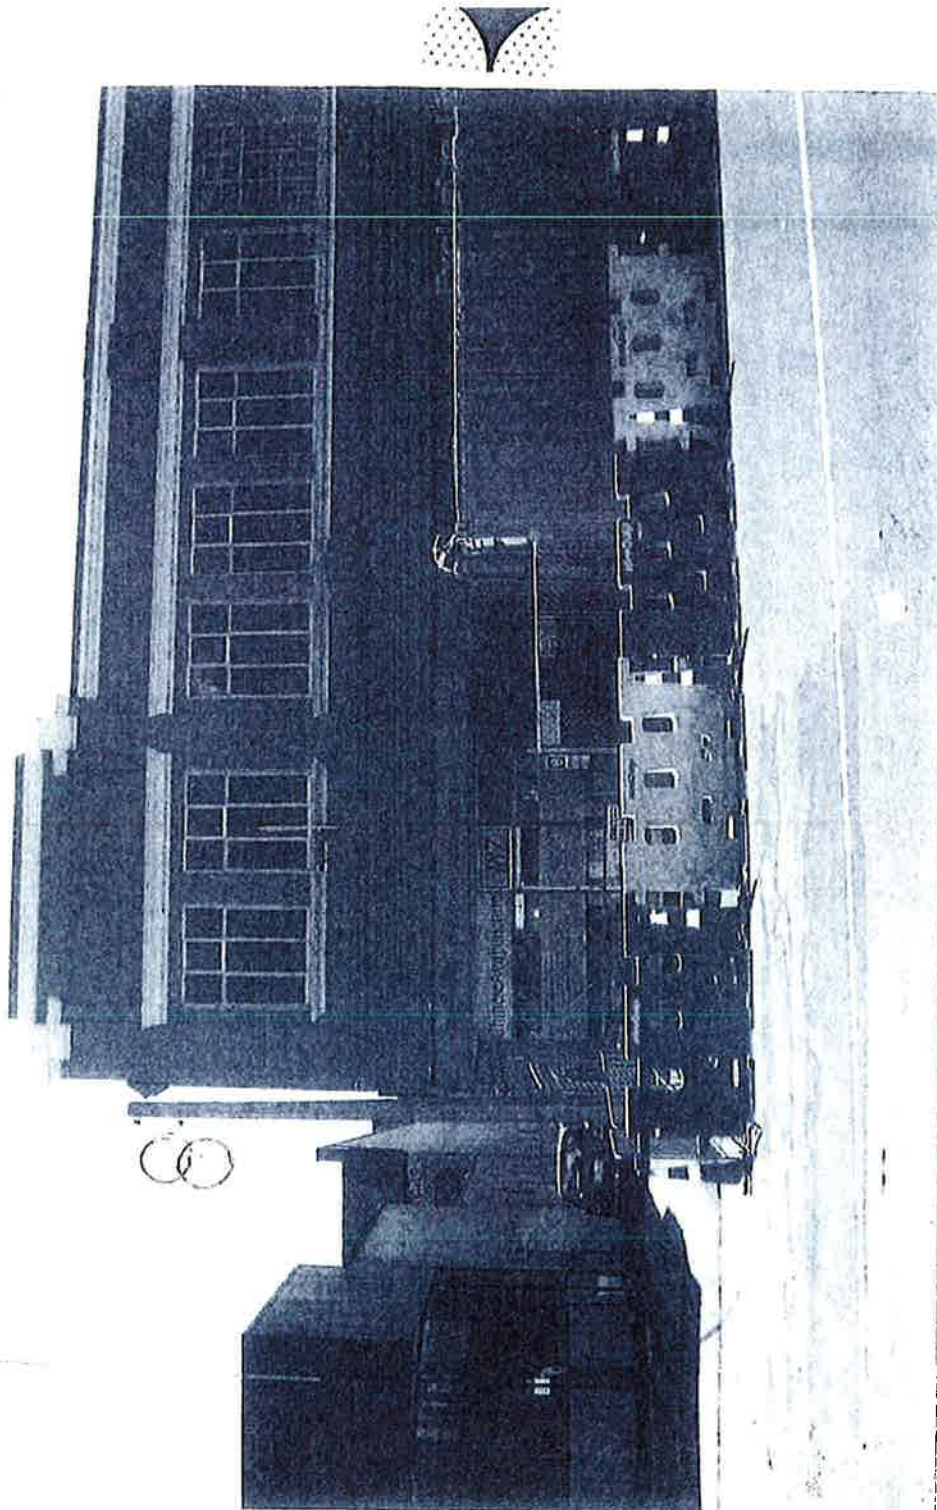
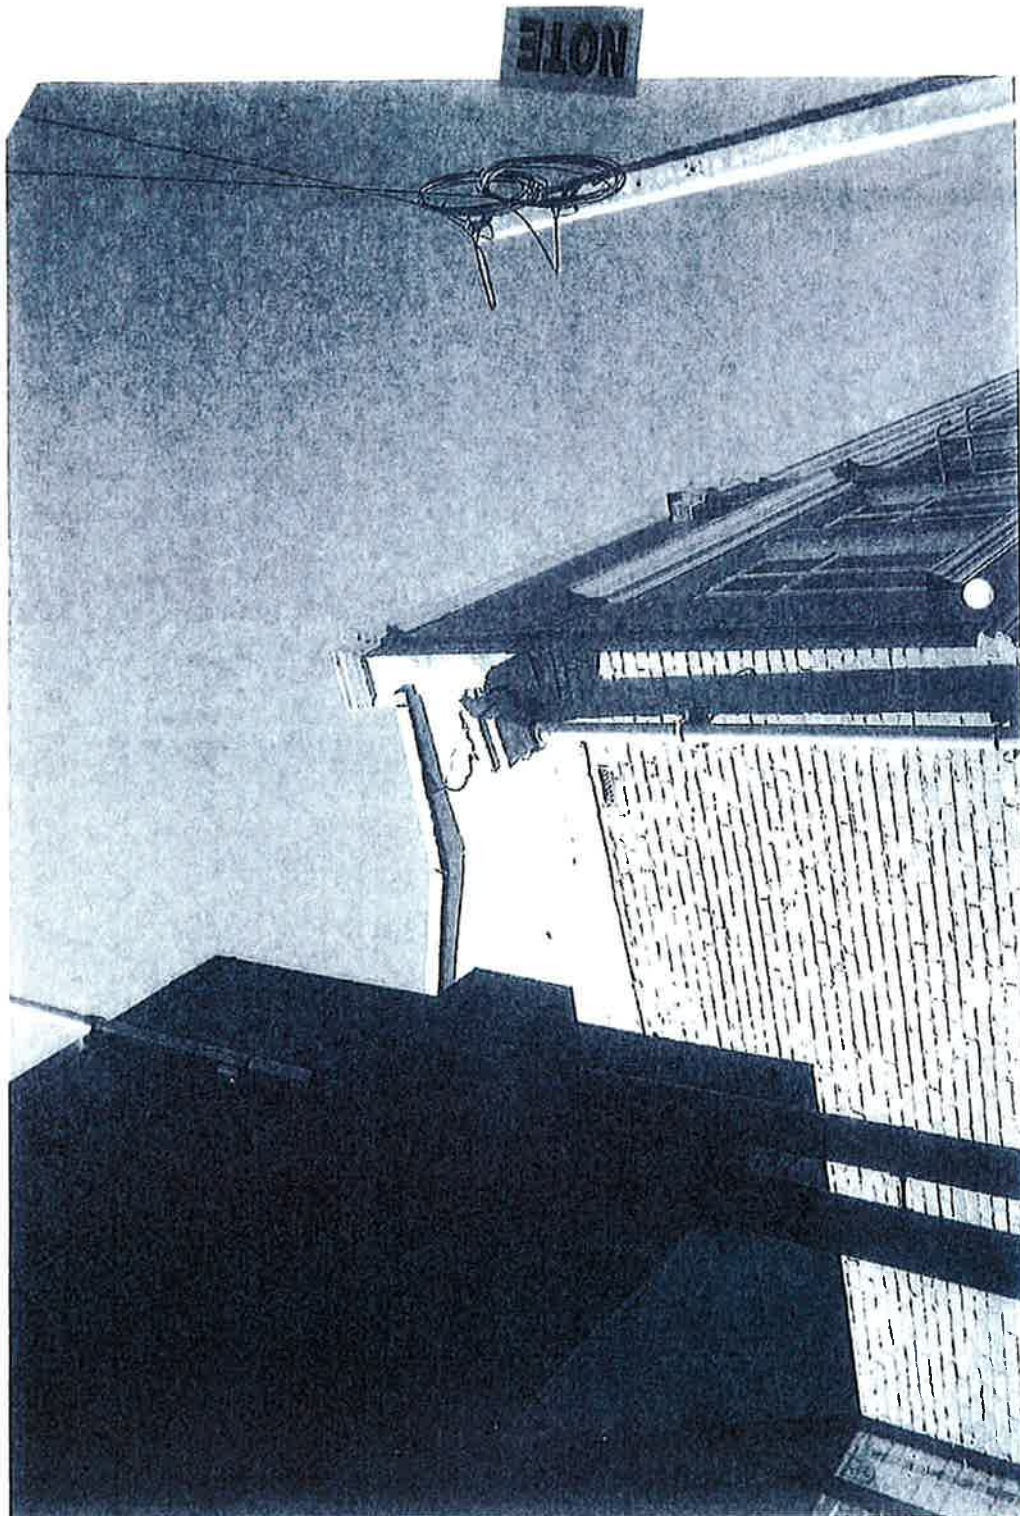
Condition of Building following 4th September 2010 earthquake

Following the 4th September, 2010 earthquake a Rapid Assessment-Level 1 of the tenancy at 187 St Asaph Street was undertaken on 5th September, 2010. The tenancy at 187 St Asaph Street integrally connected to the tenancy 593 Colombo Street. The inspection identified that “Parapet badly cracked. Risk of further collapse”. That tenancy was given a yellow sticker.

A Rapid Assessment-Level 1 was also undertaken on the buildings at 593 to 599A Colombo Street on the 5th September, 2010. The Rapid Assessment-Level 1 recorded “Minor cracking of masonry. Smashed windows at 595 Colombo, soffit of verandah buckled. Minor interior cracking in one upstairs unit inspected”. The building was given a green placard.

Personnel from Holmes Consulting Group inspected the building again on the 4th October, 2010. A site report records that a 10mm to 20mm gap was identified on the east wall between the timber framed floor and the brick façade. The displacement was observable from the exterior. A 10mm to 20mm gap was observed between the timber framed floor and the brick façade to the south wall. The west wall above first floor ceiling level was identified to be leaning outward. No gaps were identified between the floor and brick walls on the north side. The engineers commented that the façade appeared to be in good condition. Holmes Consulting Group provided the building owners with suggested temporary strengthening work to the east, west and south wall with the site reports of the 4th October, 2010.

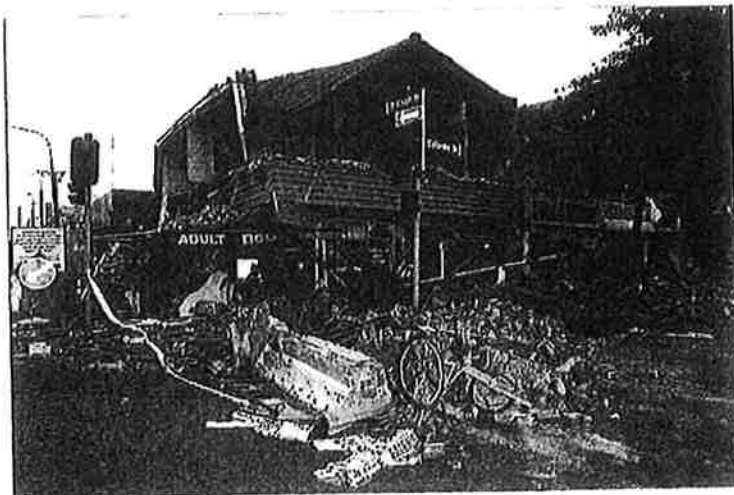
27

The building suffered significant damage in the 22nd February, 2011 earthquake with the upper floor facades to both St Asaph Street and to Colombo Street falling outwards. The building was inspected on 19th March, 2011 and assigned a red placard. A recommendation was made to "Demolish Entire Block".

The first floor façades of the building failed by an outward rotation of the façades above the first floor support in the severe shaking during the 22nd February, 2011 earthquake. These walls separated from the internal walls, party walls and adjoining façade with near vertical cracking near the junction between the walls.

Building damage following 22nd February 2011 earthquake
