Canterbury Earthquakes Royal Commission
Te Komihana Rūwhenua a te Karauna

593 Colombo Street

The Royal Commission of Inquiry is currently inquiring into the failure of a number of buildings in the Christchurch CBD, including the building at 593 Colombo Street (the Building).

**Canterbury Earthquakes Royal Commission - Requirement for
Information dated 28 October 2011
Re: 593 Colombo Street**

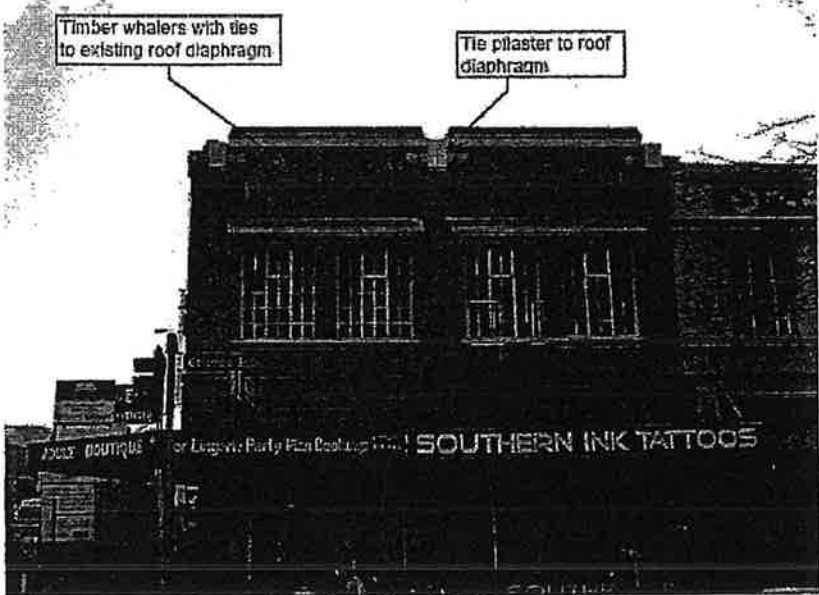
1. On the east wall, HCG observed a 10-20mm gap between the timber framed floor and brick façade. This displacement was also observed from outside. See Figure 1 for a suggested temporary strengthening scheme.
2. At the south wall, a 10-20mm gap was observed between the timber framed floor and brick façade. See Figure 2 for a suggested temporary strengthening scheme.
3. At the West wall, above the 1st floor ceiling, the brick wall appears to be leaning outwards. See Figure 3 for a suggested temporary strengthening scheme. The top of this wall may require removal depending on further investigation.
4. At the North side, no gaps between the floors and brick walls was observed. The façade appears to be in good condition.

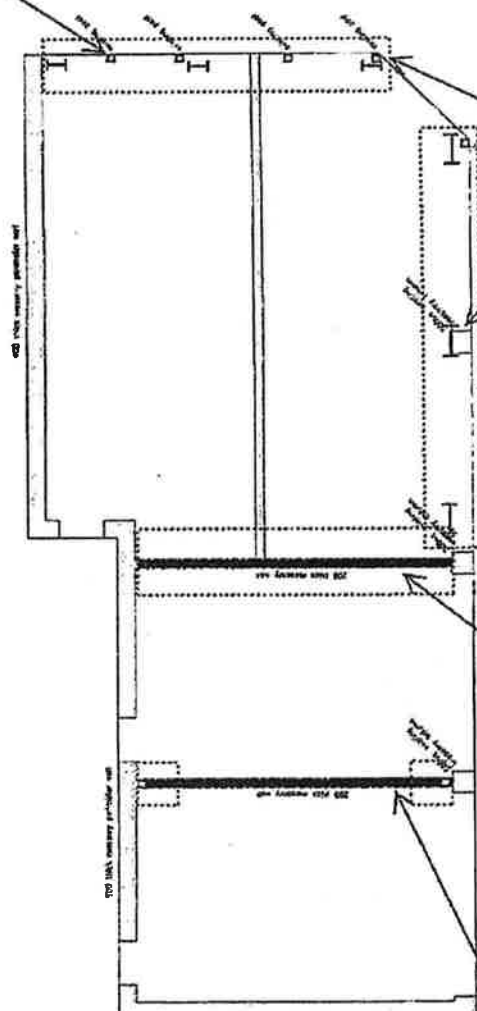
ground floor plan

1. Noticeable lateral displacements in slender steel columns. Replace existing columns with 150x150x6 SHS columns.

1. Damaged brick bearing & chase wall
 A) Repair/replace existing damaged brick wall or
 B) Remove existing damaged wall and place new beam at 1st floor to support 1st floor framing. Support walls of new wall 150x150x6 SHS columns and 400x400x1200 drop pad supports.

1. Damaged brick bearing & chase wall. Remove brick wall and replace with 200mm thick concrete wall with 2 - X012 bars at 400 c/c each way. 600x1200 concrete topping below this wall.

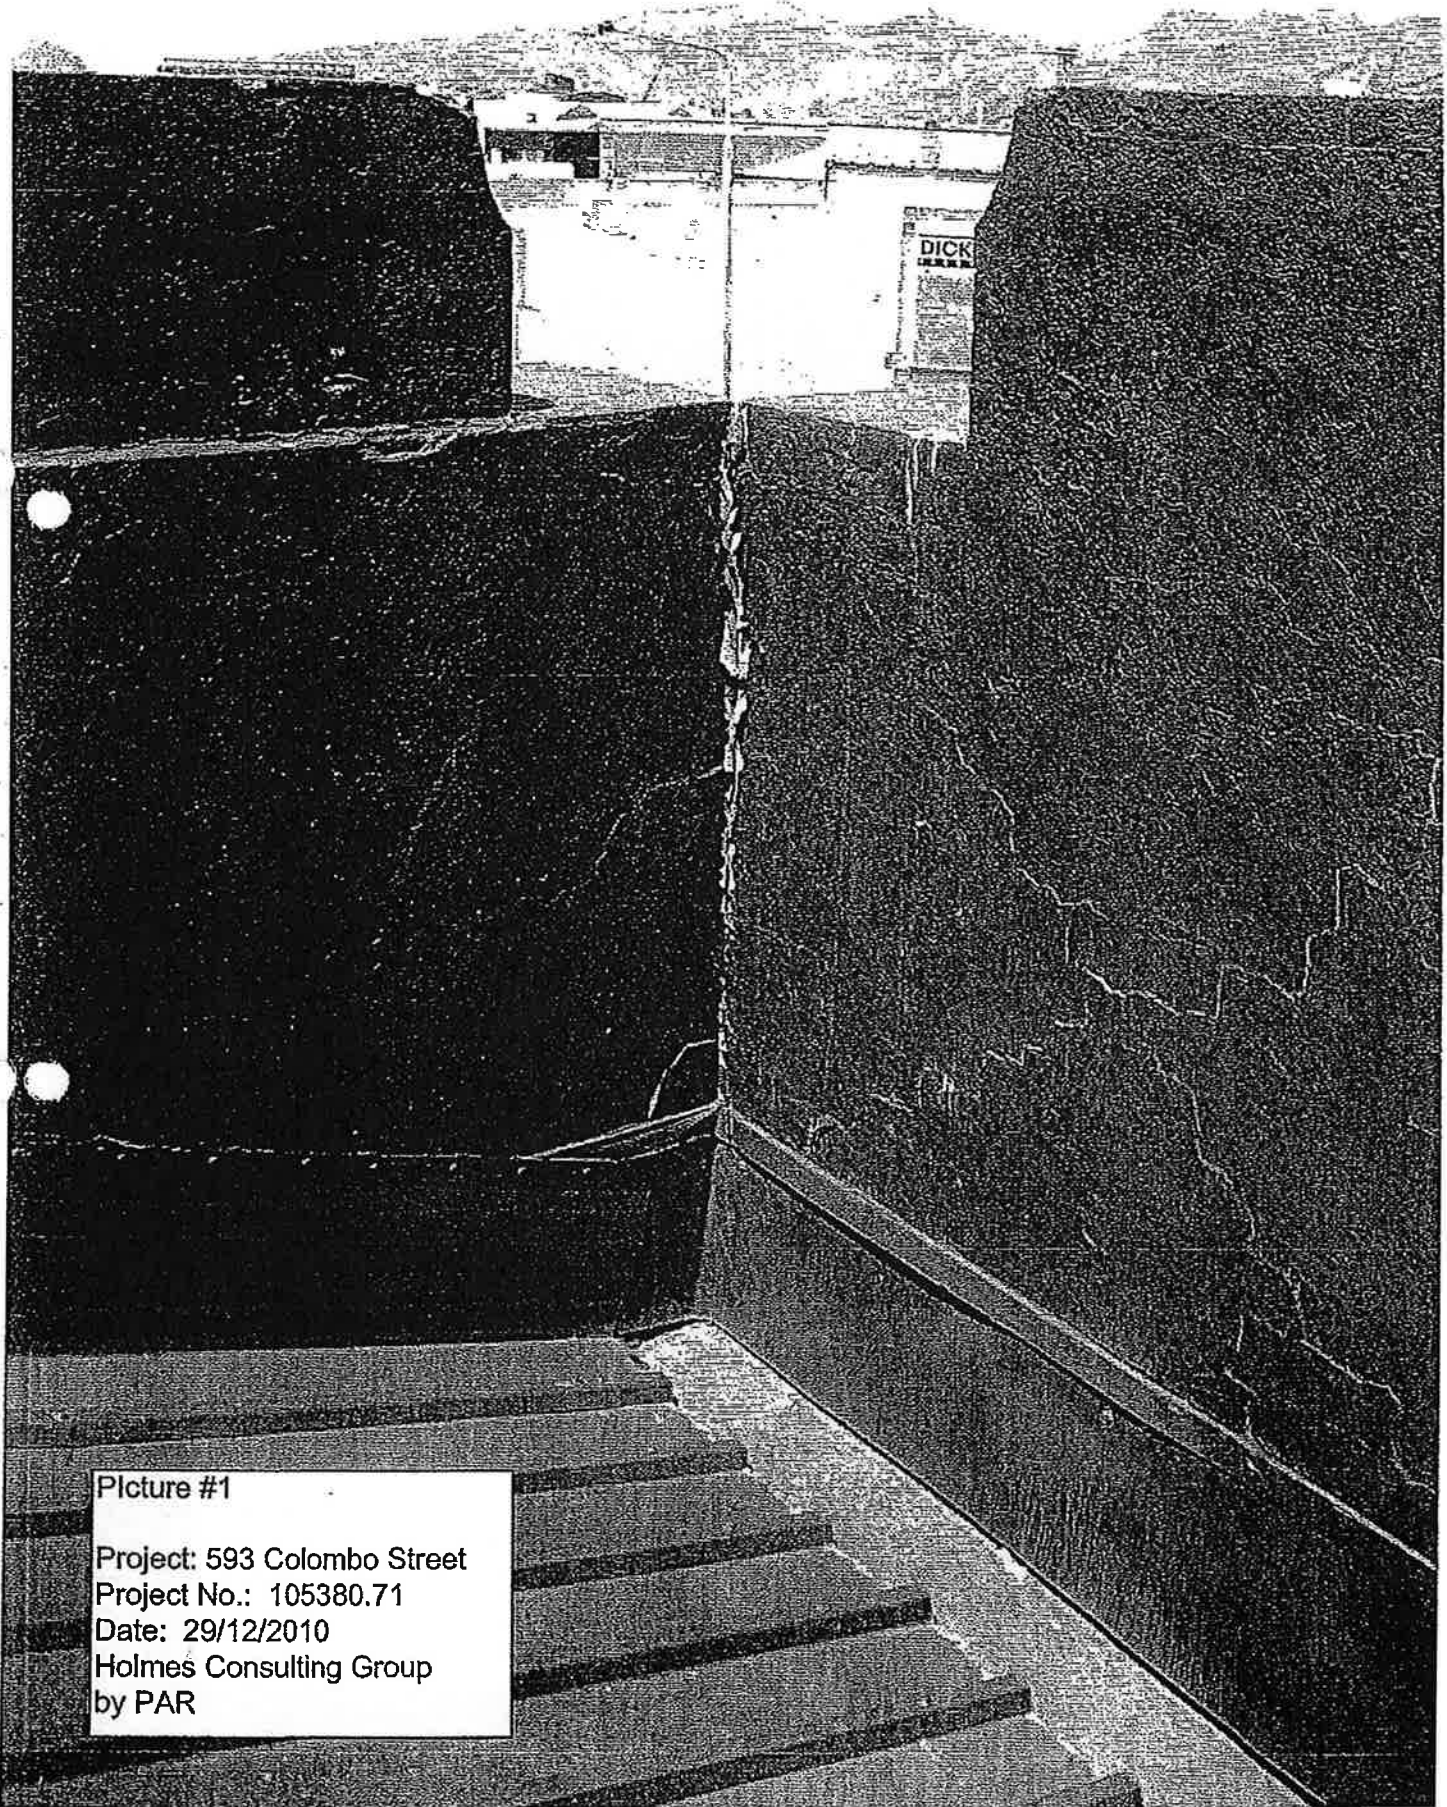
Picture #1

cracks seen from inside face of east side of south parapet. See picture #1

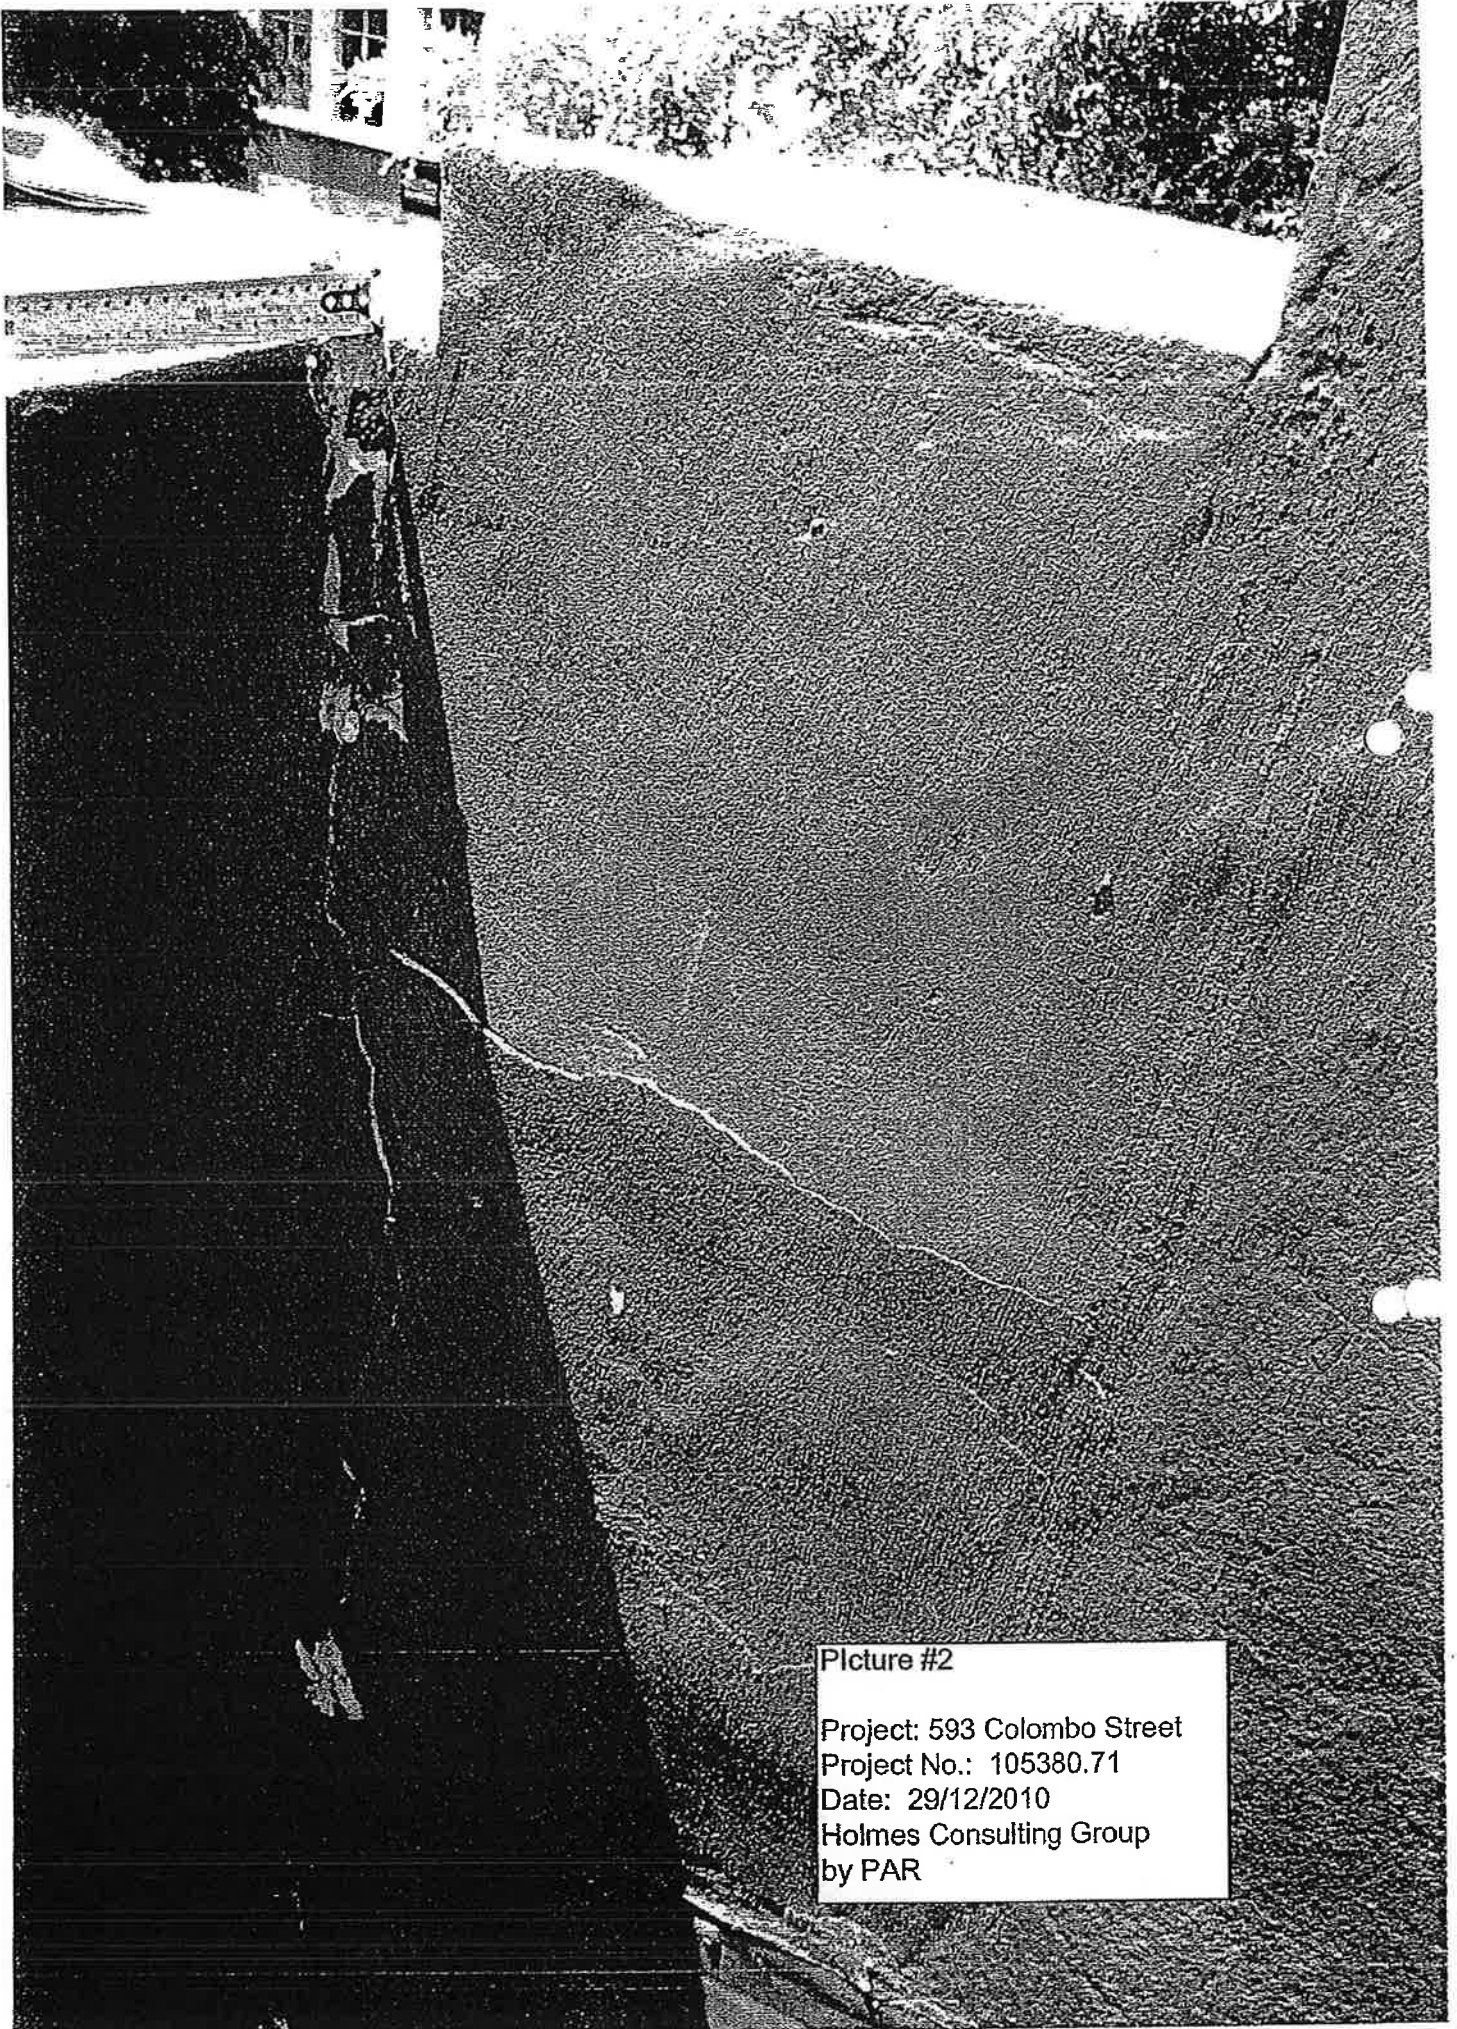
Picture #2

Parapet deflecting outward from corner. See pictures #2 & 3

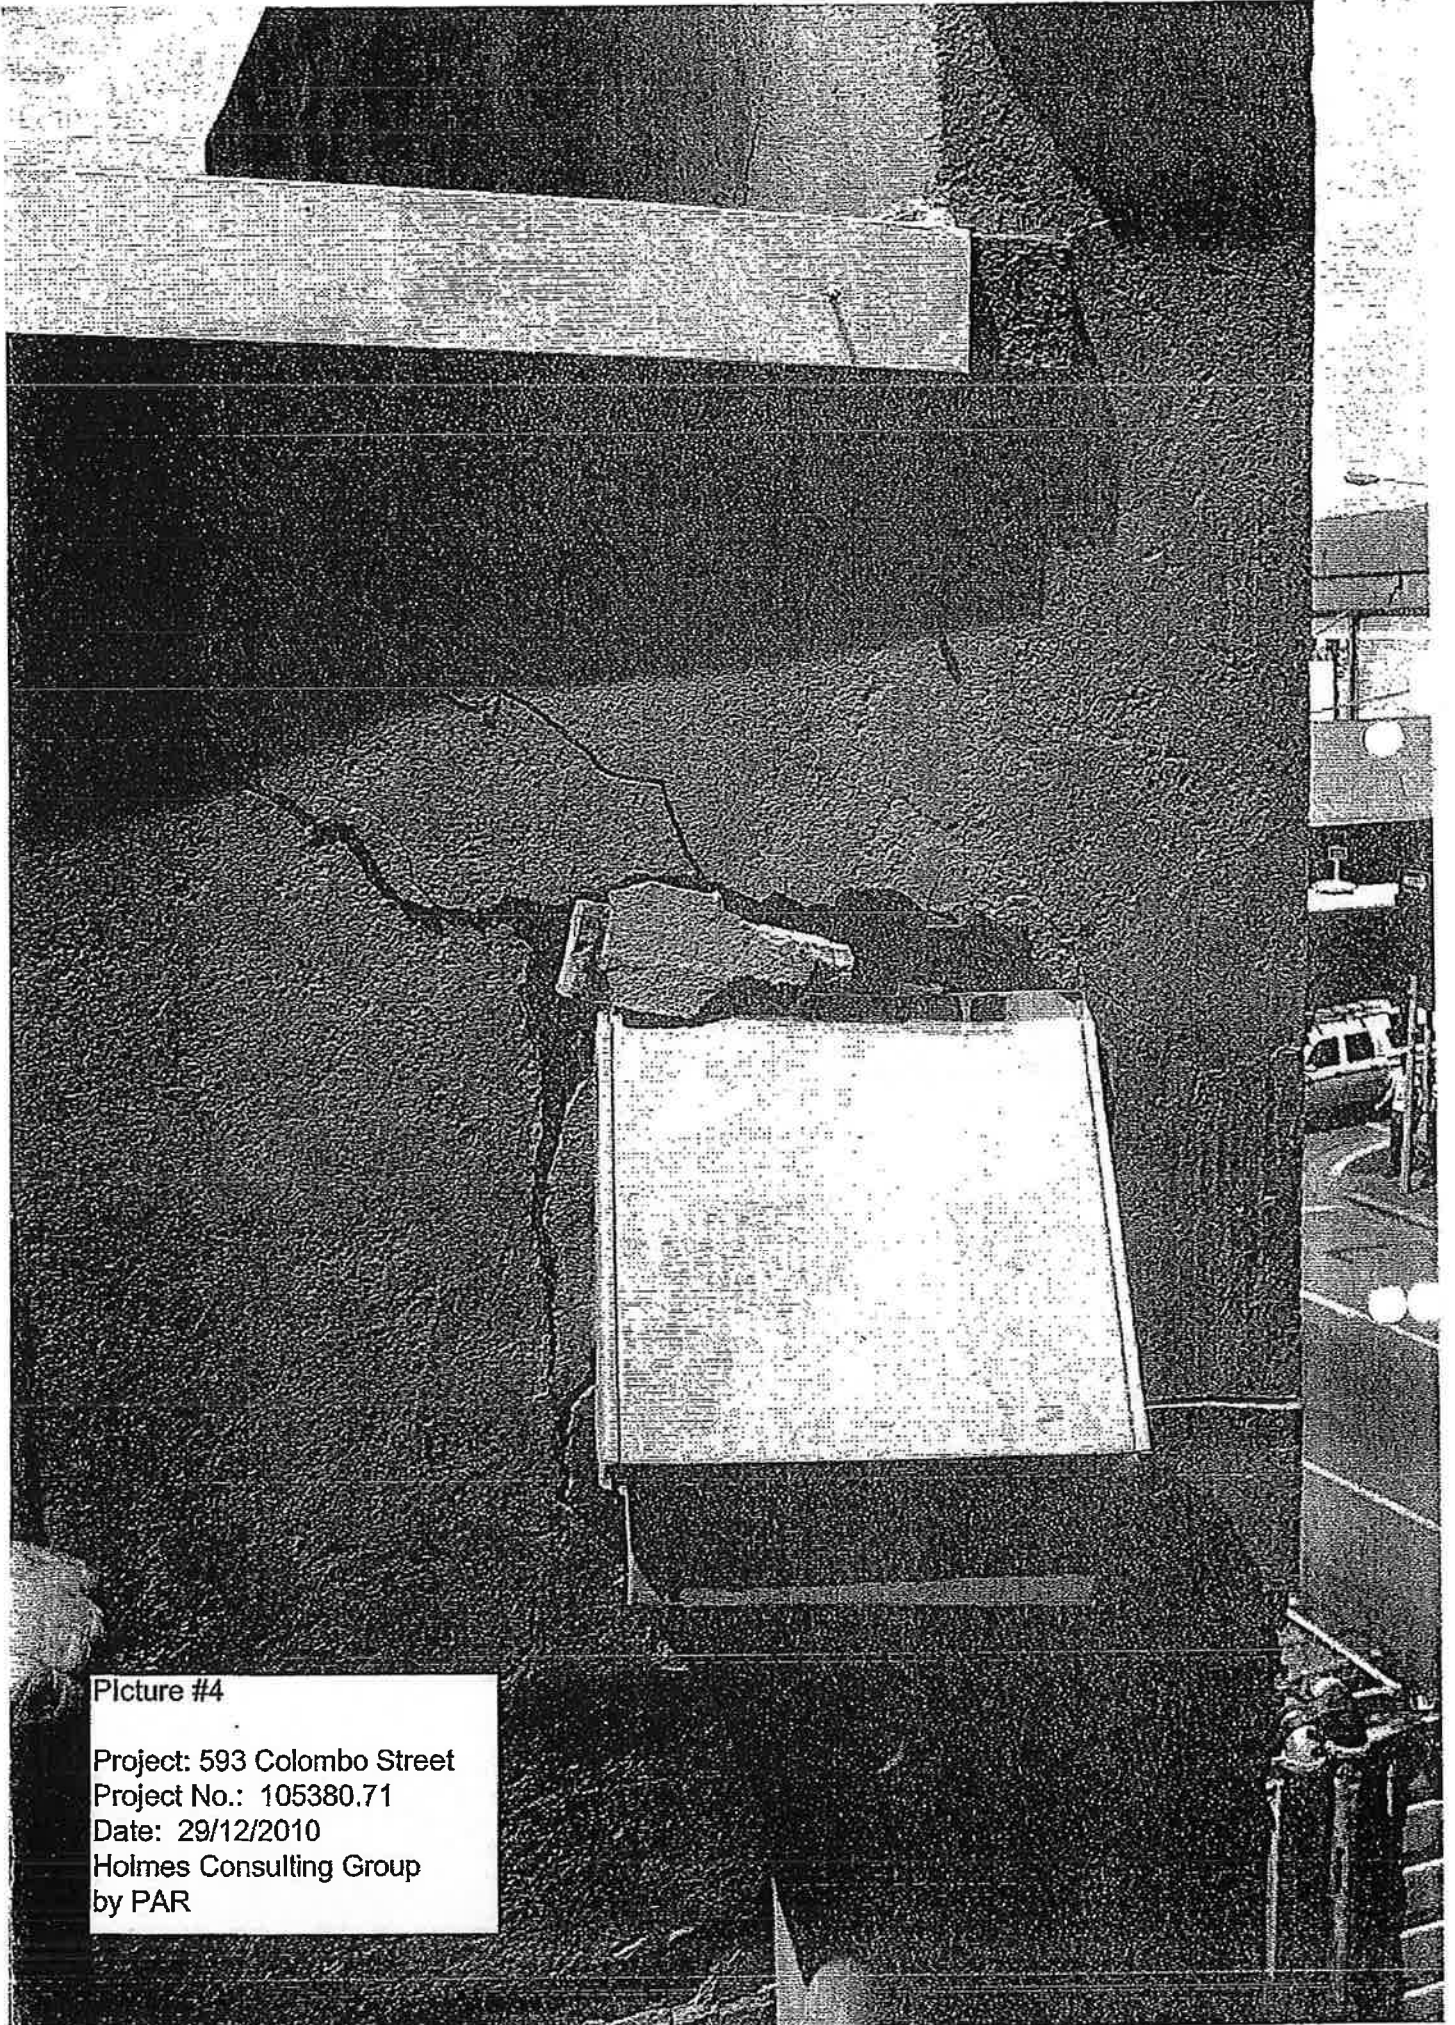
Picture #4

South side of west parapet is significantly damaged. See pictures #4 & 5

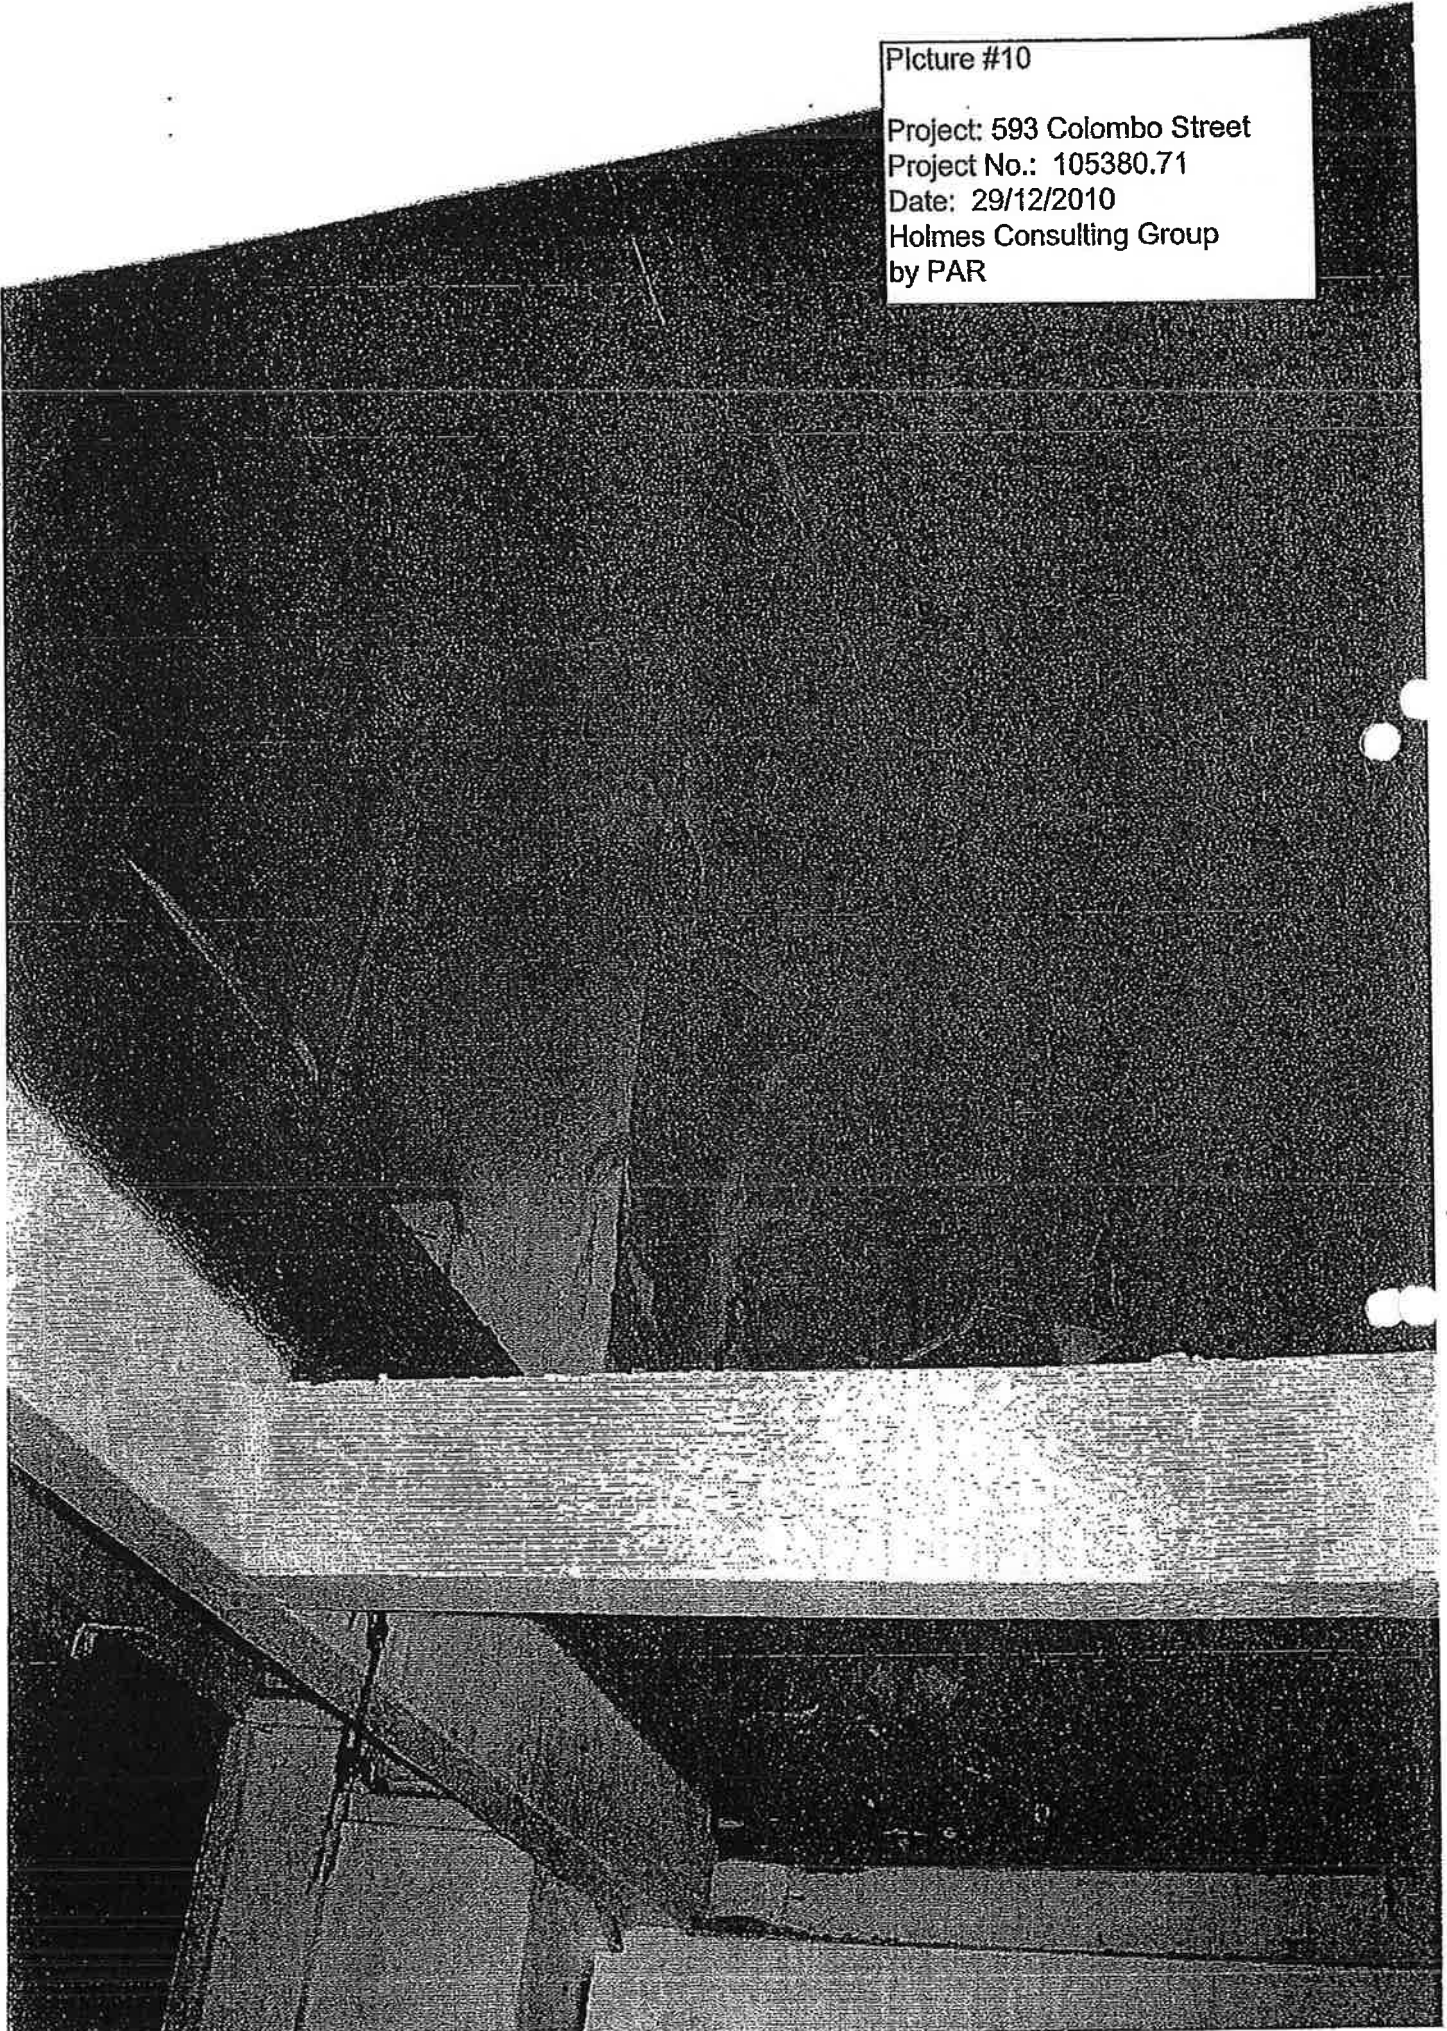
Picture #11

Interior brick bearing wall beyond has significant horizontal gaps (up to 50mm wide) between adjacent bricks. Wall needs to be replaced. See pictures #10, 11 & 12

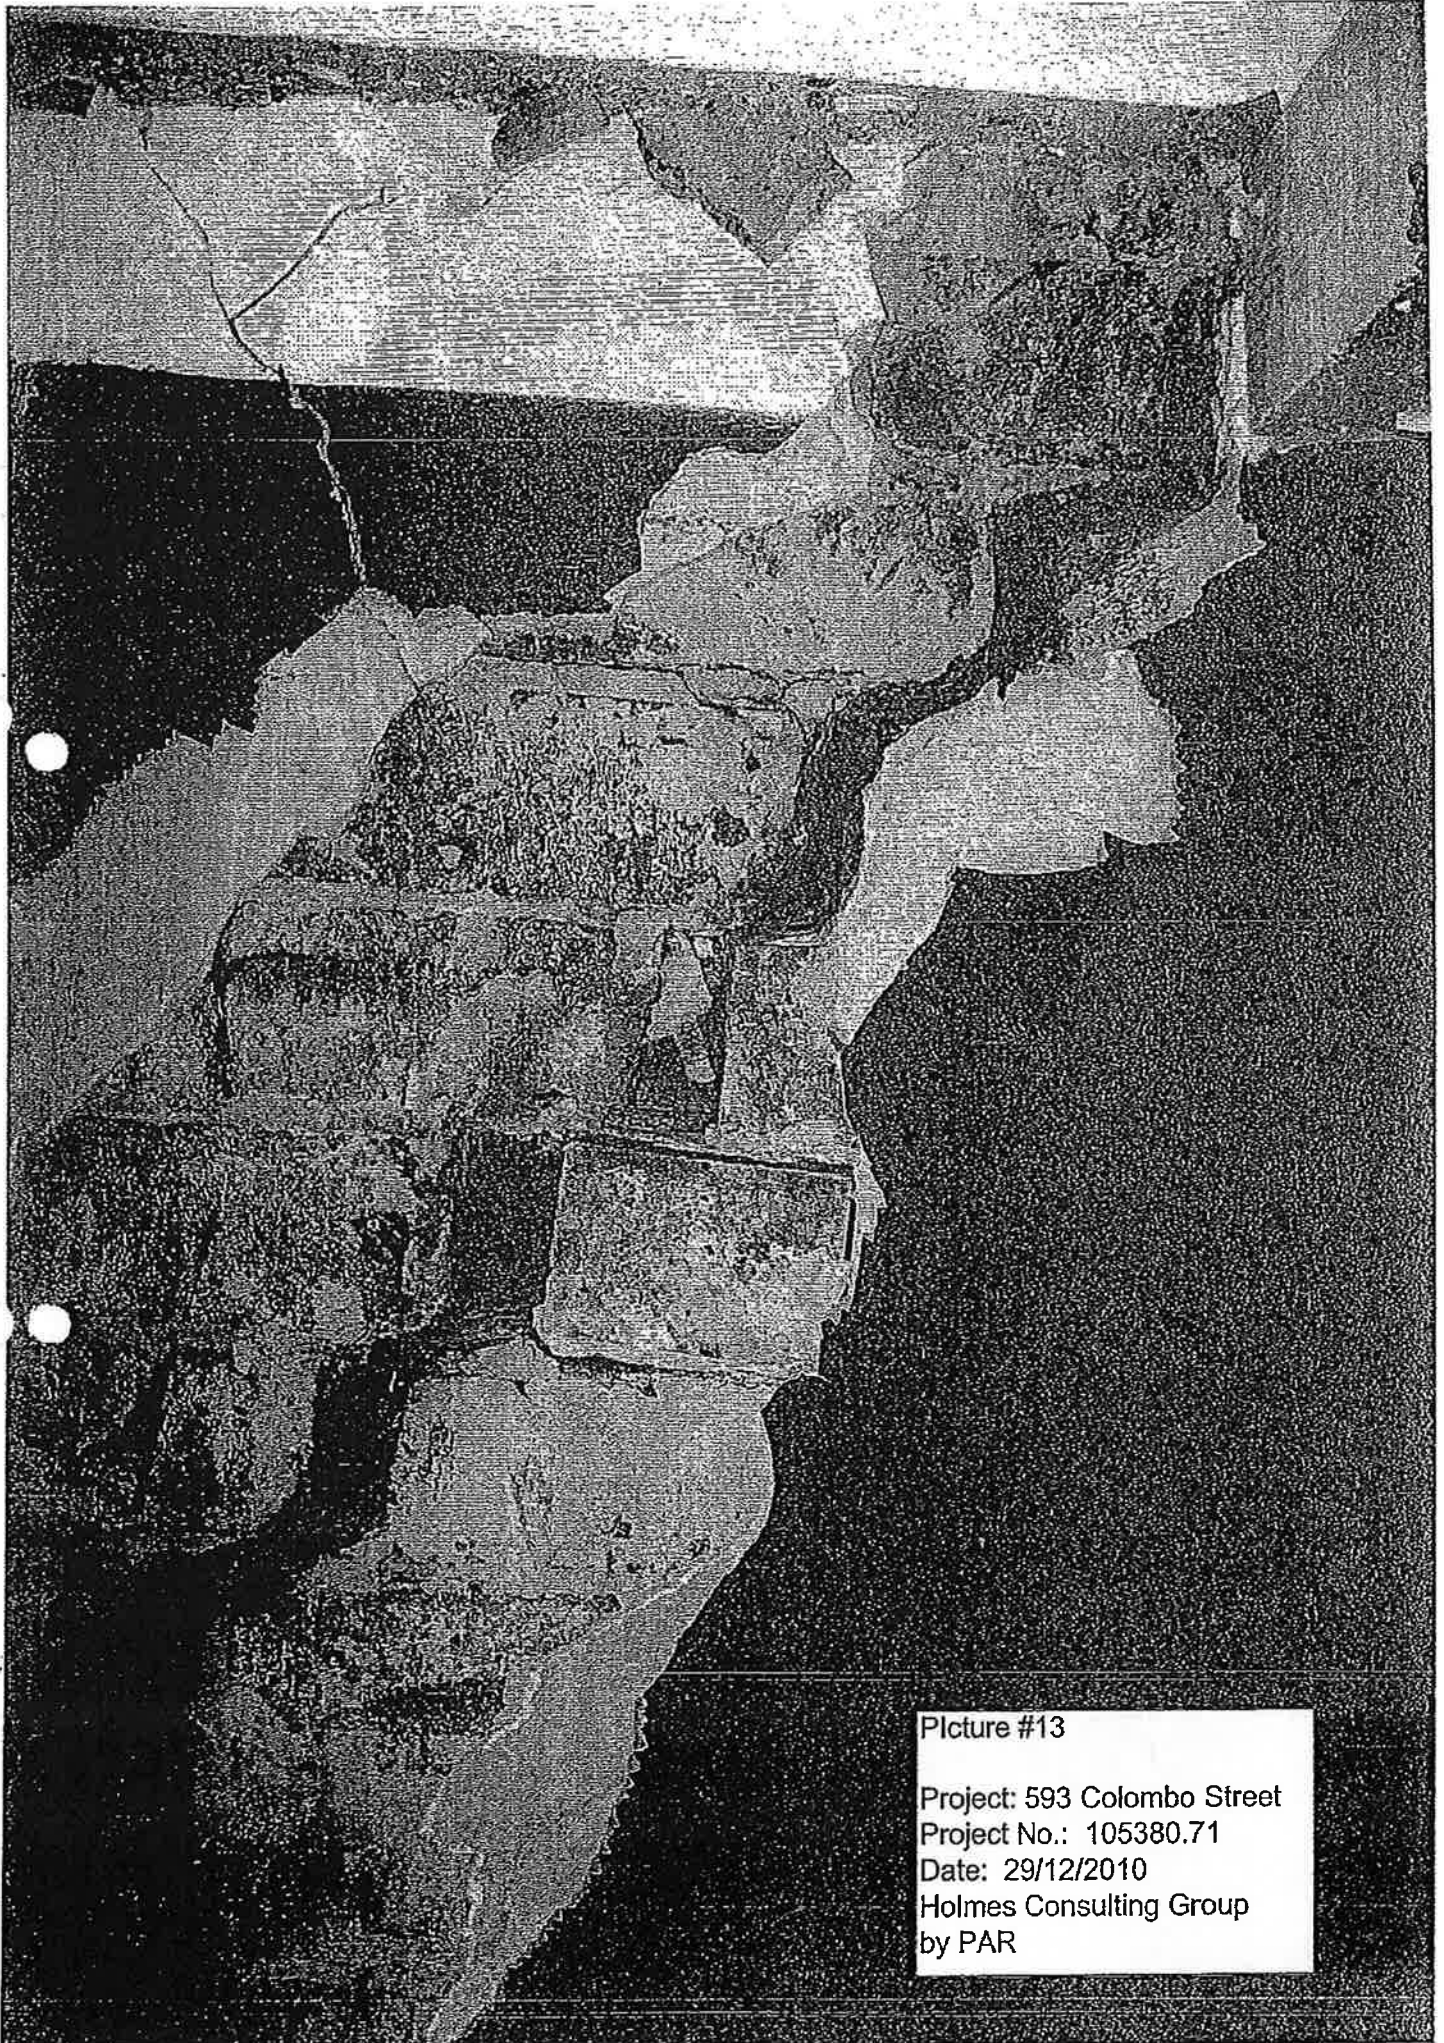
Picture #13

Interior brick bearing wall beyond has significant horizontal gaps between adjacent bricks. Wall needs to be replaced. See pictures #13, 14 & 15

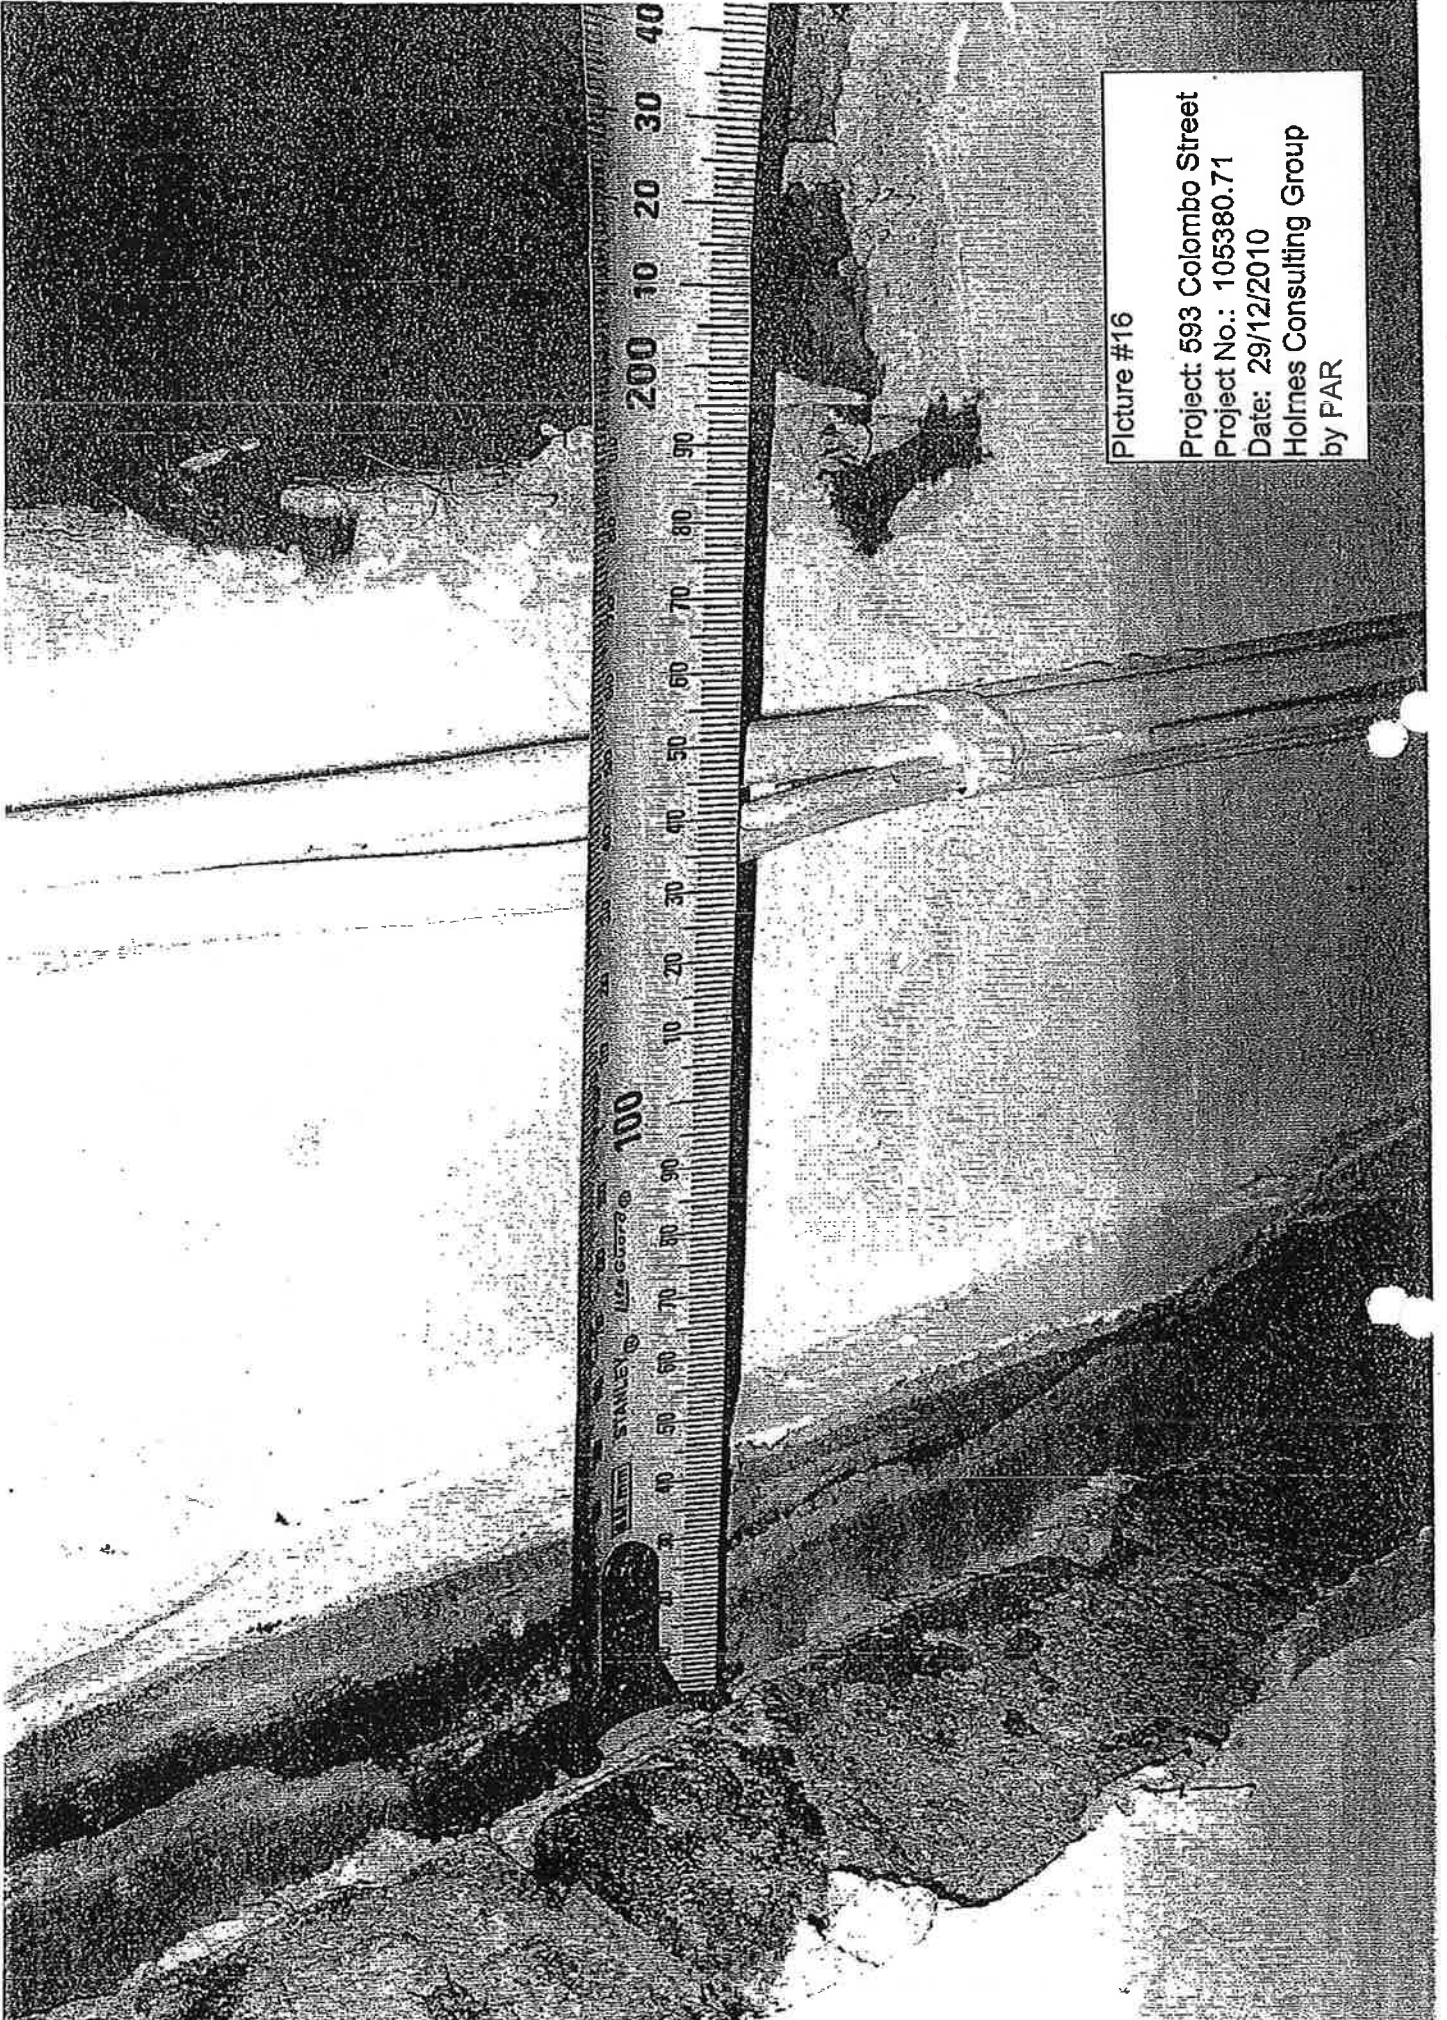
Picture #16

West wall has shifted outward to the west from the 1st floor framing by 30mm. See picture #16
