**ROYAL COMMISSION OF INQUIRY INTO BUILDING  
FAILURE CAUSED BY CANTERBURY EARTHQUAKES**

**STATEMENT OF EVIDENCE OF STEPHEN JAMES MCCARTHY IN RELATION TO  
601/601A COLOMBO STREET**

**DATE OF HEARING: WEEK BEGINNING 12 DECEMBER 2011**

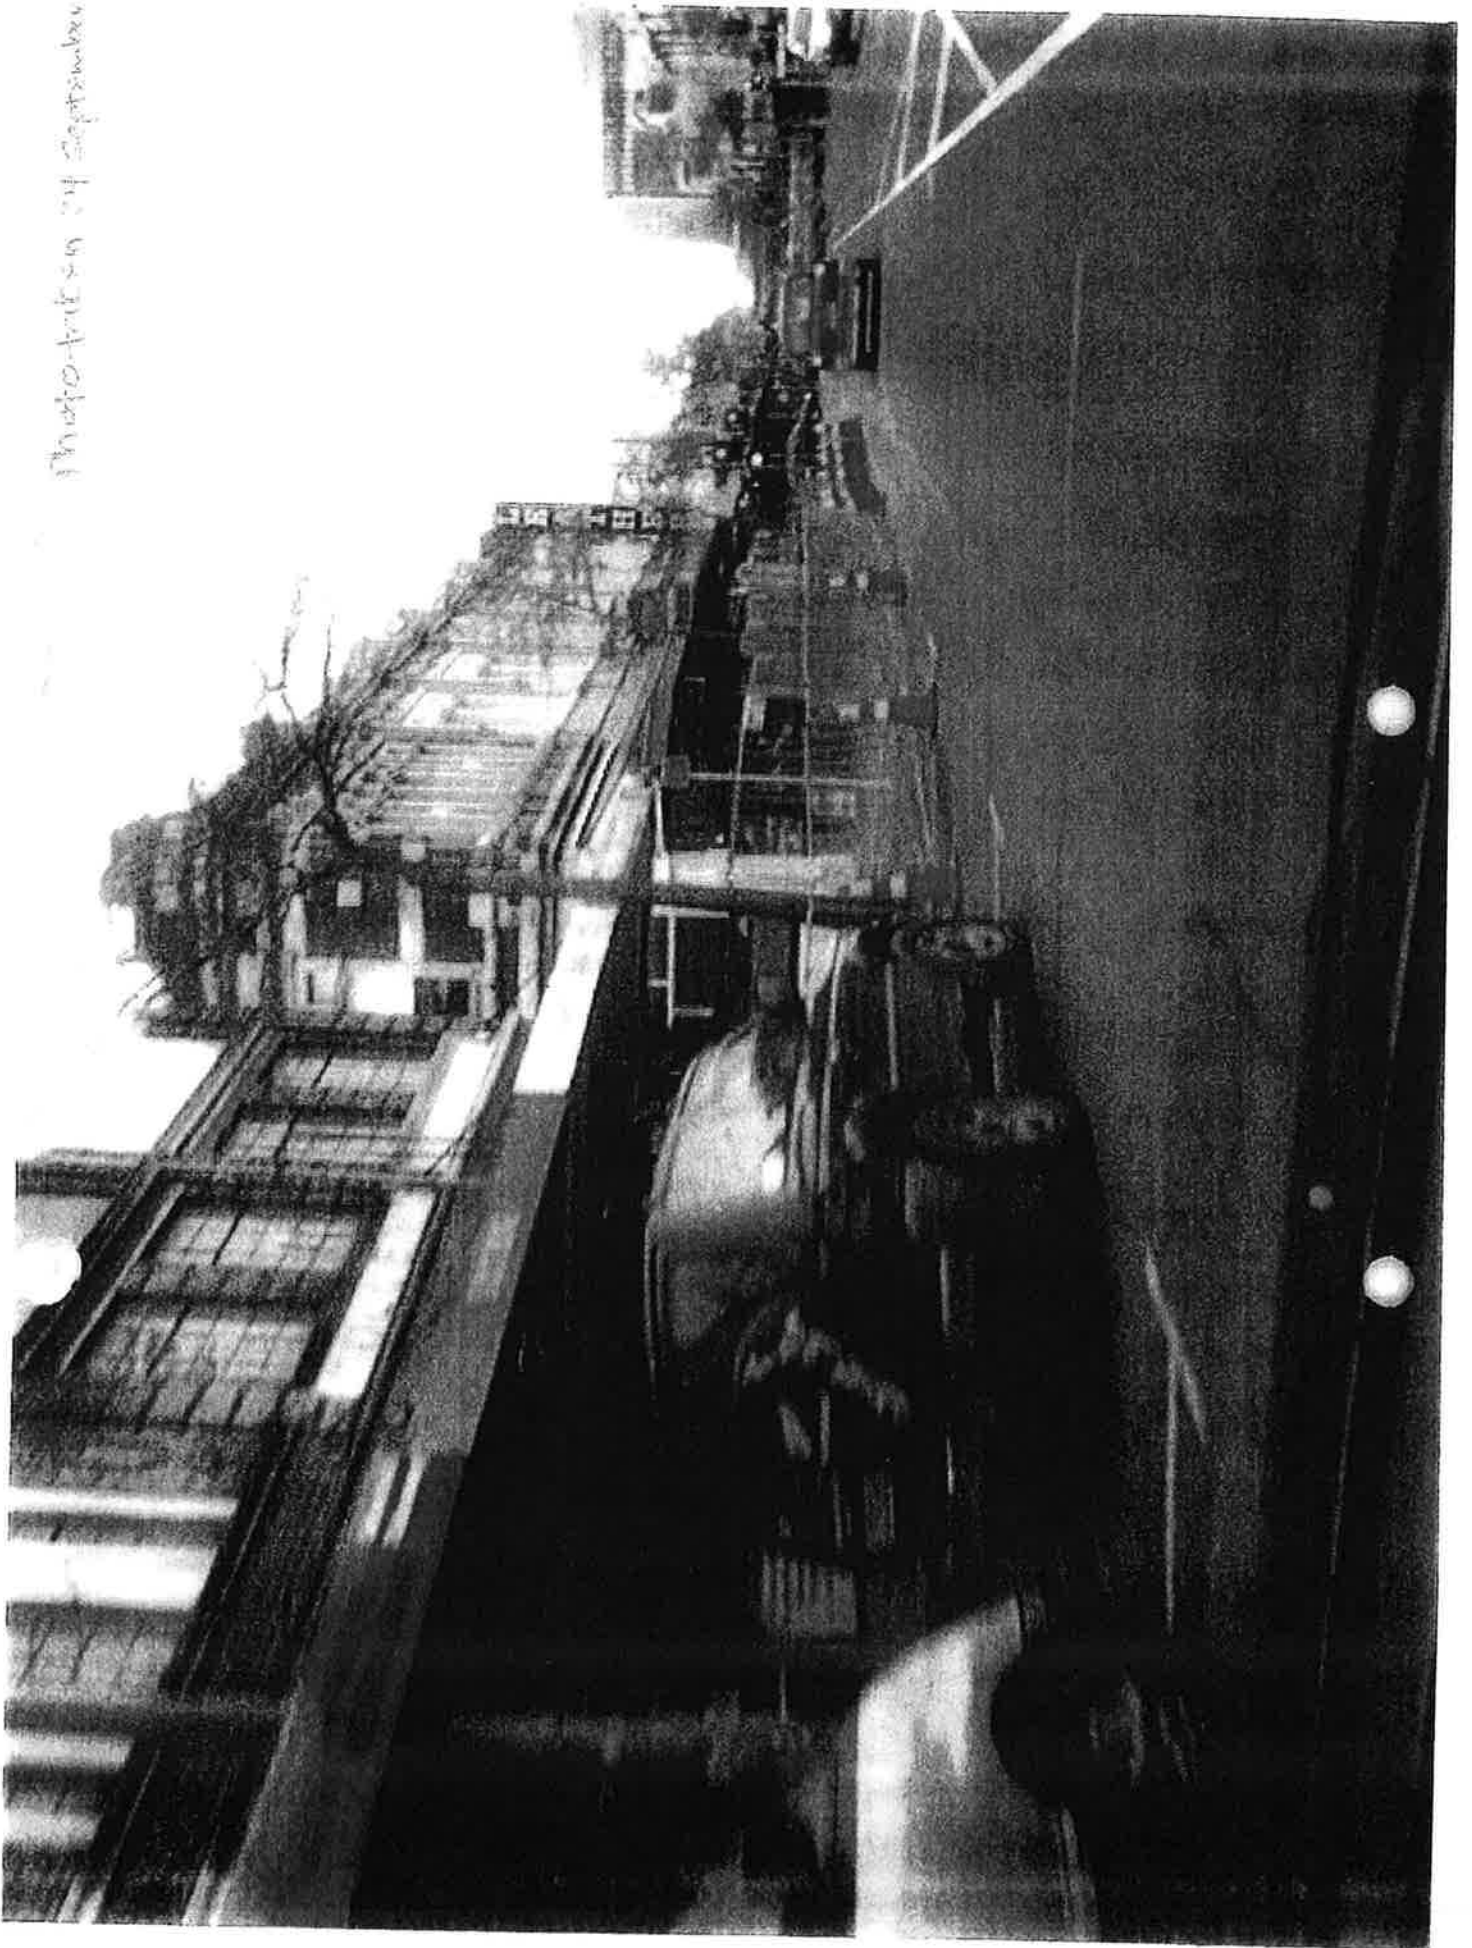
"K"

Photograph of September 2010
