**INDEPENDENT ASSESSMENT ON EARTHQUAKE PERFORMANCE  
OF  
601 – 601A Colombo Street**

**FOR  
Royal Commission of Inquiry into building failure  
caused by the Canterbury Earthquakes**

**Report prepared by Peter C Smith and Jonathan W Devine  
OF  
Spencer Holmes Ltd**

**November 2011**

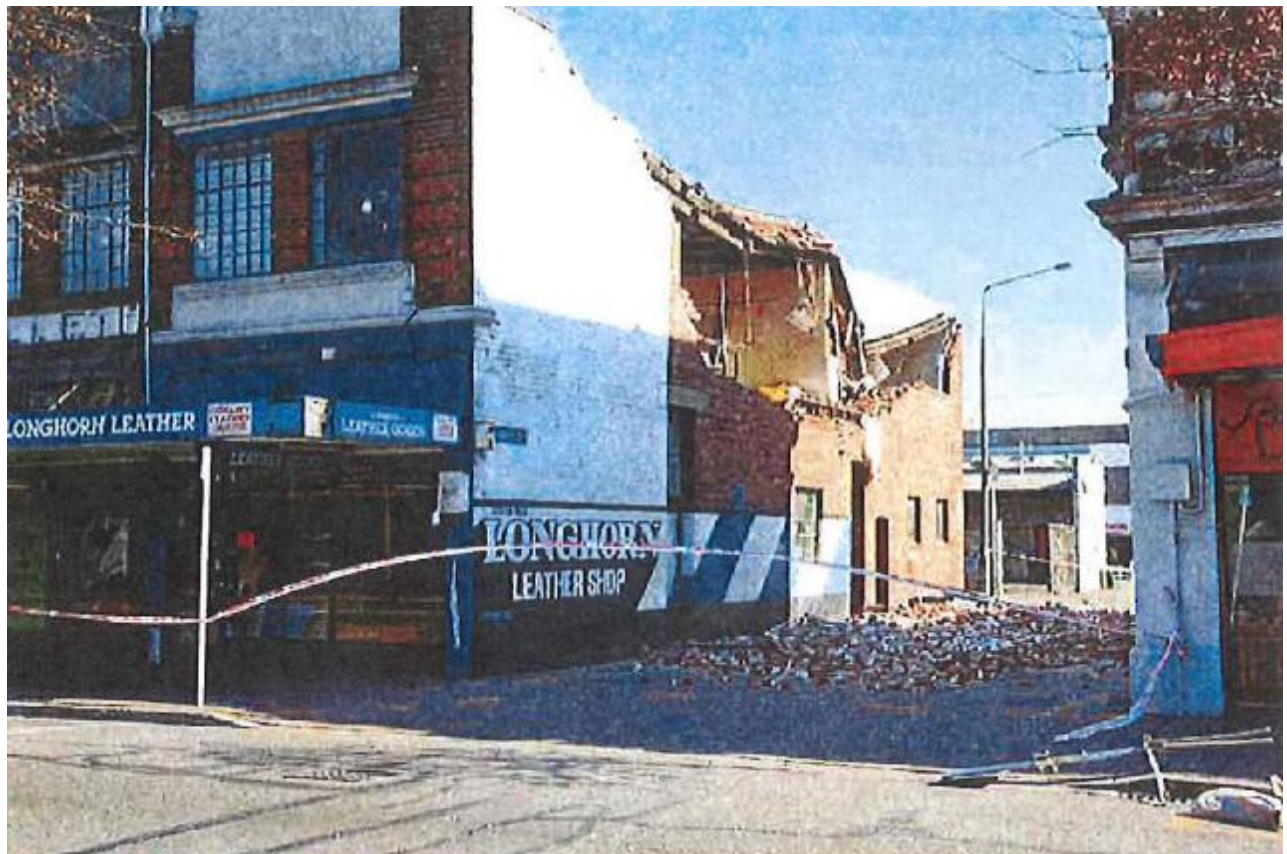
### **Record of damage following 4th September 2010 earthquake**

The building was damaged in the 4<sup>th</sup> September, 2010 earthquake. The Rapid Assessment -Level 2 identified that a portion of the Mollett Street façade collapsed. Photos show the extent of the collapse and severe cracking of the north (Mollett Street) wall. (Refer Appendix 2.) The building was assigned a red placard. The Rapid Assessment-Level 2 identified further unsafe hazards from falling and required barricades along the Mollett Street frontage.

Marton Sinclair of Eliot Sinclair inspected the buildings on 6<sup>th</sup> September, 2010. Marton Sinclair noted “A double brick wall on the north side of the building had collapsed onto Mollett Street during the 4<sup>th</sup> September, 2010 earthquake leaving the roof partially supported.”

The failure of the Mollett Street façade in the 4<sup>th</sup> September, 2010 earthquake was an out of plane failure of the first floor wall rotating at or near the first floor support due to inadequate support at roof level. Sufficient restraint was provided at each end of the wall to prevent failure of a section at each end of the wall.

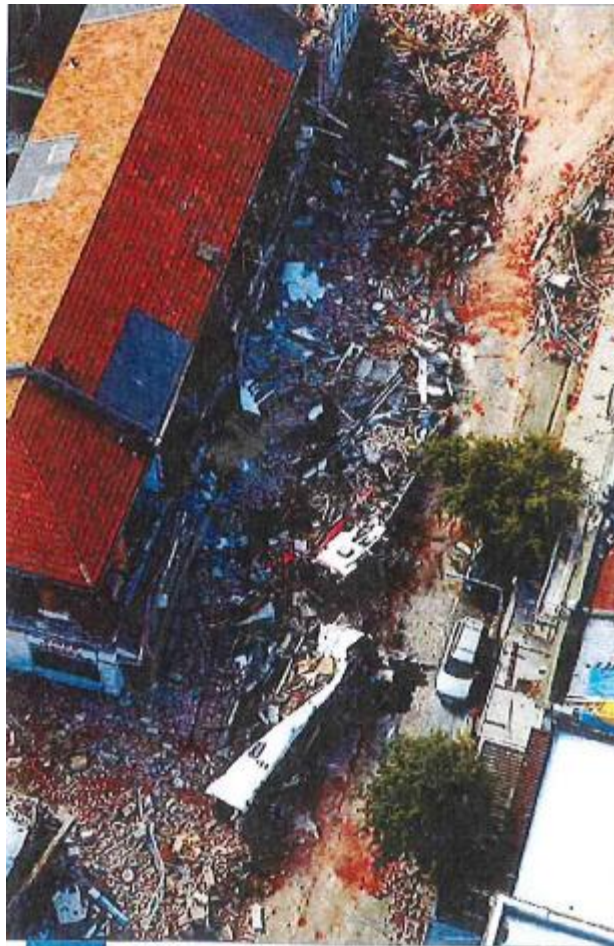
40

In the 22<sup>nd</sup> February, 2011 earthquake the upper level of the Colombo Street façade of the buildings 601-601A Colombo Street fell into Colombo Street, the Mollett Street façade of the building fell into Mollett Street and the party wall was severely damaged.

The failure of the Colombo Street façade and the remainder of the Mollett Street façade in the 22<sup>nd</sup> February, 2011 earthquake is assessed as an outward rotation of the façade about the first floor support.
