SEISMIC RISK BUILDINGS - SURVEY

# Christchurch Eq. RAPID Assessment Form - LEVEL 1

**Rapid Assessment Form - Level 2**

**173 Gloucester Street (corner of Gloucester and Manchester Street) Building  
 Inspection and Recommendations  
 Prepared for Anthony Runacres and Associates Limited**

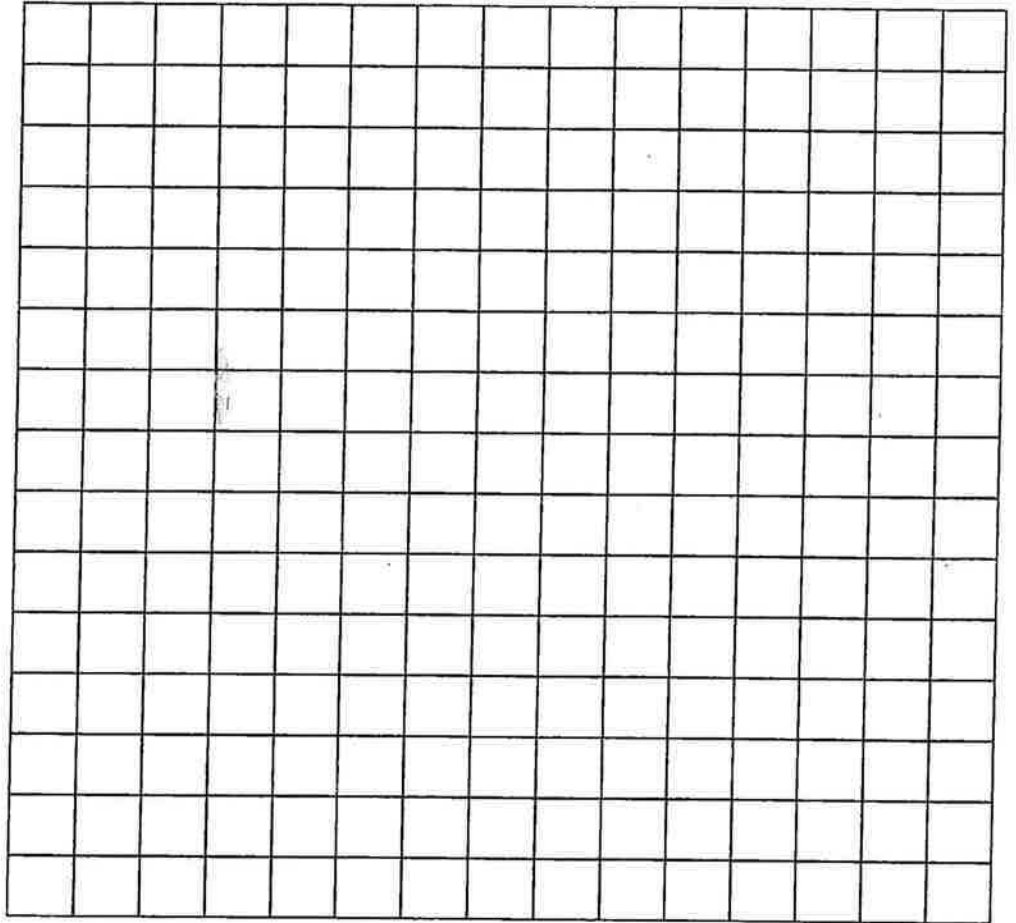
**General Comment** there are minor cracks in brickwall, mainly on the southside and also <sup>minor</sup> internal cracks in <sup>timber</sup> wall & ceiling. No damage in shoe Repair shop and in Dairy. No access to the takeaway shop.

- \* Repair the crack in the arch window lintel on the southside ASAP. Also repair all other cracks in the walls & ceiling.
- \* Check the arch lintel above Dairy ~~entrance~~ for any loose bricks. Remove/secure if found to be loose.
- \* Support arrangement (eg. steel bands) to external arch lintels shall be provided to prevent sudden failure of lintel blocks (consult a structural engineer)

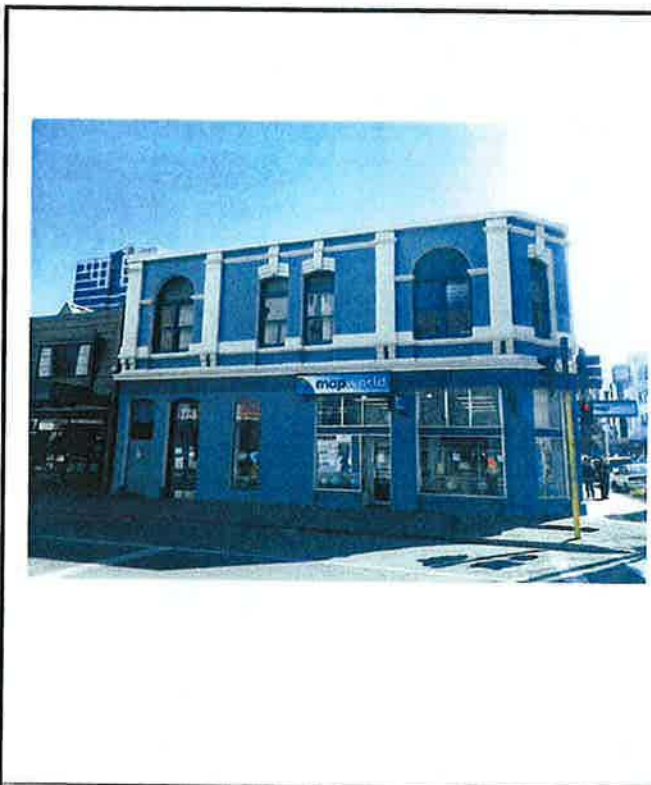
Photo 1. General view of the building

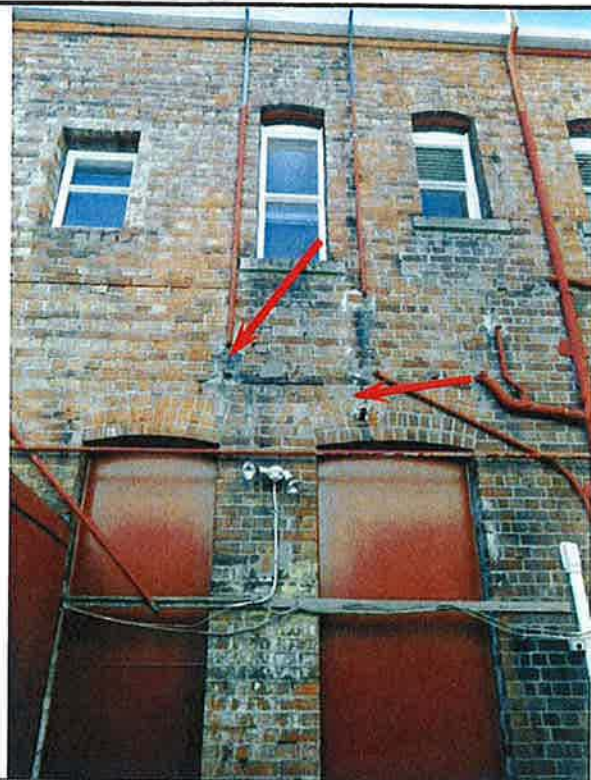
Photo 2. South wall brick parapet cracking

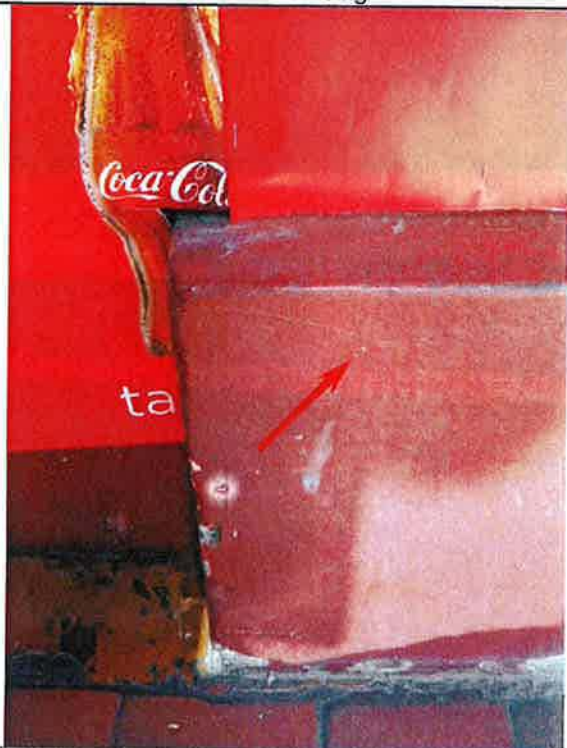
Photo 3. Cracking to foundation

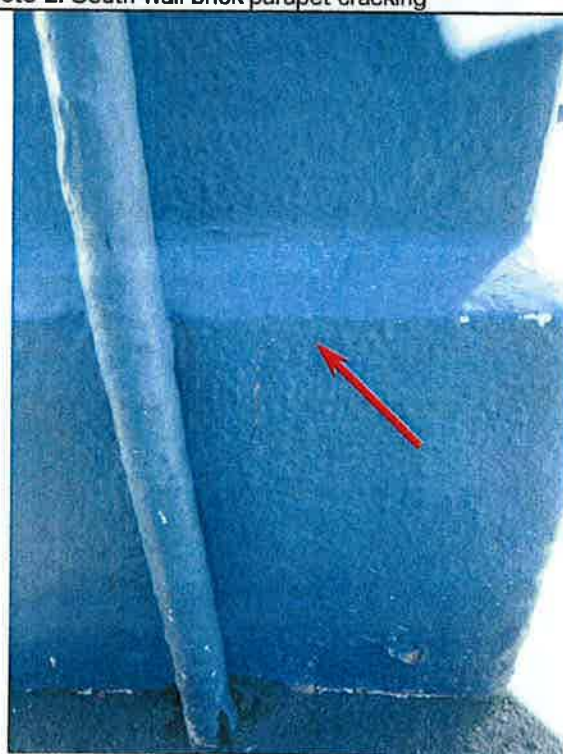
Photo 4. Cracking to foundation

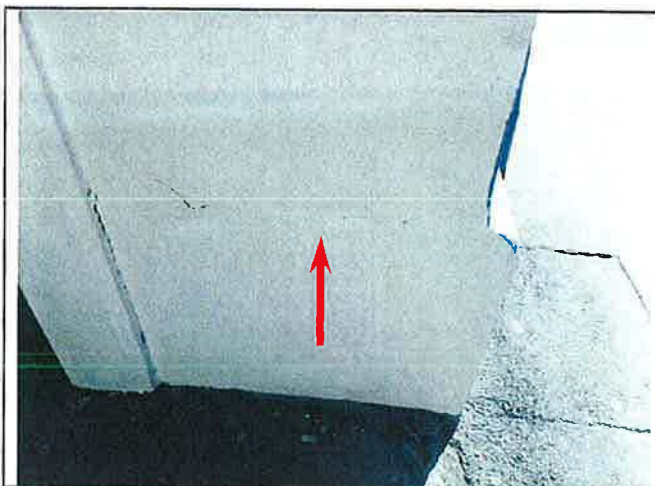
Photo 5. Plaster cracking

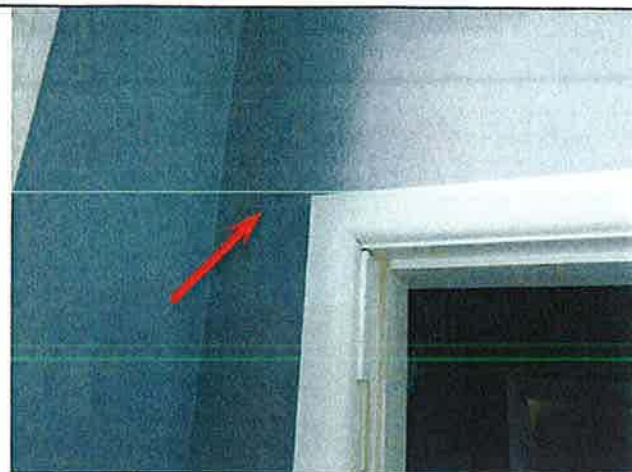
Photo 6. Plaster cracking

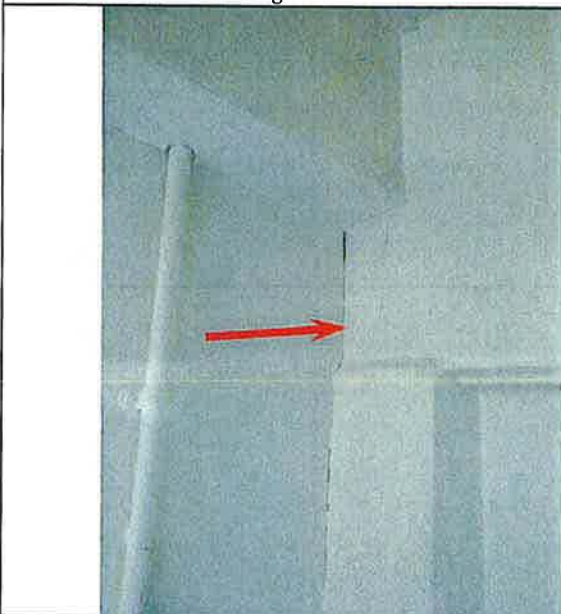
Photo 7. Plaster cracking

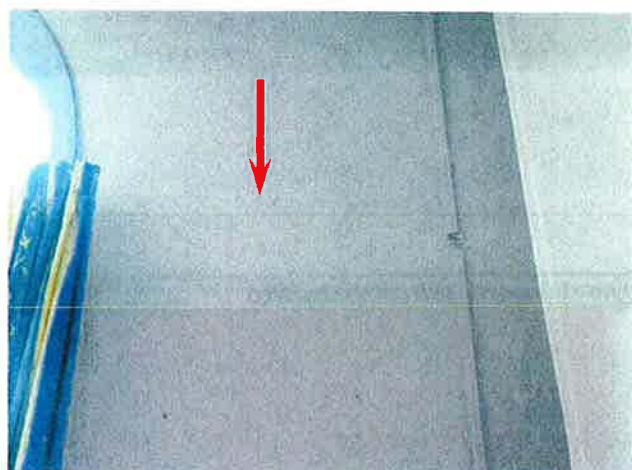
Photo 8. Plaster cracking

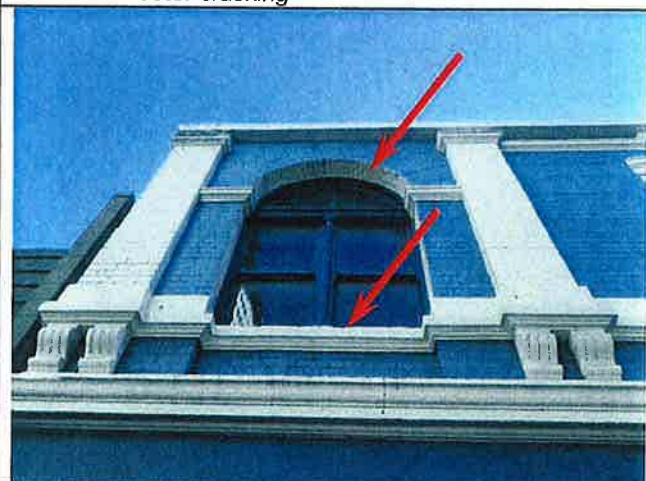
Photo 9. Cracks to Facade

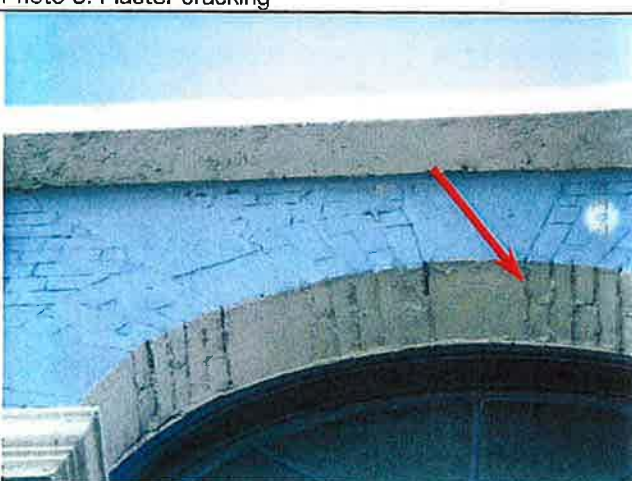
Photo 10. Detail of cracks to Facade

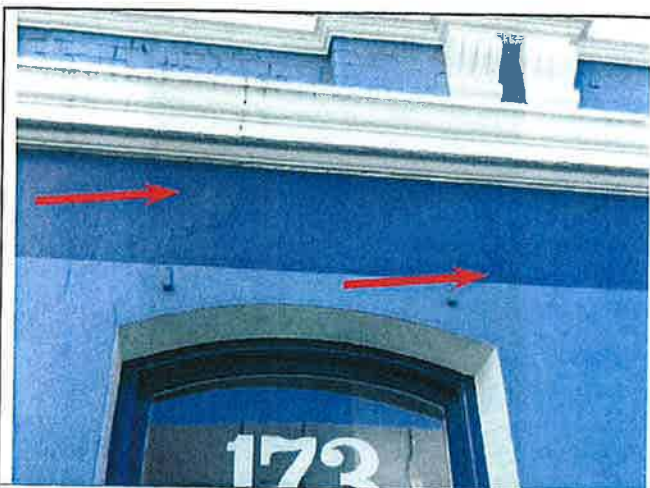
Photo 11. Cracks to Facade

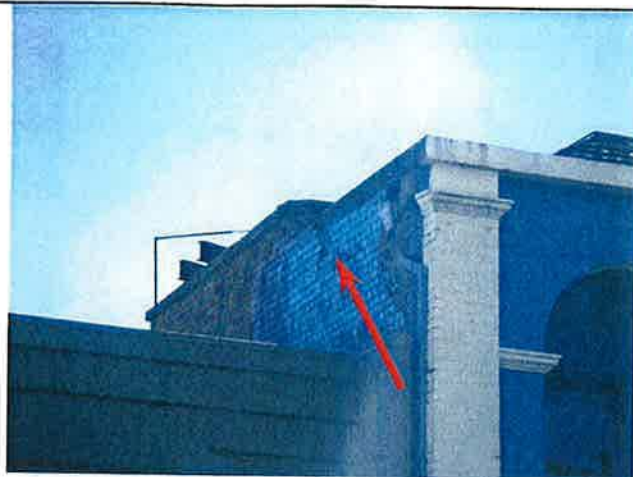
Photo 12. Cracks to wall side of the building

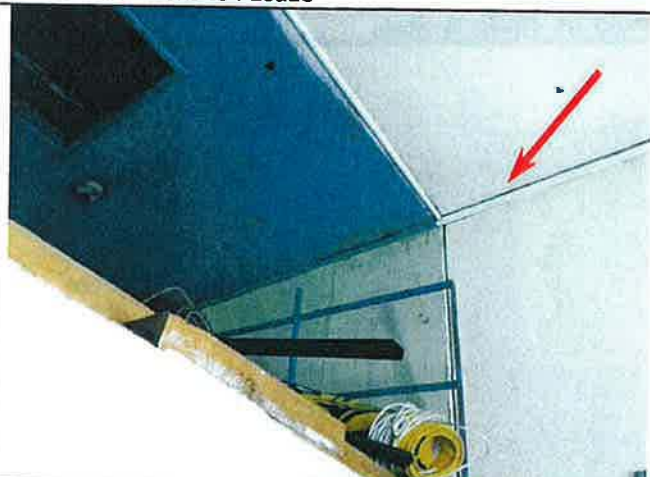
Photo 13. Slight movement to internal linings of 10mm to back wall

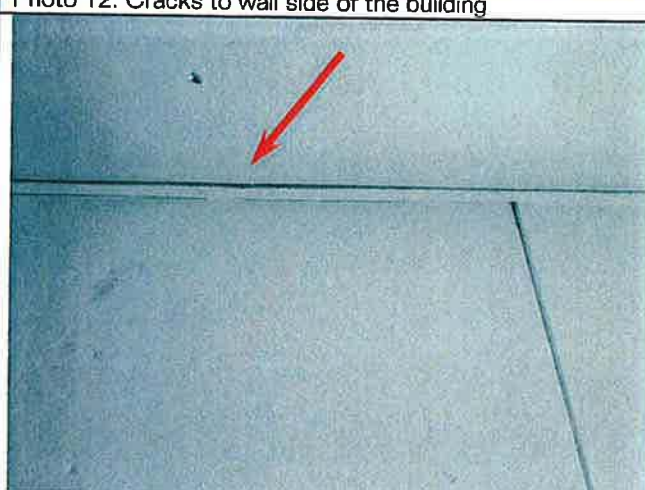
Photo 14. Detail of slight movement to internal linings of 10mm to back wall

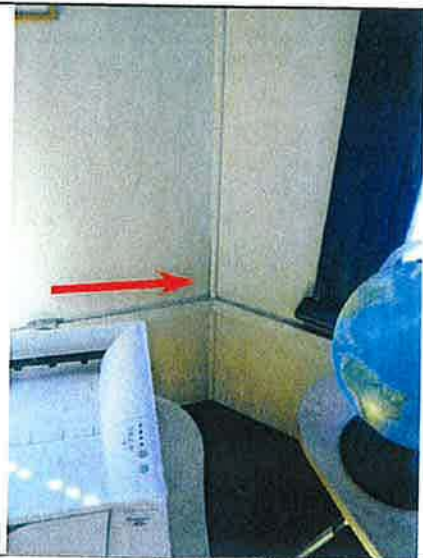
Photo 15. Plaster cracking

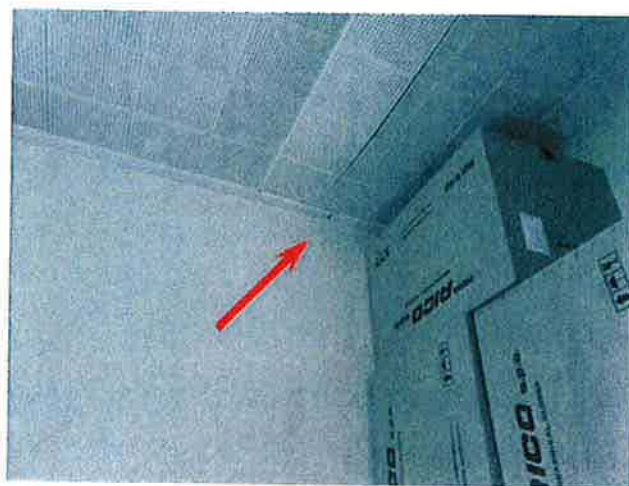
Photo 16. Ceiling NE popped

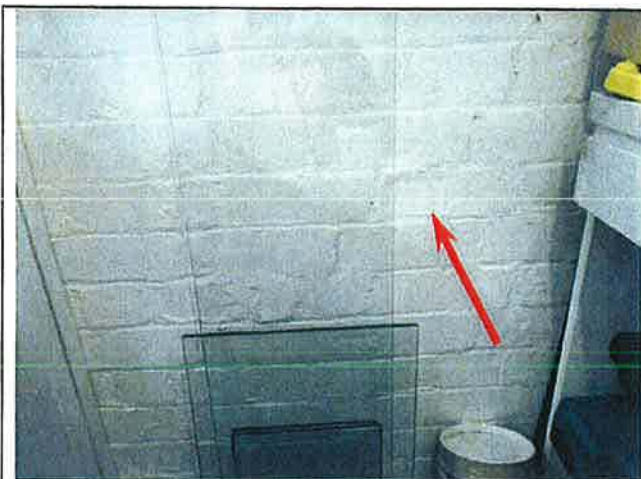
Photo 17. Cracks in internal lining

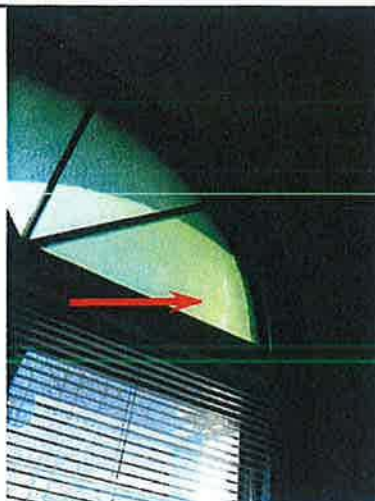
Photo 18. Cracks to glass

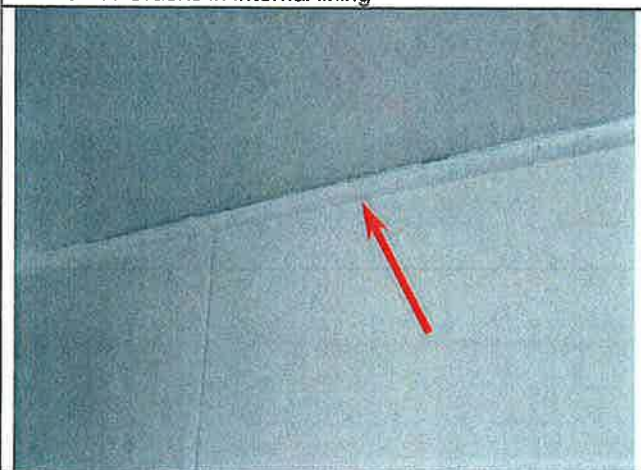
Photo 19. Plaster cracking

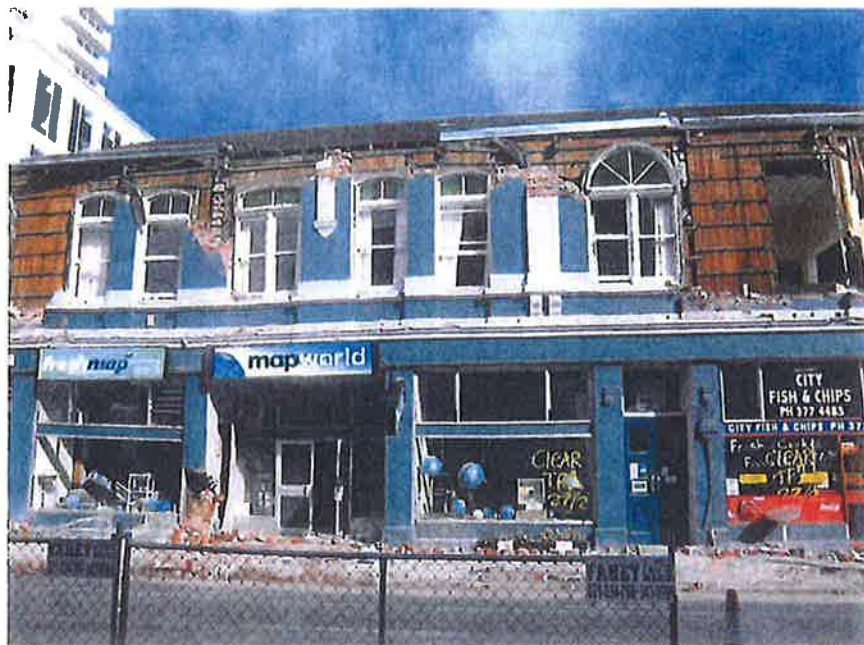
1. The unreinforced masonry on the upper floor along the Manchester Street (East) façade has almost completely collapsed from out of plane failure, (refer to photograph 1). The walls along the South façade (along Gloucester Street) have much less damage (photographs 3 and 4). This can probably be explained by the larger component of seismic shaking during the 22 February event being in the East - West direction.

4. Significant damage to the walls and columns occurred on the ground floor of the building. One of the columns on the Manchester Street façade was damaged to the extent that this caused misalignment of the upper level floor (refer to photograph 1).

Photograph 1: Manchester Street elevation, showing damage to unreinforced masonry wall and columns and misalignment of the floor.

The building has suffered significant structural damage from the 22 February earthquake, and its gravity and lateral load resisting capacity is reduced significantly. We consider that due to the unstable condition of the building and damage sustained from the earthquake, repairs are not practically or economically feasible to undertake. Any work on the building could not stop only at repairing the damage i.e., reinstating its condition prior to the earthquakes, but would also have to include seismic improvements to bring the building above the Earthquake Prone threshold limit. It would be also very difficult to construct any retrofit work safely. We therefore recommend that this building be demolished.

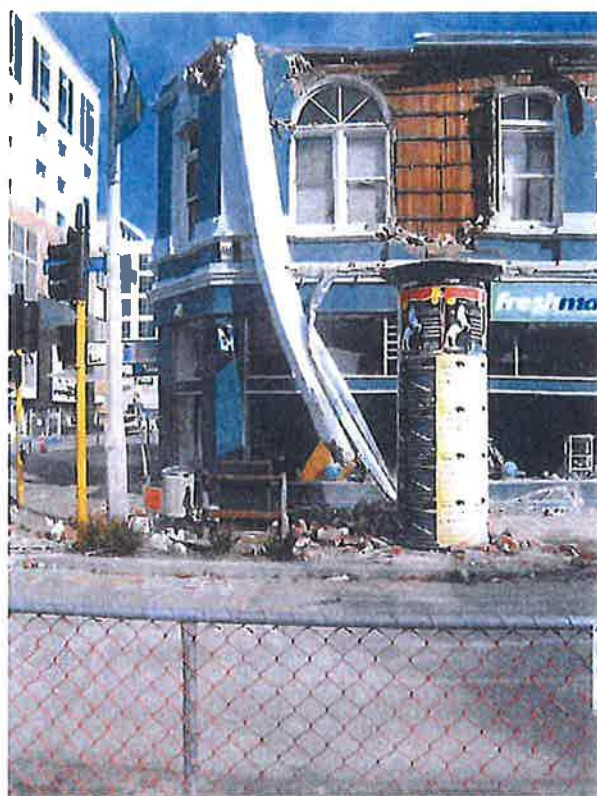
2. There is a large section of the reinforced concrete bond beam/parapet on the upper level of the east facade that is hanging precariously in place, held only by a few reinforcing bars to the remaining parapet (which could also easily collapse pulling with it other parts of the wall). This presents a falling hazard (refer to photograph 2).

Photograph 2: Corner of the building, showing collapse of the reinforced concrete parapet.

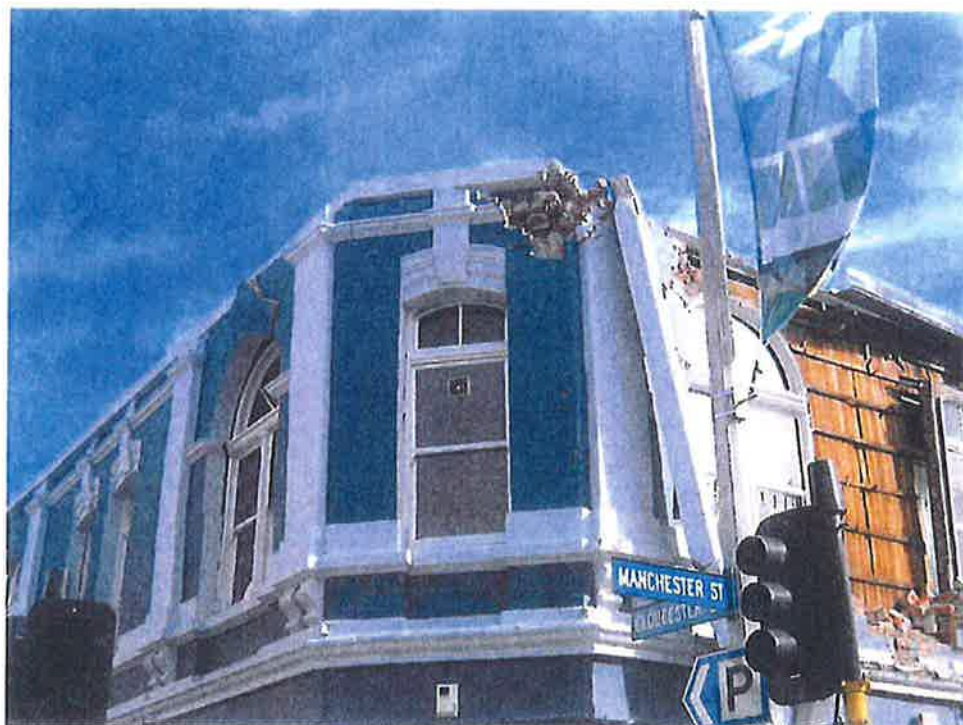
Photograph 3: Corner of the building – detail: Observe less severe damage to unreinforced masonry along the Gloucester Street facade

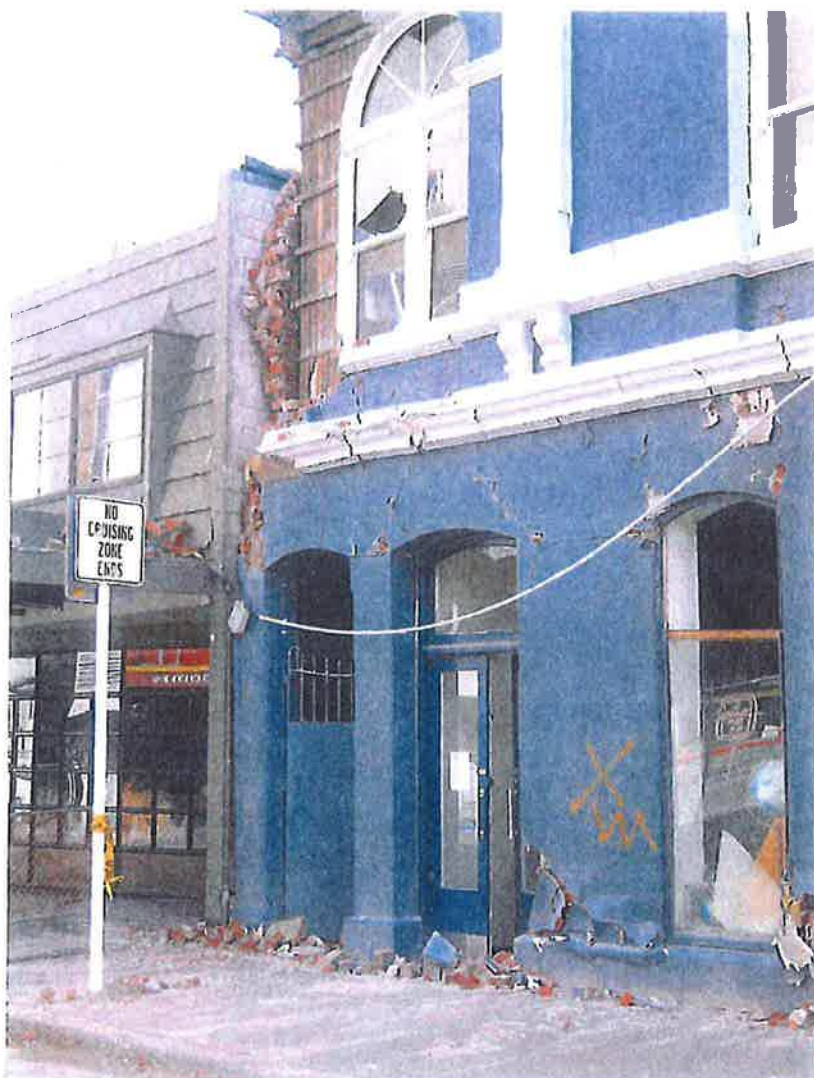
3. A large portion of the south-west corner of the upper floor walls has collapsed (south façade). This is probably result of pounding with the neighbouring building to the west (refer to photograph 5).

Photograph 5: Gloucester Street Elevation – west end: Damage to the first floor corner – likely due to the pounding with the West neighbour's building.
