Review of Expert Panel and Beca Report on PGC Building

William T. Holmes
Structural Engineer
San Francisco

Pyne Gould Corporation Building

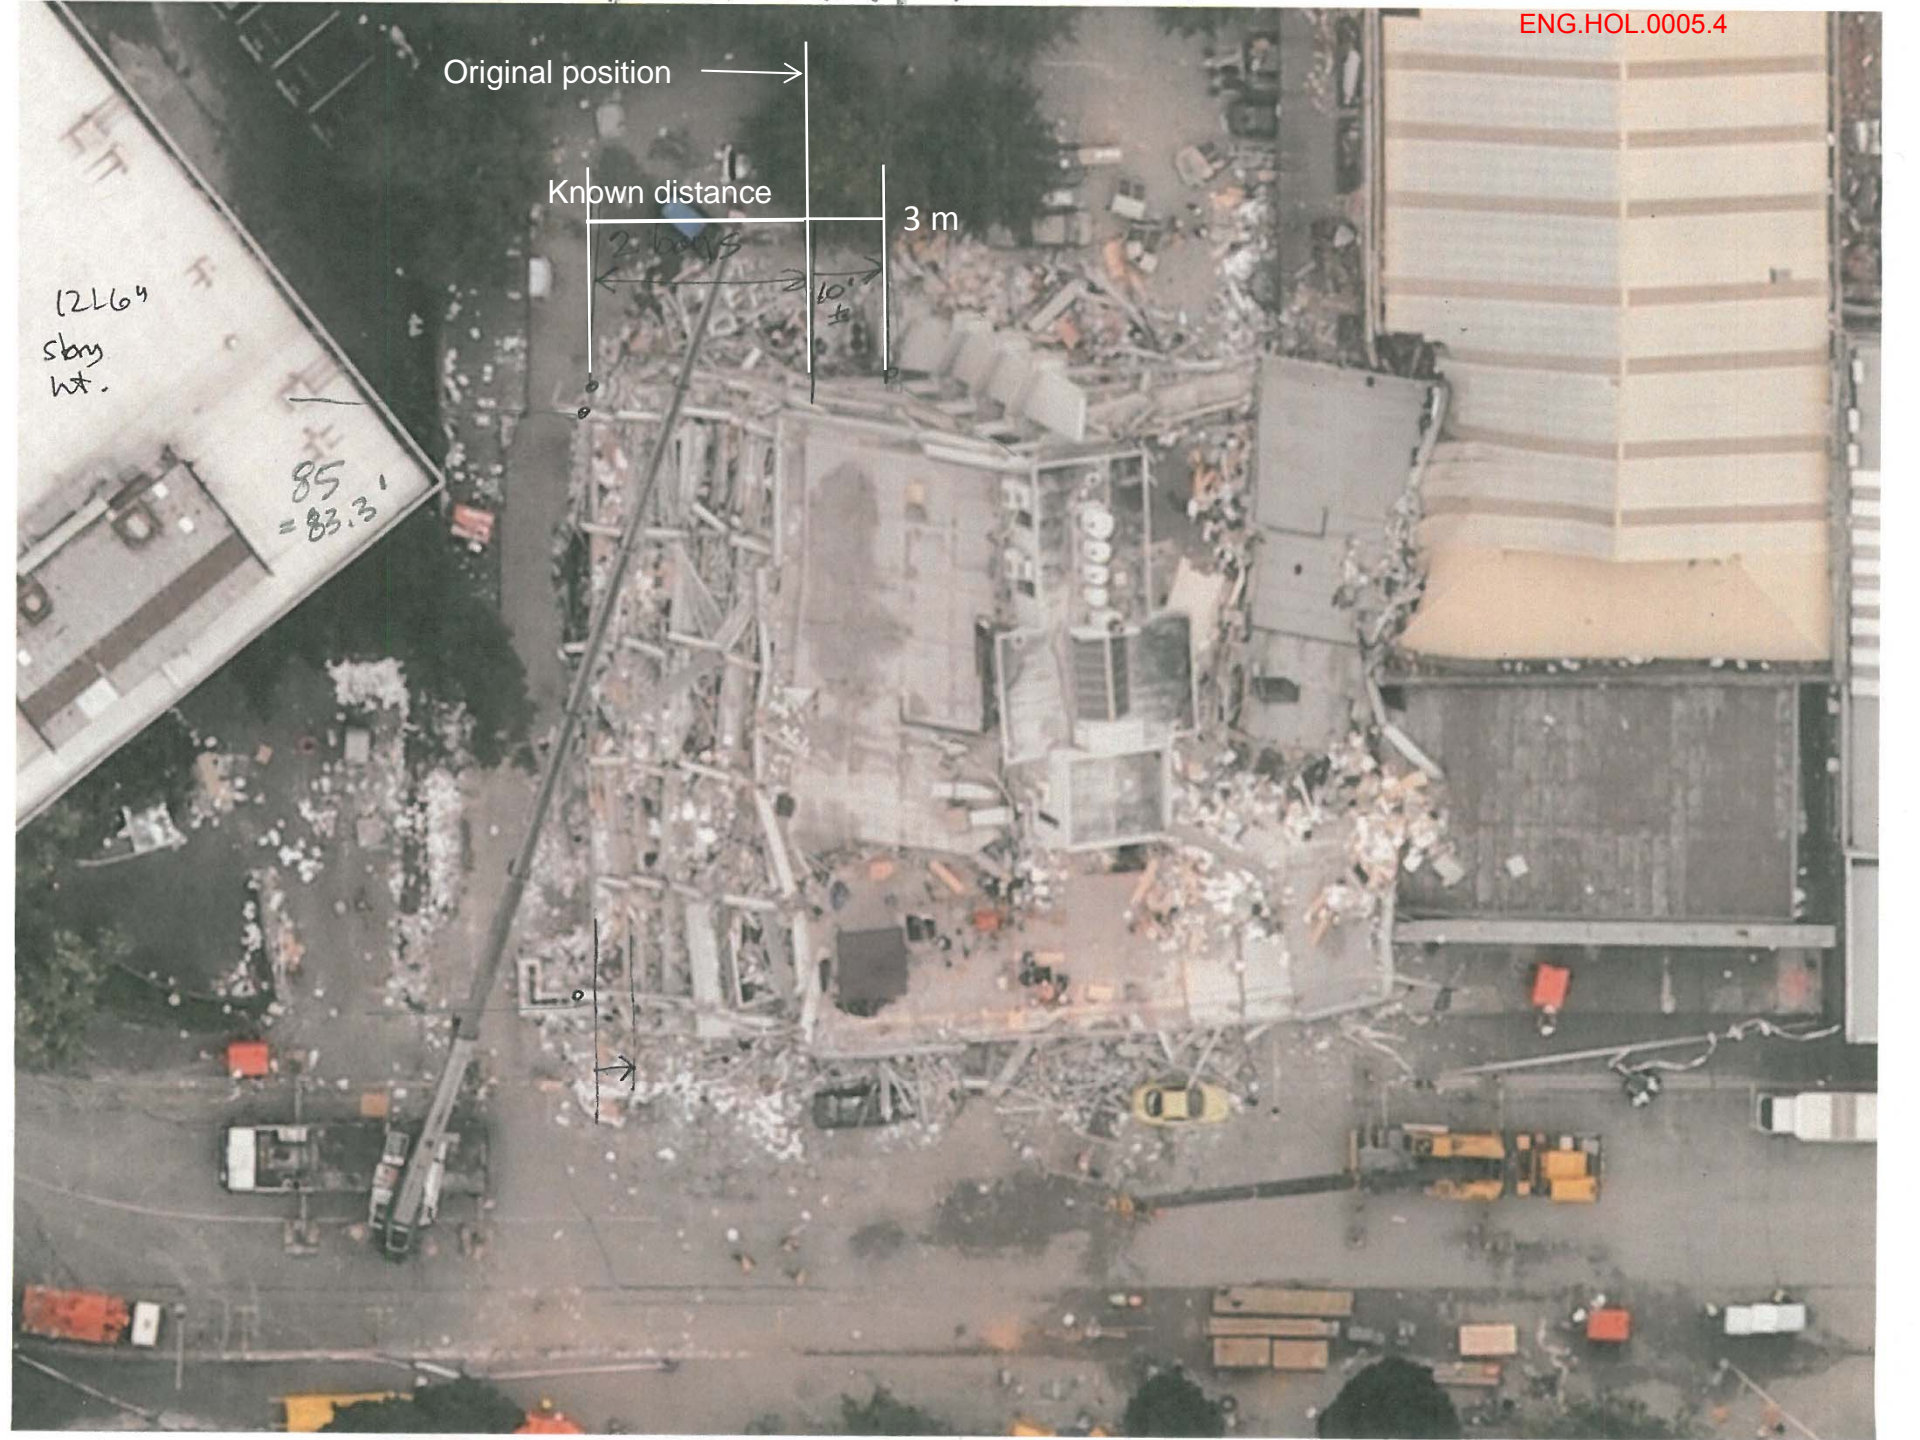
- All agree that building collapsed due to failure of the central tower at floor 1-2
 - Failure caused large movement of Level 2 downward and to the east (about 3 m)

Known distance

3 m

2.60 m

60° ±

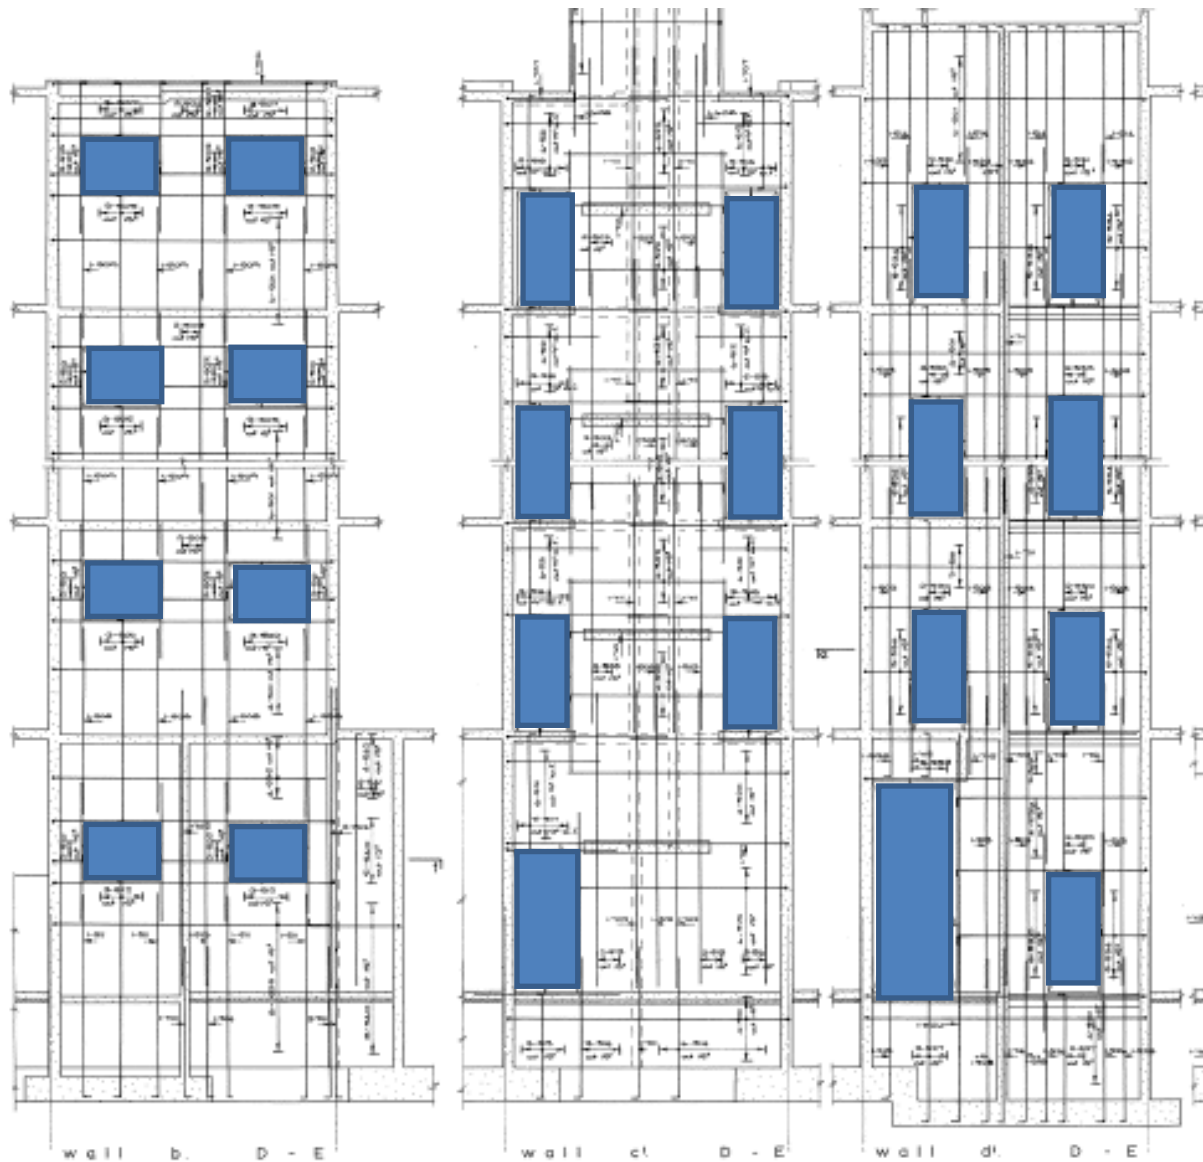
Level 1-2 had many seismic deficiencies

- Light central reinforcement.
 - Weak in global flexure (overturning)
 - Weak in EW shear (many openings, low R/F ratio, small trim bars. Piers in North Wall appear to be “shear critical”)

Can these walls provide sufficient coupling of east and west wall for the tower to act as a unit?

If so, would the south wall fail in shear prior to a flexural tower failure?

Our calculations indicate these various failure modes have reasonably close yield strengths.— Too close to call.

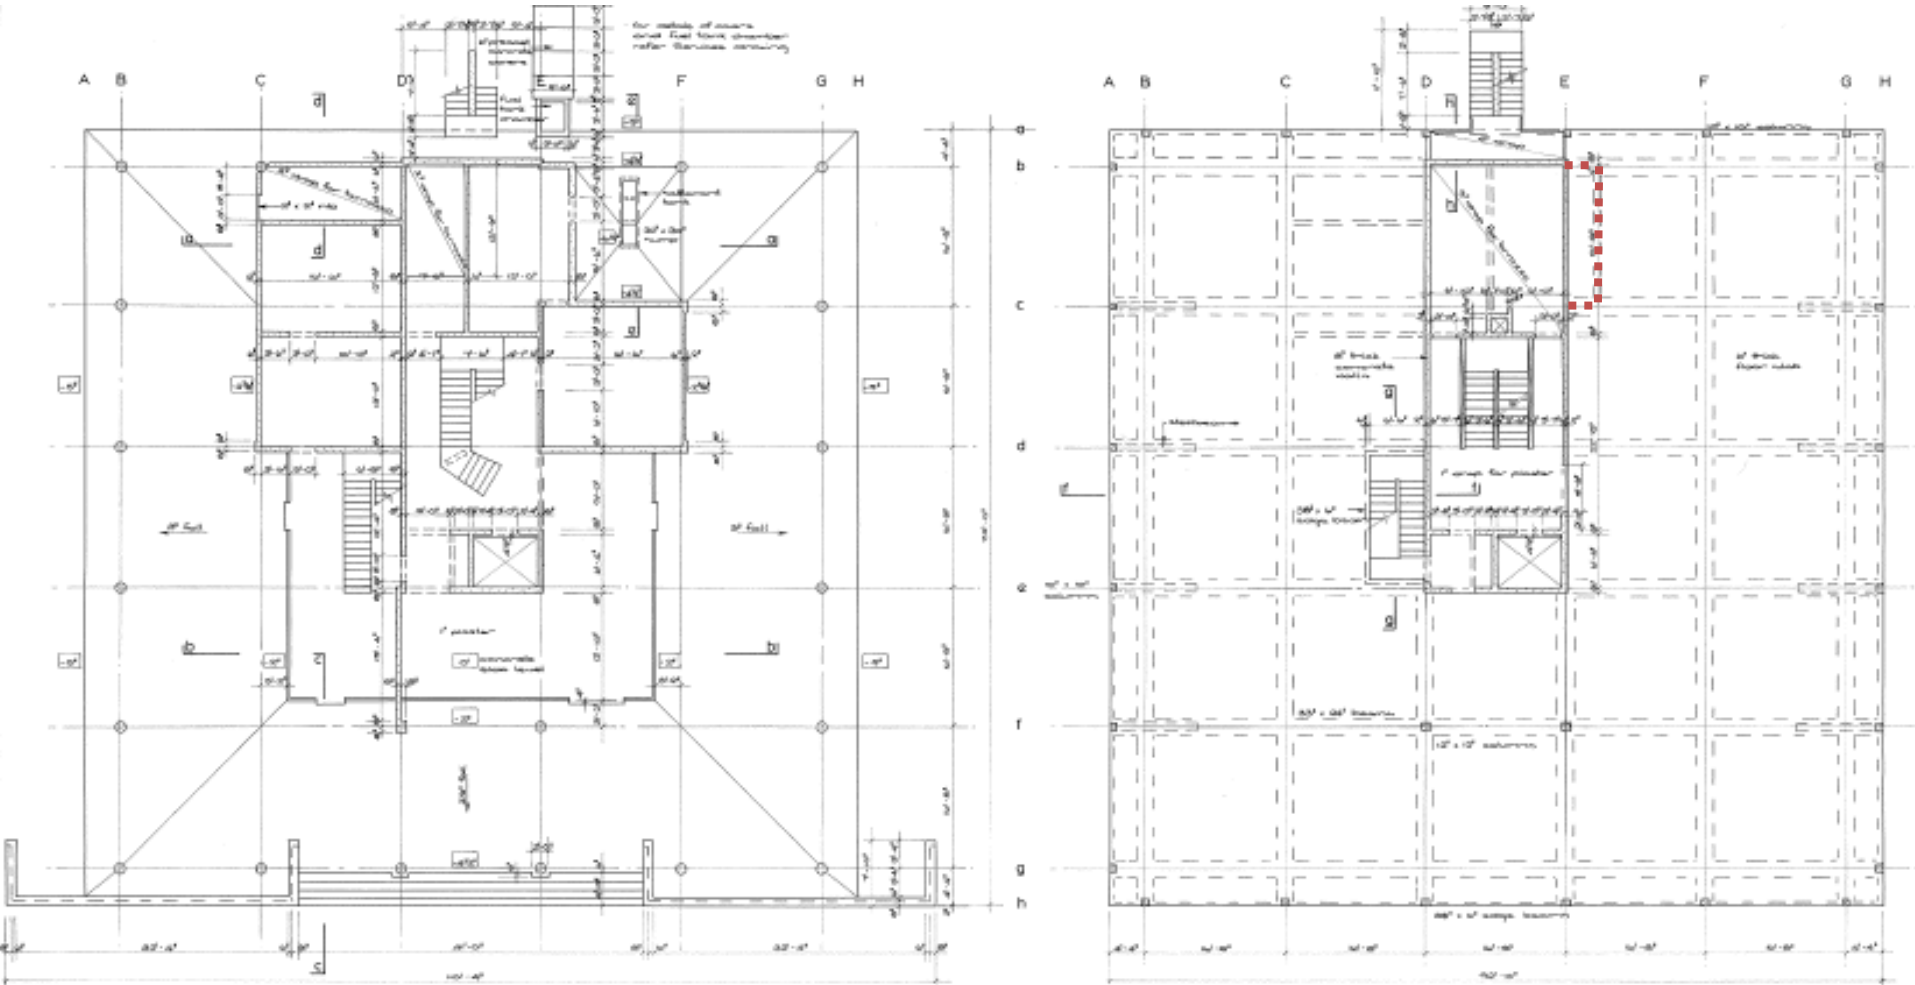
Structural plan of Ground and Level 1

Additional Seismic deficiencies

- Discontinuity at north end of east wall

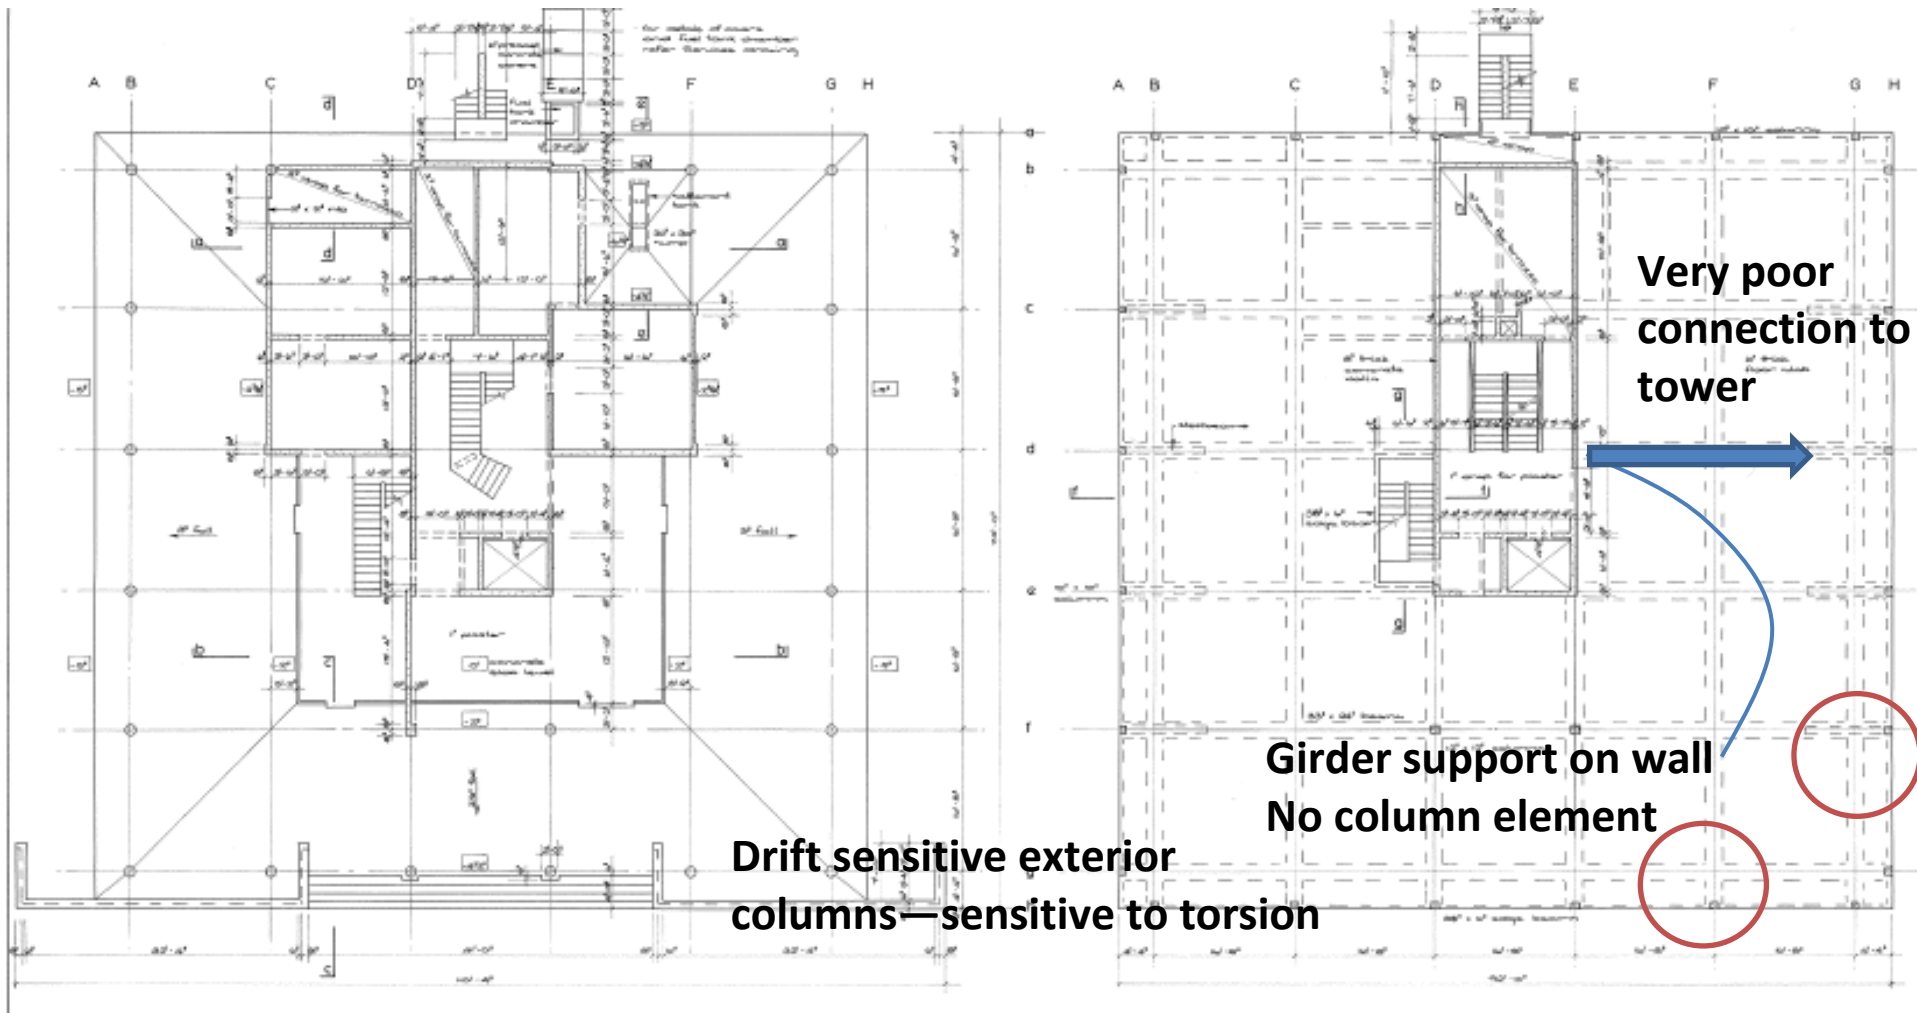
Structural plan of Ground and Level 1

Seismic deficiencies

- Discontinuity at north end of east wall
- No confined “column” elements under floor girders
- Poor connection of girders to tower at all levels
- Displacement critical gravity columns at perimeter (retrofit props not intended to support gravity loads under very large displacements.)

Drift sensitive exterior columns—sensitive to torsion

Very poor connection to tower

Girder support on wall
No column element
