SEISMIC RISK BUILDINGS - SURVEY

Date Inspected: 18/12/1991 File No: _____
 Address of Building: 7 Riccarton Rd
 Legal Description of Site: _____
 Name of Owner: _____
 Address of Owner: _____
 Principal Tenants: Oakley's Fruit, grain, produce Ltd
 Occupancy: (please tick) 8 hours 24 hours 5 days 7 days
 Use (eg. Office, Workroom, Factory, Commercial, Storage, Other): _____

Christchurch Eq. RAPID Assessment Form - LEVEL 1

Christchurch Eq RAPID Assessment Form - LEVEL 2

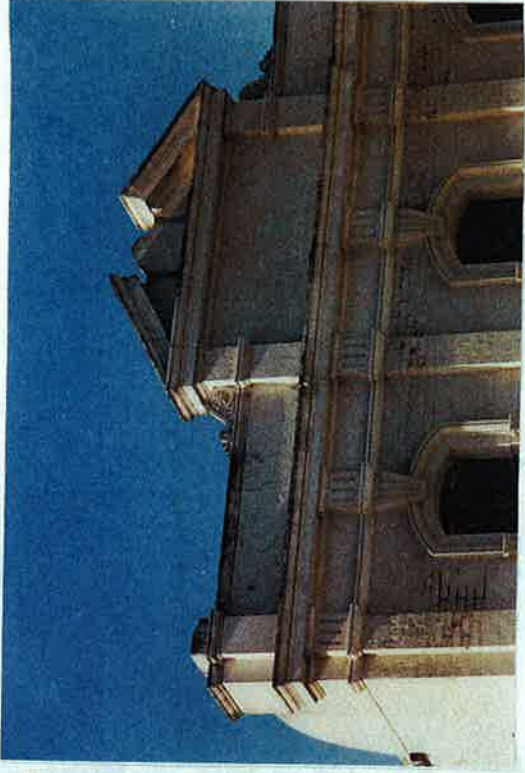
Cracked Walls Lateral Displacement Settlement
 Remarks: Parapet is cracked

LACKS IN PARAPET

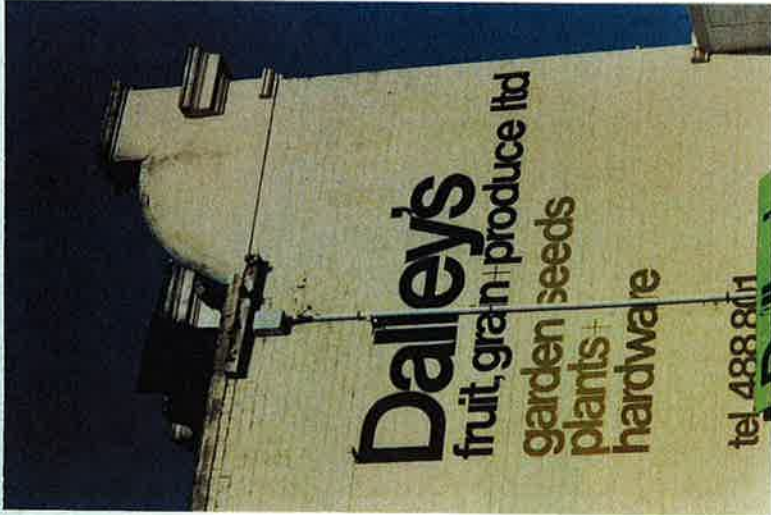
CRACKED PARAPET SIDE - NOTE WEEDS GROWING
