Royal Commission of Inquiry into Building Failure Caused by the Canterbury Earthquakes

Project: 391/391A Worcester Street, Christchurch

Site Report

Post Earthquake Structural Inspection

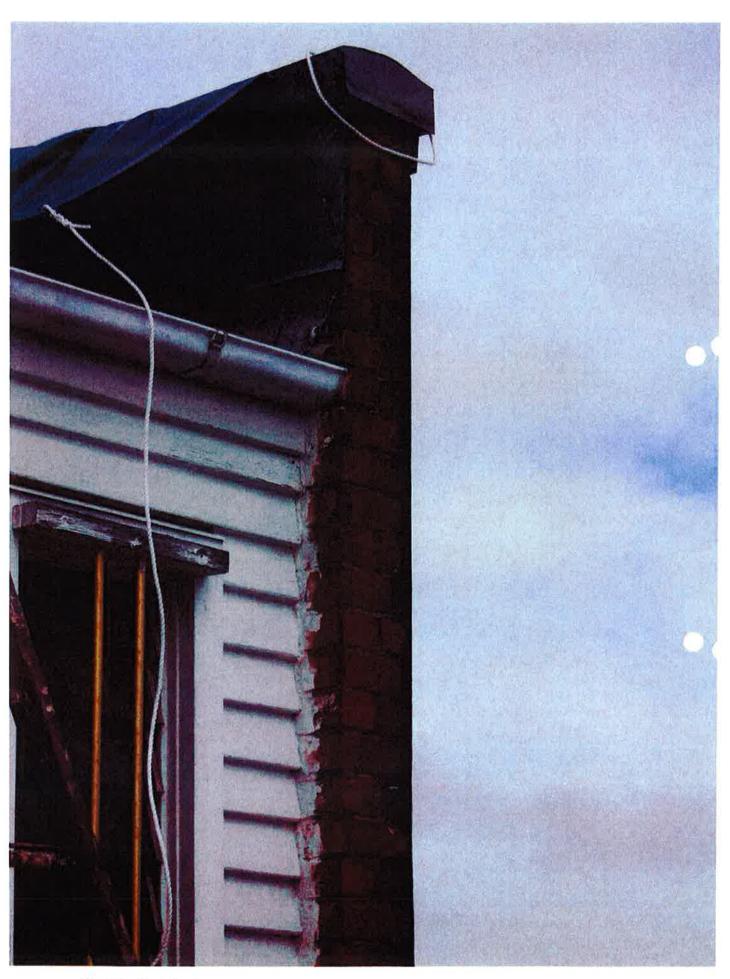
Photos attached of the rear west corner and view from the street from the day of my inspection.
