UNDER THE COMMISSIONS OF INQUIRY ACT 1908
IN THE MATTER OF CANTERBURY EARTHQUAKES ROYAL COMMISSION

DECLARATION OF GEOFFREY HADFIELD

**POST EARTHQUAKE
REPORT ON INSPECTION
&
SCOPE OF WORKS FOR REPAIRS**

**OF WALL OF FISH SHOP
AT 389A WORCESTER ST, CHRISTCHURCH
FOR VERO INSURANCE NZ LTD
CLAIM No. 3893363**

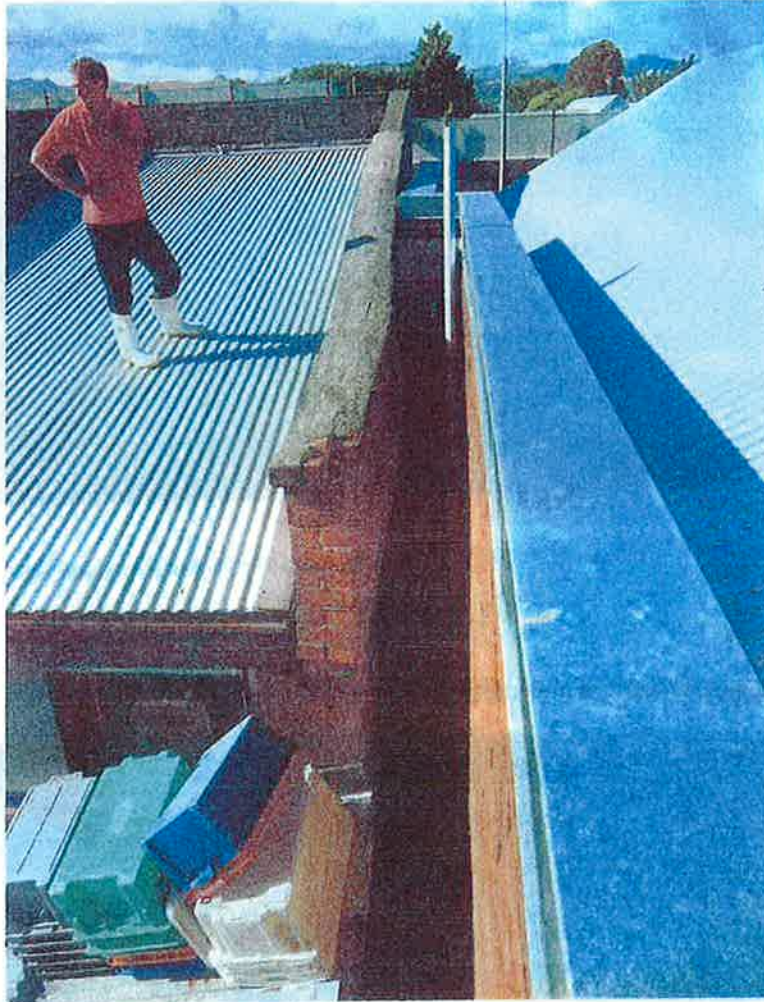
27/1/11 – 389A WORCESTER ST

Subsequent aftershocks did not bring to light any further damage until the aftershock of 26 December 2010 which badly damaged the west wall of the west shop. It is my opinion that this wall would have been severely loosened by the main shock and later aftershocks to the extent that it became very susceptible to a slightly bigger aftershock, such as the one on the 26th of December, 2010.

WEST WALL DISPLACED TO WEST A LITTLE BIT AT TOP BUT MUCH WORSE BELOW

1. Repair the east shop roof – now complete.
2. Remove 6.3m of brick west wall and foundations.
3. Construct a new self supporting block wall and foundations to replace the above wall.
4. Construct a new floor for the rear 6.3m of the west shop tied into the new wall to provide an anchor to the foundations and wall to resist earthquake loads.
5. Re-support the roof and ceiling joists.
6. Repair the roof and ceilings.
7. Flash the new wall over the top and down onto the roof.
8. Flush plaster and paint the internal face of the new wall.
9. All other work required to fully restore the building.

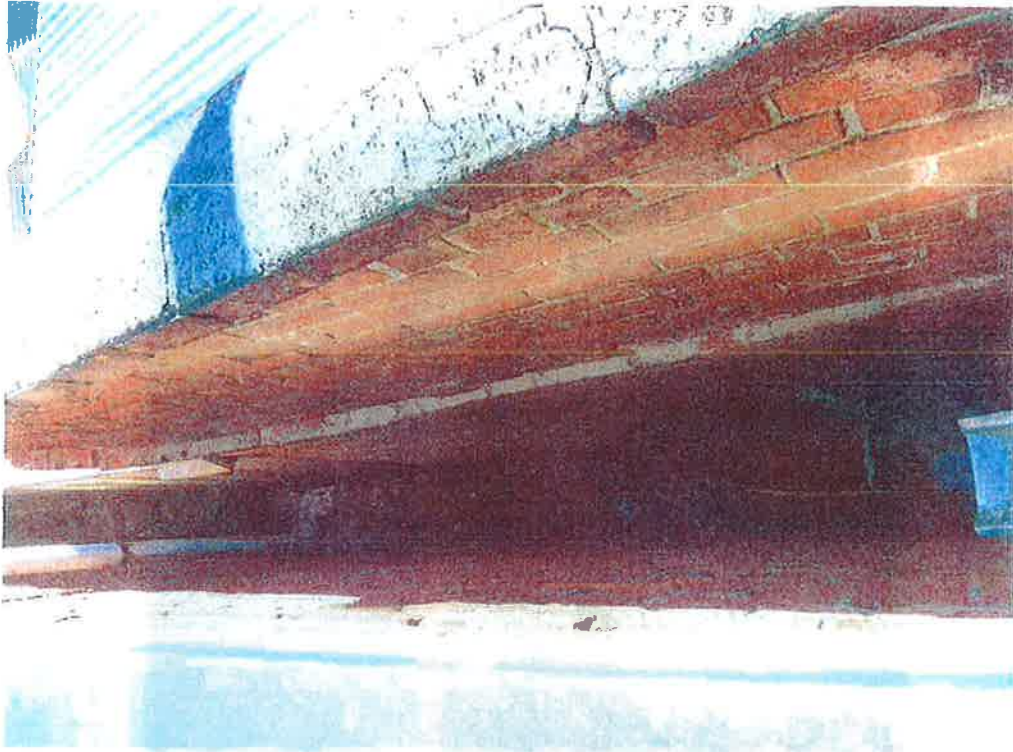
27/1/11 – 389A WORCESTER ST – WEST WALL DISPLACED AT ROOF LINE & BELOW
