SEISMIC RISK BUILDINGS - SURVEY

Date Inspected: 7/1/1990 File No: _____
 Address of Building: 240-246 High Street (242 High Street)
 Legal Description of Site: Lot 1 DP 3675
 Name of Owner: Y. Yankov
 Address of Owner: 41 Urunga Avenue, Christchurch
 Principal Tenants: Jag
 Occupancy: (please tick) 8 hours 24 hours 5 days 7 days
 Use (eg. Office, Workroom, Factory, Commercial, Storage, Other): _____

Project Name 242-246 High St

Project Name 242-246 High St
 Project No: 105380.06
 S.R. No: 002
 Date: 15 September 2010
 Reviewed By: Alistair Boys

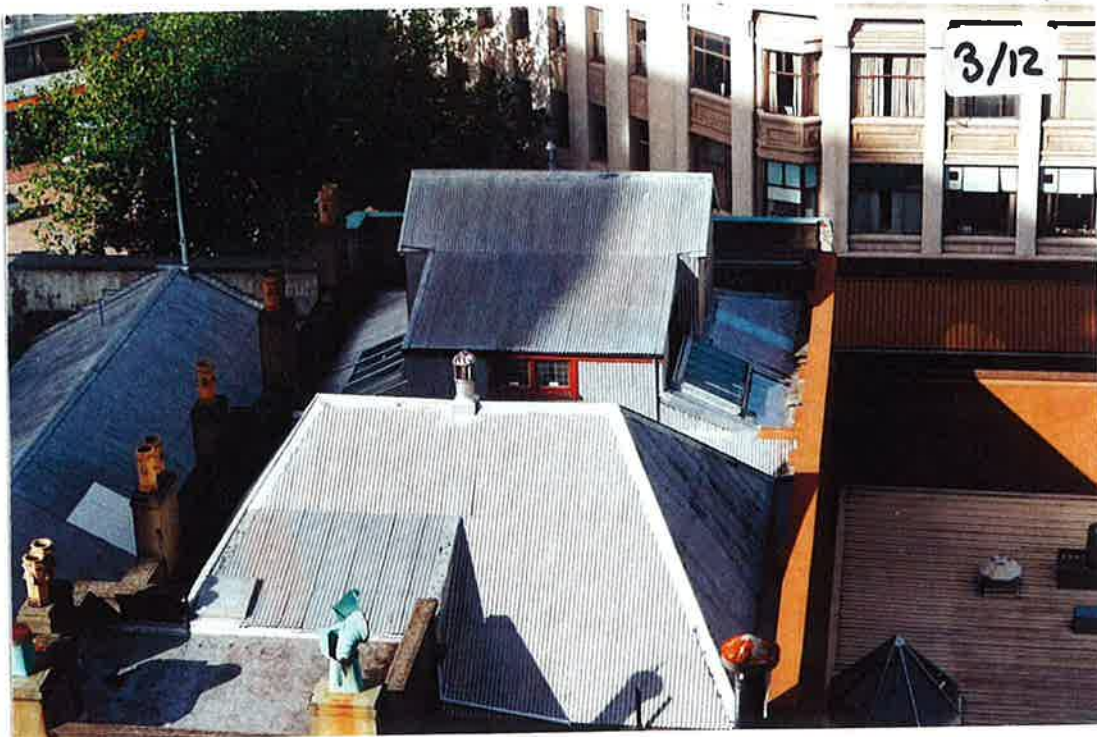
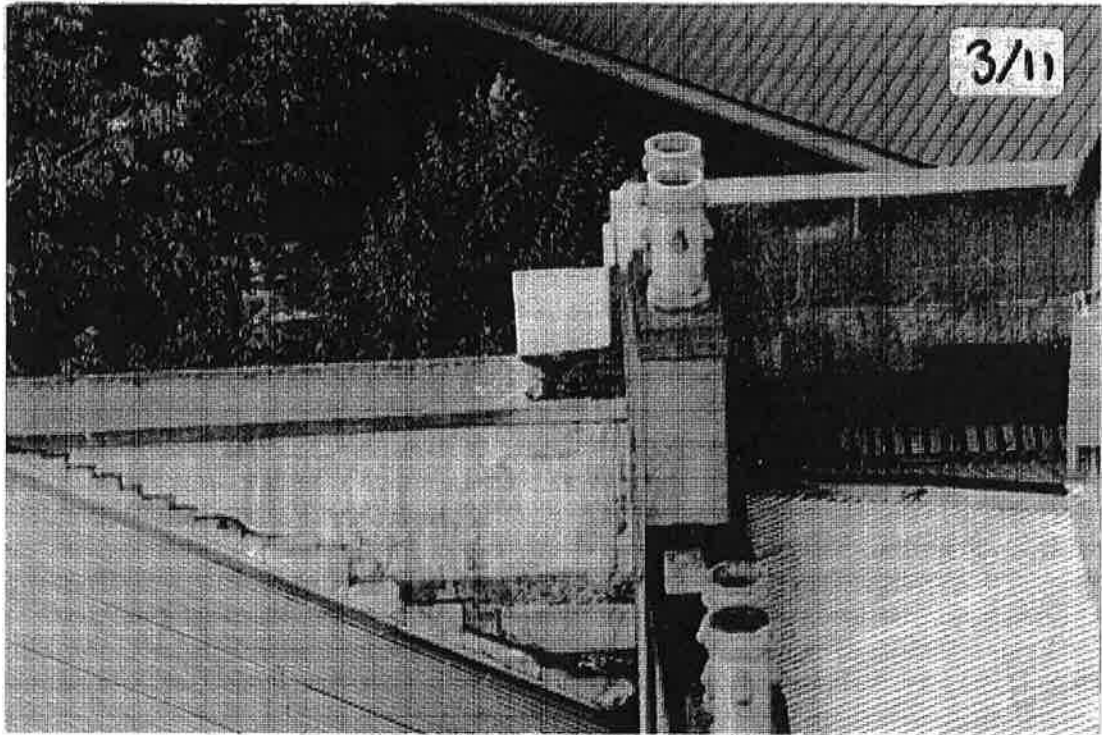
Photo Reference: 3/1/12, 1

Parapet: ~2.5 m
Chimney: 5 (all hazardous) on the east elev
Cornice: (cracked) (~600mm o/m)

Comments: Street elev: recently painted and perhaps re-plastered, therefore no visible cracking on the face.

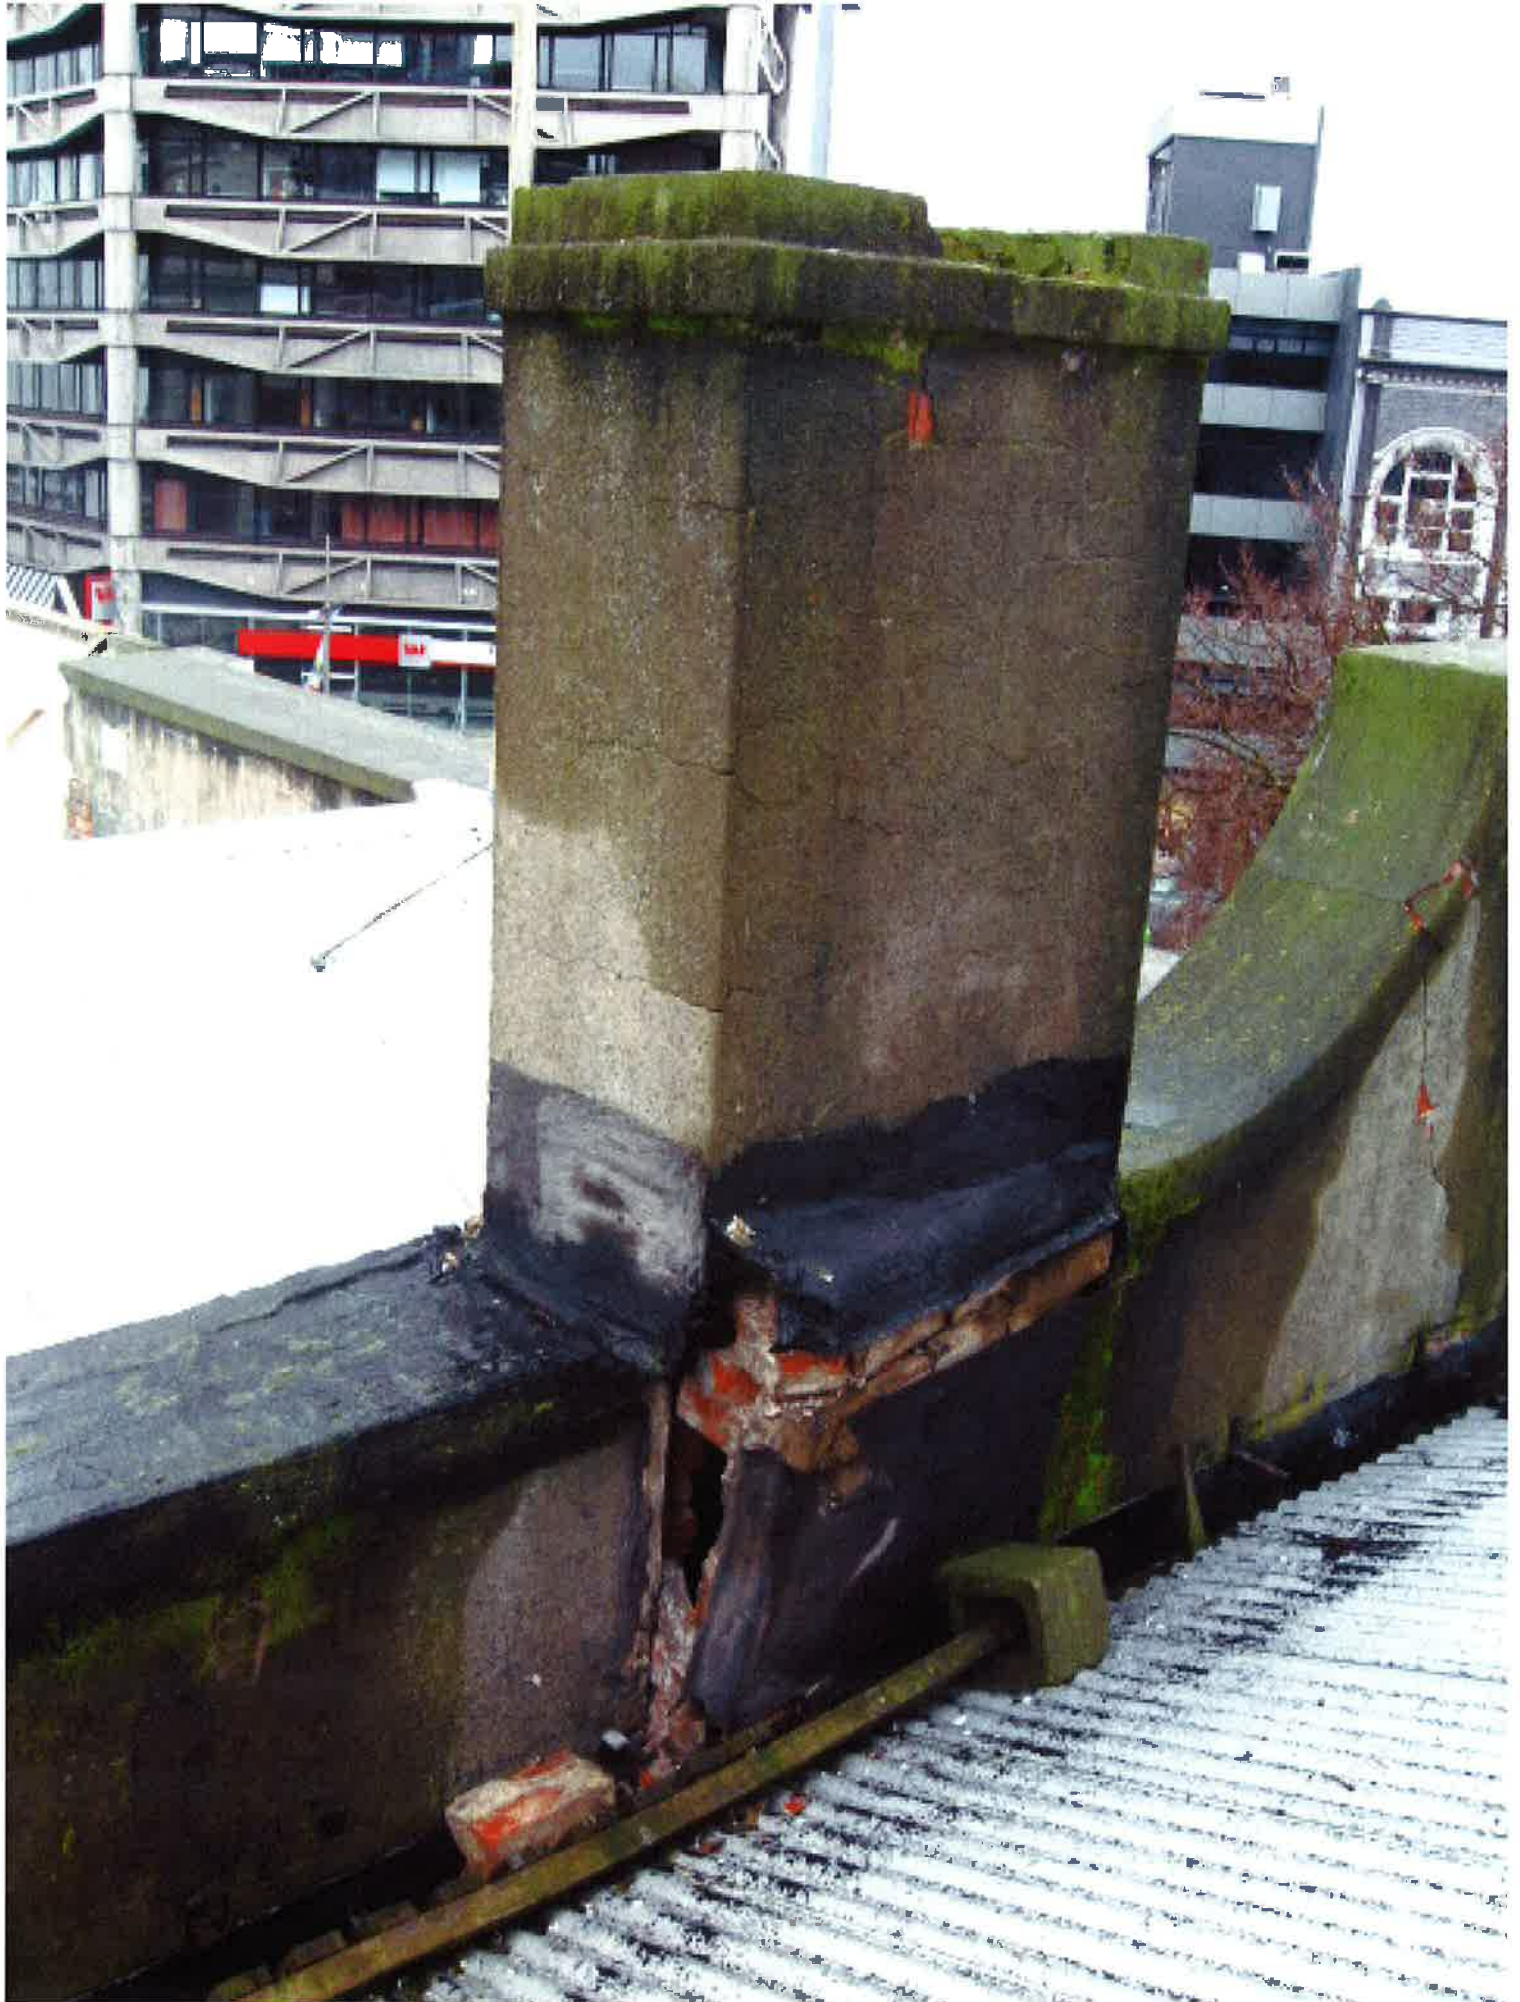
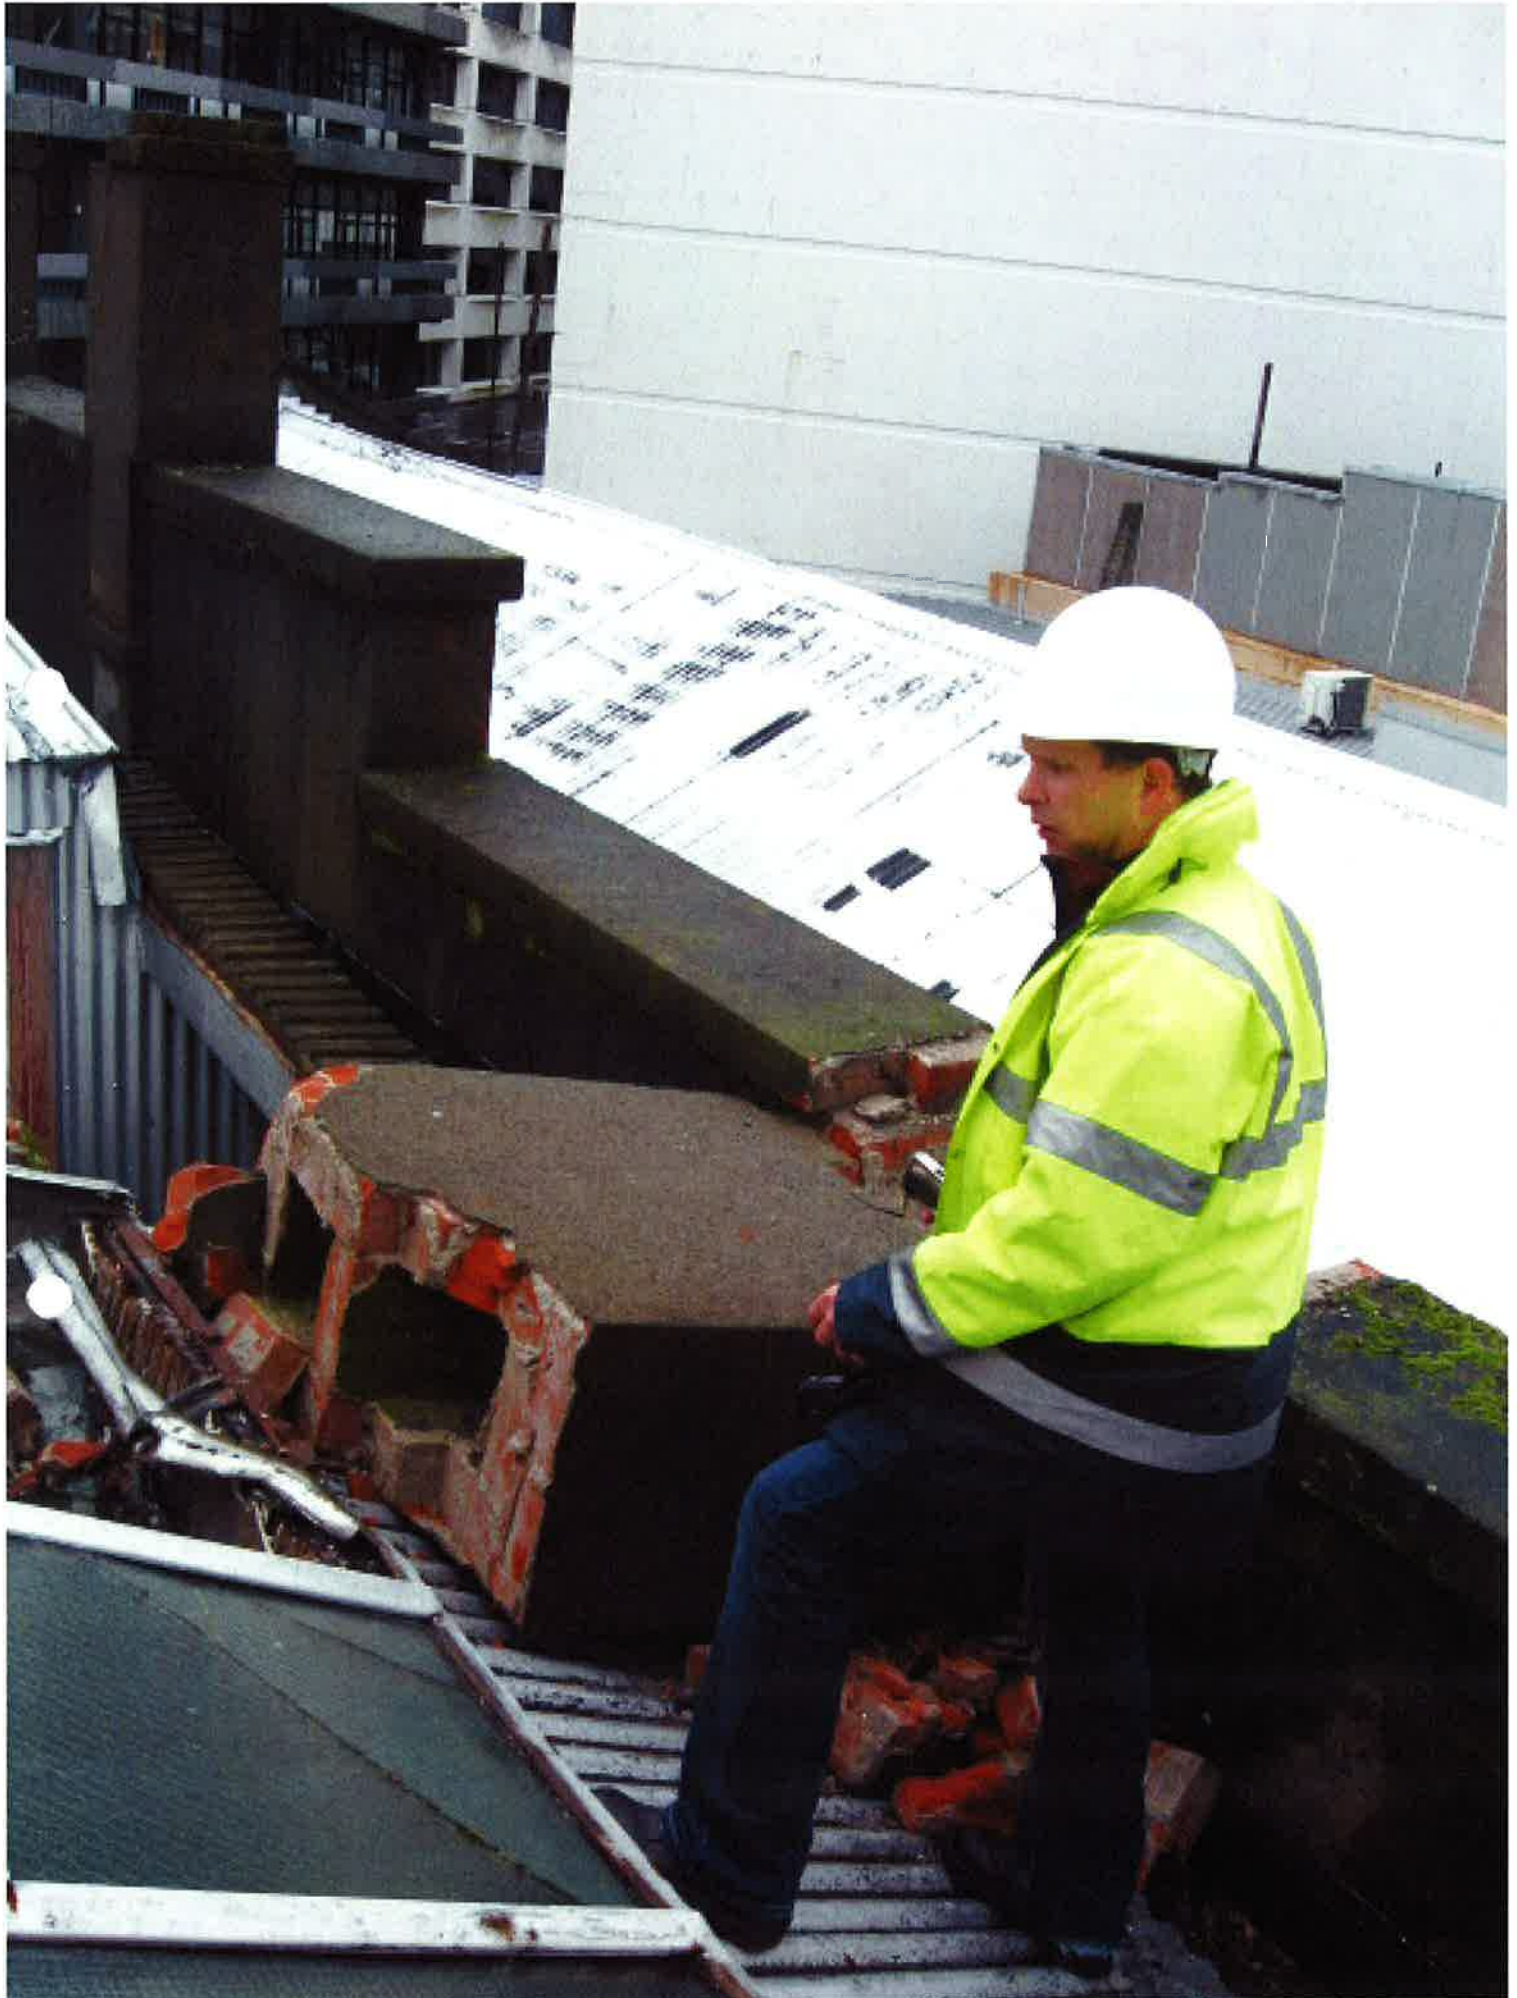
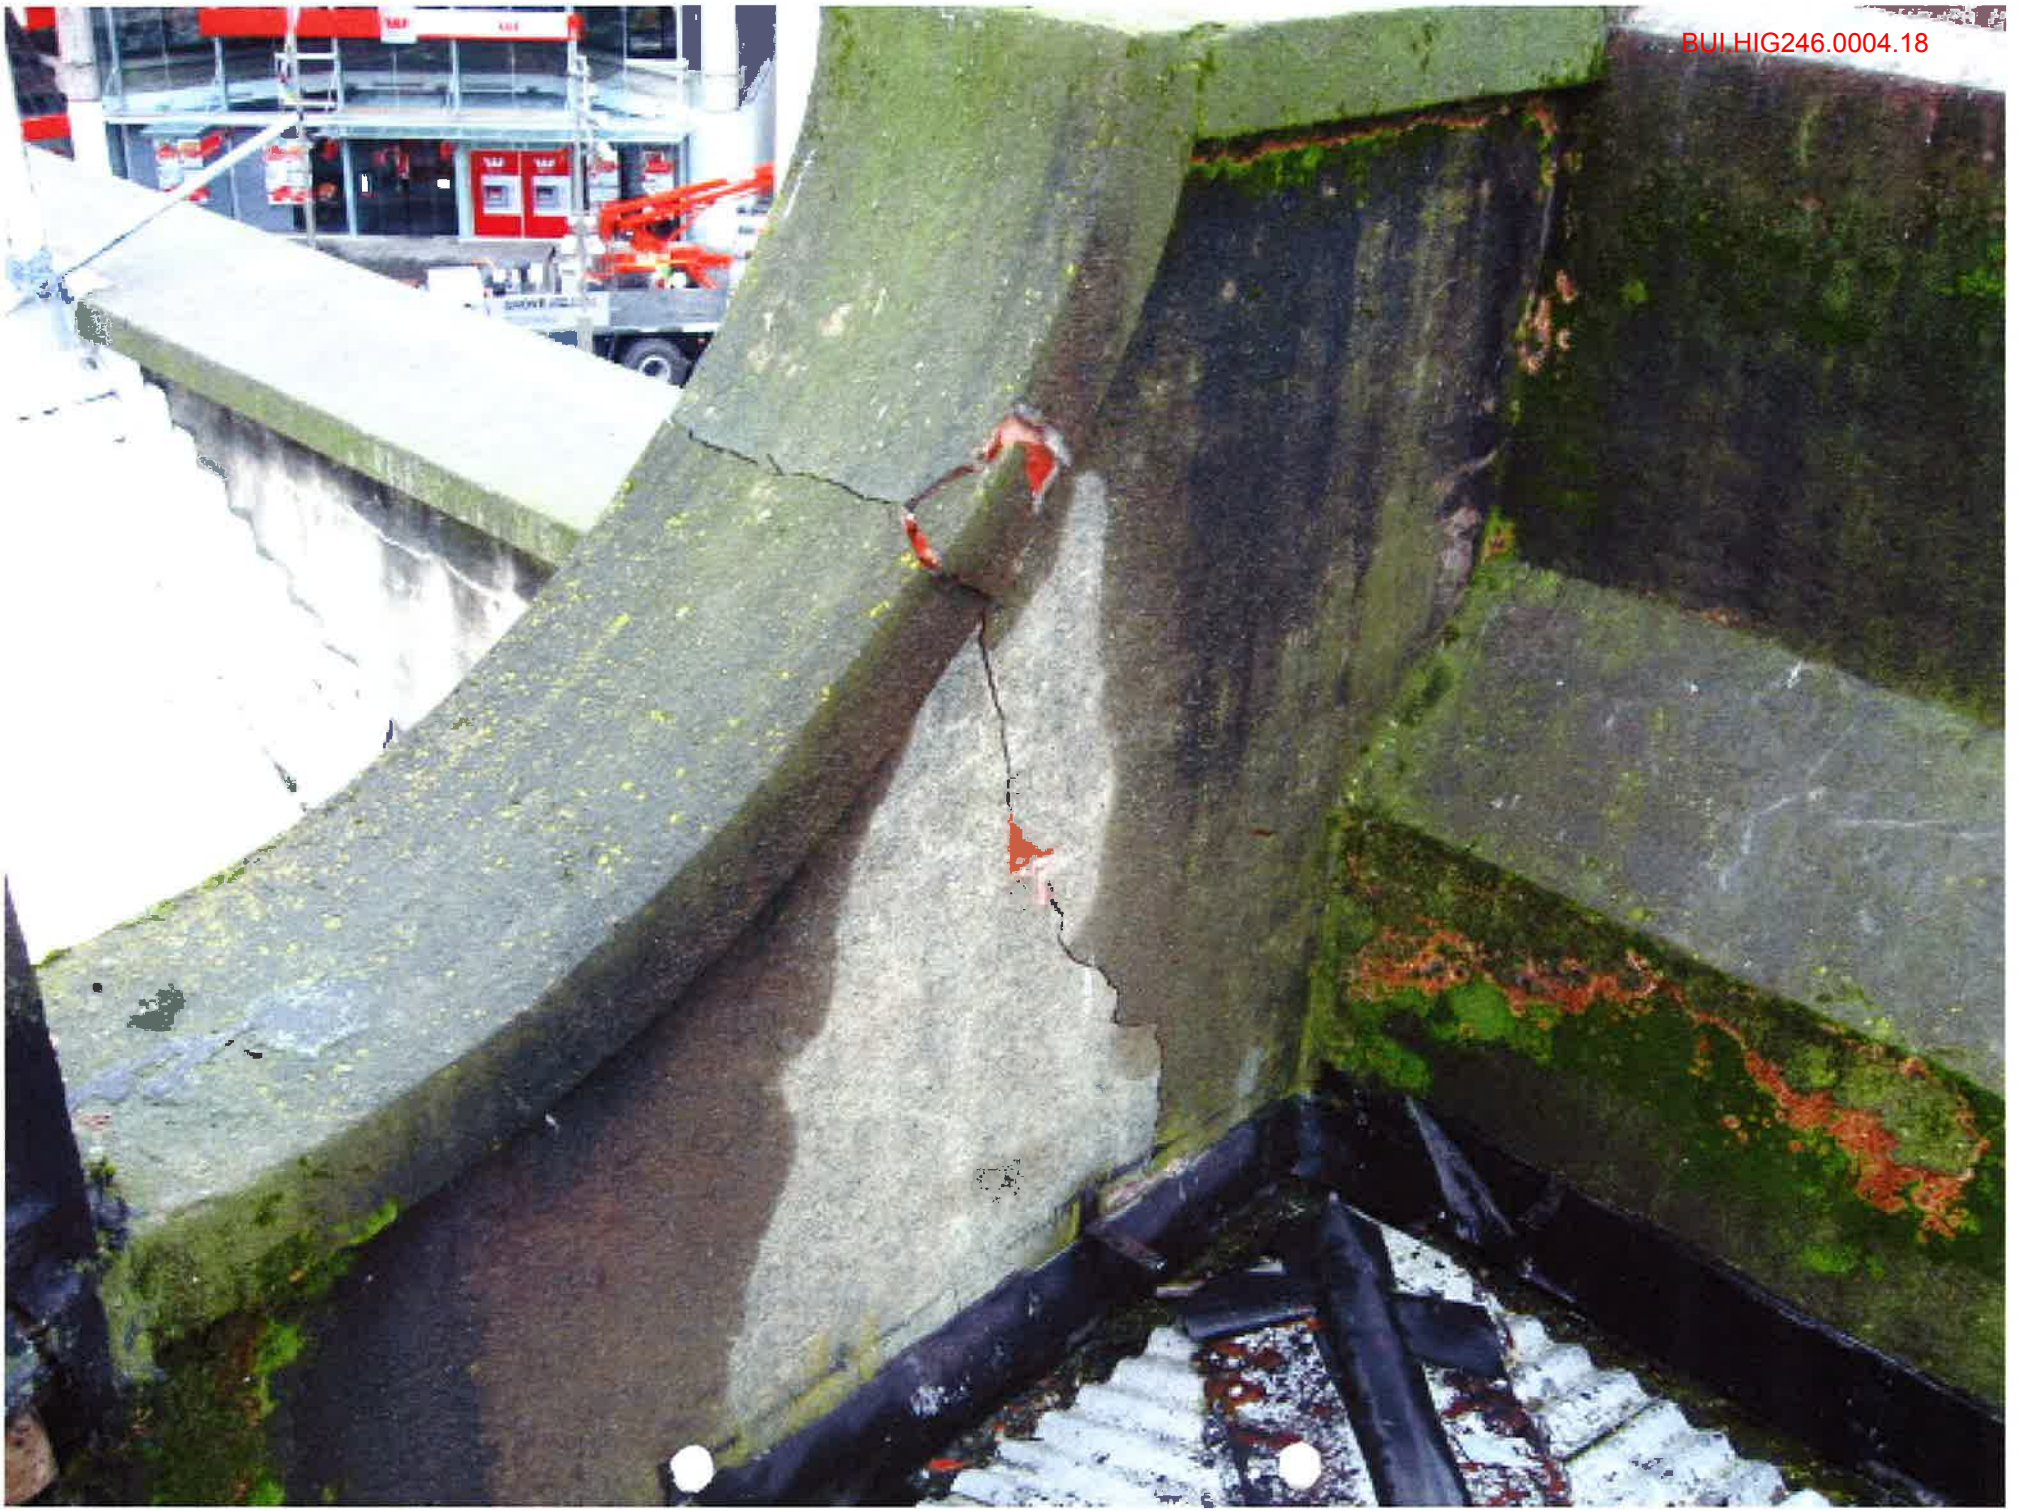
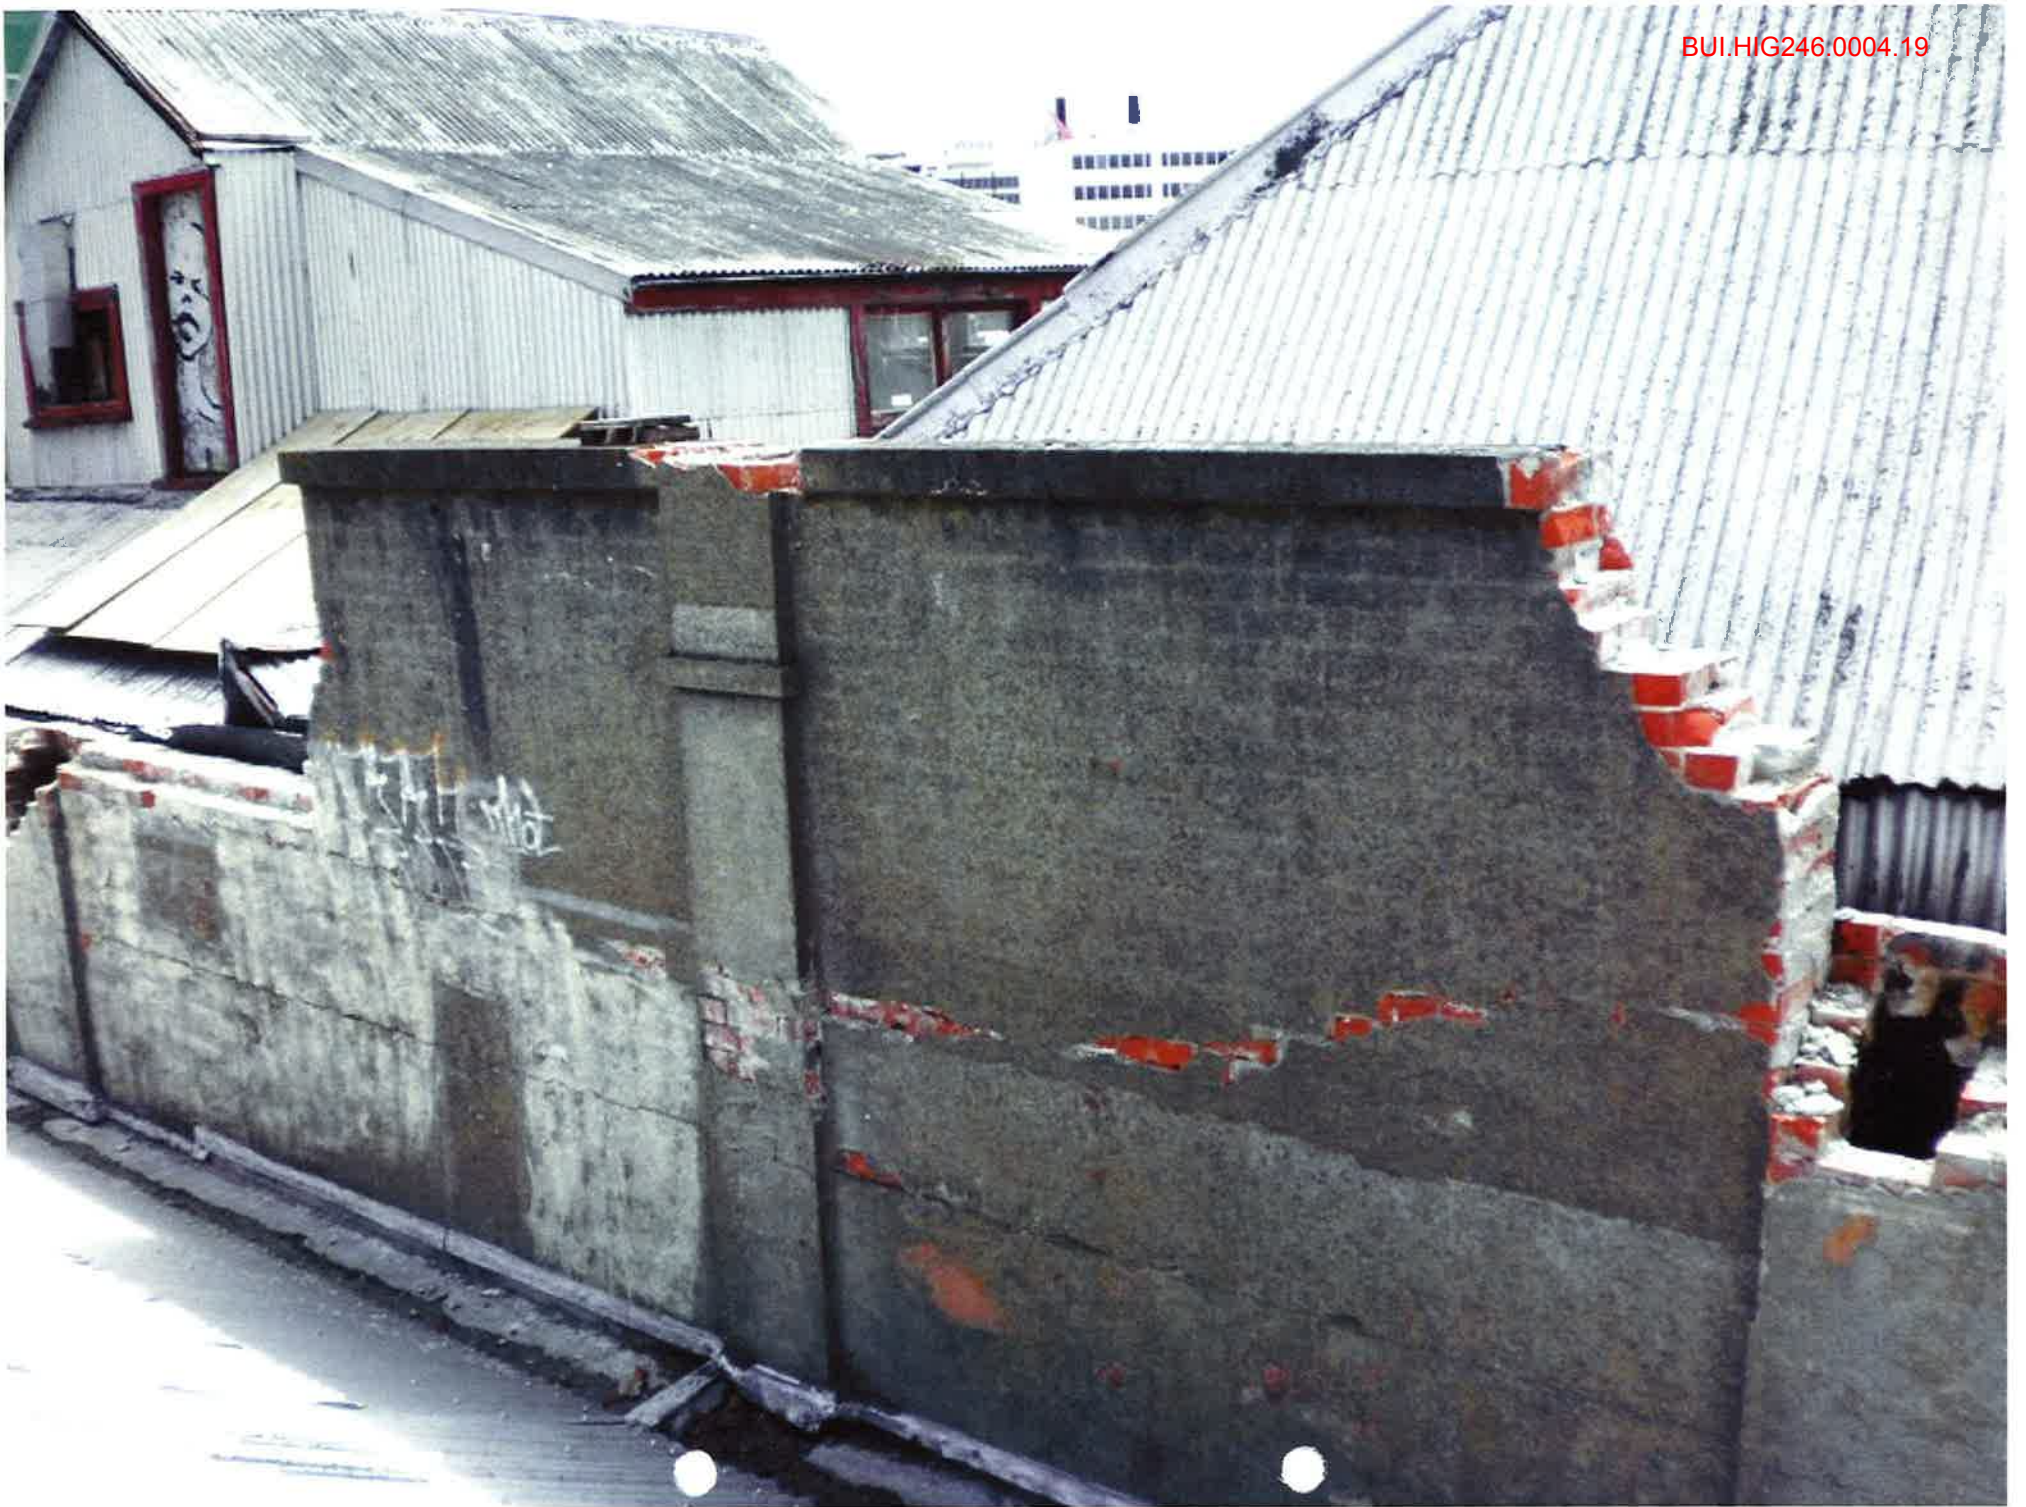
Damage observed was generally limited to lathe and plaster ceiling.

On the top of the building there is damage to the parapet/chimneys. One had fallen through a sky light and landed on the floor inside the building. Others are cracked and couple topple given an aftershock.

- 3 Storey URM Building, Retail on ground floor and basement, and empty apartments above.
- Internally damage limited to lath and plaster ceilings.
- Front and Northern boundary parapets are undamaged.
- The southern boundary wall has fallen and damaged chimneys and significant cracking to the supporting parapet.
- Advised the contractor to remove all loose masonry from chimneys and parapets, and provided a temporary restraint detail for the remaining cracked parapet adjacent to the front corner of the building (detail attached).
- Building is to remain as YELLOW Tagged until remedial works completed.
- Adjacent building has also been YELLOW Tagged due to falling hazard from boundary wall.

- Re-inspect 3 Storey URM building at 242-246 High St with contractor to remove falling hazards from damage chimneys and parapet.

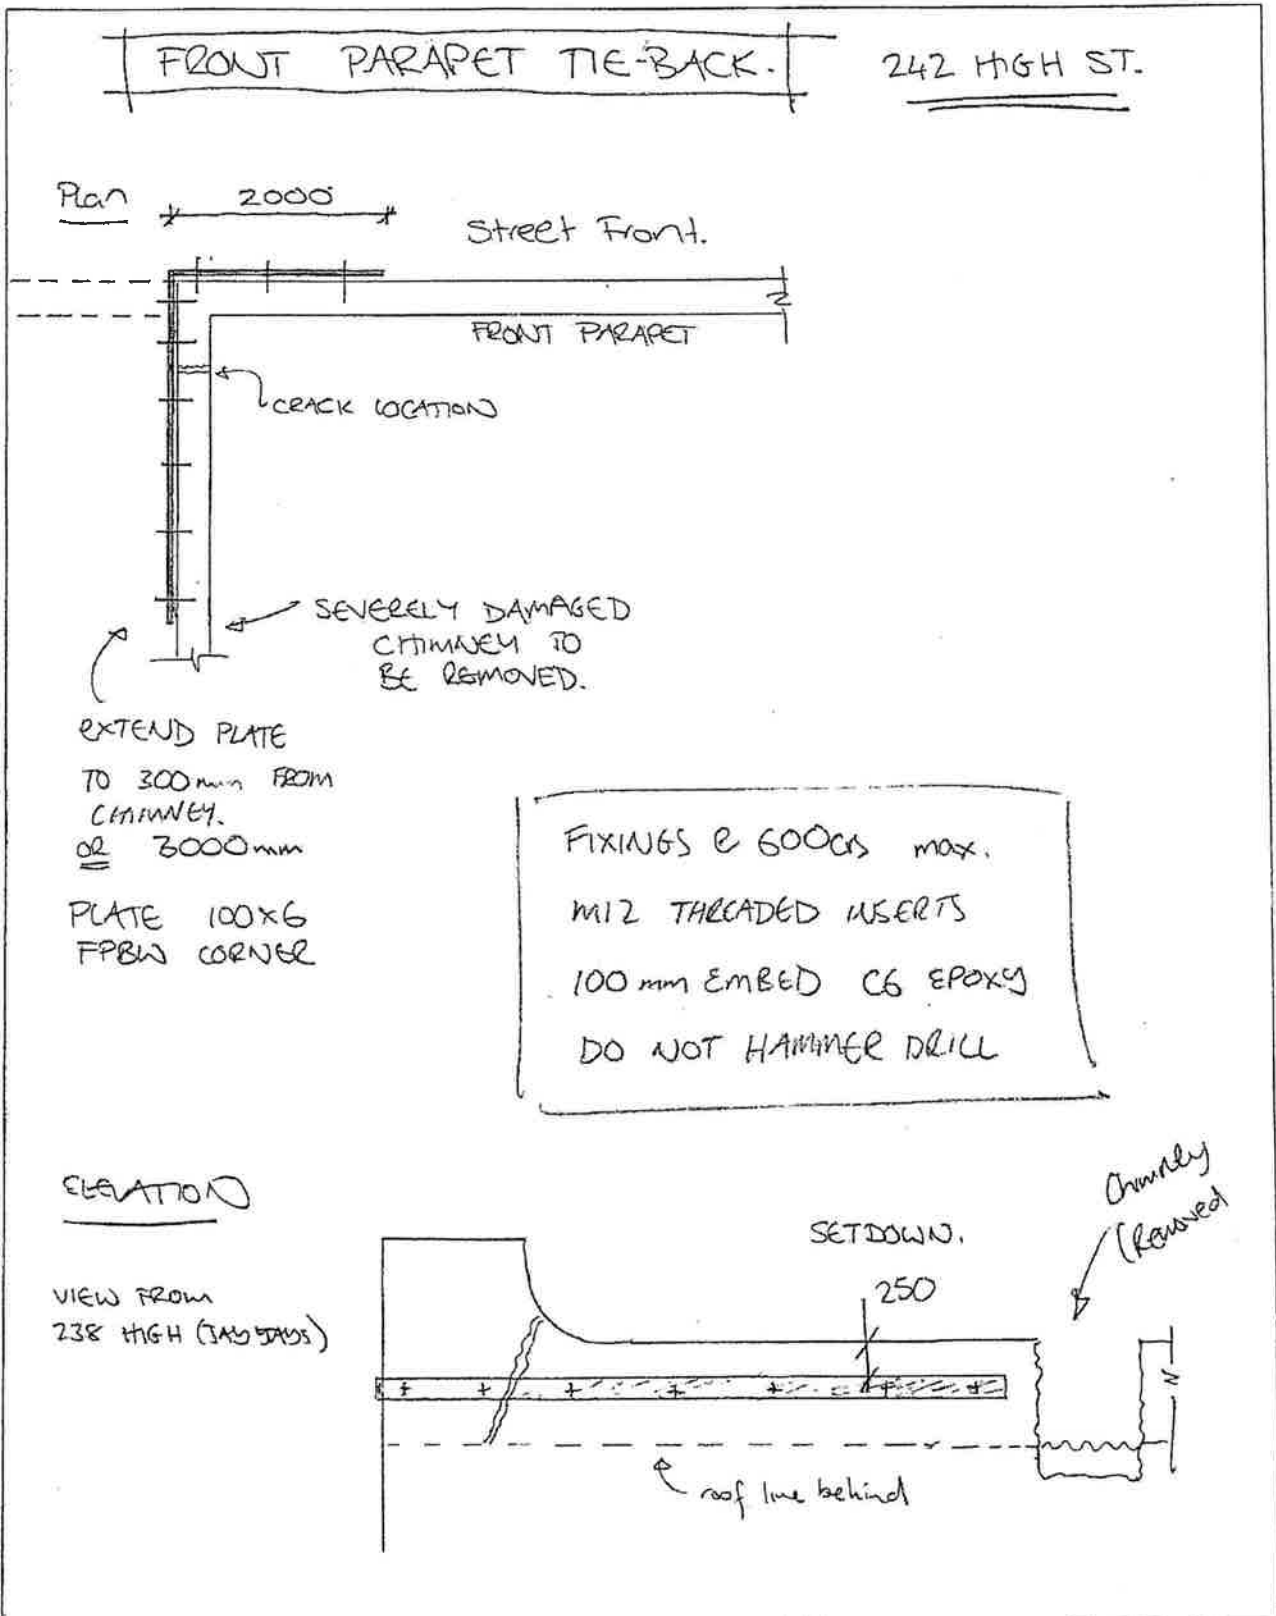
CALCS/SKETCHES

- Metal strap installed to front parapet corner as required.
- Chimneys removed from South parapet down to roof level. The majority of the parapet appears relatively undamaged except for a short segment approximately half way along the roof. Please remove this segment of parapet (approximately 2m long 0.7m high) down to roof level (also adjacent 5m long section).
- Once this work is complete the parapet is considered to be as stable as it was before the earthquake. Long term, we recommend the parapet be investigated with a view to securing the taller sections of the parapet.
