Canterbury Earthquakes Royal Commission Te Komihana Rūwhenua a te Karauna

242-246 High Street

The Royal Commission is inquiring into the failure of the building that was located at 242-246 High Street (the Building).

SITE REPORT

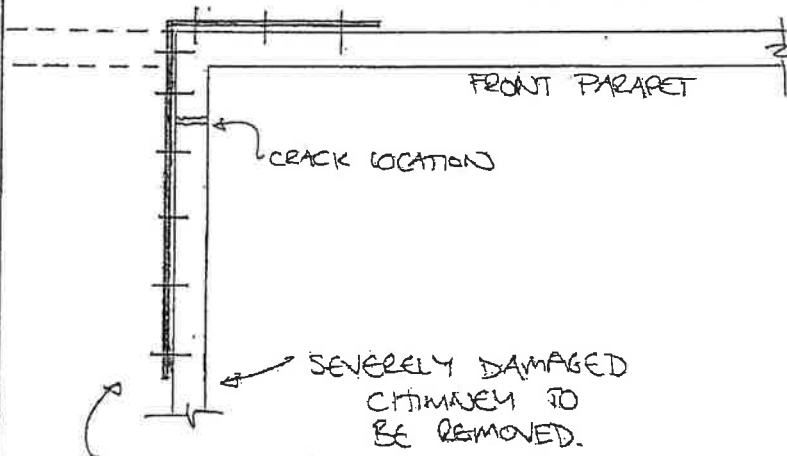
Plan 2000 Street Front.

- Re-inspect 3 Storey URM building at 242-246 High St with contractor to remove falling hazards from damage chimneys and parapet.

- 3 Storey URM Building, Retail on ground floor and basement, and empty apartments above.
- Internally damage limited to lath and plaster ceilings.
- Front and Northern boundary parapets are undamaged.
- The southern boundary wall has fallen and damaged chimneys and significant cracking to the supporting parapet.
- Advised the contractor to remove all loose masonry from chimneys and parapets, and provided a temporary restraint detail for the remaining cracked parapet adjacent to the front corner of the building (detail attached).
- Building is to remain as YELLOW Tagged until remedial works completed.
- Adjacent building has also been YELLOW Tagged due to falling hazard from boundary wall.

EXTEND PLATE TO 300mm FROM CHIMNEY. OR 3000mm

PLATE 100x6 FPBW CORNER
