SEISMIC RISK BUILDINGS - SURVEY

earthquake damage report**structex**

This report covers our assessment of the structural condition of the building located at 116 Lichfield Street, Christchurch on the morning of 7th December 2010 based on a visual inspection inside and out.

USAR Damaged Building Reconnaissance Report

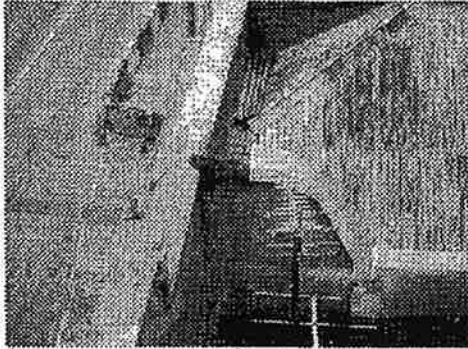
Parapet of 145 Manchester Street

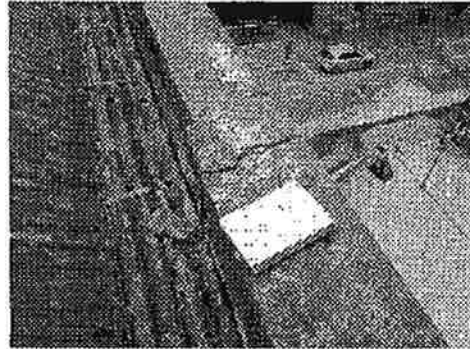
Parapet of 116 Lichfield Street

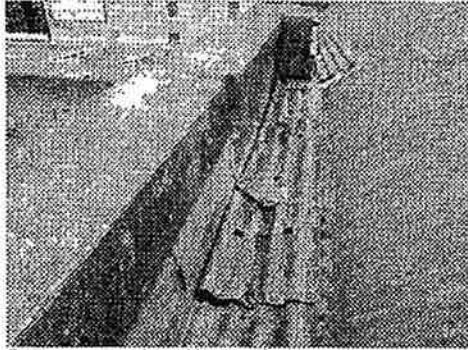
Parapet return of 116 Lichfield Street

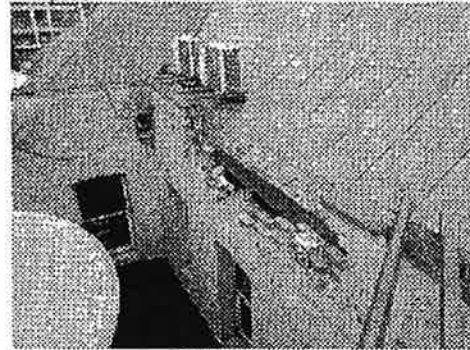
Inspection of the building showed that parapets around the central lightwell were damaged and loose bricks precariously placed.

Collapsed parapet of 116 Lichfield Street above egress stair.

Require the loose bricks and parapets to be removed around the lightwell and the stairs reinstated to provide egress if upper floors are to be used.

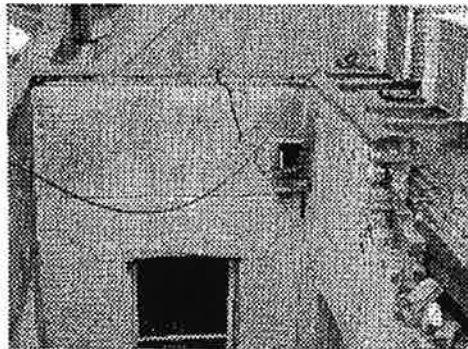
Damaged parapet.

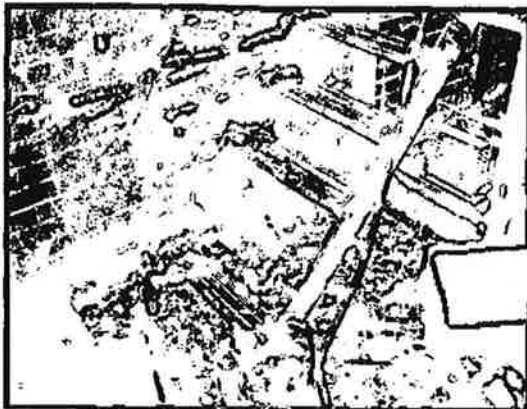
Damaged stairwell stair tread and handrail

The fire escape stair treads and handrails should be repaired.

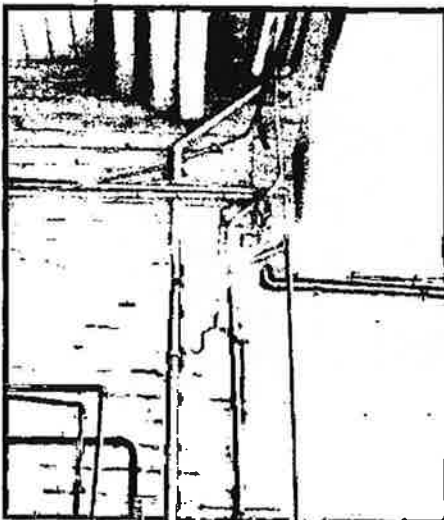
- Some stone facing panels appeared to have popped off ground floor perimeter columns (mortar cracked).
- Vertical and diagonal cracks to bricks each side of alleyway at SE corner of the building.
- Minor plaster board wall/ceiling cracks.

Alleyway wall crack

- Vertical and diagonal cracks and cracked archways in the URM walls should be stitched with Helifix ties (refer www.helifix.com.au). The mortar joints should then be repointed.

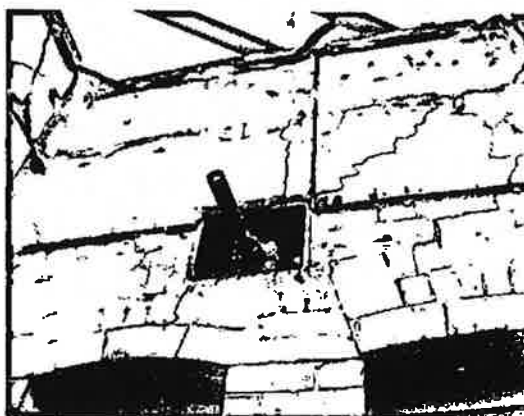
The parapets to the fire escape remain a fall hazard to the area below and are preventing access to the upper levels of both 114 and 116 Lichfield Street. A roof water tank is also supported on these unsecure parapets.

Severe cracking to south wall and parapet of fire escape

- Once the fire escape parapets have been removed, the damaged brickwork directly under should be repaired. The sections of wall with loose and/or dislodged bricks, particularly above the windows, should be carefully lowered and rebuilt. A new reinforced concrete capping beam should be formed over tying the walls together. A new parapet can be constructed over, either from reinforced concrete or from lightweight materials. The roof structure should then be tied into the concrete beam.

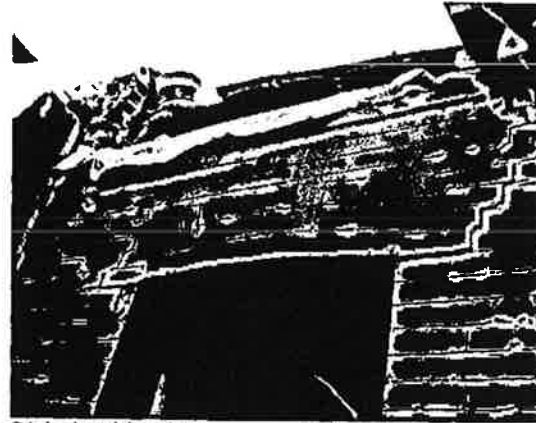
Dislodged bricks to north end of fire escape

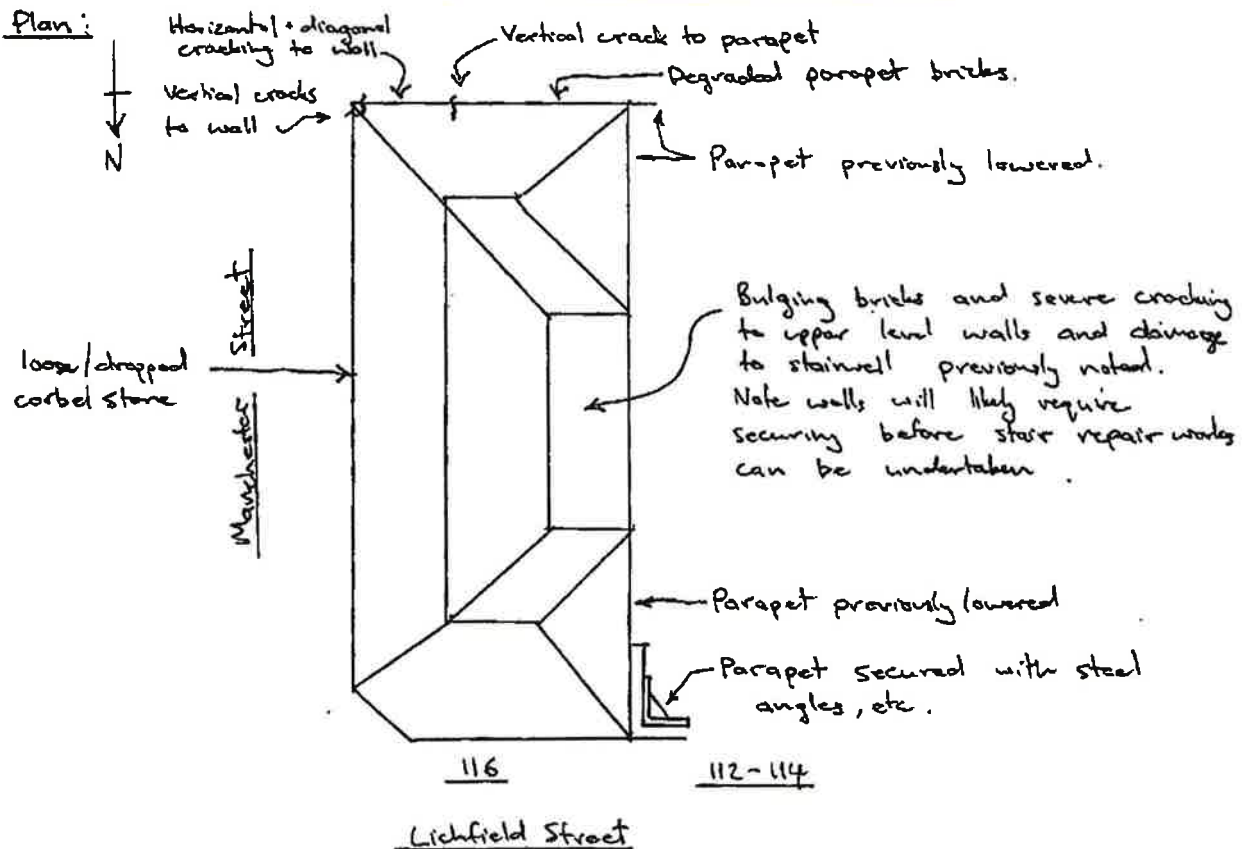
These high level bricks and stone blocks are potential fall hazards to the areas directly adjacent and should be secured as soon as possible, (or the fall areas cordoned off).

We suggest securing works be undertaken as per attached (contractor to wait for insurer approval).
