**IN THE MATTER OF
THE CANTERBURY EARTHQUAKES ROYAL COMMISSION**

BRIEF OF EVIDENCE OF RHYS COLLIN SMITH

Dated 16 December 2011

194 Hereford Street (Joe's Garage) ("the building")

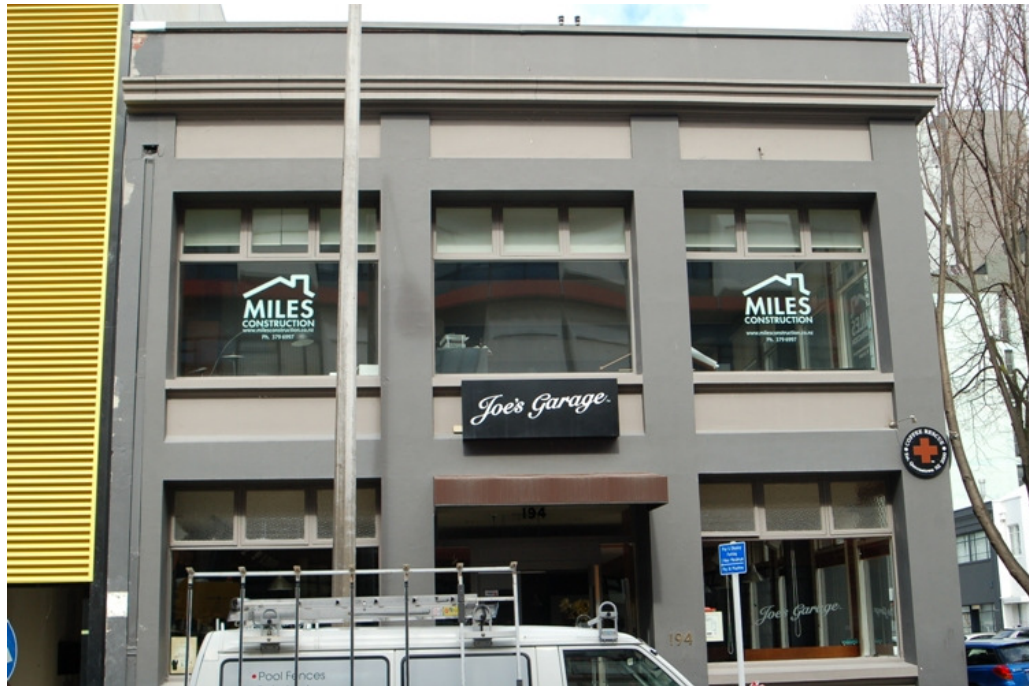
Photo 1

Photo 1: General view of the front (north) elevation. The wall was constructed from unreinforced brick masonry (URM) and had lightly reinforced concrete bond (or ring) beams that ran full width over each level of windows. The wall was plastered on the outside and exposed on the inside.

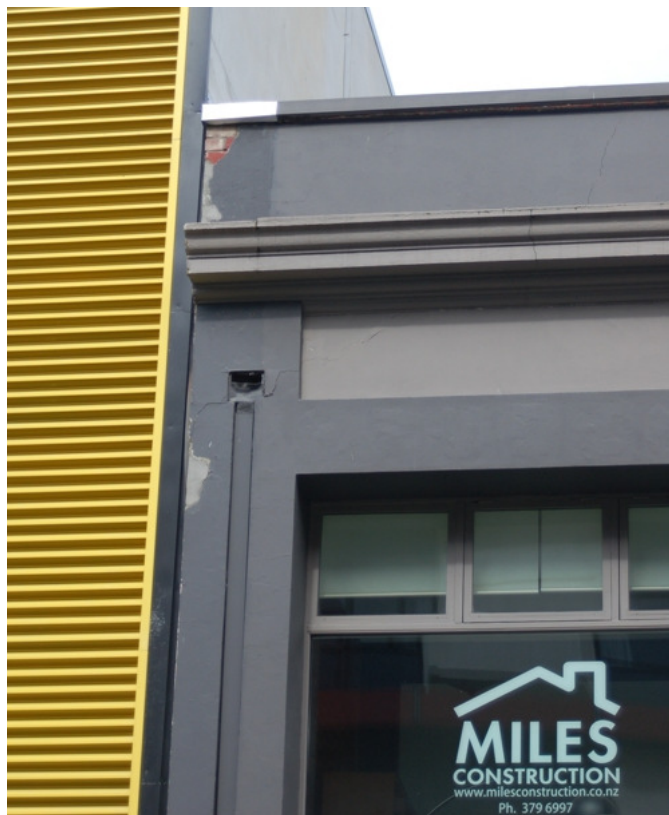
Photo 2

Photo 2: Close-up of the upper left corner of the wall. There was a crack starting from the edge by the rainwater overflow and ran diagonally up to the right through to the top of the parapet.

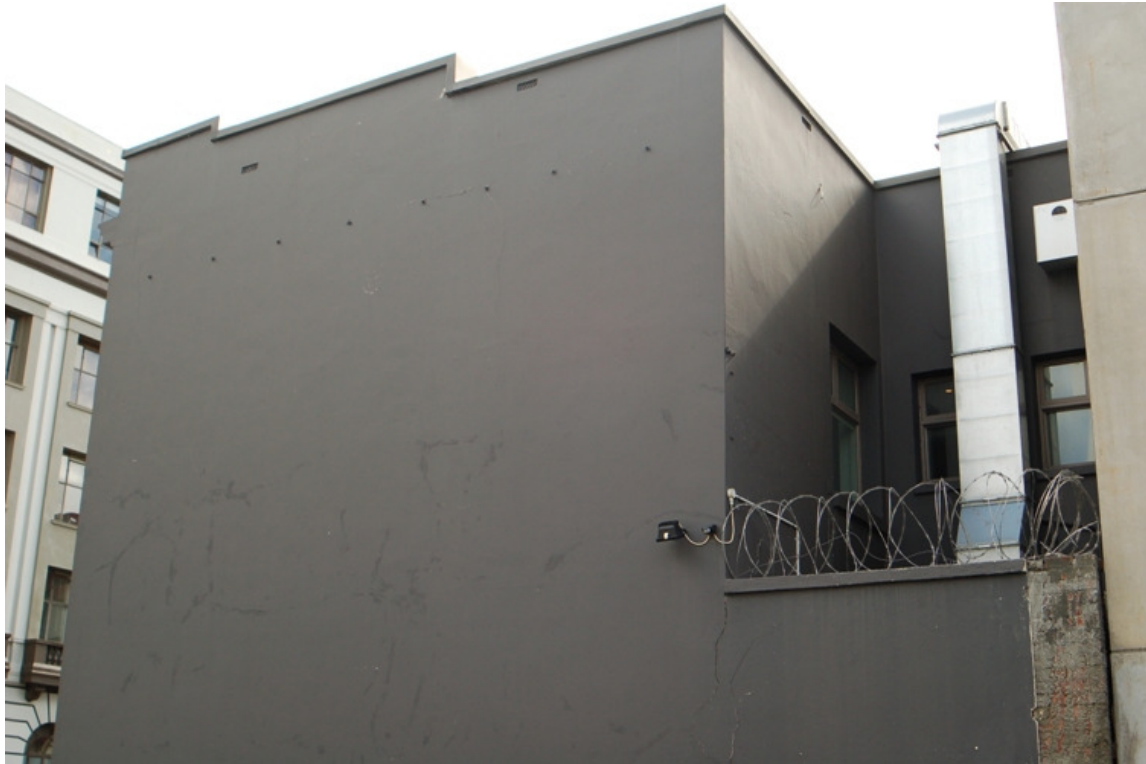
Photo 3

Photo 3: General view of the rear (south) wall. The two storey section was double skin cavity URM and the lower wall to the right was solid double brick. Behind the lower wall was a service yard which housed a self contained coolstore.

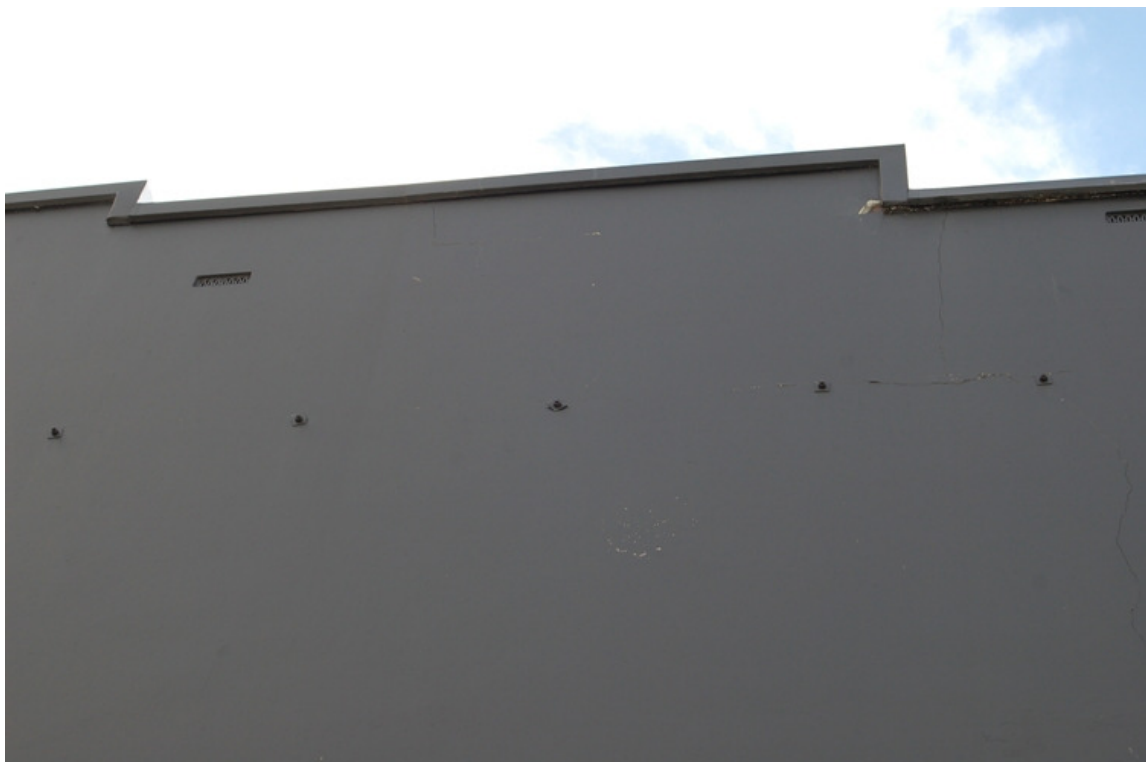
Photo 4

Photo 4: Close-up of the central upper area of the rear wall showing hairline cracks in the wall.

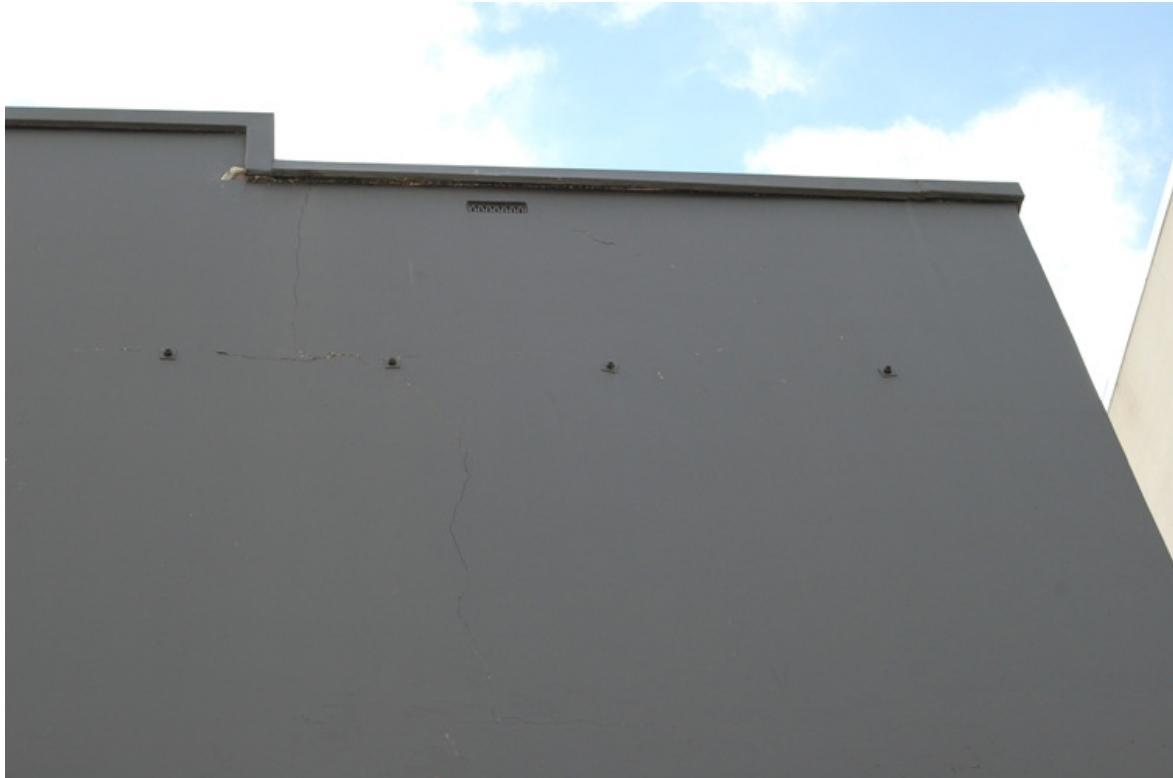
Photo 5

Photo 5: Close-up of the right upper area of the rear wall showing hairline cracks in the wall.

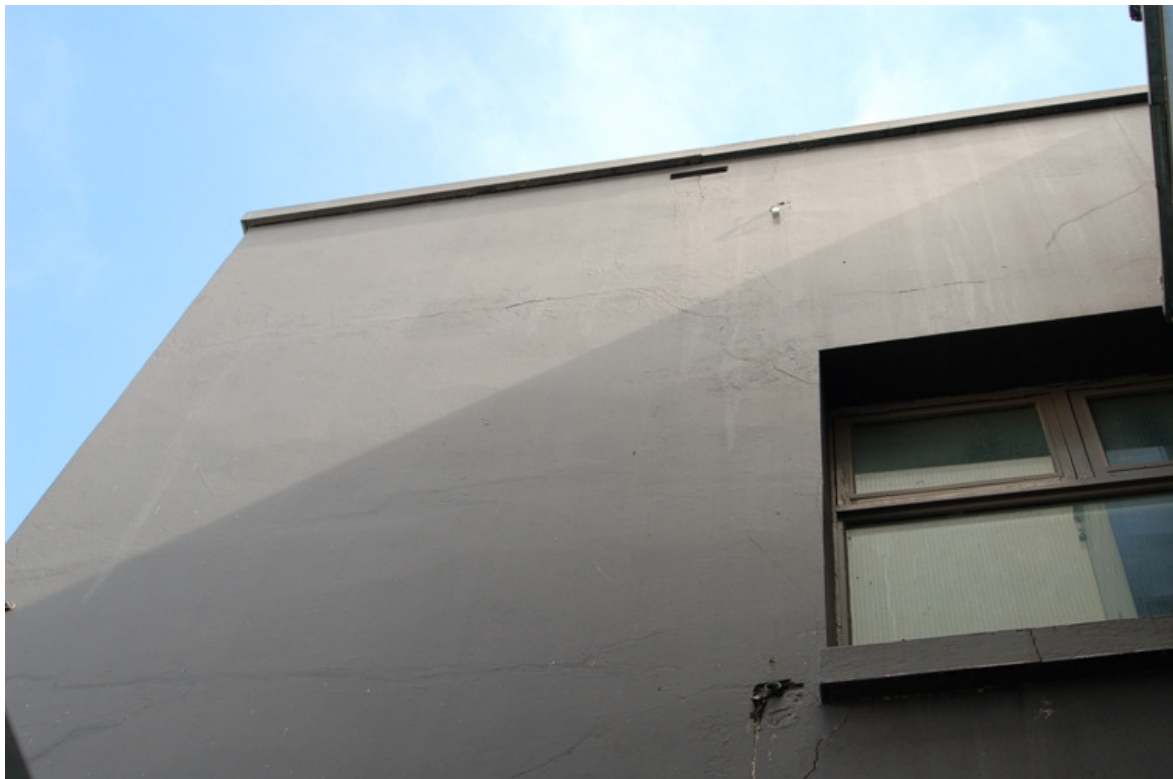
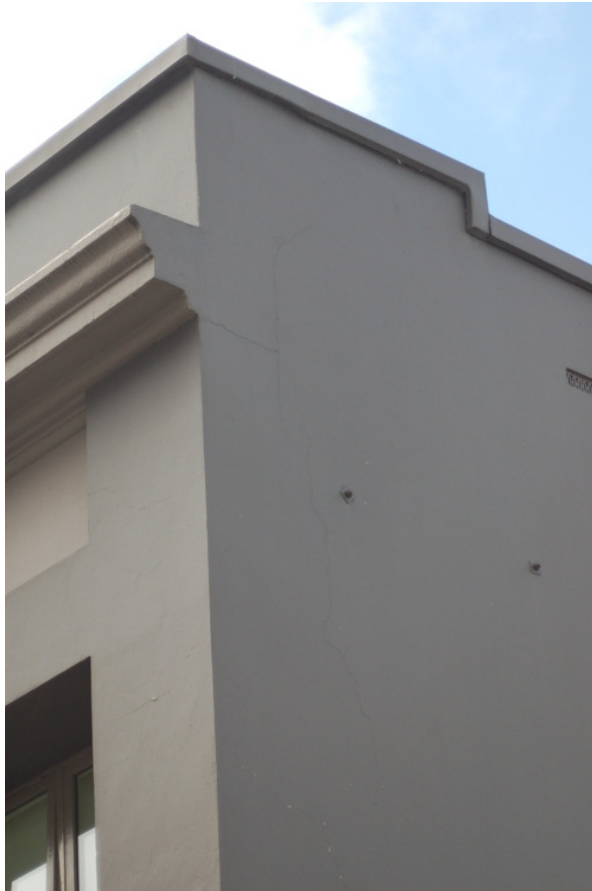
- Photo 6: Close-up of the upper return wall over the service yard showing hairline cracks in the wall.
- Photo 7: Close-up of the upper southeast corner showing hairline cracks in the wall.

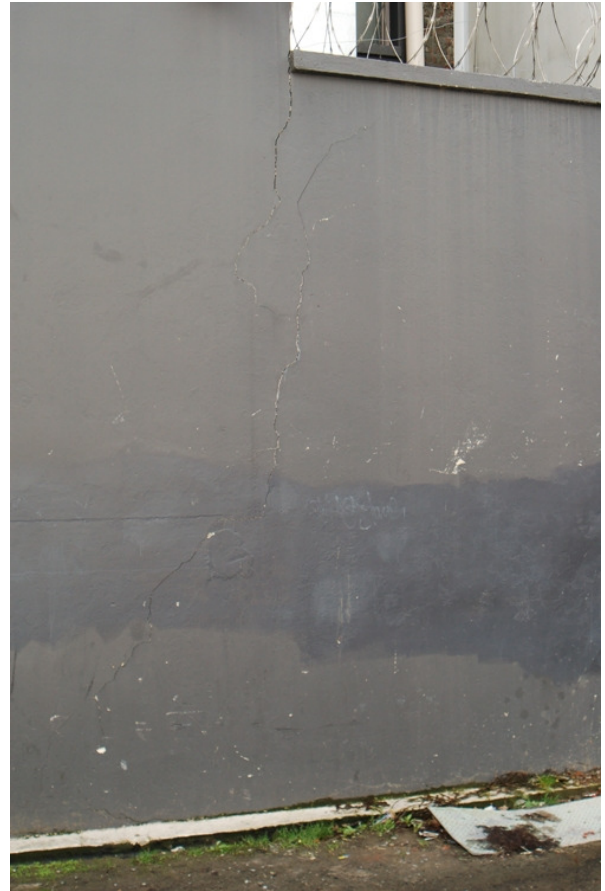
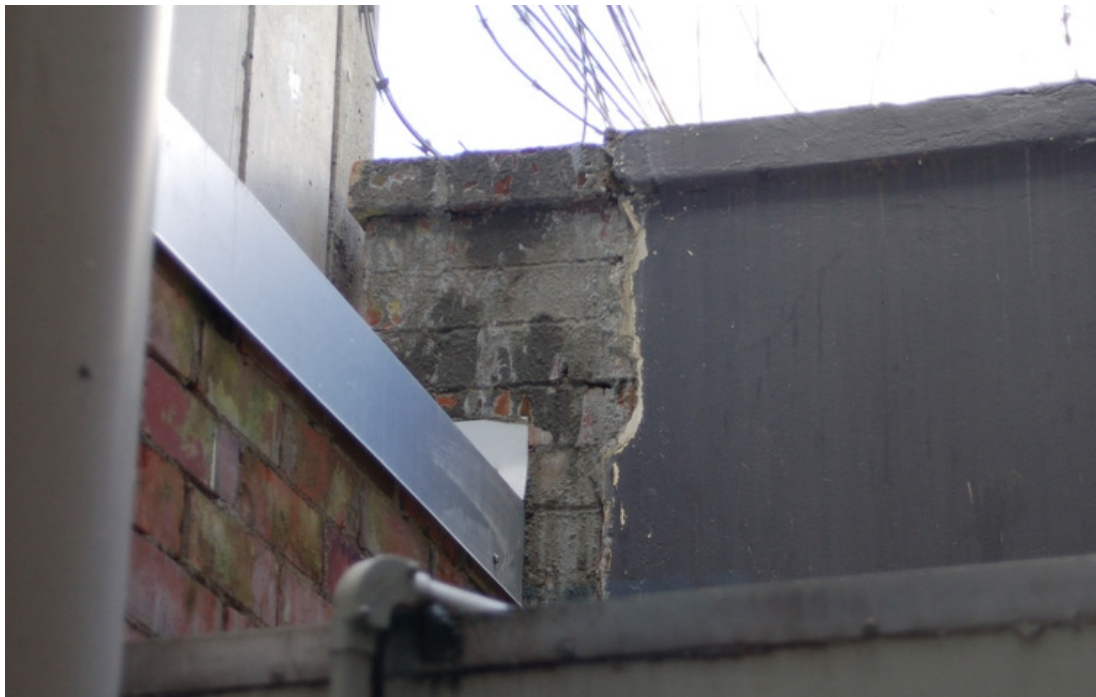
- Photo 8: Close-up of the junction of the lower wall with the main rear wall showing vertical crack.
- Photo 9: A view of the walls in the southeast corner of the service yard. The east end of the wall had been reconstructed by the builders of No. 186.

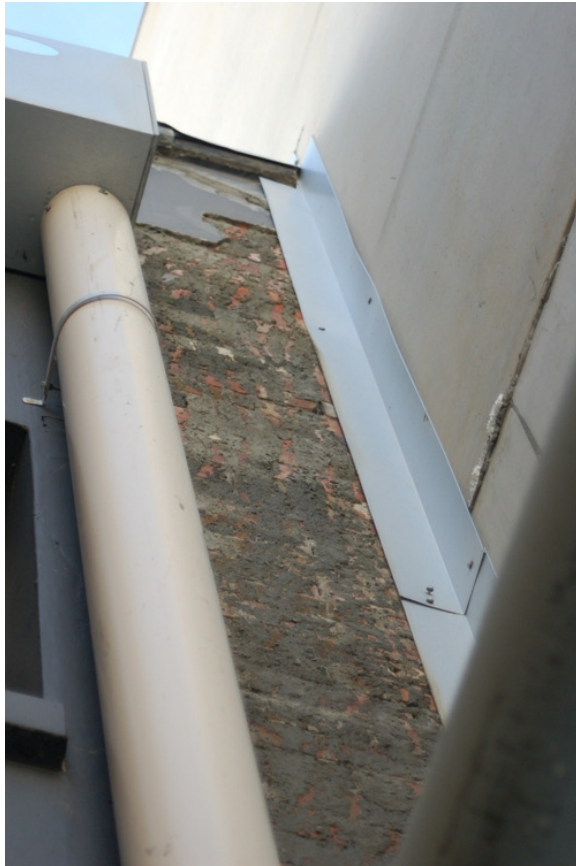
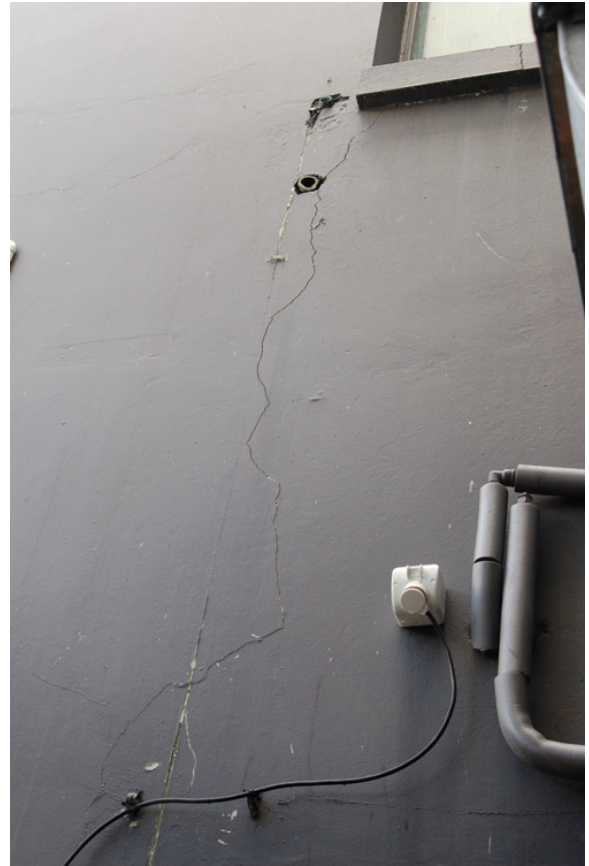
- Photo 10: Shows where builders of No. 186 have fitted a flashing over the gap between the buildings without allowing for differential movement.
- Photo 11: Shows a vertical crack in the wall over the west side of the service yard.

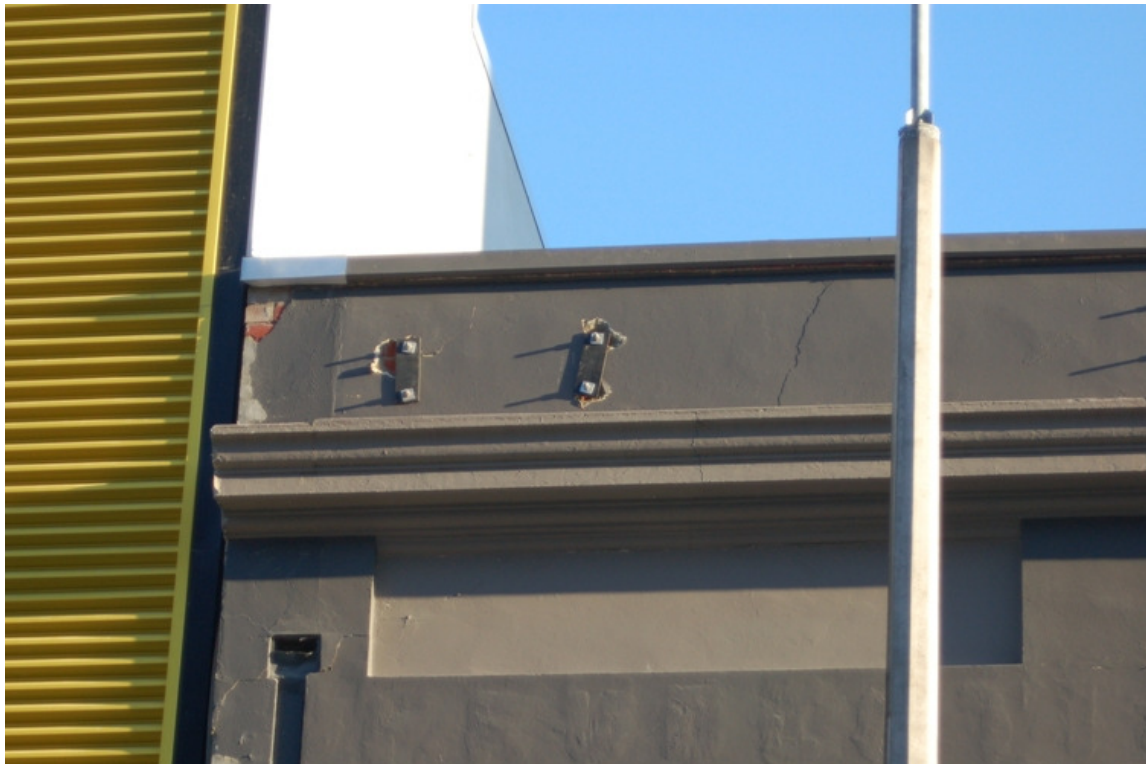
Photo 1

Photo 1: Close-up of the left end of the front parapet showing plates of temporary restraints. A vertical crack was evident to the right of these.

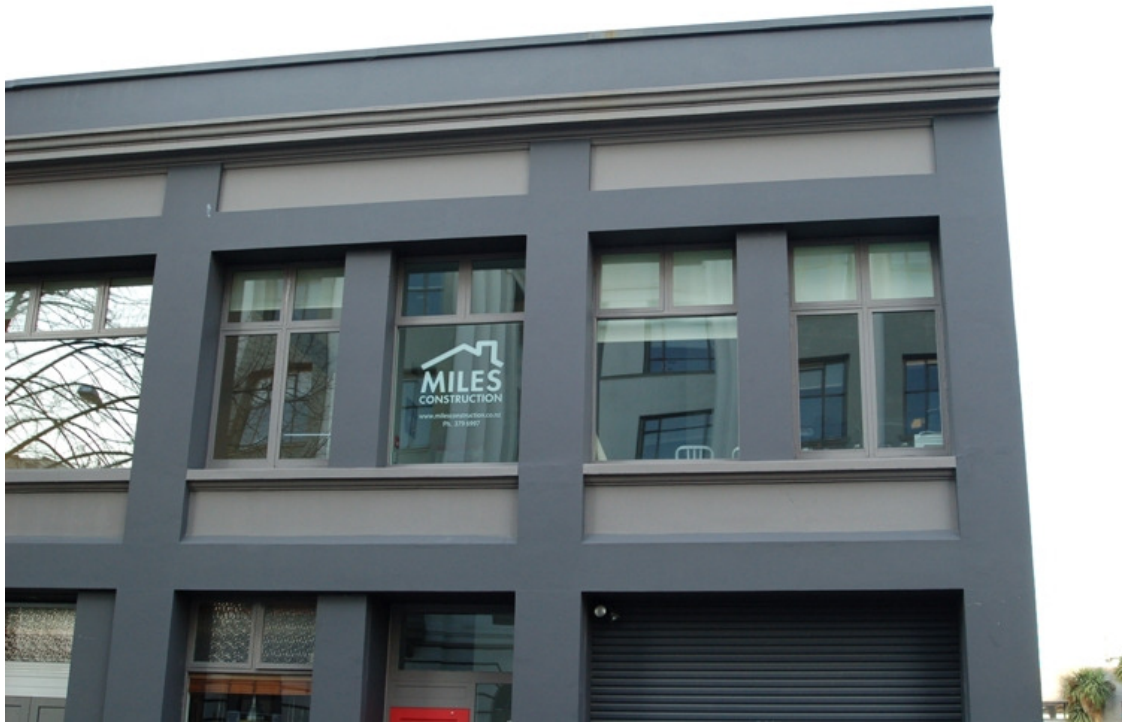
Photo 3

Photo 3: View of south end of the Liverpool St (west) frontage taken for the record. There was no damage evident.

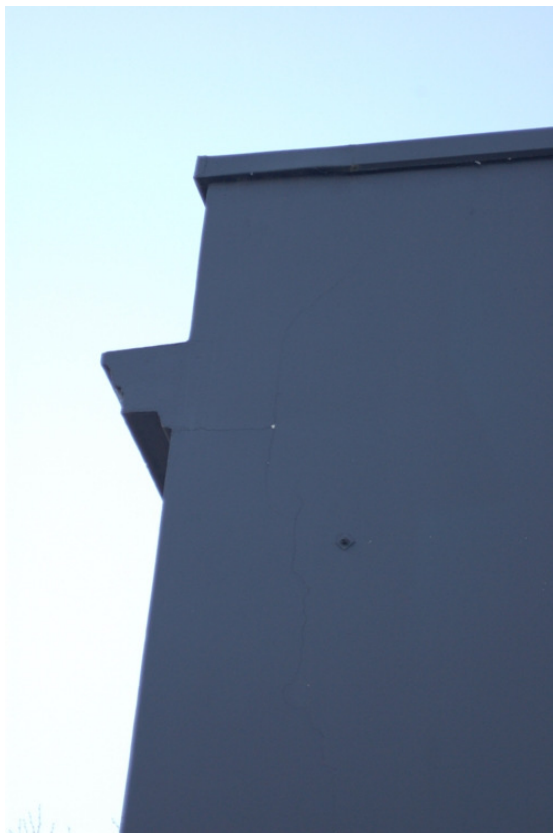
Photo 4

Photo 4: Close-up of the upper left side of the rear wall recording extent of cracks.

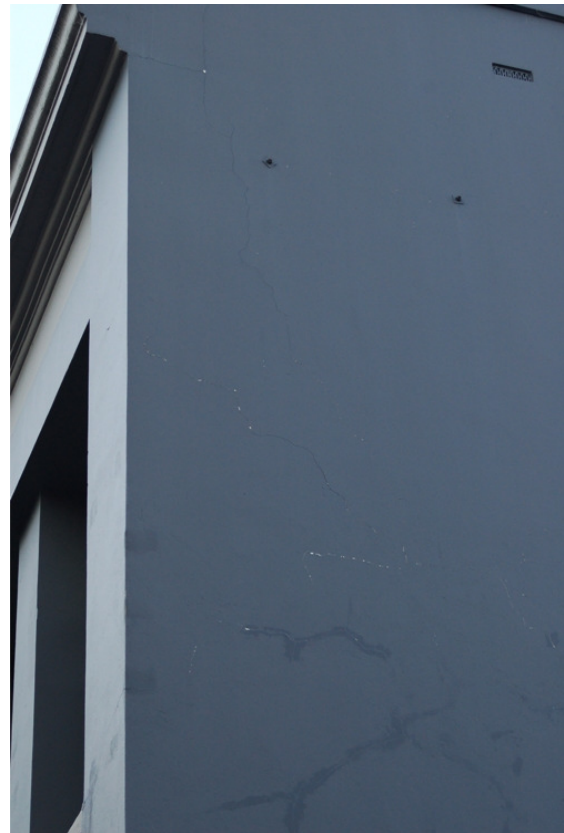
Photo 5

Photo 5: Close-up of the left side of the rear wall at first floor recording extent of cracks.

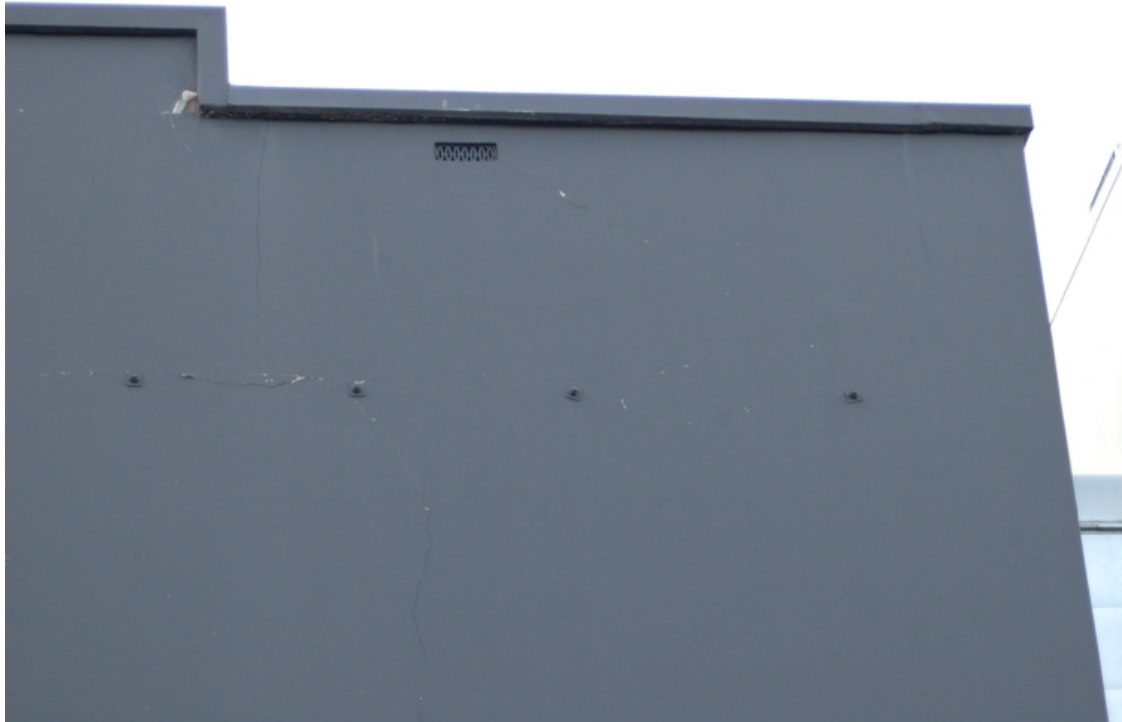
Photo 6

Photo 6: Close-up of the upper right side of the rear wall recording extent of cracks. A horizontal crack ran along the line of the strengthening bolts and there were some cracks higher up in the parapet.

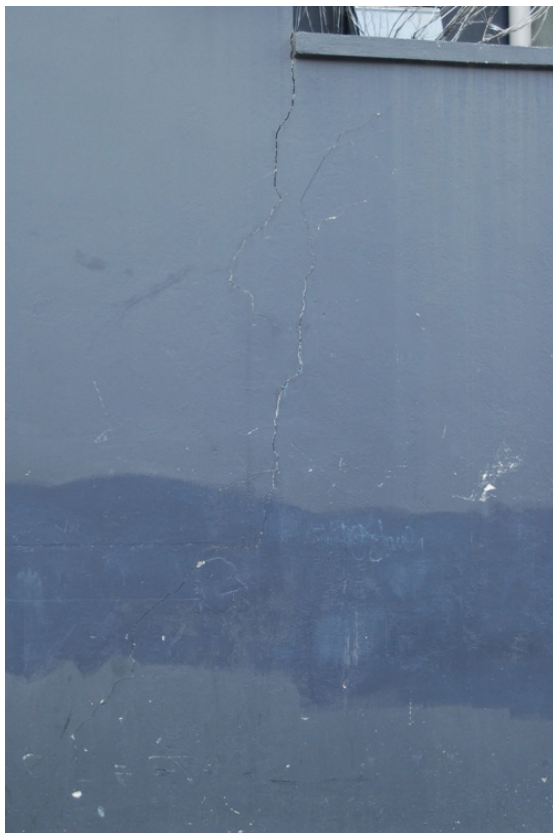
Photo 7

Photo 7: Close-up of the junction of the lower wall with the main rear wall showing vertical crack. The length of the crack has increased since previous inspection.

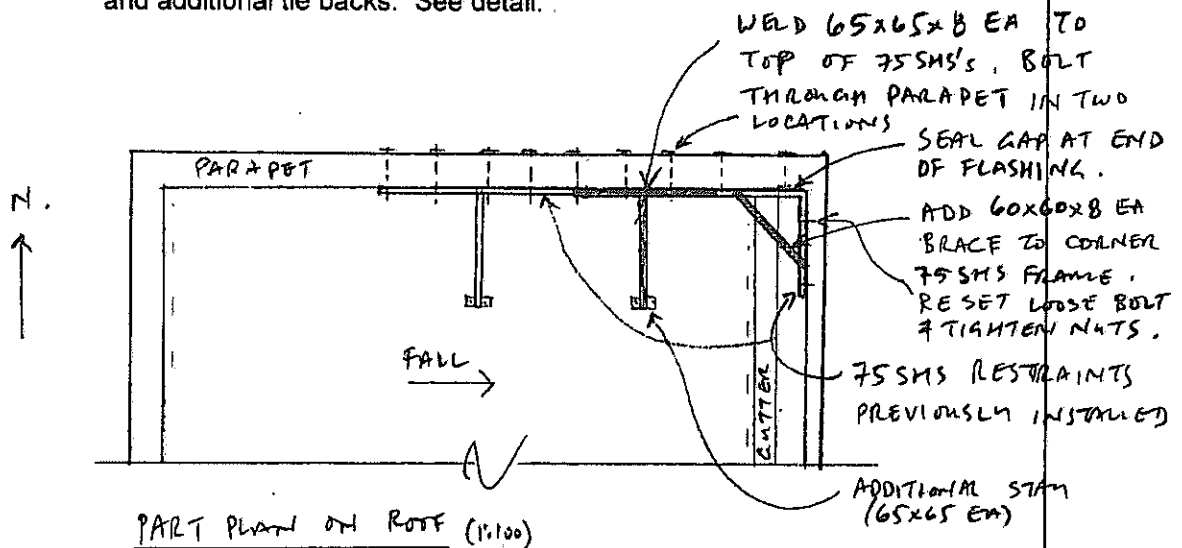
- Front parapet - Parapet has moved in between previously installed restraints. Extend restraints to join them together, add a diagonal brace and additional tie backs. See detail:

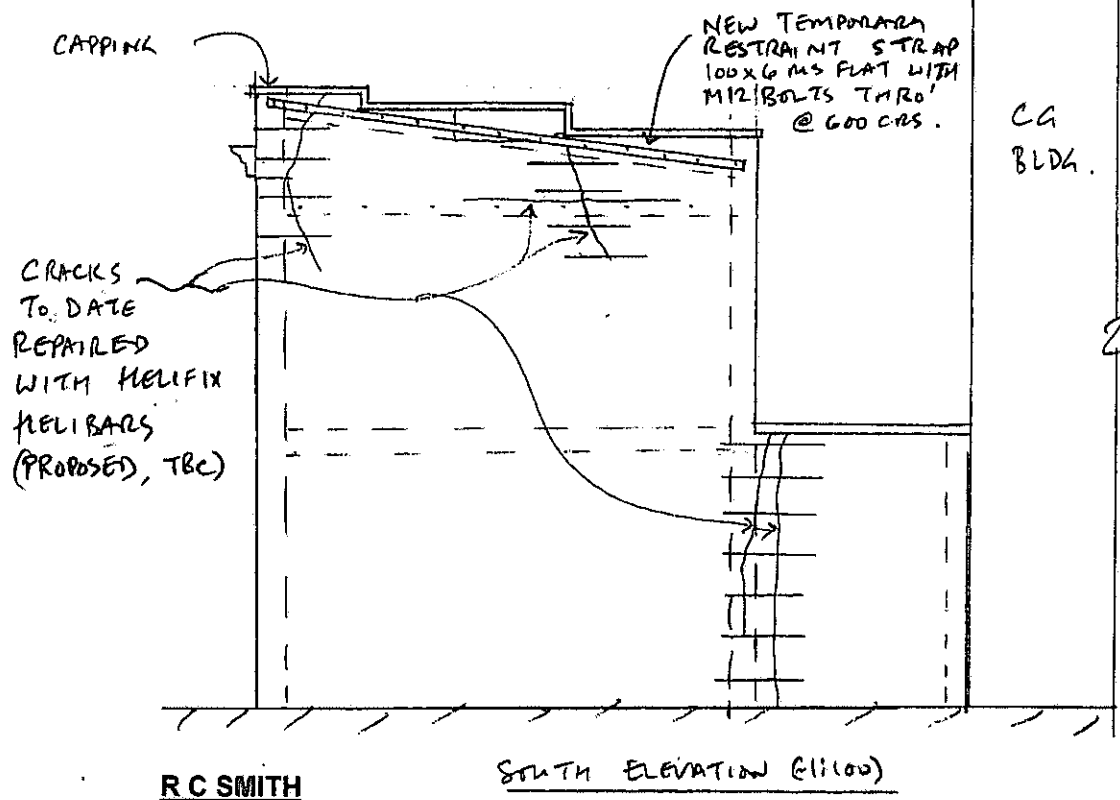
- Rear parapet - Unstable above existing restraint line (at ceiling level).
Fit flat strap at angle just below capping and bolt through - Provide access first to investigate roof framing to check if feasible to tie back into (Open up roofing or ceiling).
- Engineer to meet with council to get steer on extent of strengthening required to back wall.

25. At page 2 of 2 of the report I provided a detail in relation to the rear parapet which was potentially unstable above the existing restraint line. The solution was to fit a flat strap at an angle just below the capping and to bolt it through. I noted that the contractor was to provide access first to investigate the roof framing to check if it was feasible to tie back into. It is also recorded that I was to meet with CCC to get a steer on the extent of strengthening required for the back wall.

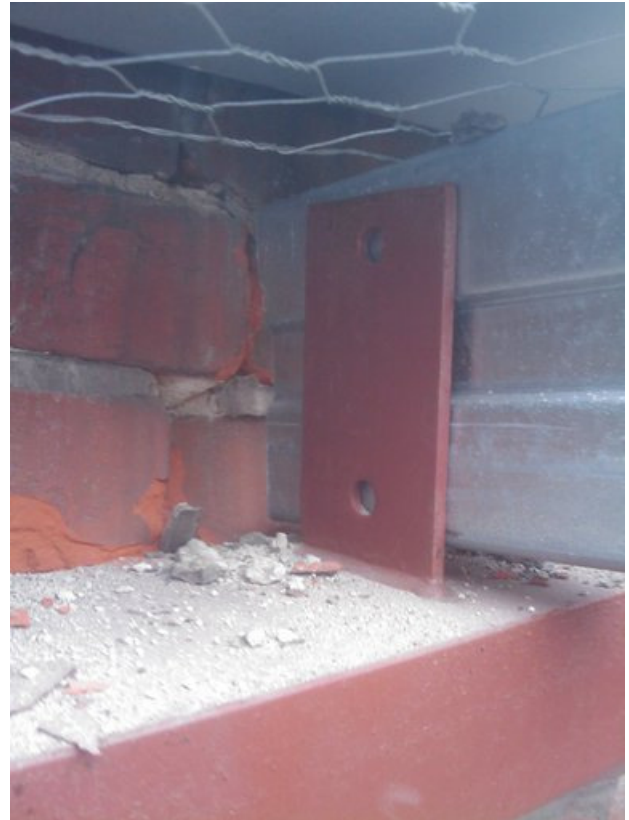
Photo 4

Photo 4: Close-up of a purlin cleat showing bolts missing.

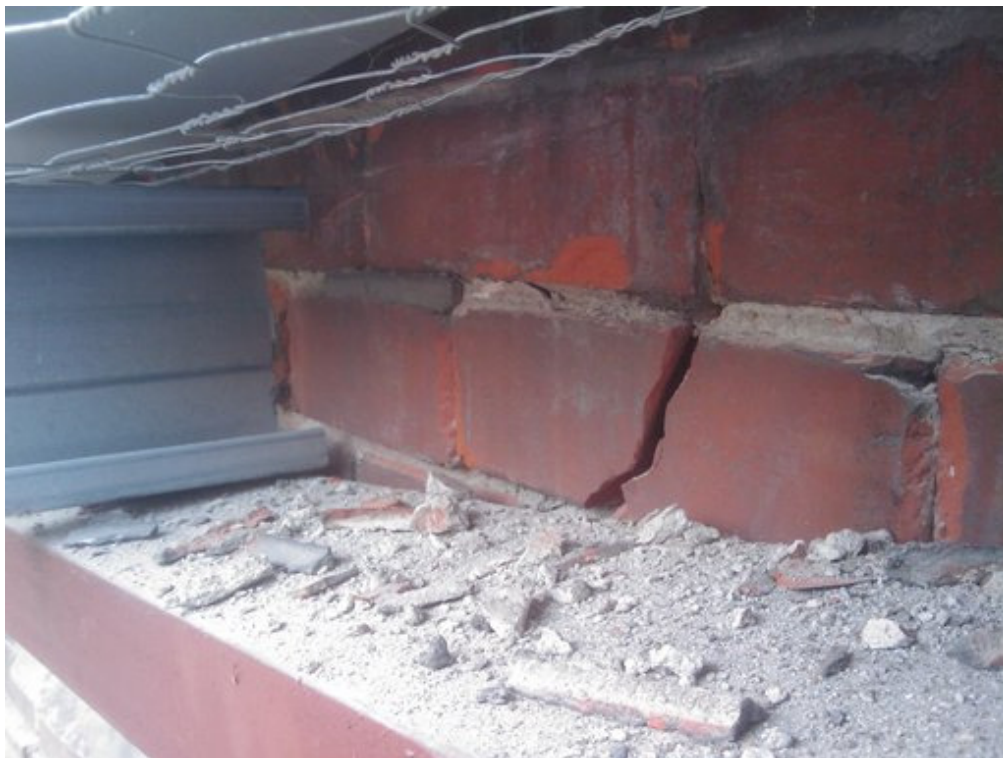
Photo 5

Photo 5: Close-up showing cracked bricks on the inside leaf of the parapet. The weak lime-based mortar had been shaken out and can be seen lying on the PFC.

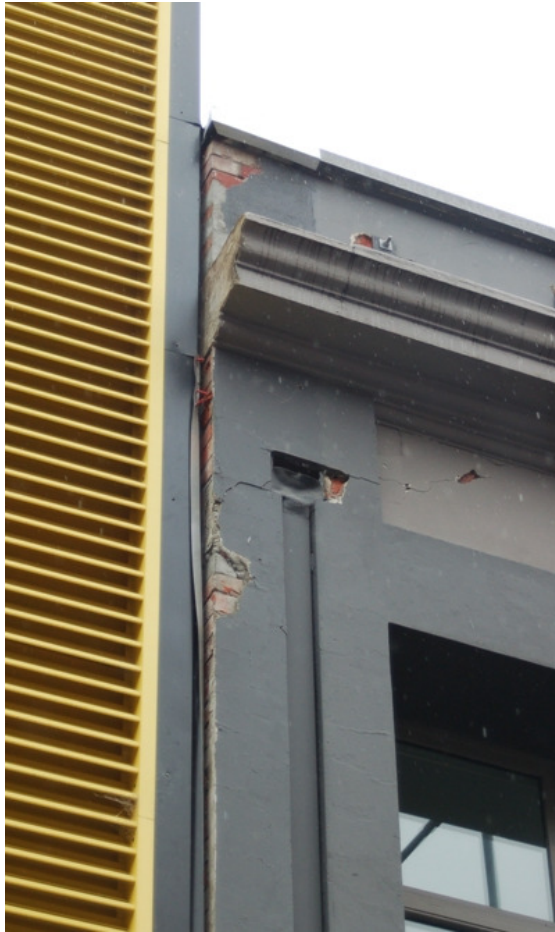
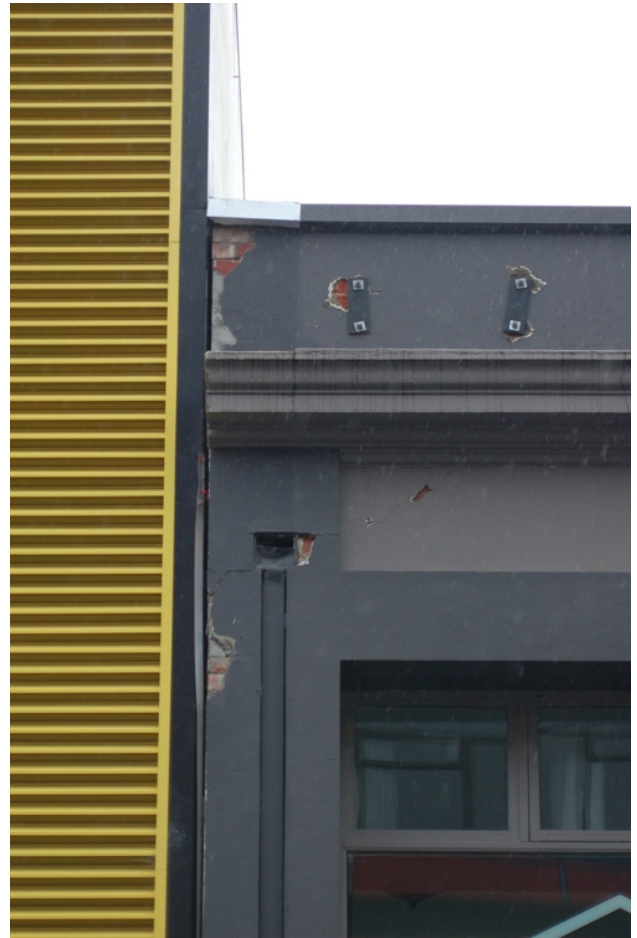
- Photo 1: Close-up viewed at an angle toward the east end of the north parapet. Pieces of plaster have fallen off at the cracks.
- Photo 2: Straight-on view of Photo 1.

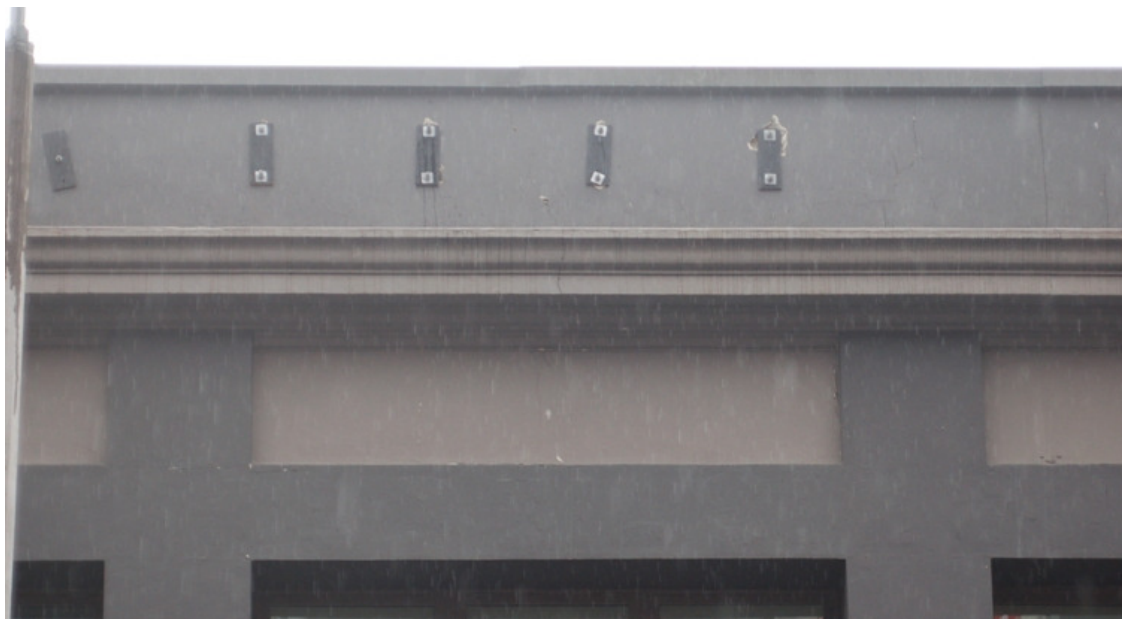
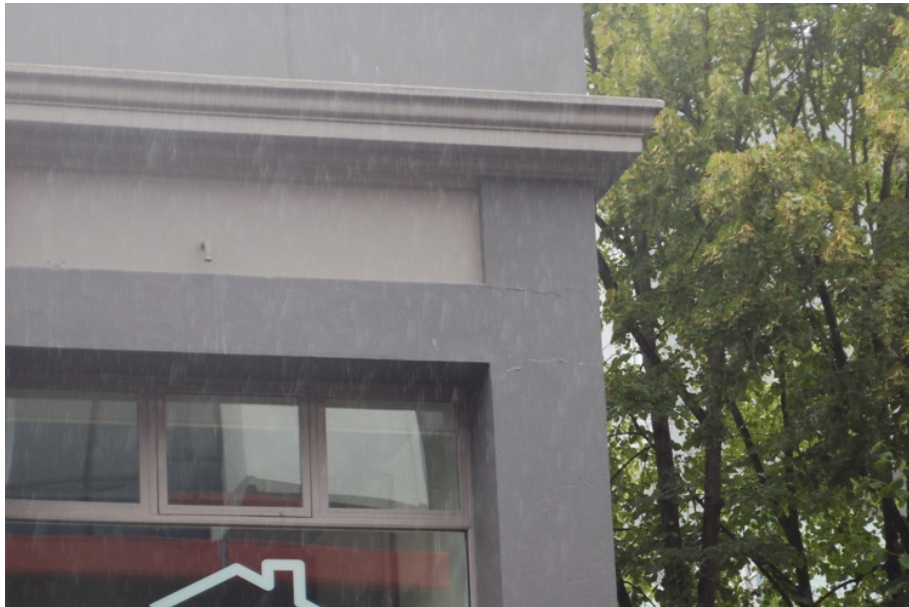
- Photo 3: View of the plates to the central north parapet recording no noticeable change to the cracks.
- Photo 4: Close-up of the right side of the front bond beam showing minor cracking of the plaster above and below the beam.

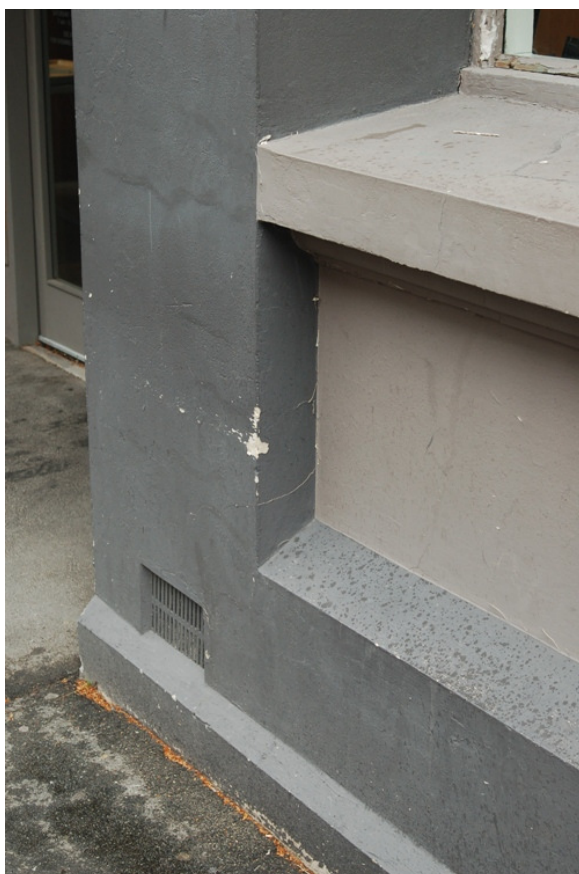
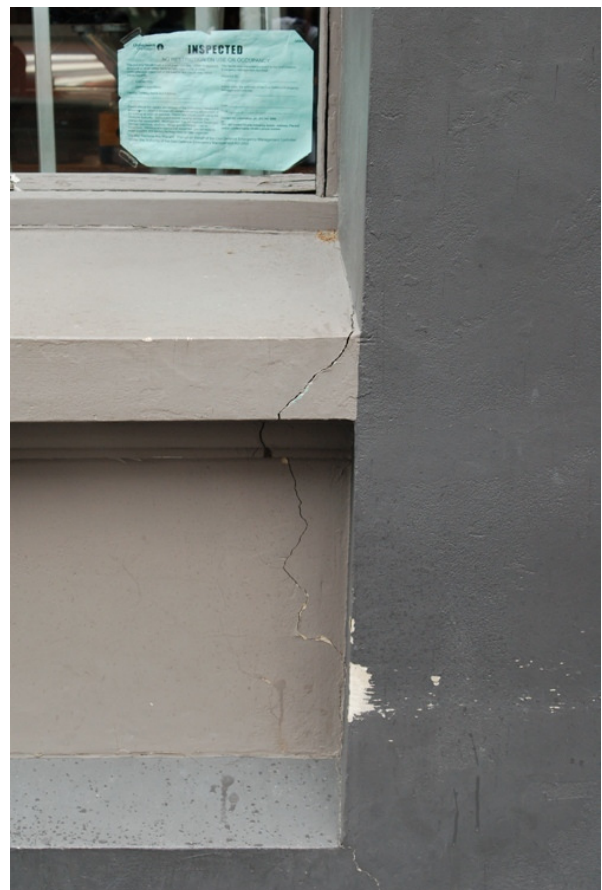
- Photo 5: Shows some minor cracks in the brick panel to the right of the front door.
- Photo 6: Shows a vertical crack in the end of the wall below the window to the left of the front door.

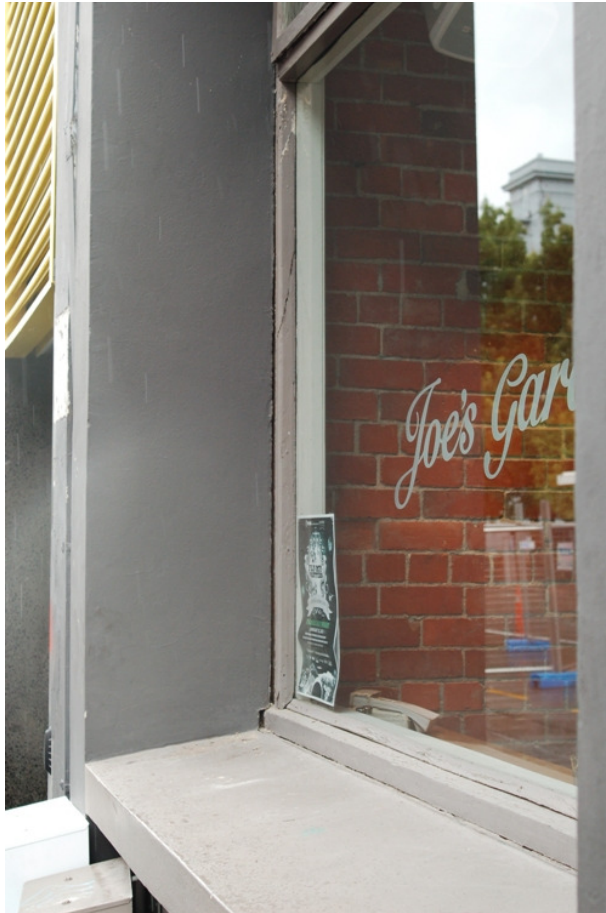
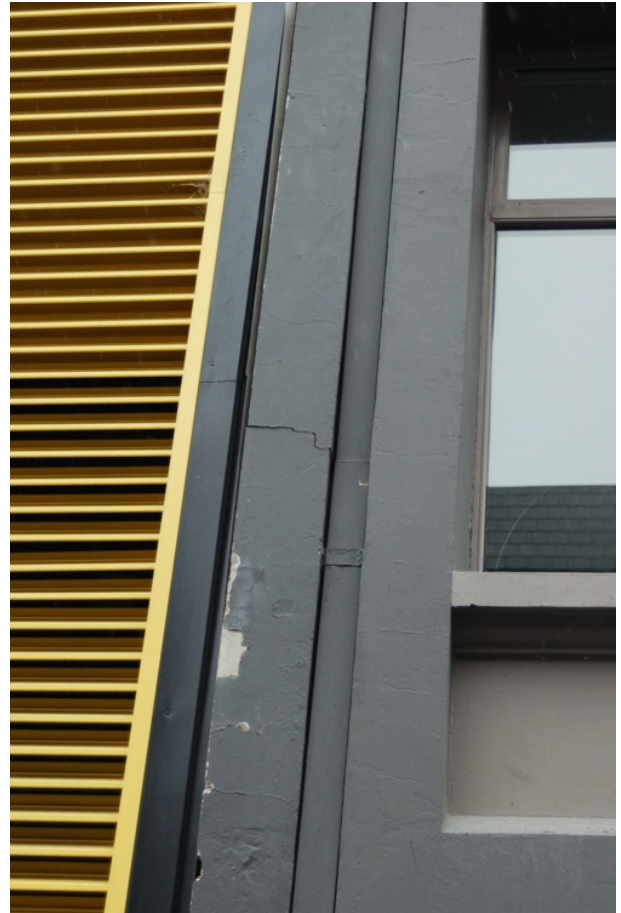
- Photo 7: Shows where the bottom left corner of the front window frame had moved inward by approx. 15mm.
- Photo 8: Close-up of horizontal crack at first floor window level in the far left front URM column.

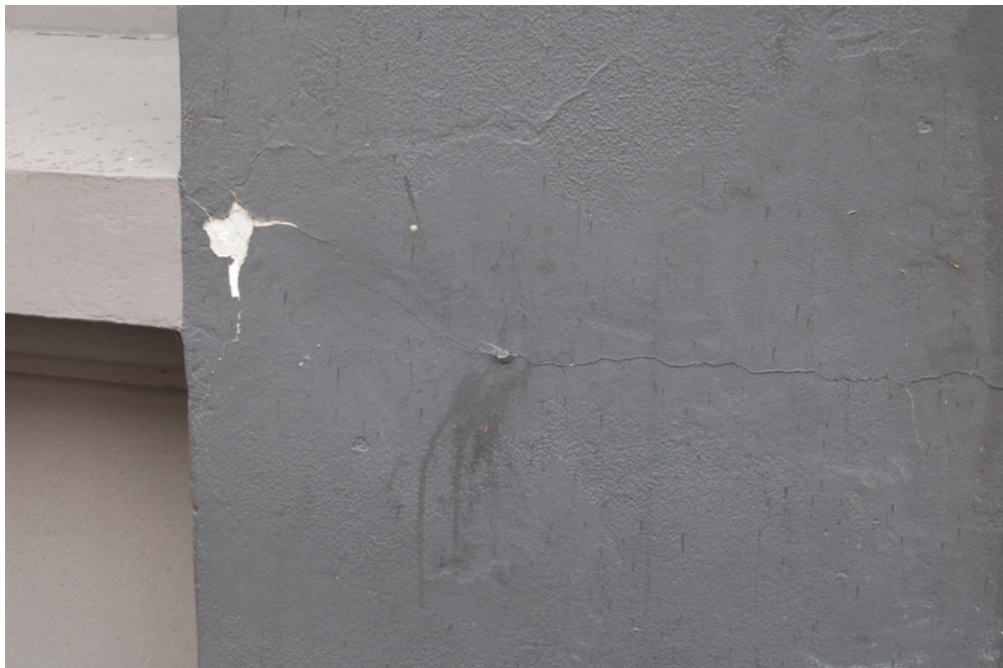
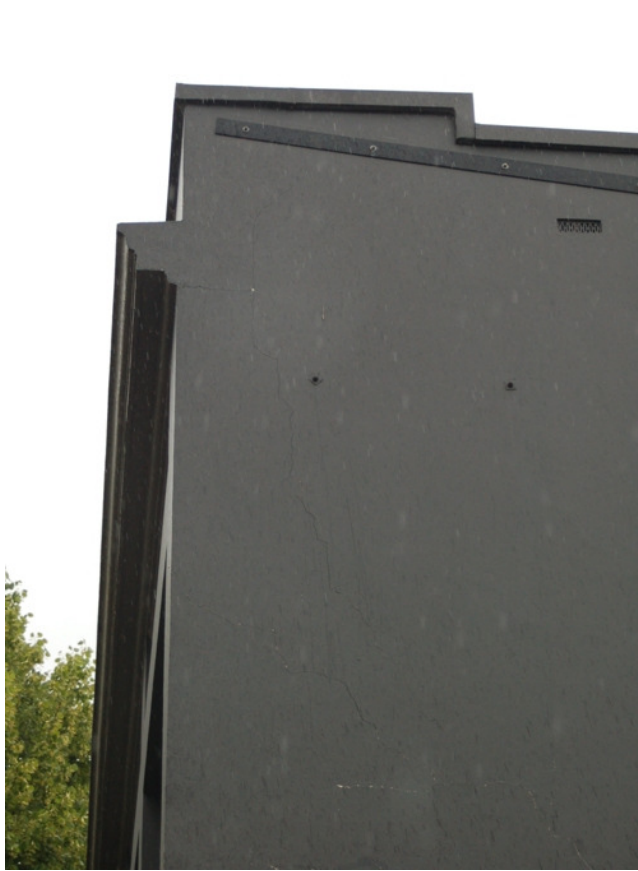
- Photo 9: Close-up of a hairline horizontal crack in a front URM column at ground floor window sill level.
- Photo 10: View of upper left side of rear wall recording minor increase of cracking. End of the temporary parapet restraint strap can be seen.

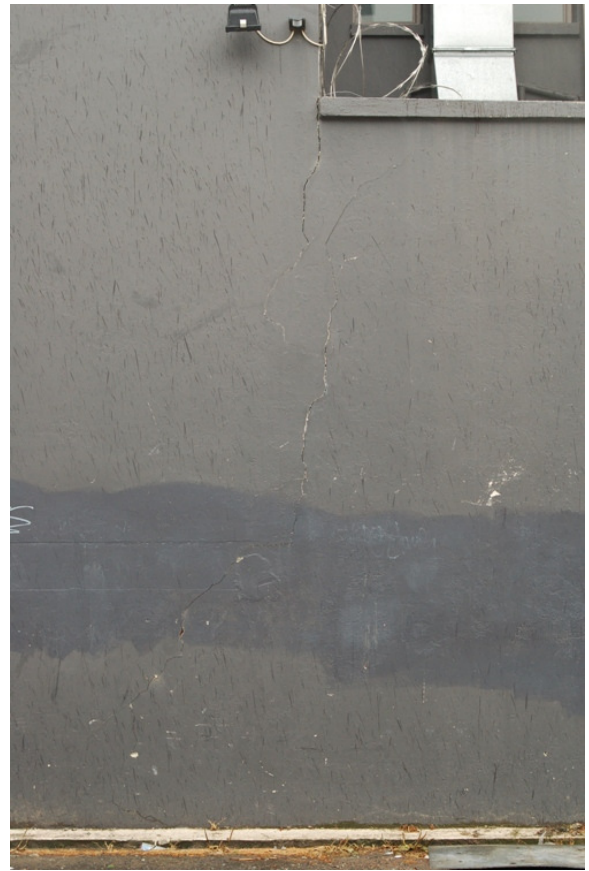
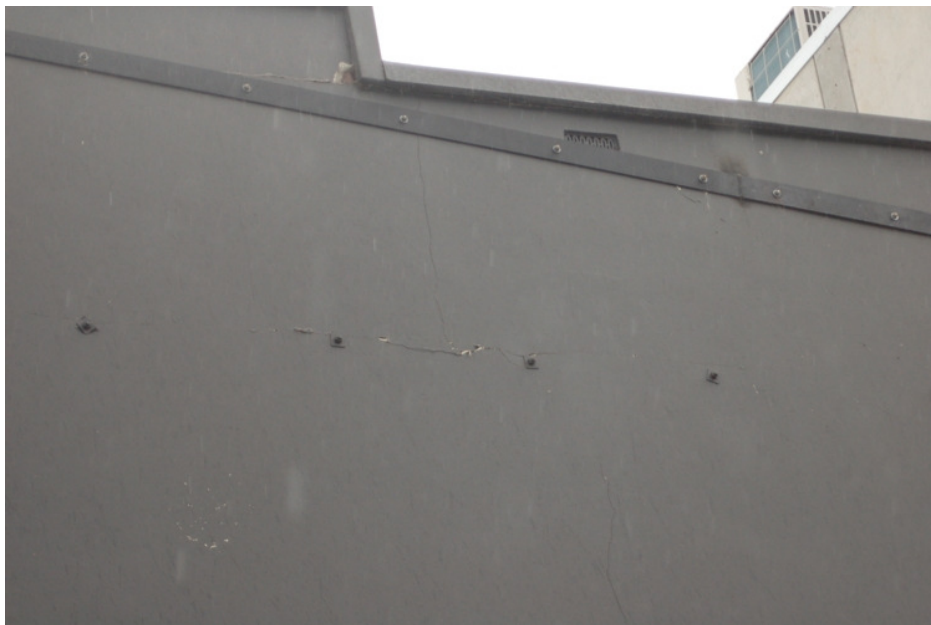
- Photo 11: View of the junction of the lower wall with the main rear wall showing minor increase in vertical crack
- Photo 12: View of upper centre of rear wall recording minor degradation to horizontal crack. Temporary parapet restraint strap can be seen.
