**IN THE MATTER OF
THE CANTERBURY EARTHQUAKES ROYAL COMMISSION**

BRIEF OF EVIDENCE OF RHYS COLLIN SMITH

Dated 16 December 2011

194 Hereford Street (Joe's Garage) ("the building")

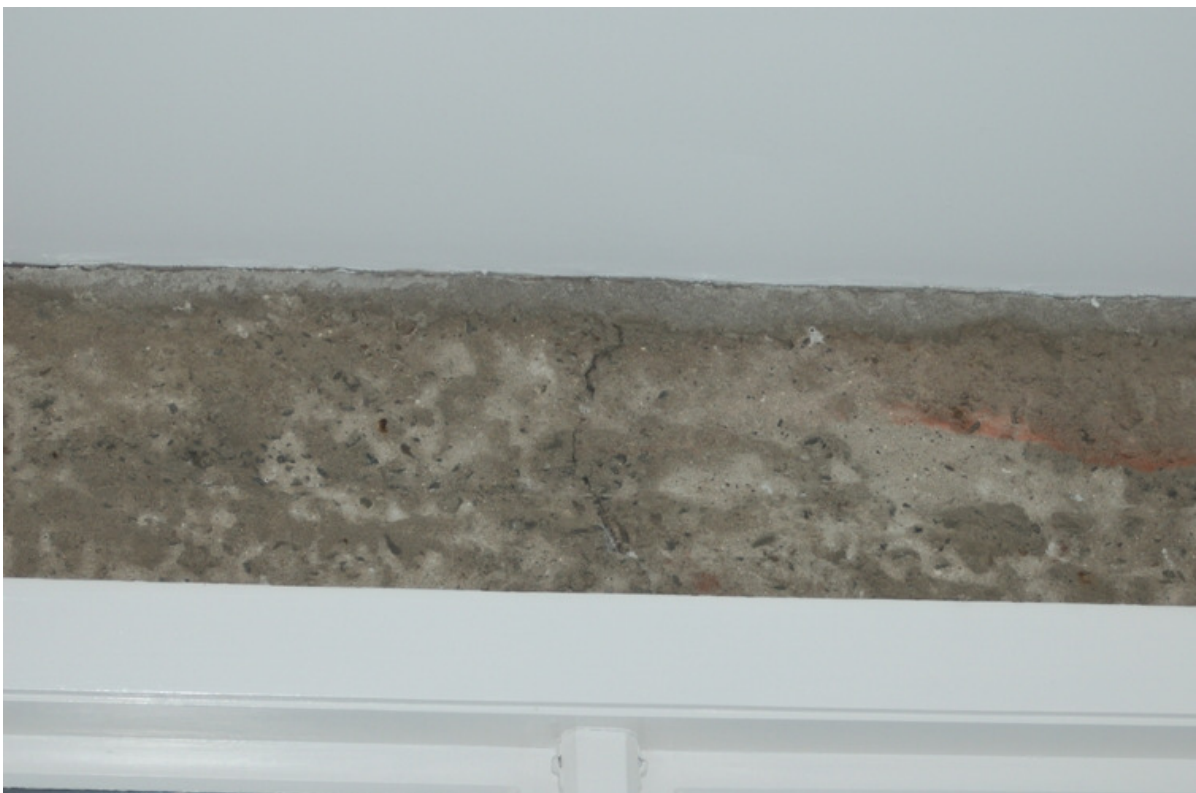
Photo 14

Photo 14: Shows a vertical crack in the back of the front upper bond beam.

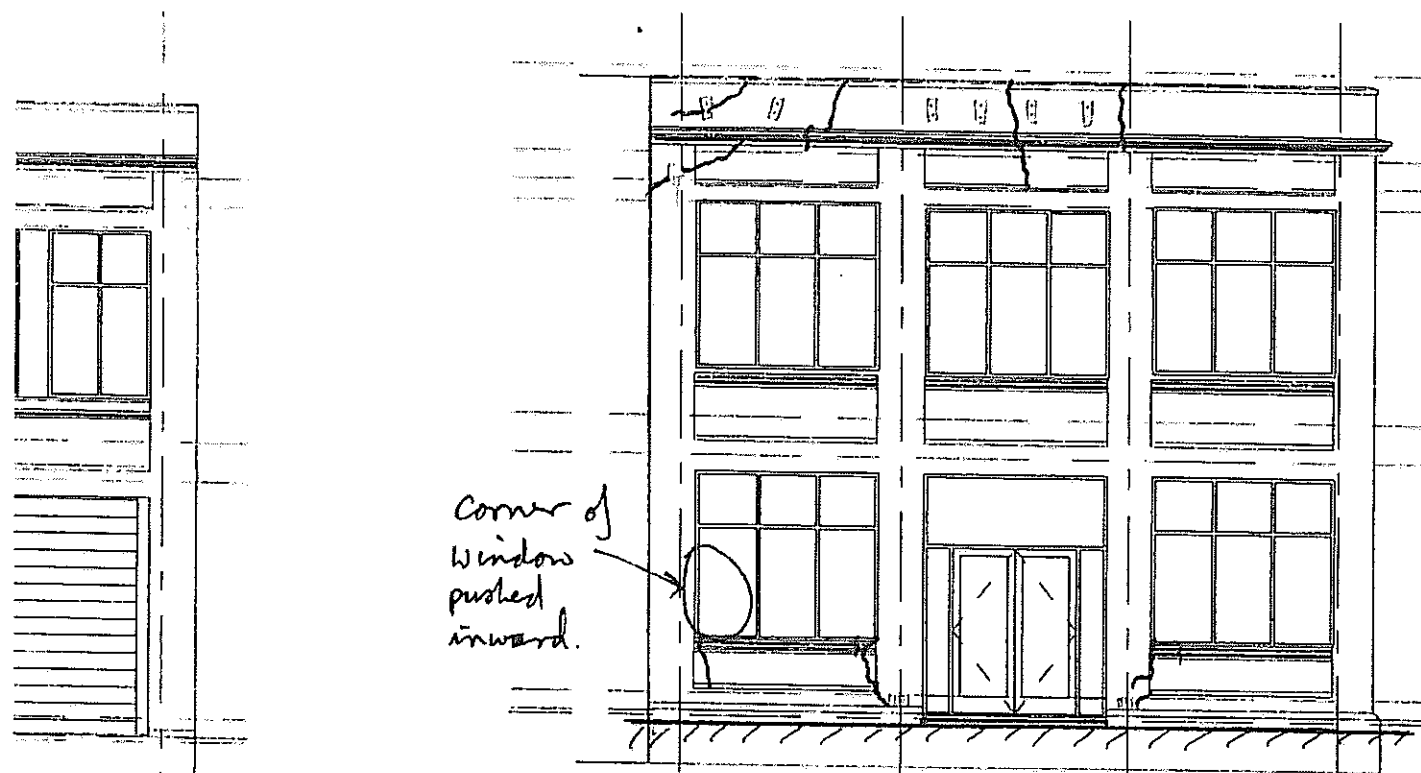
FIGURE 1.
NORTH ELEVATION
(3) 1:100

- The north parapet has vertical and diagonal cracks as shown in Figure 1 of the Appendix. The parapet has been temporarily tied back for the east two thirds to the roof plane to prevent falling outward.

- Cracks at the ends of the lower masonry panels under the north façade windows. Refer to Figure 1.
- Various cracks in the south wall as shown in Figure 2. This is a cavity wall and the lime mortar is degraded to the extent that the bricks on the inner side of the parapet are loose and falling into the cavity at the roof level.

- a) Repair the cracks using Helifix bars or similar so as to return the walls to pre-earthquake condition and strengthen or rebuild the parapets in light-weight construction;
- b) Repair and strengthen the walls to 67% NBS or as close as reasonably practicable. Rebuild the parapets as a) above;
- c) As b) above for the facades but rebuild the south and cool room area walls in reinforced concrete block.

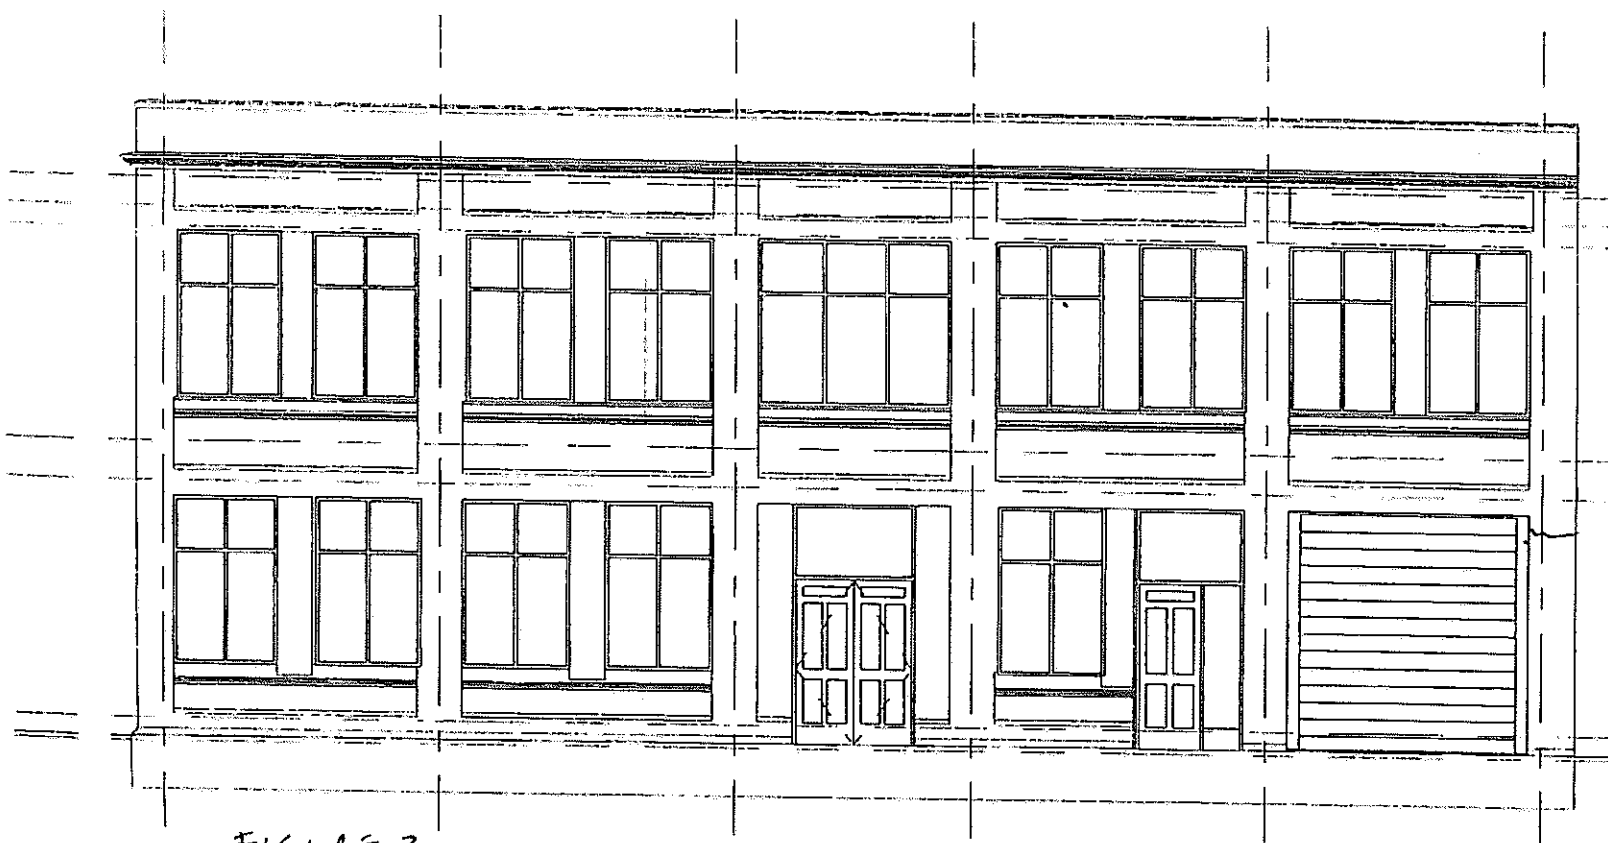
FIGURE 3.

- Minor flexural cracks to URM columns and panels in west façade as shown on Figure 3.
- A flashing between the north facades of 194 and 196 Hereford Street has been dislodged in the Boxing Day Earthquake. This flashing was fitted after the September earthquake presumably by the builders of the new premises at no. 196. There is an approximately 50mm gap between the buildings and this is to allow for the independent movement of each building however the flashing had not been designed to allow for any movement.

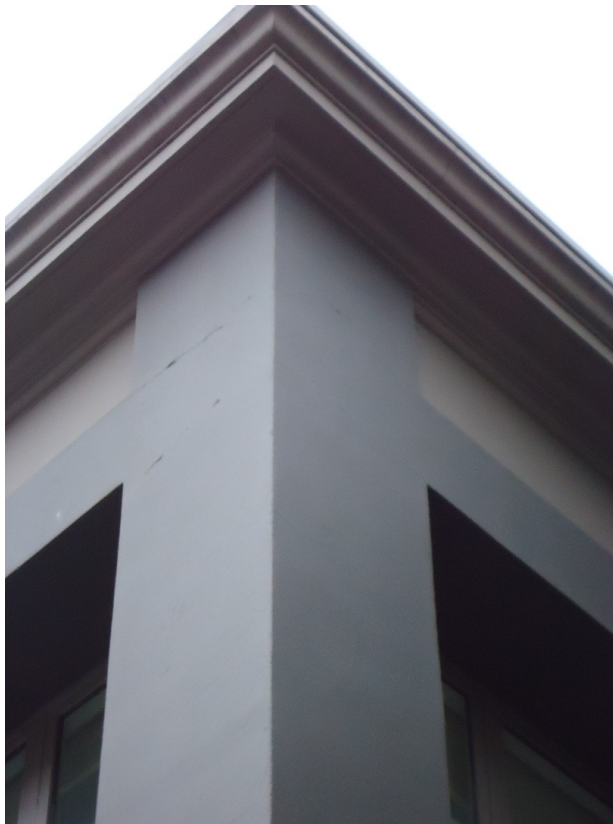
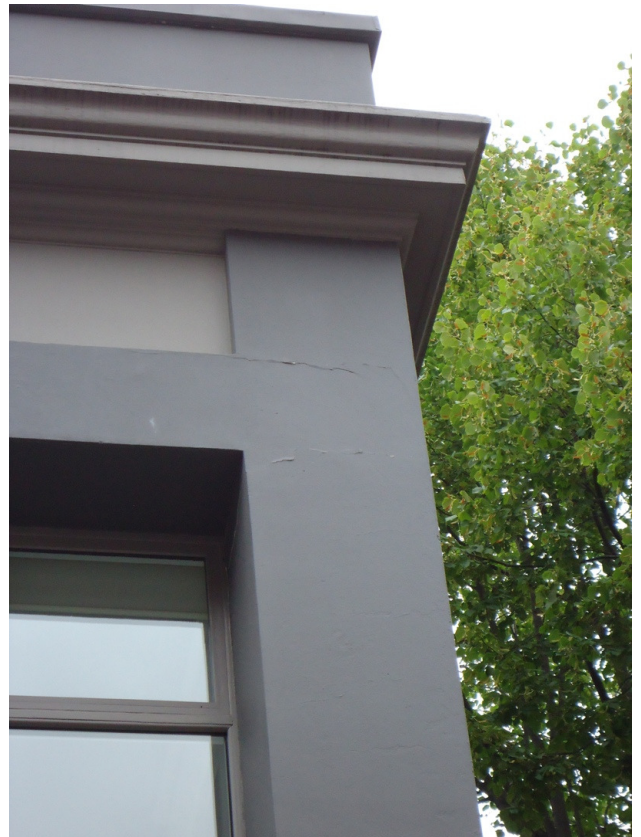
Had a quick look out the building. Appears to be more cracks to the Hereford St / Liverpool st corner where column meets ring beam – May note be anything but attached are photos for you to have a look at – let me know your thoughts

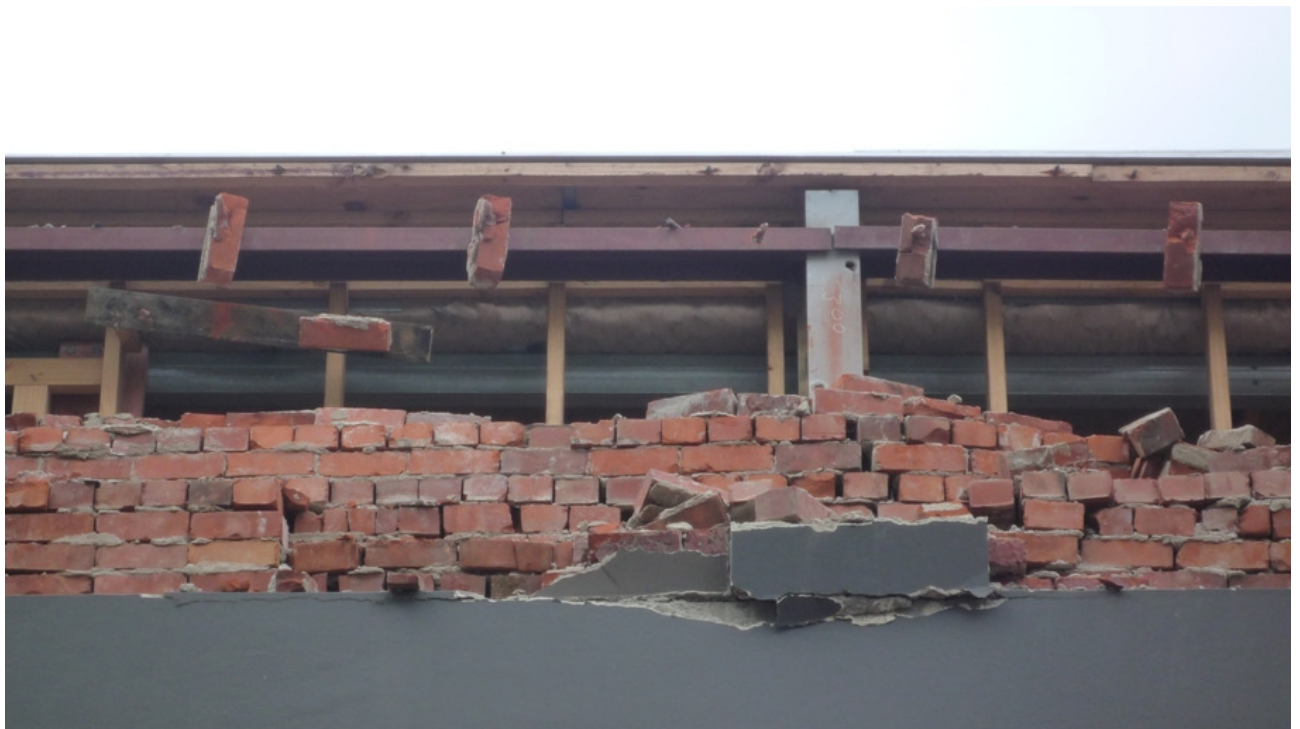
47. Photo 11 shows the standard detailing from the Earthquake Society recommendations. The damage shows that the standard solution to parapet restraint simply failed in the force of this earthquake.
48. Photo 5 illustrates the failure of the upper east wall in the north bay. This wall supported the bond beam.
