SEISMIC RISK BUILDINGS - SURVEY

Address: 309 Durham St (Methodist Mission Church)  
Legal Desc.:  
Owner:  
Date: 17/12/92 Date Building Built:   
BU/40/

**Re: Earthquake Damage Inspection for Durham Street Methodist Church**

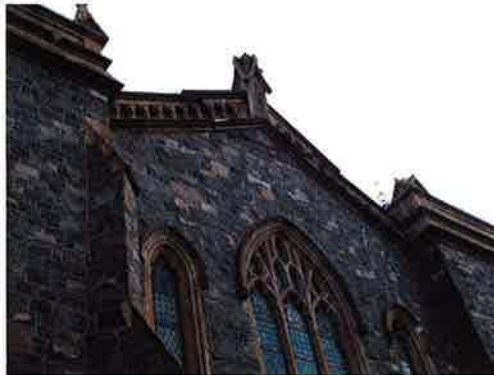
Gable cracked

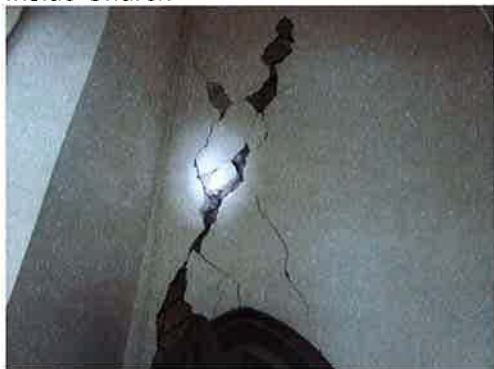
Damage in the East tower

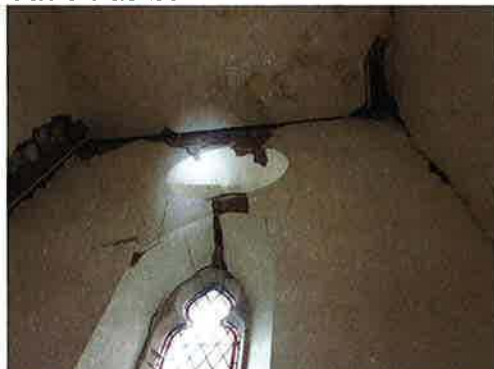
Damage in the East tower

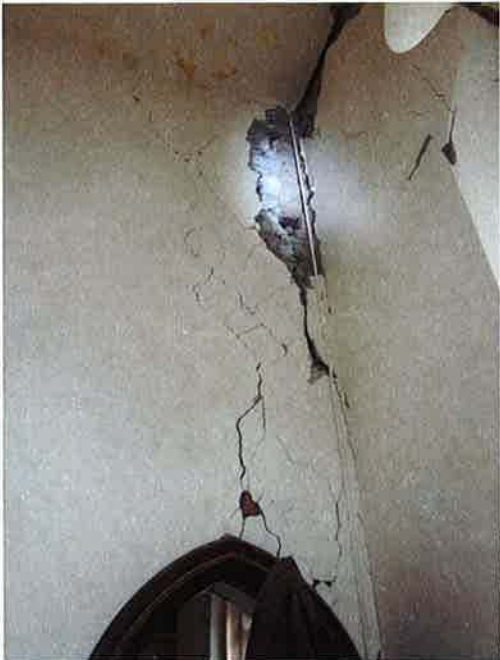
Damage in the East tower

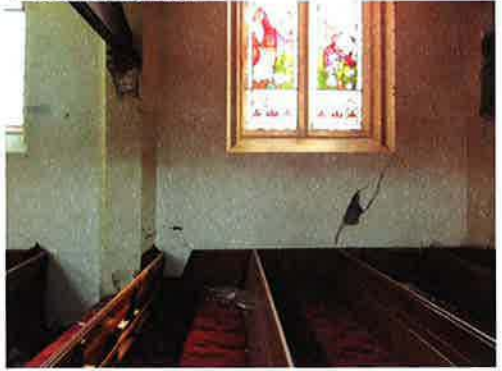
Mezzanine floor support and cracked North Wall

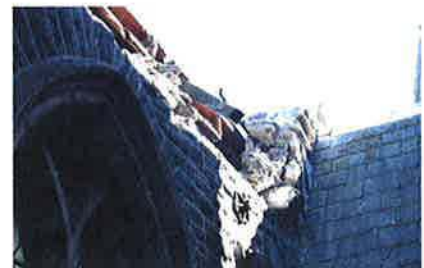
Significant damage has occurred to the upper section of the east wall where part of this wall at roof level has collapsed out.

Hall east wall damage

The hall is significantly damaged from the earthquake and will require reconstruction of the entire west wall, reconstruction of the upper section of the east wall, reconstruction of the junctions between the trusses and east side wall, and repairs to the ceiling. Some areas of the ceiling will require replacement.

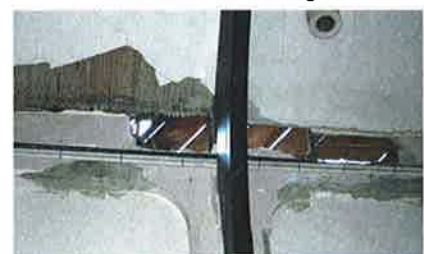
damage at truss locations in Hall

Damage has also occurred between the timber roof truss and the side walls with varying degrees of cracking, including spalling of the stone around the truss support.

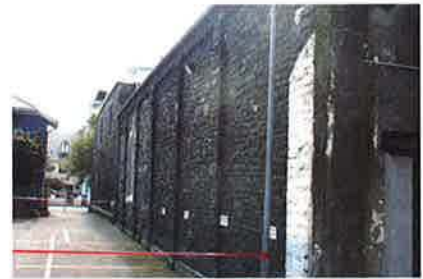
The western side of the Hall wall has two continuous, almost full length horizontal cracks, one located about 1200mm from the floor and the other located near the top of the wall. The wall is leaning out significantly between these two cracks. It is estimated that the wall has an outward lean of about 200-250mm.

west wall of Hall leans out

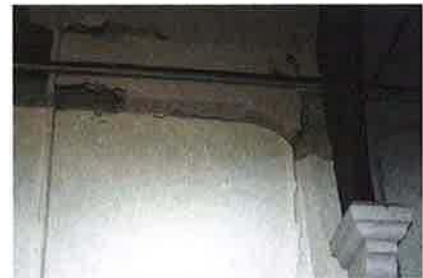
A number of cracks are present in the infill stone walls between the side wall columns.

Cracks to the infill stone walls in Hall

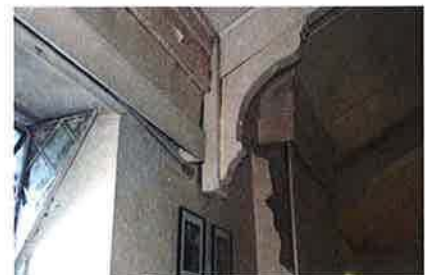
Annex west wall displaced from Truss

The west wall of the annex has displaced from the roof trusses as well as from the north gable wall and has formed a crack in the north west corner near the ceiling level.

The displacement does not appear to be excessive and could be repaired by grouting up the existing cracks and re-fixing the roof structure to the western exterior wall.

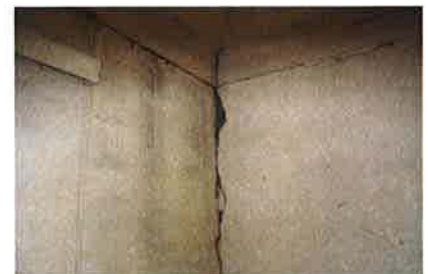
Crack formed in north wall corner of Annex

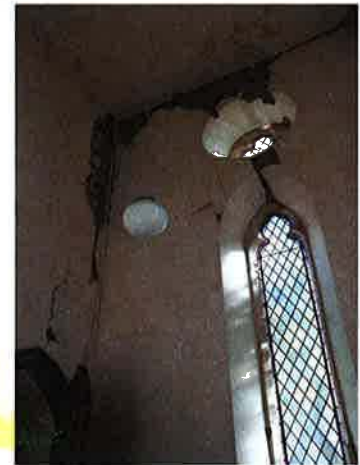
The auditorium measures approximately 28 x 18m in plan. The main area of damage has occurred in the eastern towers where the stairs are located. Significant damage has occurred in this area with cracks clearly visible on the exterior face, generally in the stone mortar joints. The plaster has spalled significantly on the interior face with significant damage visible to the brick interior face and to the core of the wall.

damage to auditorium stair walls, east end

- (a) Remove the towers and east wall of the auditorium and retain all stone work. Reconstruct the towers and east wall in reinforced concrete and place stone on the exterior face to retain the same visual appearance both internally and externally.

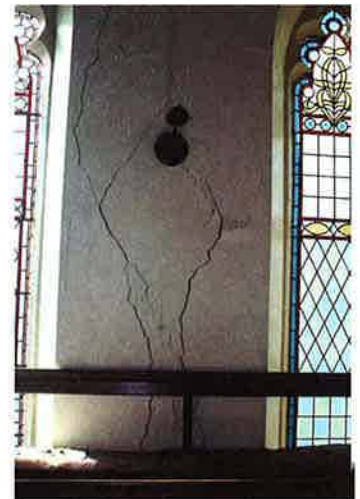
Significant cracking has occurred to the eastern wall of the auditorium facing Durham Street.

east wall damage

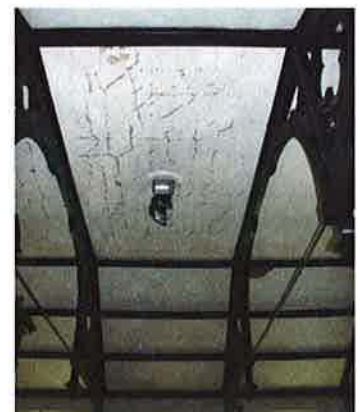
The lathe and plaster ceiling is also significantly cracked through the entire ceiling.

Cracked ceiling in auditorium

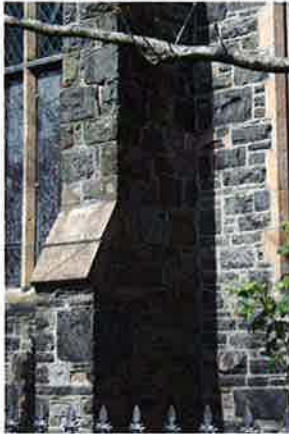
The buttresses to the outside side walls are generally cracked along the mortar joints between the stone.

Cracks to mortar joints in Auditorium buttresses

- (b) Inject cracks to the side walls and buttresses with grout injection to re-establish strength.
- (c) Secure roof trusses into side walls at buttress locations.
- (d) Possibly install concrete insitu column within the side wall buttresses, and flush with inside face to enhance side wall strength to 67% code.
- (e) Remove lathe and plaster ceiling and relin with bracing installed behind ceiling to enhance strength to 67% code.
- (f) Tie end wall west gable, and new east wall gable into roof structure.
- (g) Remove loose stonework around side wall windows and re-fix in place with steel pins or grouted joints to enhance strength.
- (h) Re-fix gallery beams and associated spalled stone work in place.
- (i) Re-level ground floor and realign posts supporting gallery floor.

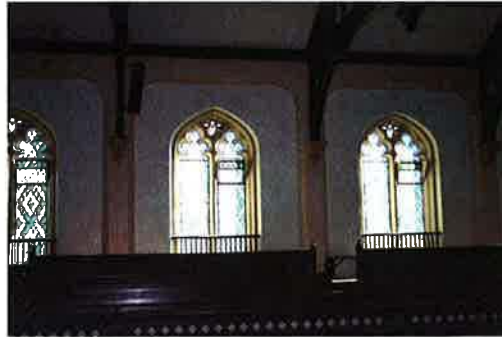
The side walls to the auditorium are still in relatively good condition with some cracking on the inside plaster face above the windows.

Side walls of Auditorium in good condition with some cracking above windows

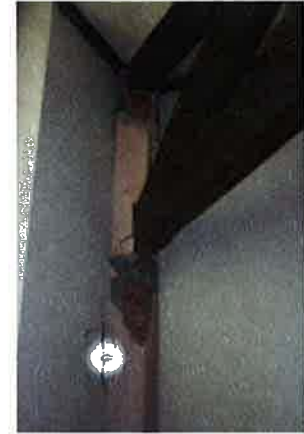
Some spalling of stone work has occurred where the timber gallery beams are housed into the stone walls.

Spalling of stone around gallery beams in Auditorium

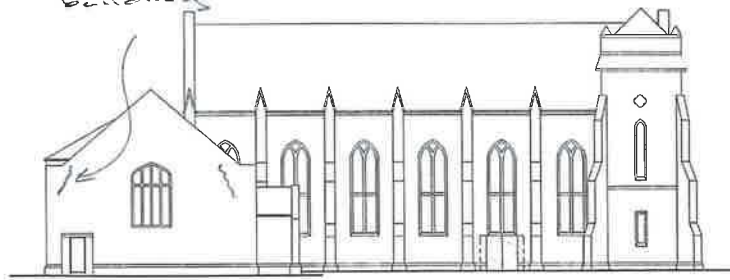
SOUTH ELEVATION

Cracks visible  
inside face of  
building

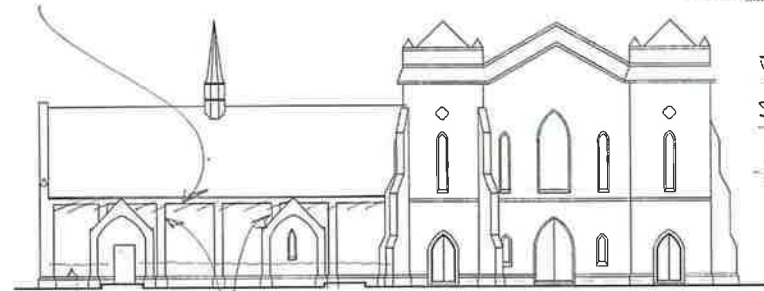
EAST ELEVATION

Upper section  
of wall collapsed

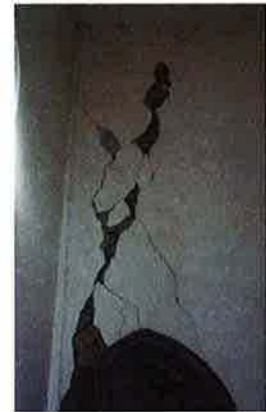
cracked & spalling plaster  
north tower

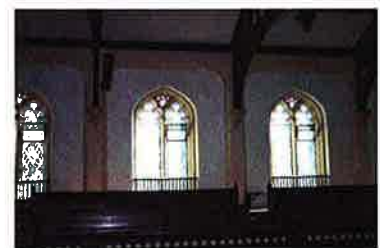
Auditorium side walls

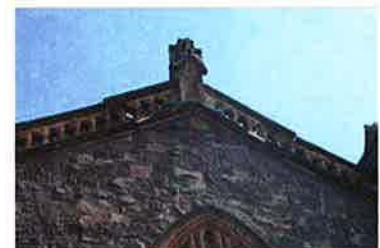
dislodged east gable  
parapet & finial

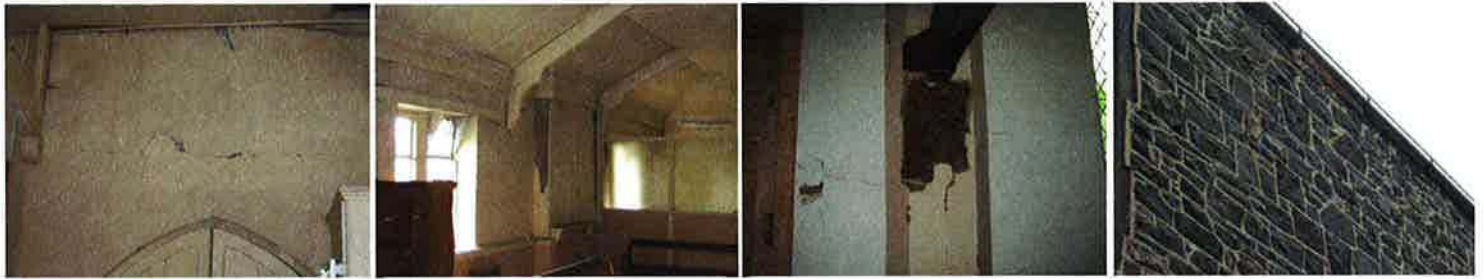
cracks to back of  
west wall gable

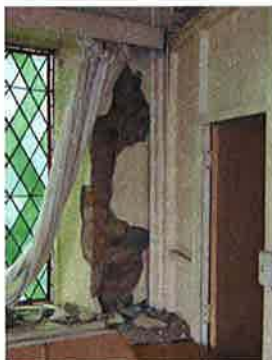
Annex north wall  
spalling plaster around  
window

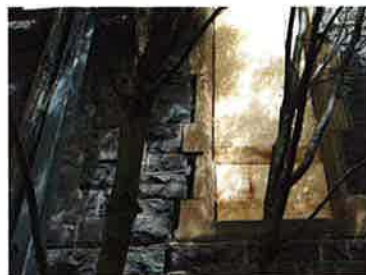
Damaged stone to north  
tower window

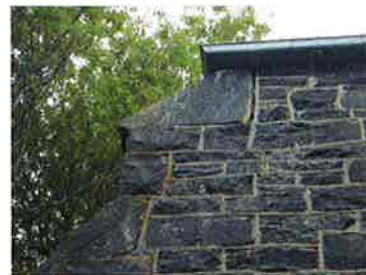
North wall buttress displaced  
stone

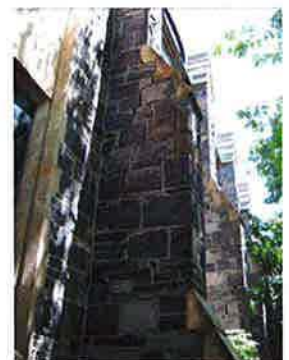
north wall cracked  
buttresses

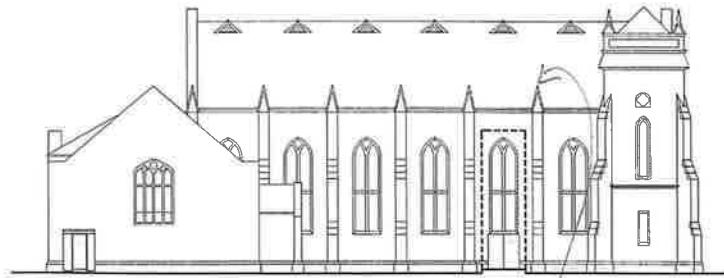
SOUTH ELEVATION

Some stone window frames dislodged.

Some battress stones dislodged

Some stone finials dislodged

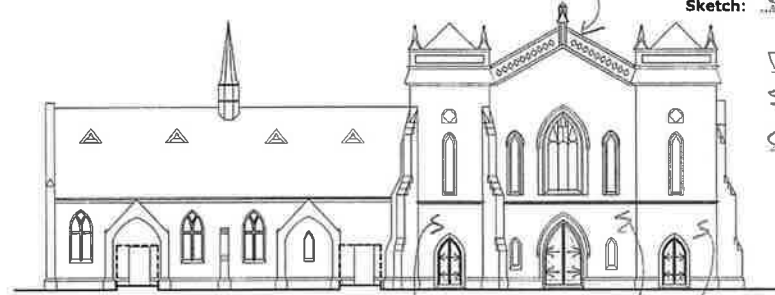
EAST ELEVATION

Minor cracking to exterior south tower

Extensive cracking to exterior north tower and east gable
