**INDEPENDENT ASSESSMENT ON EARTHQUAKE PERFORMANCE
OF**

The Methodist Church Building At 309 Durham Street North

**FOR
Royal Commission of Inquiry into building failure caused by the Canterbury
Earthquakes**

**Report prepared by Peter C Smith and Jonathan Devine
Spencer Holmes Ltd**

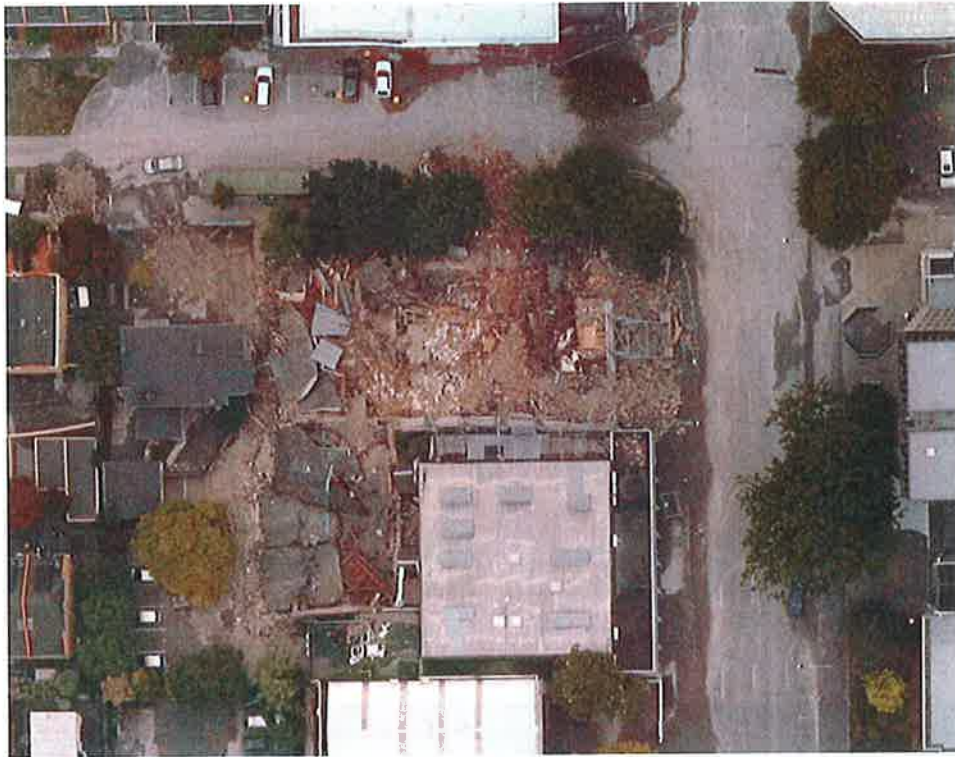
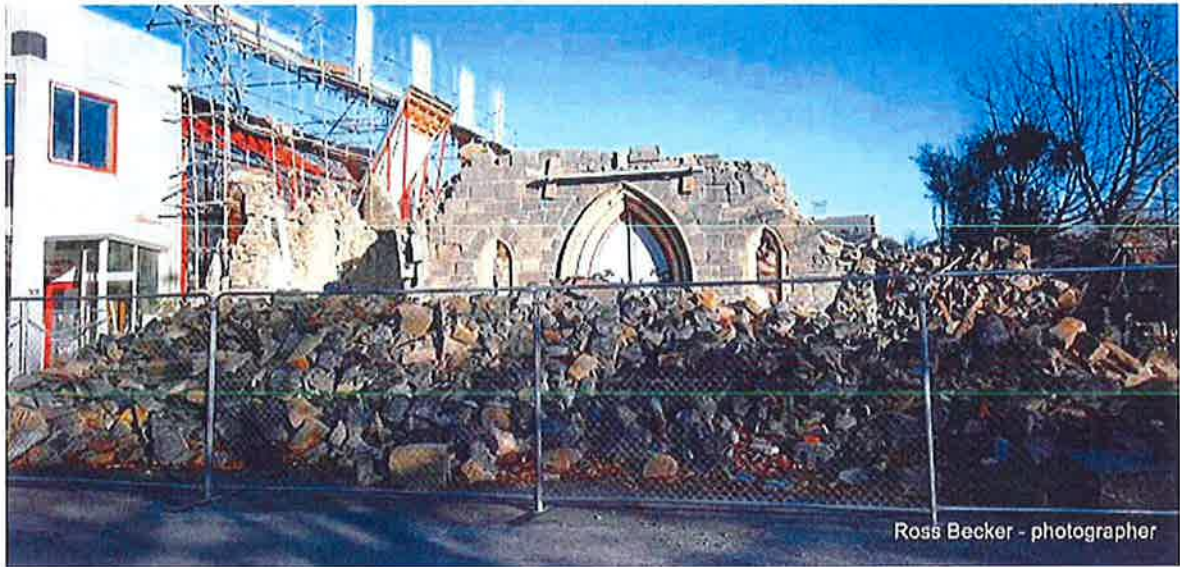
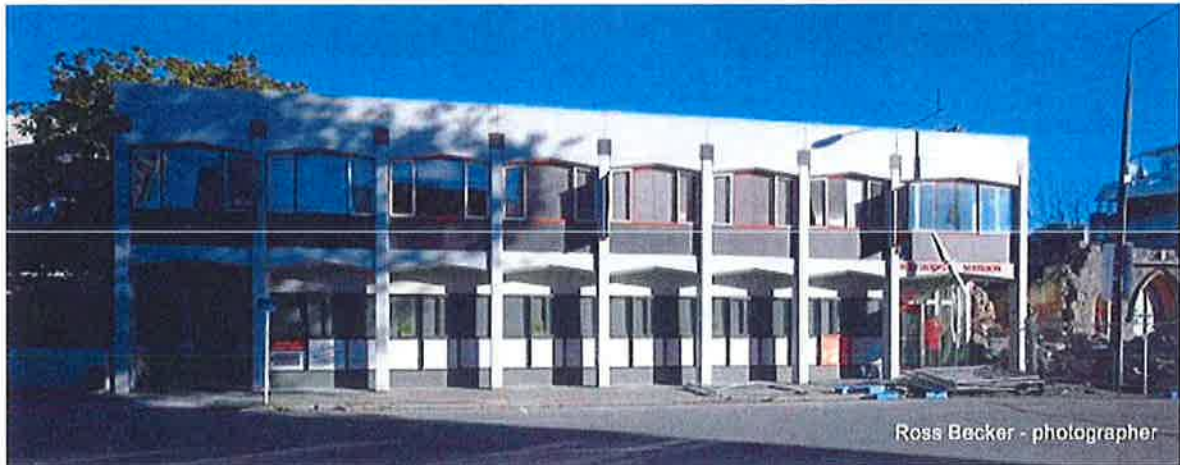
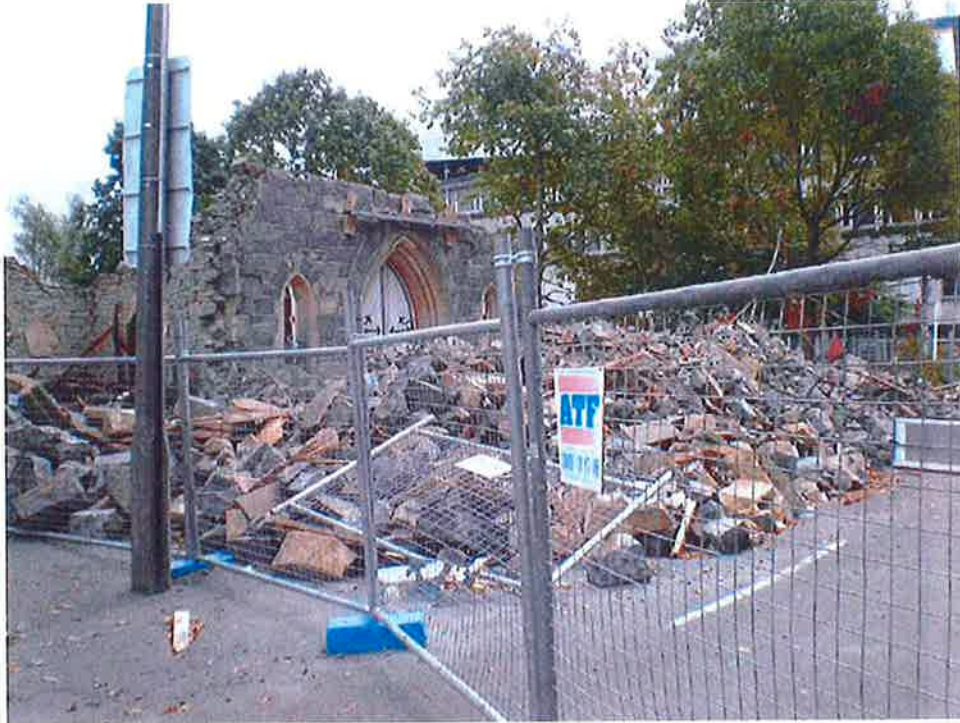
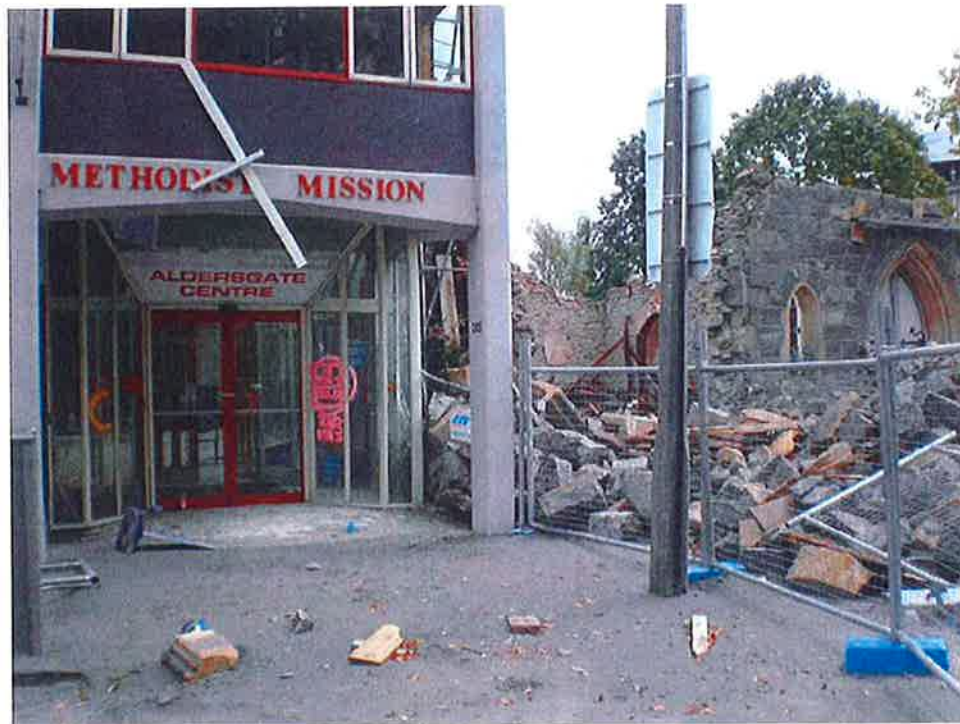
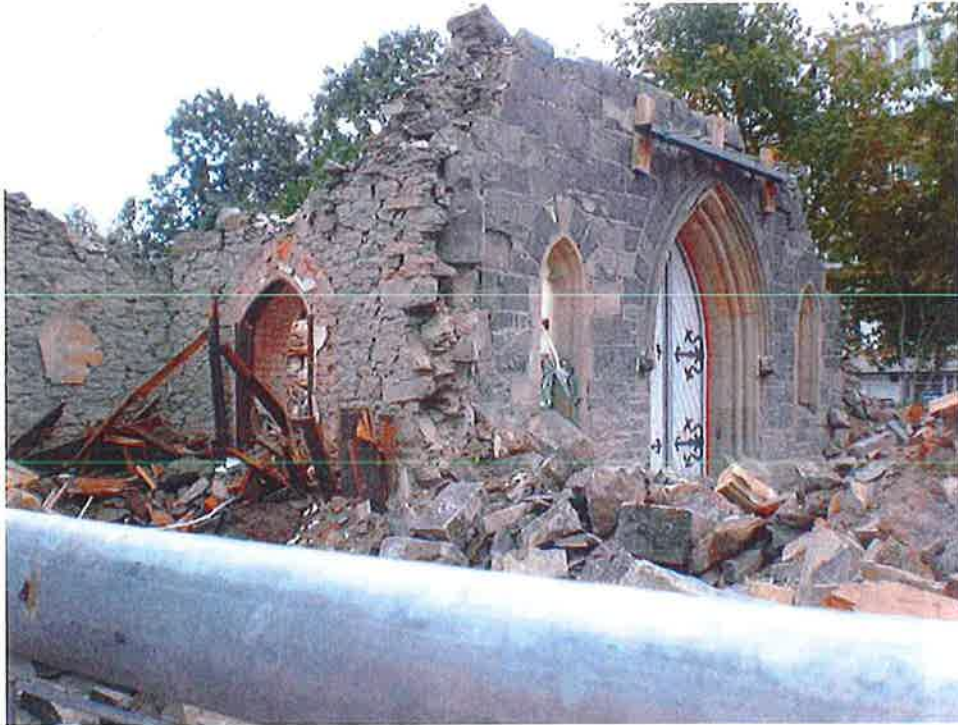
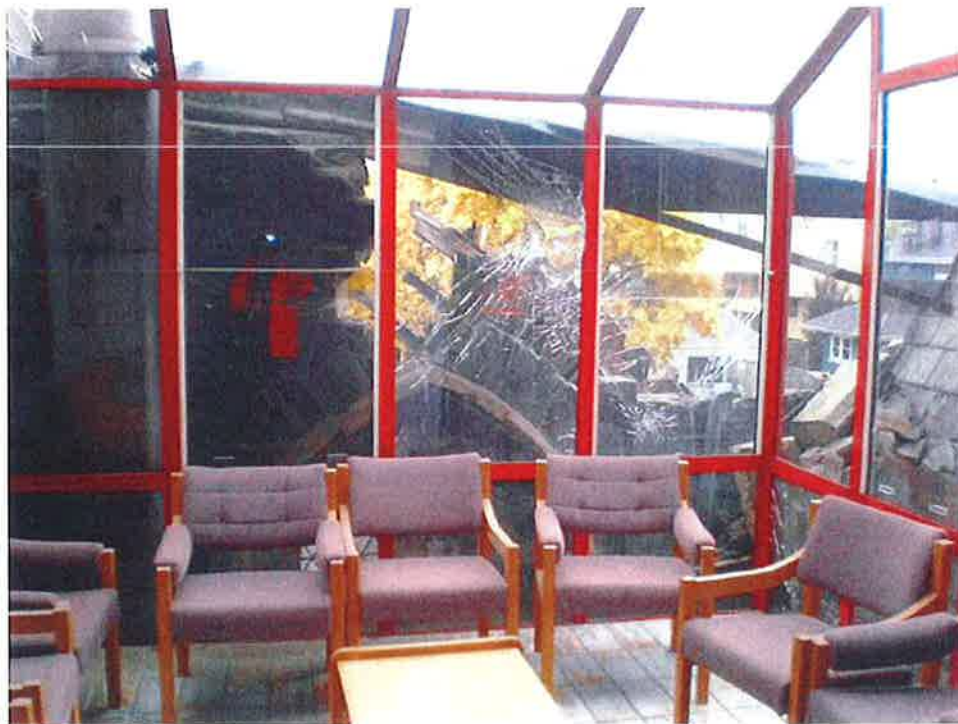
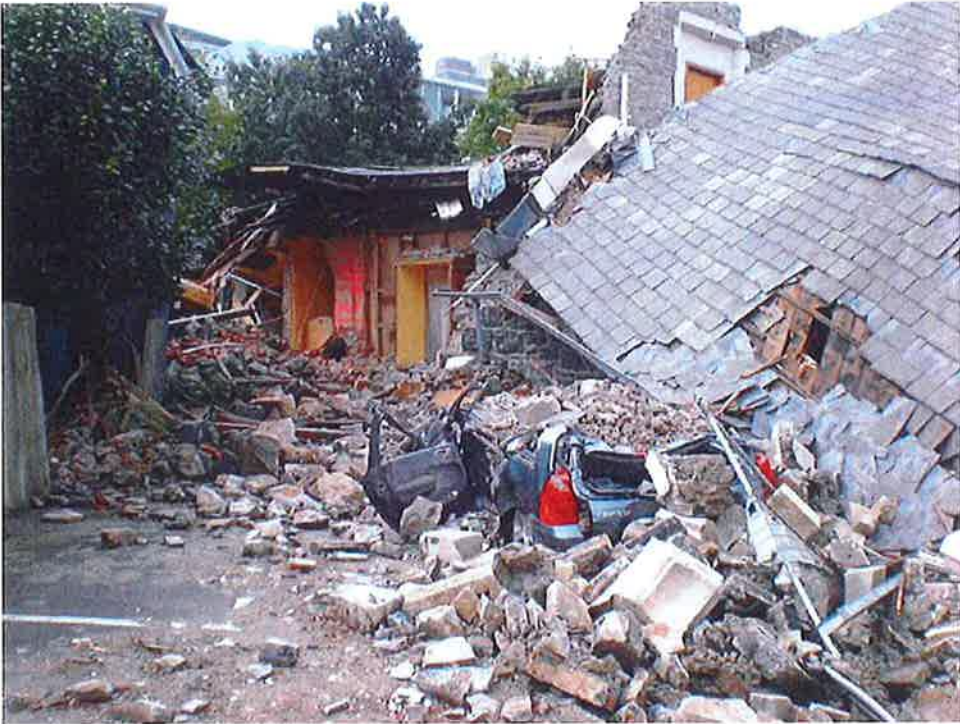
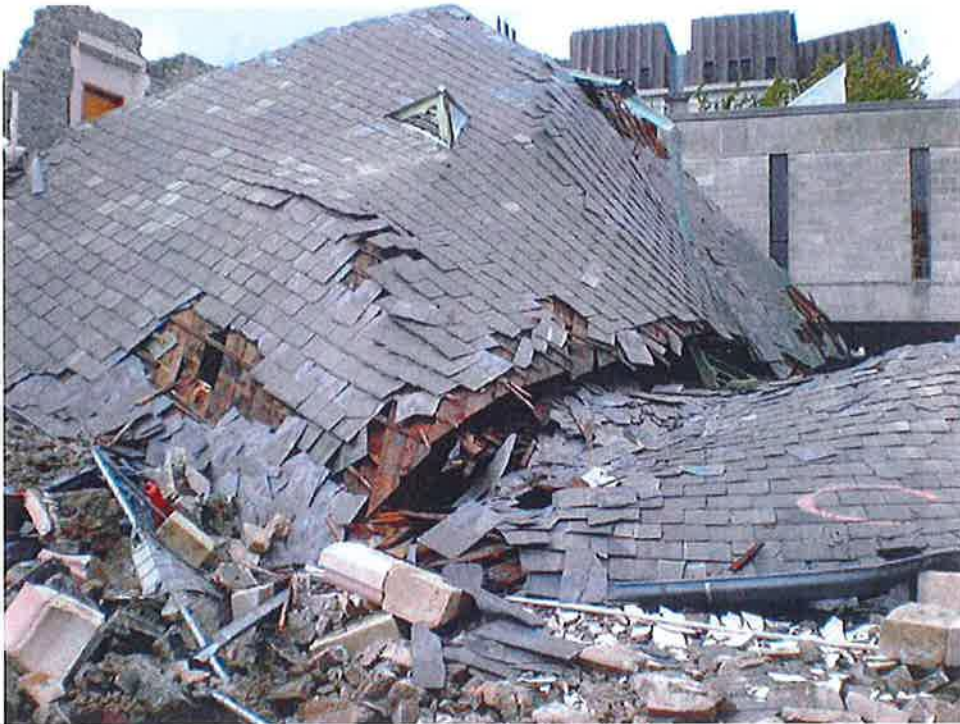
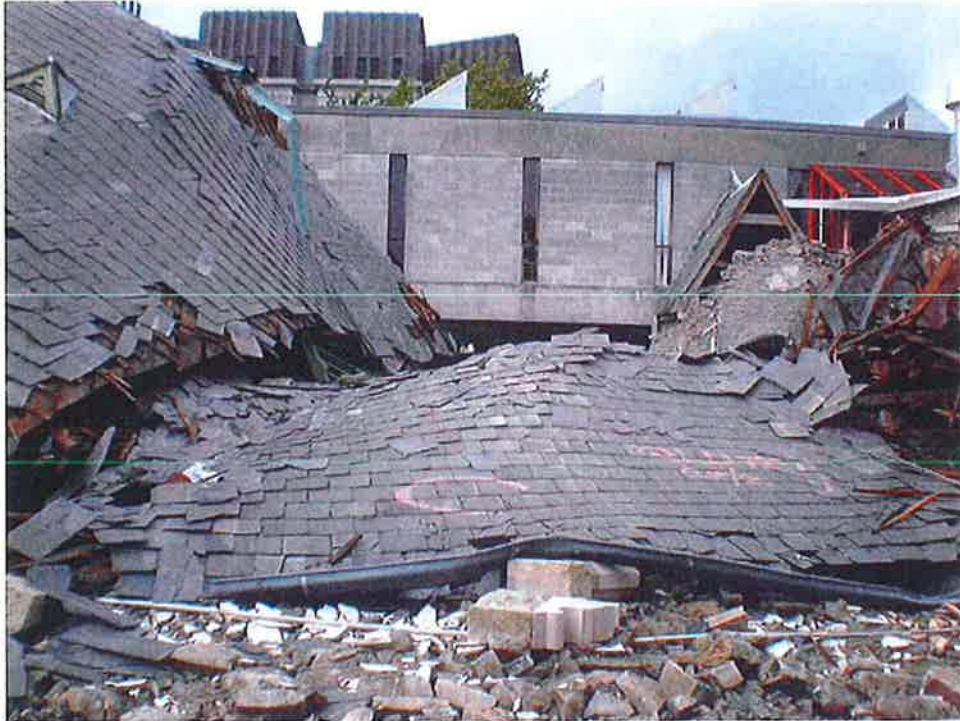
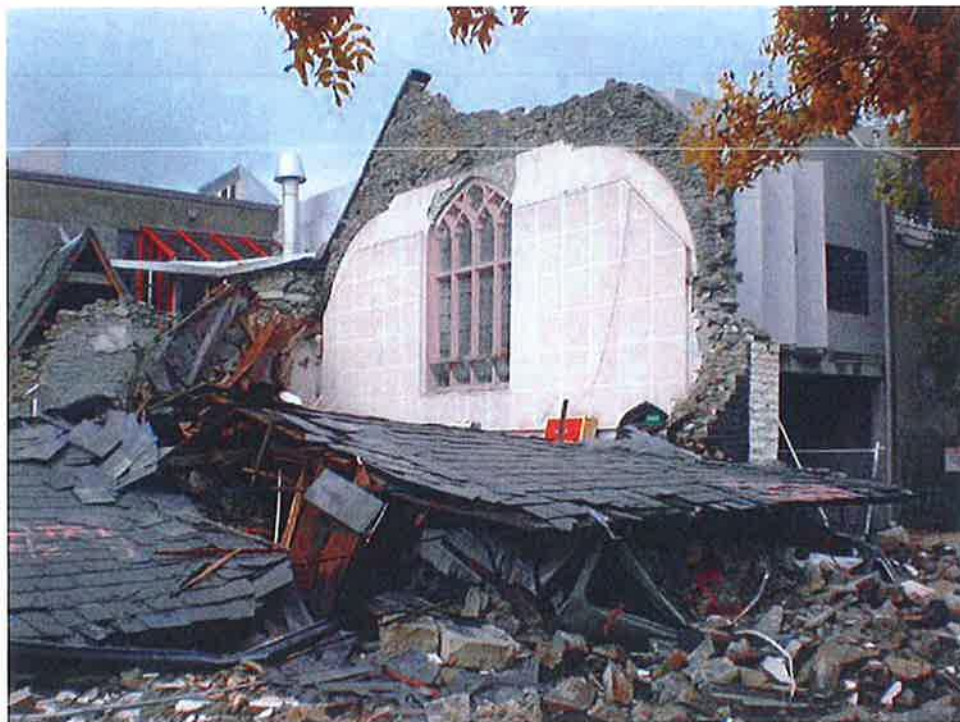
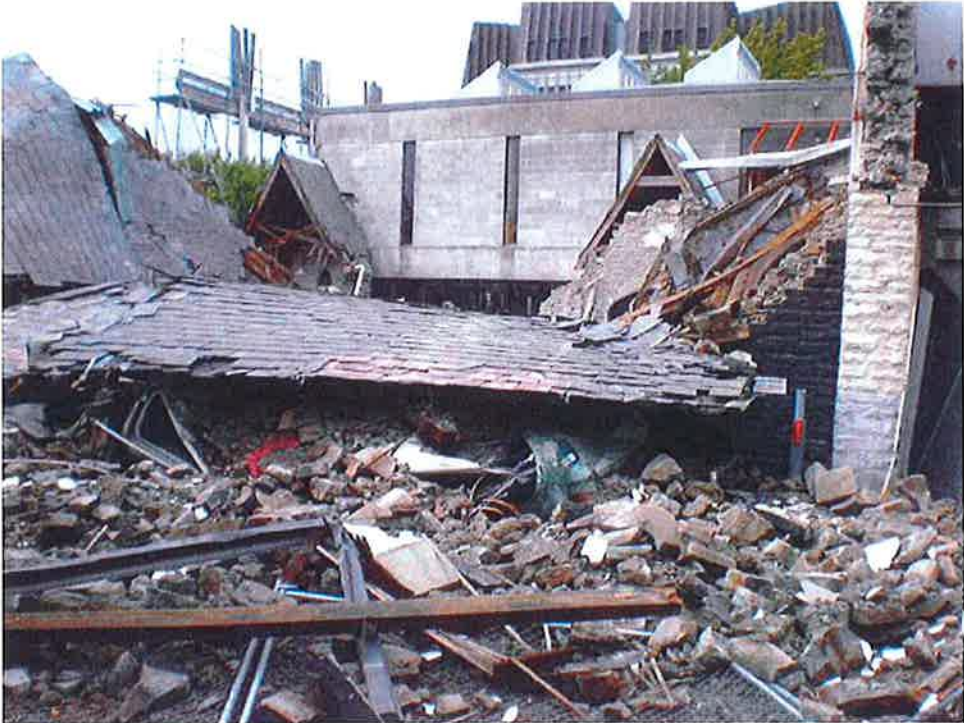
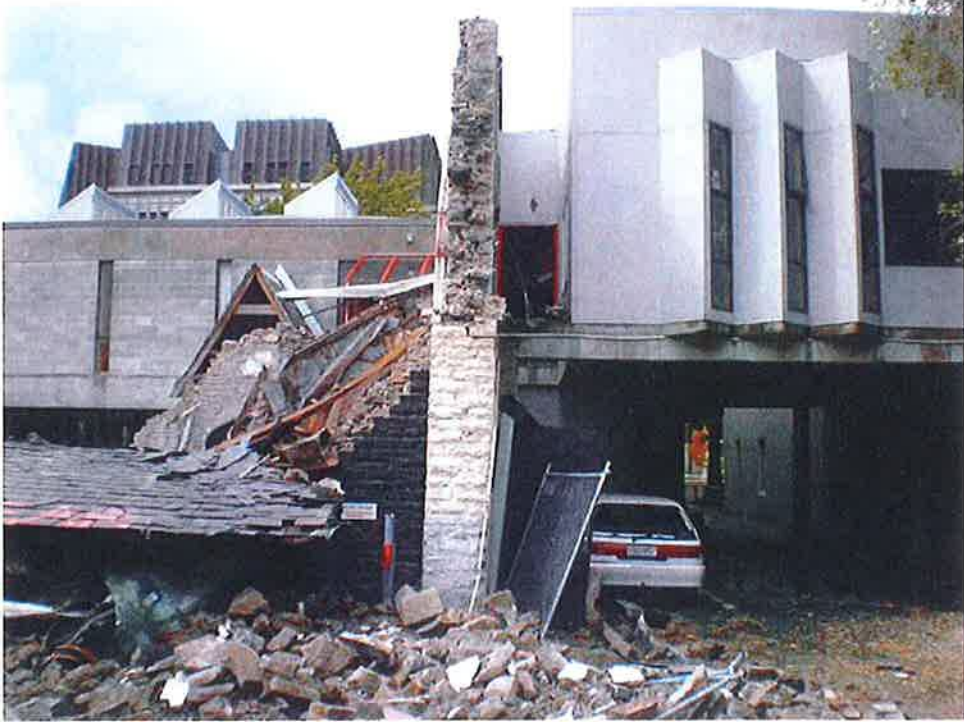
We understand that the building collapsed in the earthquake of 22nd February, 2011 and three men were tragically killed in the building when they were part of a group of eight workmen involved undertaking the removal of the organ from the building.

We would note that the temporary propping was ineffective at preventing collapse of the walls supported. Based on GNS Science records of measurements of accelerations in the Christchurch CBD during the 22nd February 2011 earthquake, the building is likely to have been subjected to accelerations of 0.9g. The propping was design with a risk factor of 0.5, effectively half of current code, and so was not designed for the accelerations experienced on the 22nd February, 2011.

Photographs of damage following 22nd February 2011 earthquake
