## Canterbury Earthquakes Royal Commission

### **309 Durham Street North (Durham Street Methodist Church) Information request**

**Re: Methodist Church, Durham Street, Christchurch - Structural Assessment Report**

**Re: Durham Street Methodist Church Hall  
Structural Assessment & Strengthening Report**

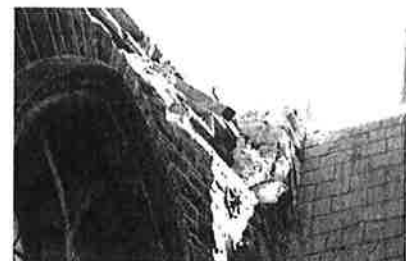
Significant damage has occurred to the upper section of the east wall where part of this wall at roof level has collapsed out.

Hall east wall damage

The hall is significantly damaged from the earthquake and will require reconstruction of the entire west wall, reconstruction of the upper section of the east wall, reconstruction of the junctions between the trusses and east side wall, and repairs to the ceiling. Some areas of the ceiling will require replacement.

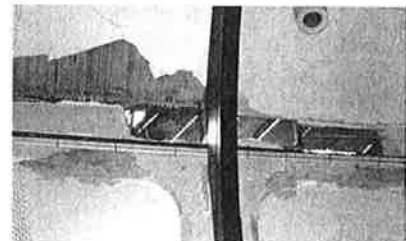
damage at truss locations in Hall

Damage has also occurred between the timber roof truss and the side walls with varying degrees of cracking, including spalling of the stone around the truss support.

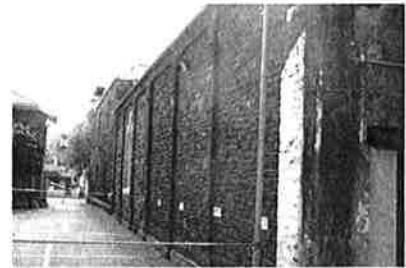
The western side of the Hall wall has two continuous, almost full length horizontal cracks, one located about 1200mm from the floor and the other located near the top of the wall. The wall is leaning out significantly between these two cracks. It is estimated that the wall has an outward lean of about 200-250mm.

west wall of Hall leans out

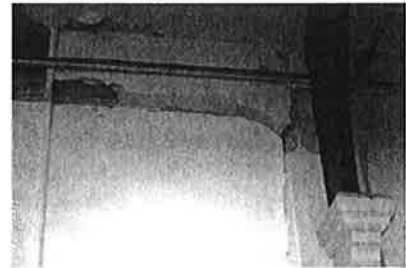
A number of cracks are present in the infill stone walls between the side wall columns.

Cracks to the infill stone walls in Hall

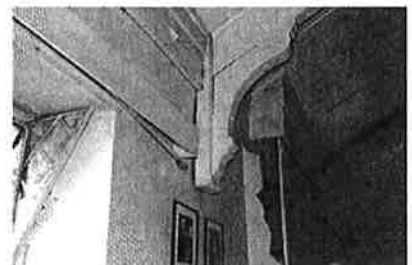
The west wall of the annex has displaced from the roof trusses as well as from the north gable wall and has formed a crack in the north west corner near the ceiling level.

Annex west wall displaced from Truss

The displacement does not appear to be excessive and could be repaired by grouting up the existing cracks and re-fixing the roof structure to the western exterior wall.

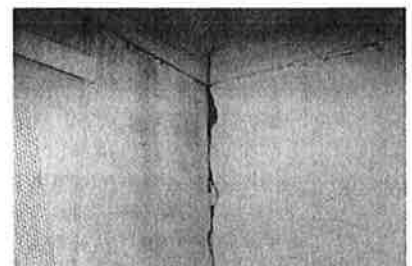
The main area of damage to the annex appears to be on the west wall where the top of the wall has displaced from the roof structure and at the north wall junction.

Crack formed in north wall corner of Annex

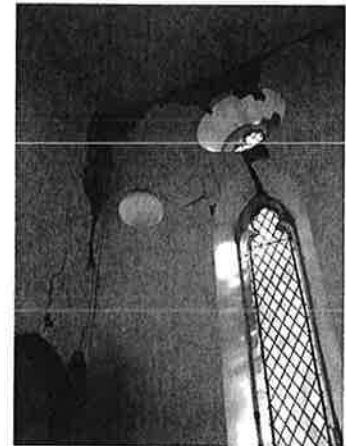
The auditorium measures approximately 28 x 18m in plan. The main area of damage has occurred in the eastern towers where the stairs are located. Significant damage has occurred in this area with cracks clearly visible on the exterior face, generally in the stone mortar joints. The plaster has spalled significantly on the interior face with significant damage visible to the brick interior face and to the core of the wall.

damage to auditorium stair walls, east end

- (a) Remove the towers and east wall of the auditorium and retain all stone work. Reconstruct the towers and east wall in reinforced concrete and place stone on the exterior face to retain the same visual appearance both internally and externally.

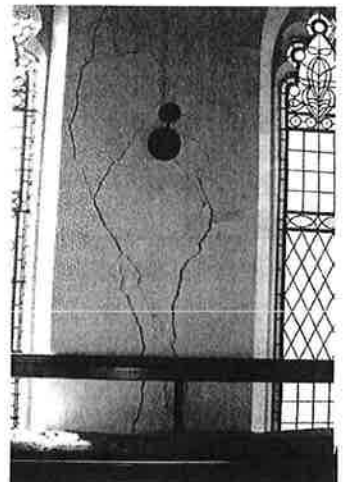
Significant cracking has occurred to the eastern wall of the auditorium facing Durham Street.

east wall damage

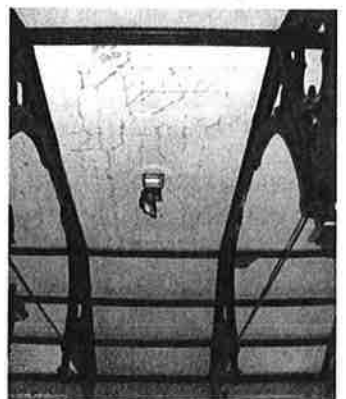
The lathe and plaster ceiling is also significantly cracked through the entire ceiling.

Cracked ceiling in auditorium

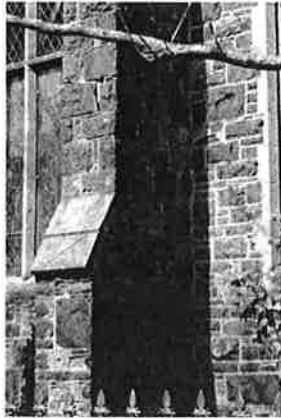
The buttresses to the outside side walls are generally cracked along the mortar joints between the stone.

Cracks to mortar joints in Auditorium buttresses

- (b) Inject cracks to the side walls and buttresses with grout injection to re-establish strength.
- (c) Secure roof trusses into side walls at buttress locations.
- (d) Possibly install concrete insitu column within the side wall buttresses, and flush with inside face to enhance side wall strength to 67% code.
- (e) Remove lathe and plaster ceiling and reline with bracing installed behind ceiling to enhance strength to 67% code.
- (f) Tie end wall west gable, and new east wall gable into roof structure.
- (g) Remove loose stonework around side wall windows and re-fix in place with steel pins or grouted joints to enhance strength.
- (h) Re-fix gallery beams and associated spalled stone work in place.
- (i) Re-level ground floor and realign posts supporting gallery floor.

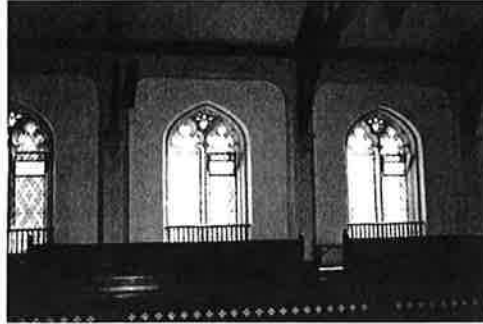
The side walls to the auditorium are still in relatively good condition with some cracking on the inside plaster face above the windows.

Side walls of Auditorium in good condition with some cracking above windows

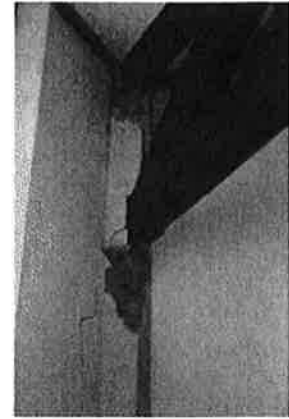
Some spalling of stone work has occurred where the timber gallery beams are housed into the stone walls.

Spalling of stone around gallery beams in Auditorium

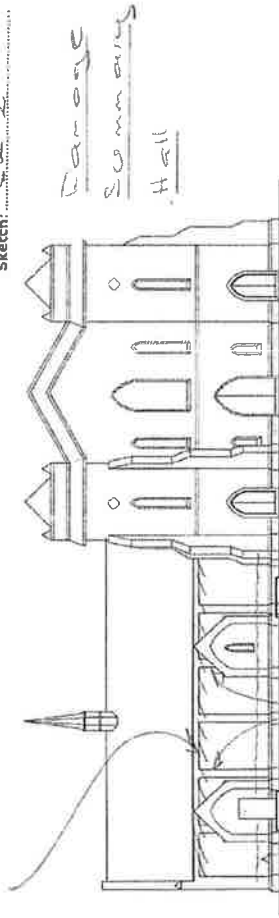
EAST ELEVATION

roof tie connections  
 disturbed.

cracks to  
 create face  
 of wall to  
 both sides  
 of building

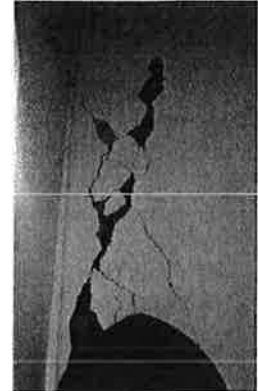
cracked & spalling plaster  
north tower

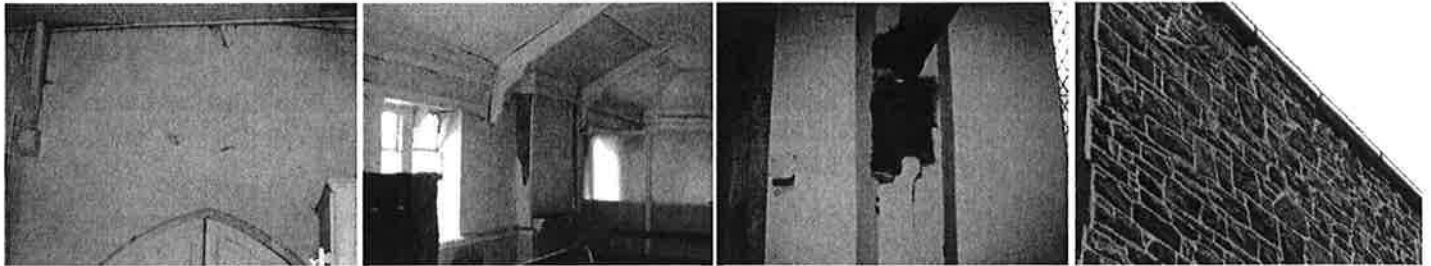
cracks to back of  
west wall gable

Annex west wall damaged  
truss support & displaced  
wall

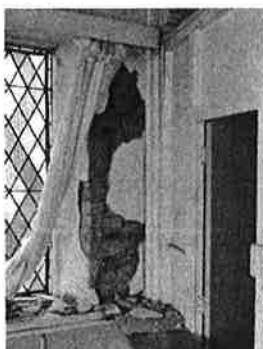
Annex north wall  
spalling plaster around  
window

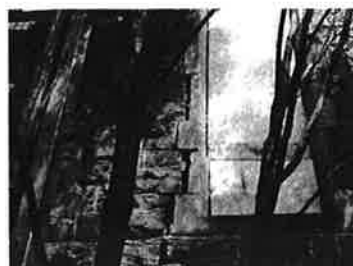
Damaged stone to north  
tower window

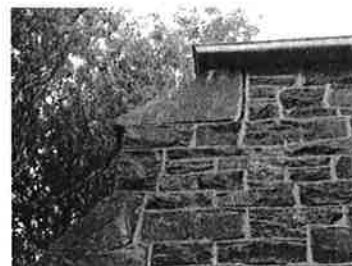
North wall buttress displaced  
stone

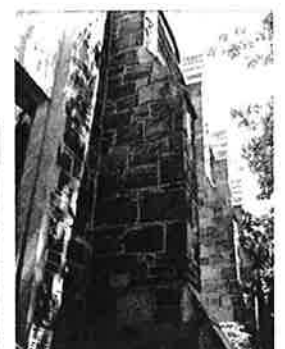
north wall cracked  
buttresses

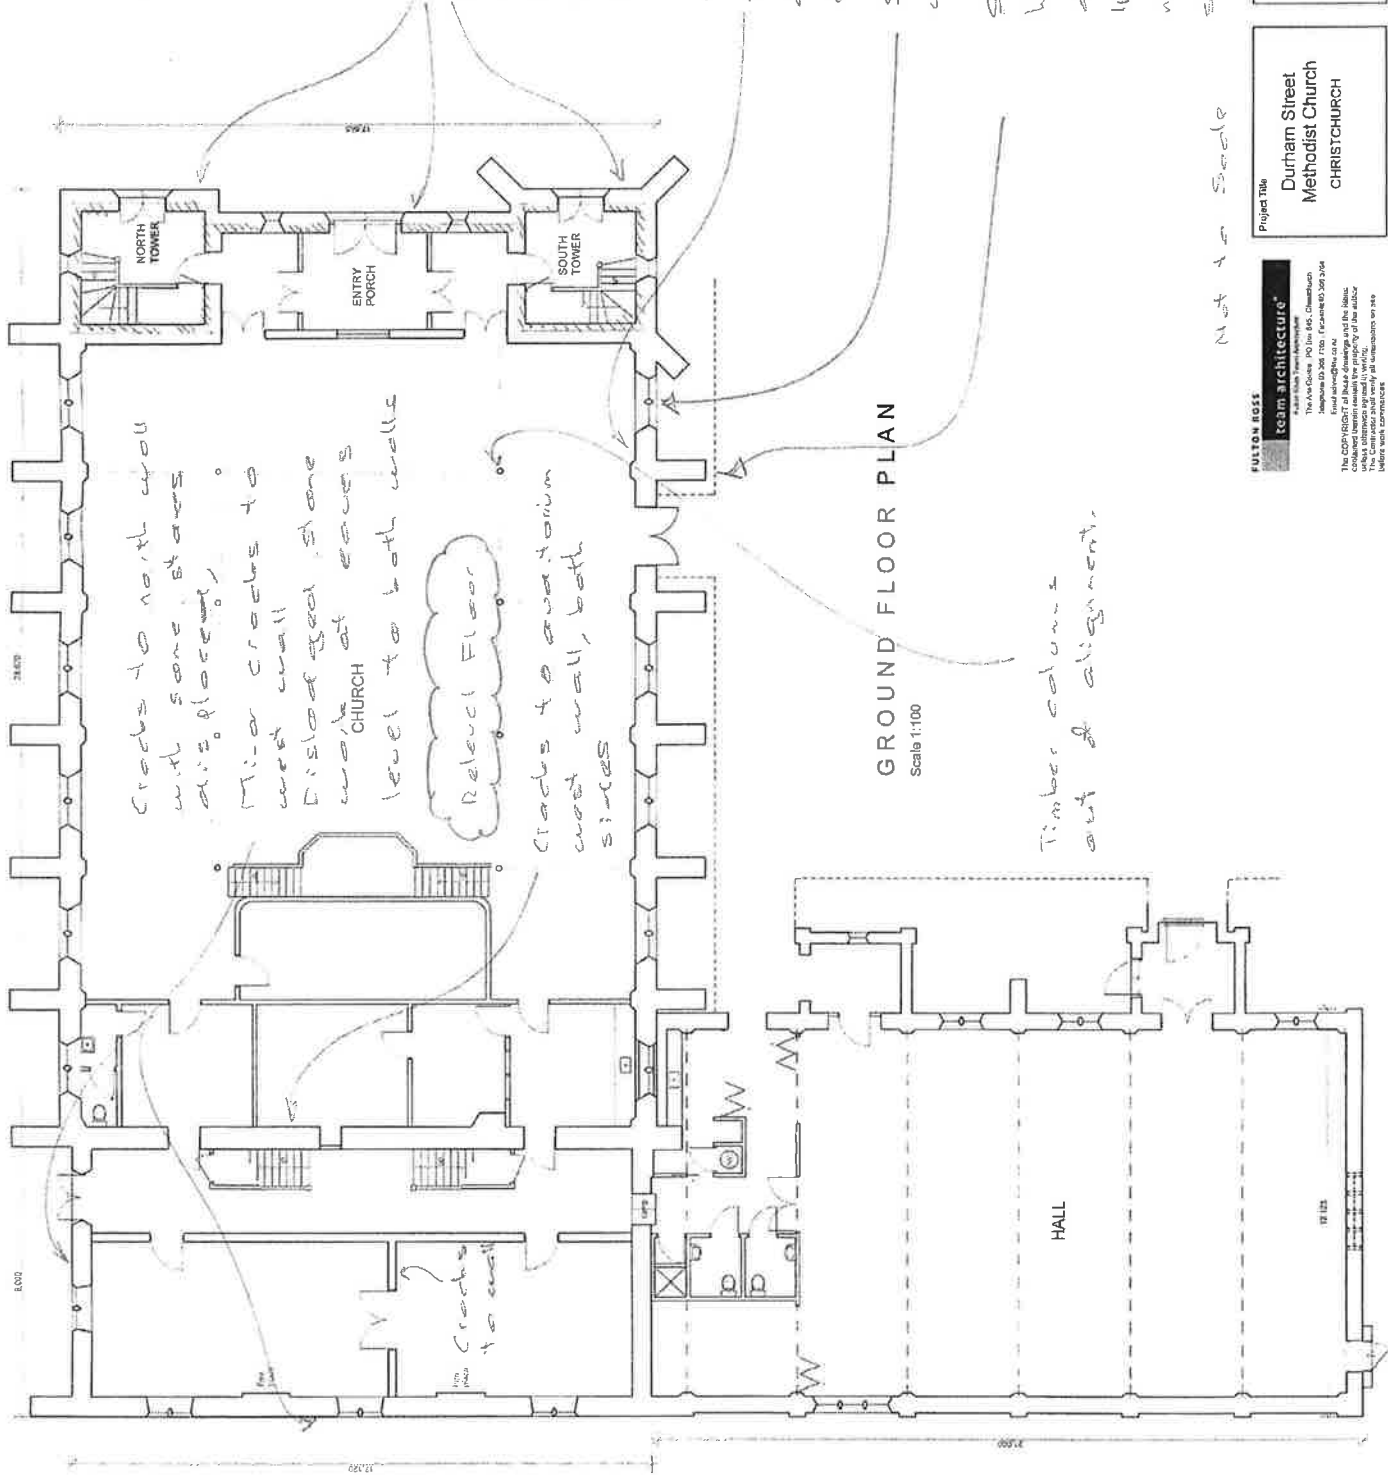
Cracks to north wall  
with some stones  
displaced.

Minor cracks to  
west wall  
Displaced stone  
work at corners  
level to both walls

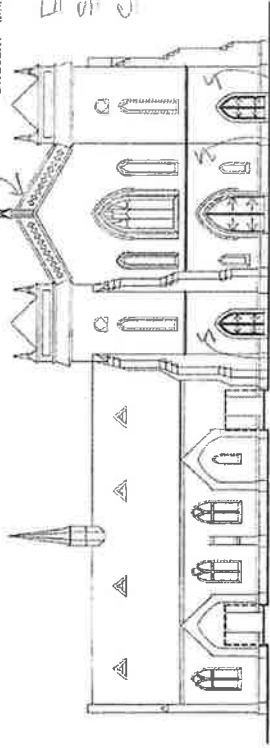
EAST ELEVATION

Extensive cracking  
to exterior north  
tower and east  
gable

Minor cracking  
to exterior  
south tower

Dislodged stone  
at eaves and  
above door

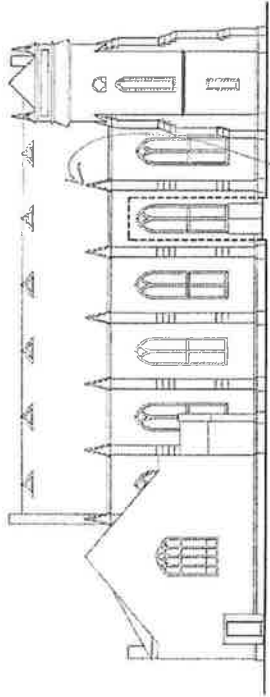
SOUTH ELEVATION

Some stone  
windows panels  
misaligned

Some stone  
panels  
misaligned

Some battress  
stones misaligned

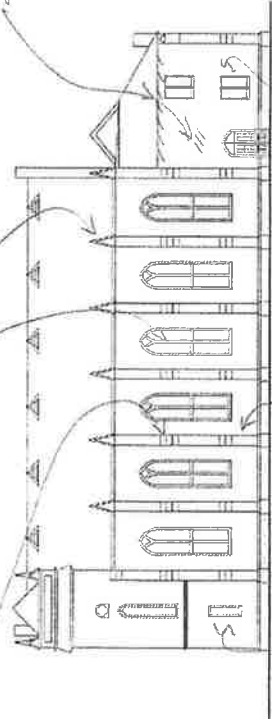
NORTH ELEVATION

Extensive  
cracking

Large cracks to  
north wall battresses  
Cracks to remaining  
battresses

Extensive cracking  
to exterior stone  
at tower

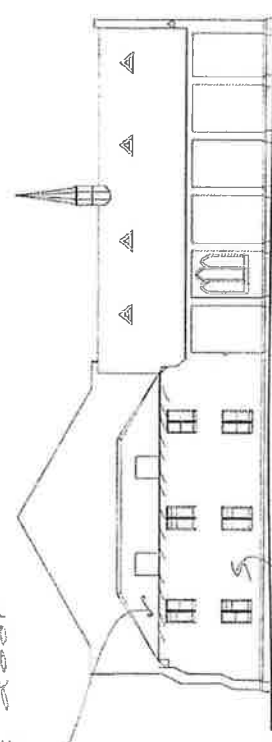
WEST ELEVATION

Minor cracking  
to stone

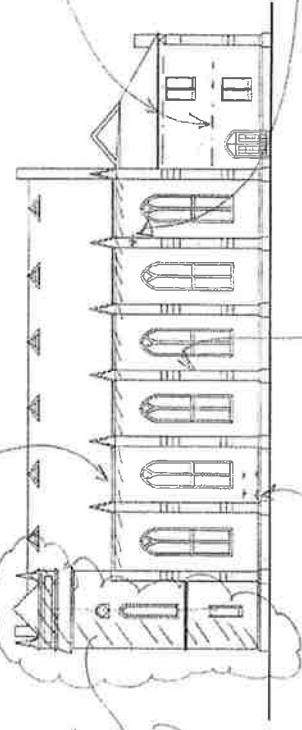
**NORTH ELEVATION**

Recently  
 extensively  
 damaged  
 walls

Stainless steel tie  
 rods in all walls  
 and battresses at  
 600 c/s each way
