246 High Street, Christchurch

Christchurch Eq. RAPID Assessment Form - LEVEL 1

Christchurch Eq RAPID Assessment Form - LEVEL 2

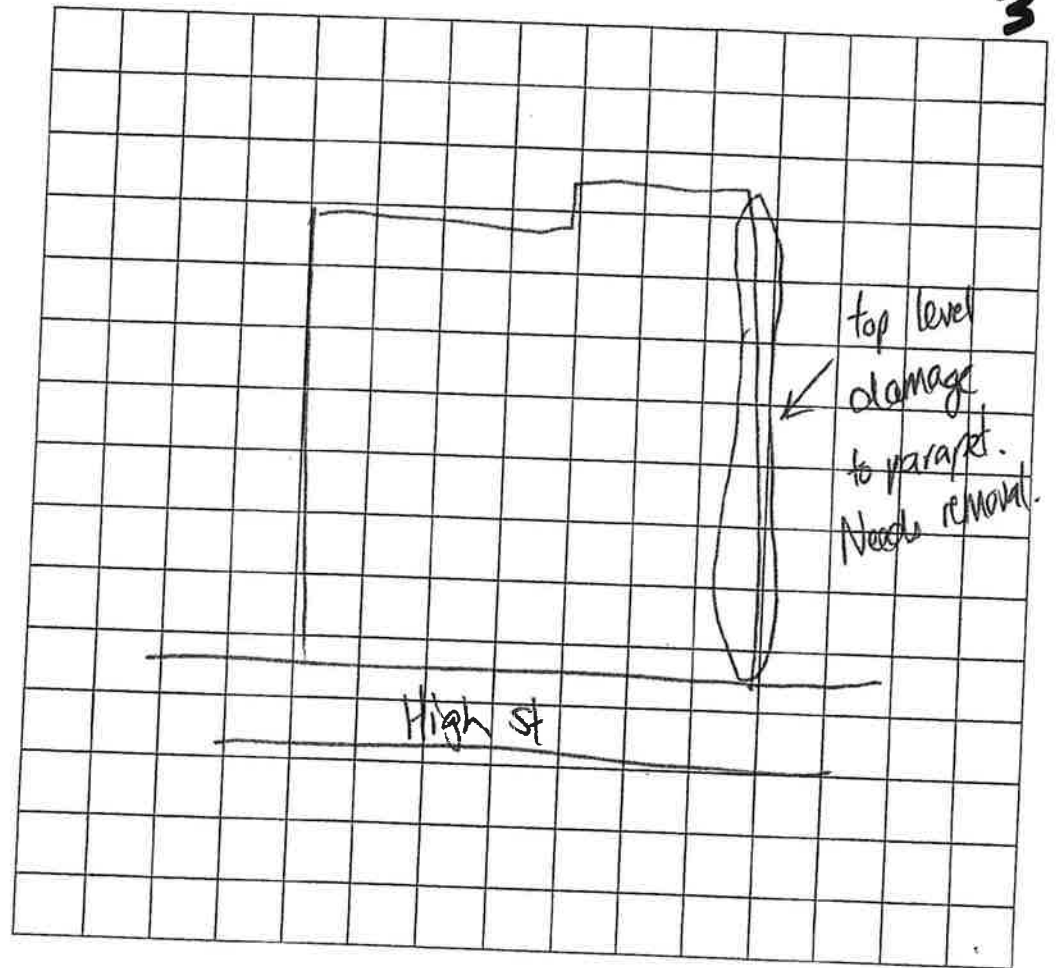
✓
Sketch (optional)

Structural Hazards/ Damage	Minor/None	Moderate	Severe	Comments
Foundations	<input checked="" type="checkbox"/>	<input type="checkbox"/>	<input type="checkbox"/>	
Roofs, floors (vertical load)	<input checked="" type="checkbox"/>	<input type="checkbox"/>	<input type="checkbox"/>	
Columns, pilasters, corbels	<input checked="" type="checkbox"/>	<input type="checkbox"/>	<input type="checkbox"/>	
Diaphragms, horizontal bracing	<input checked="" type="checkbox"/>	<input type="checkbox"/>	<input type="checkbox"/>	
Pre-cast connections	<input checked="" type="checkbox"/>	<input type="checkbox"/>	<input type="checkbox"/>	
Beam	<input checked="" type="checkbox"/>	<input type="checkbox"/>	<input type="checkbox"/>	
Non-structural Hazards / Damage				
Parapets, ornamentation	<input type="checkbox"/>	<input checked="" type="checkbox"/>	<input type="checkbox"/>	R/S parapet are damaged & unstable will require removal.

Neighbouring building to the right of 242 ~~is~~ is currently green placarded but ~~should be~~ it is recommended that its changed to ~~green~~ yellow due to the danger from the damaged parapet.

- parapet on right hand side of the bldg needs to be secured or removed prior to bldg being occupied.
