**INDEPENDENT ASSESSMENT ON EARTHQUAKE PERFORMANCE
OF**

194 Hereford Street

**Royal Commission of Inquiry into building failure
caused by the Canterbury Earthquakes**

December 2011

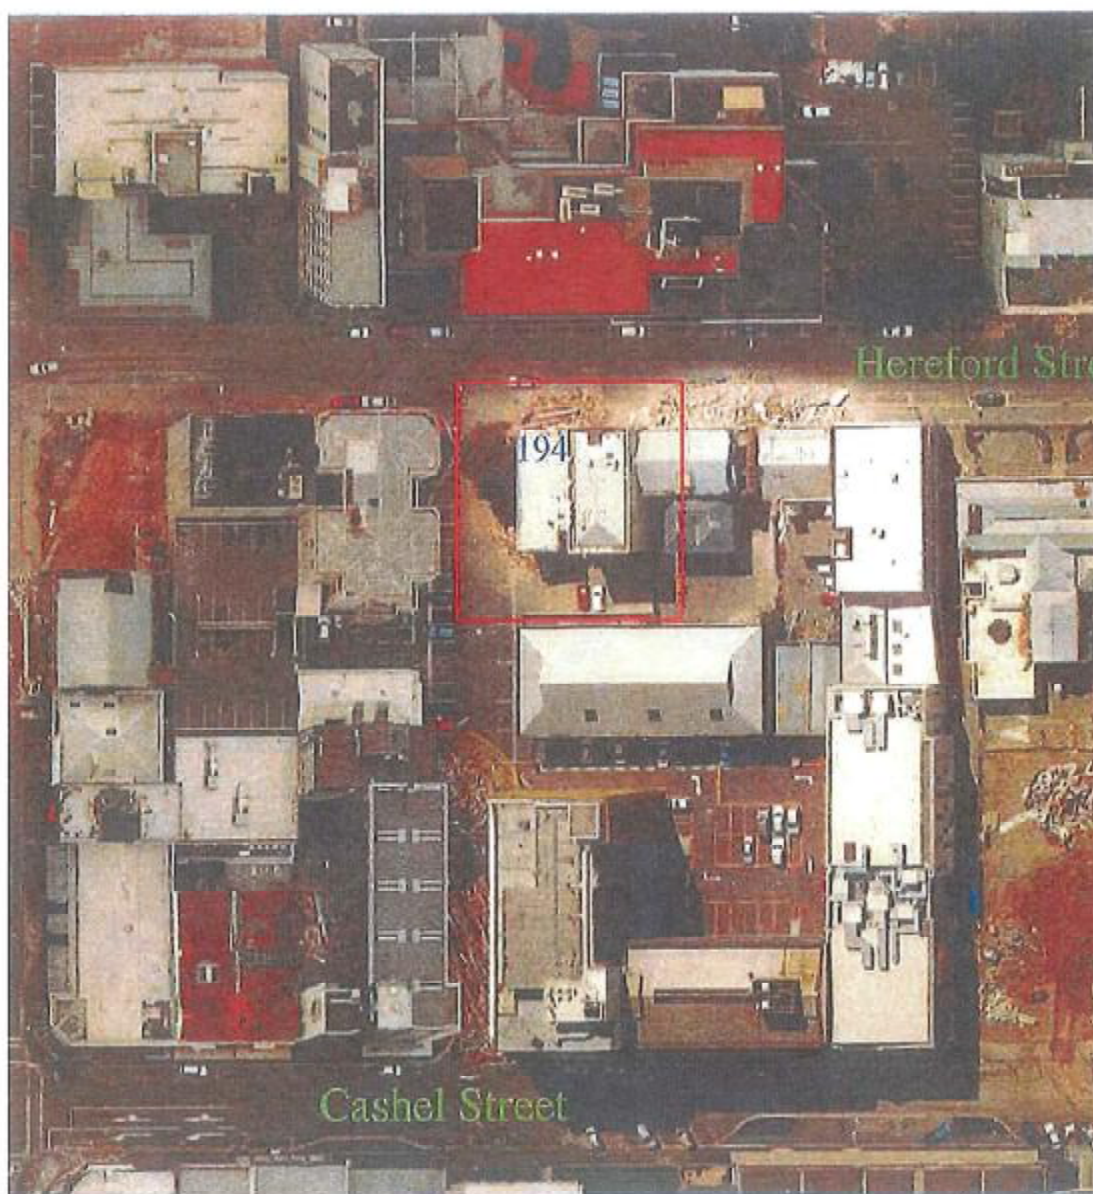
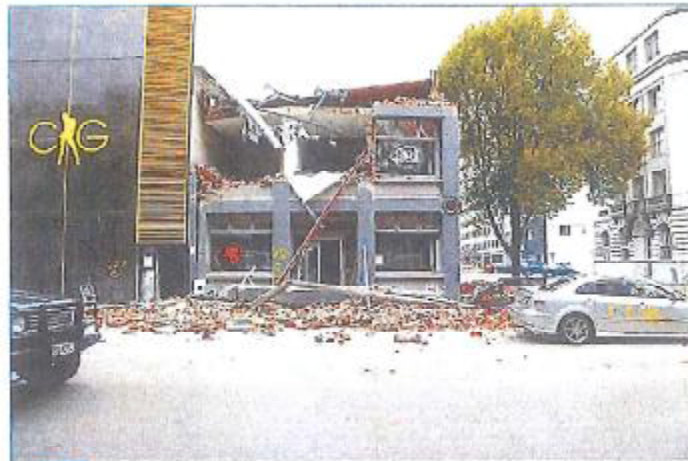
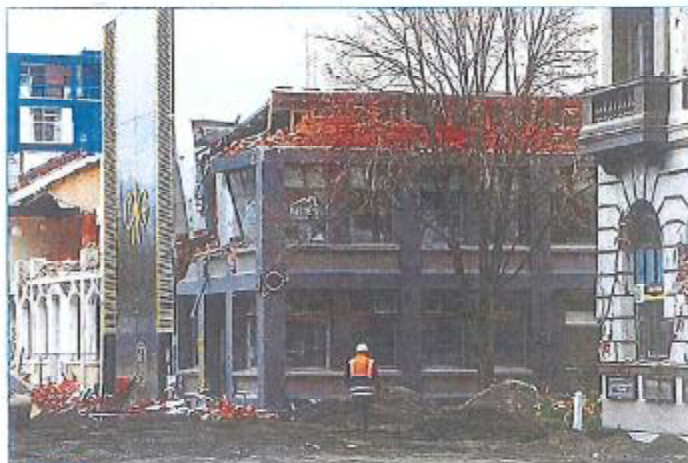
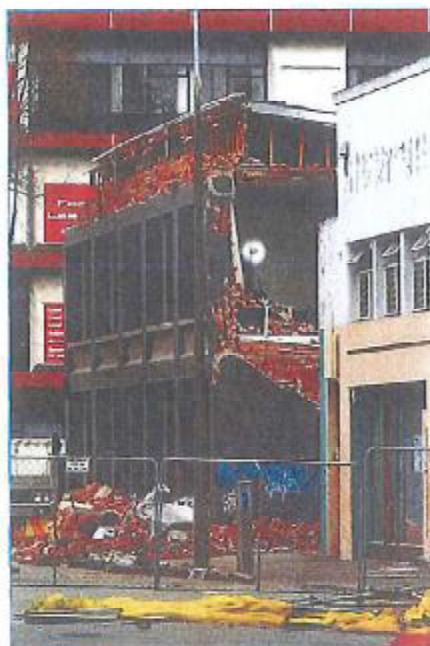
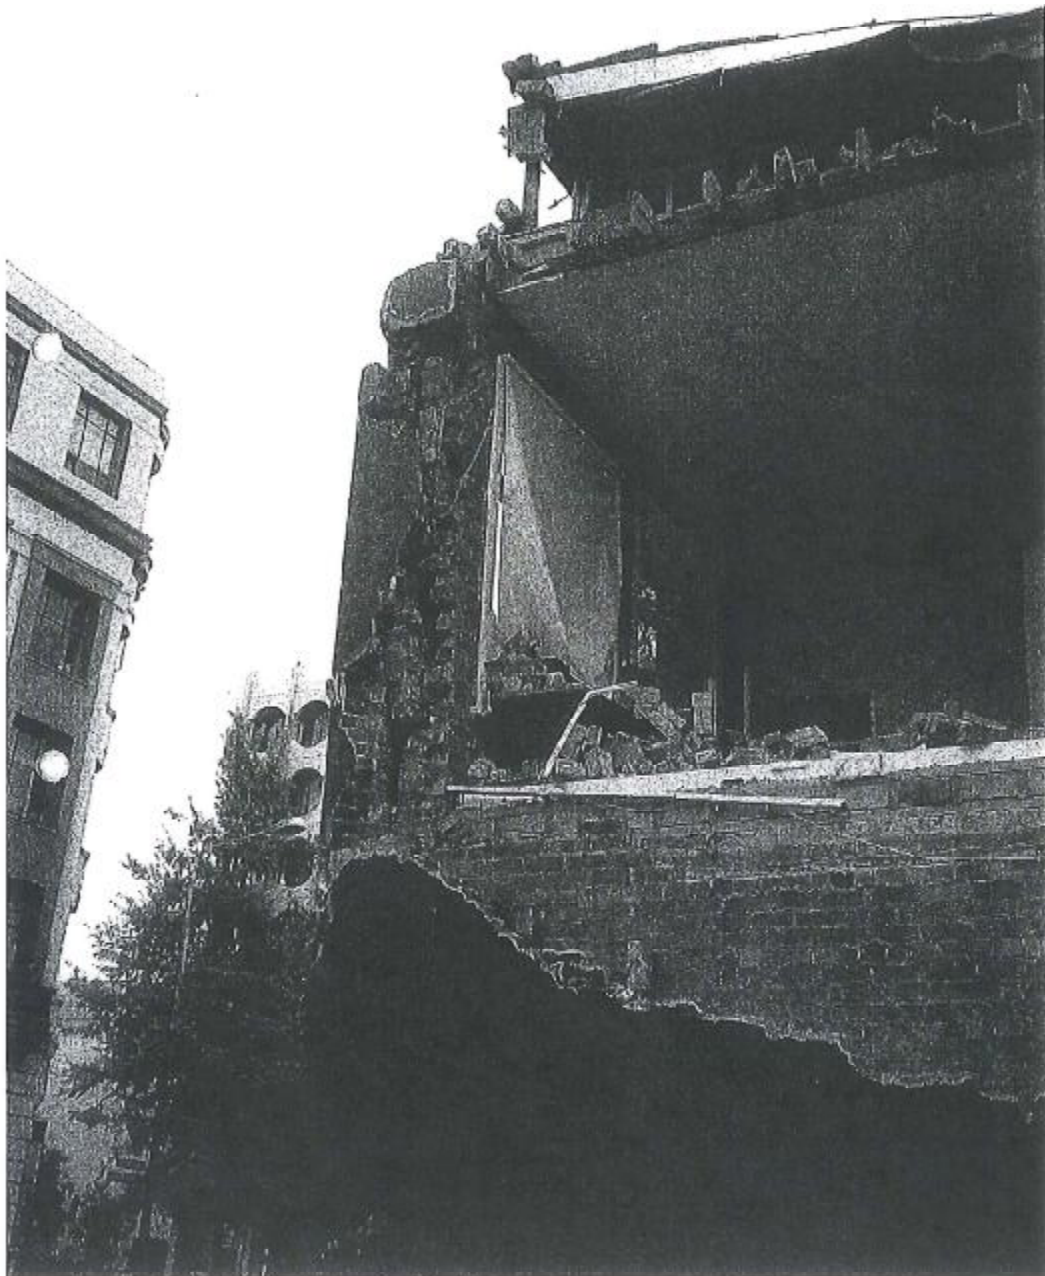
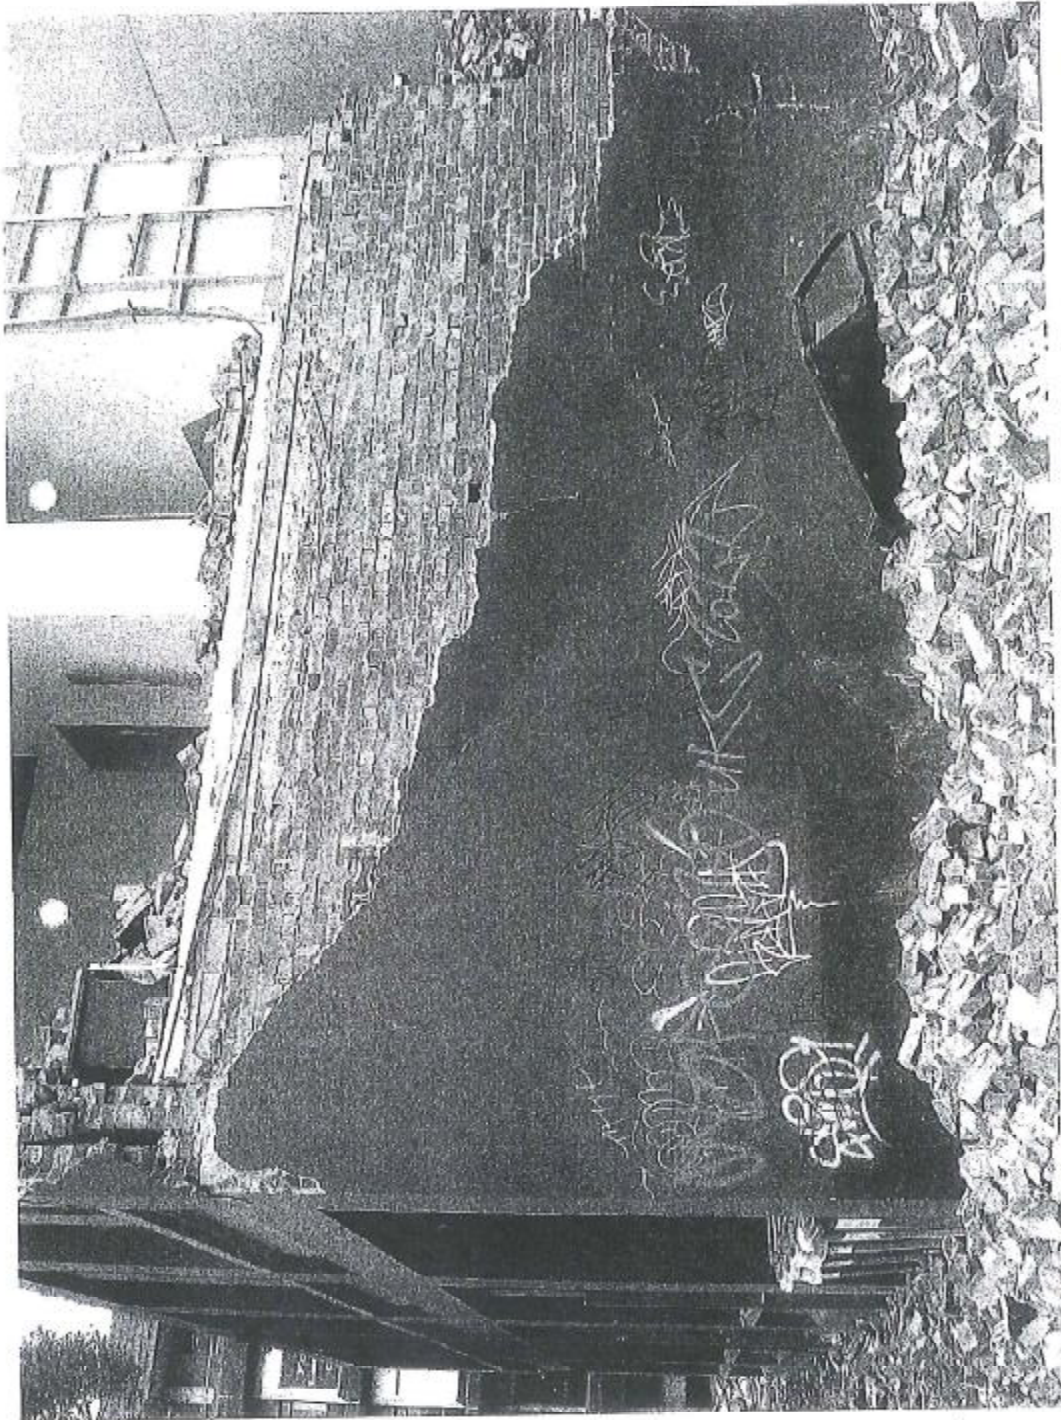
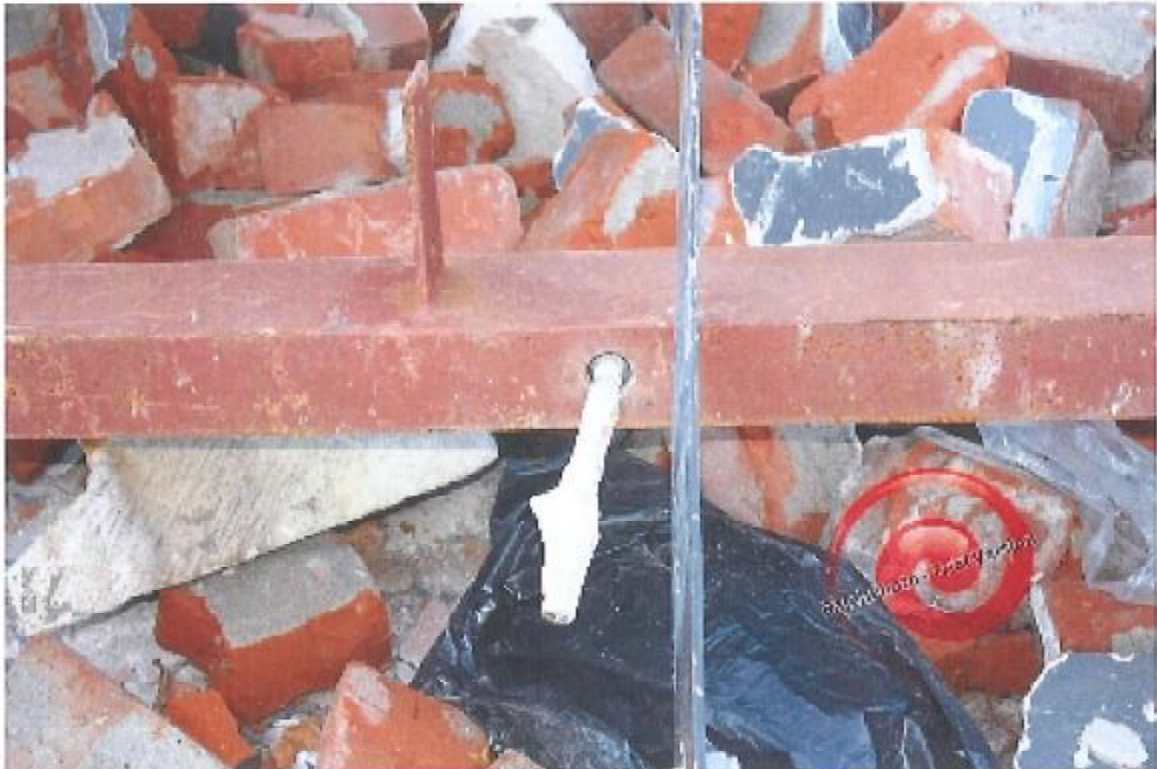
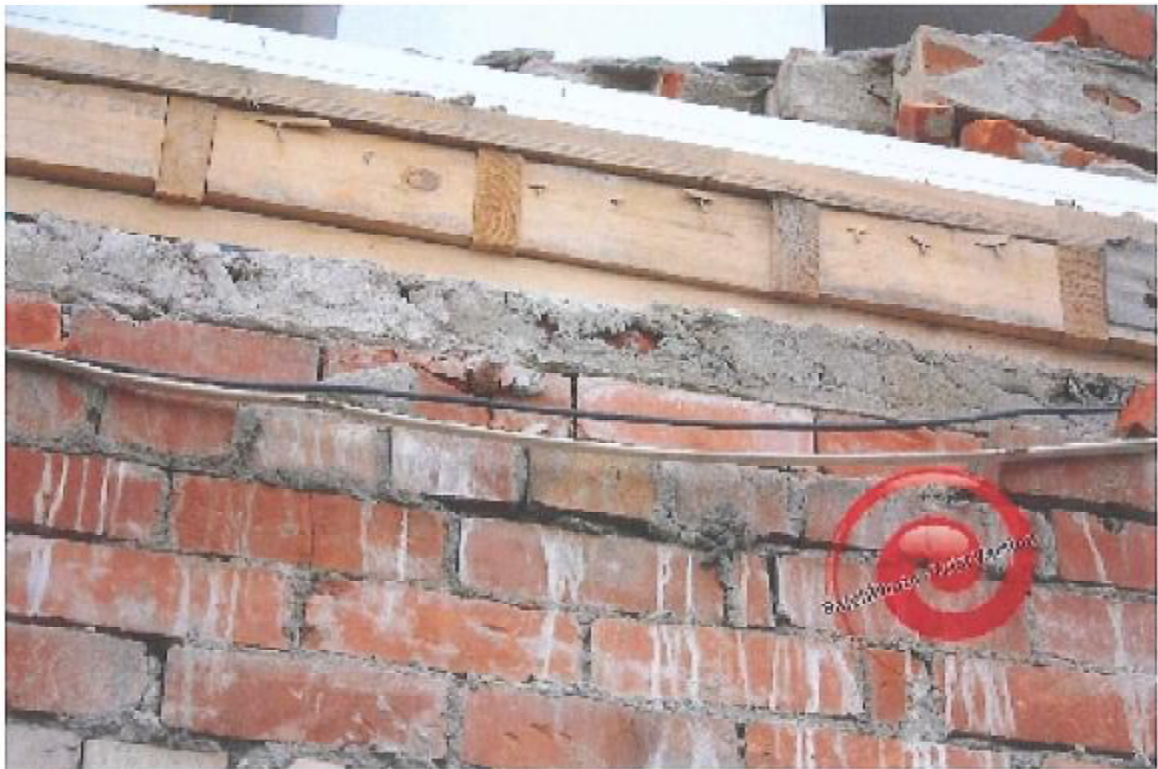
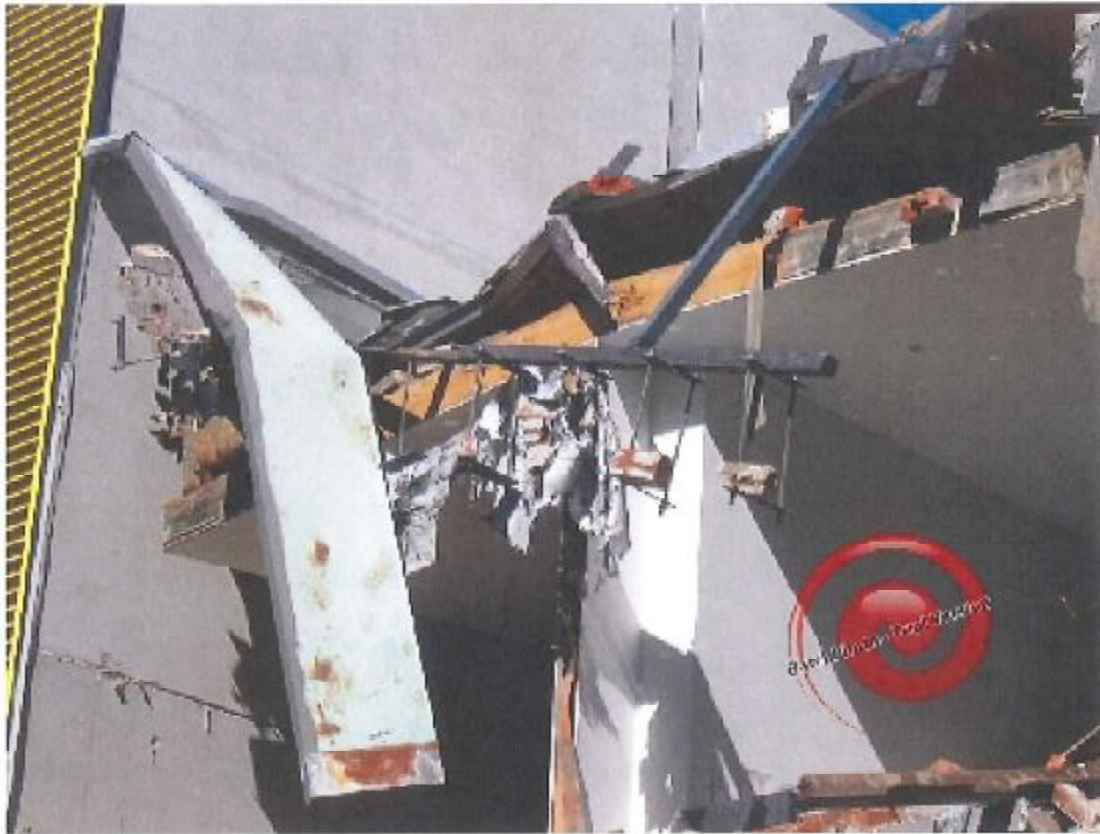
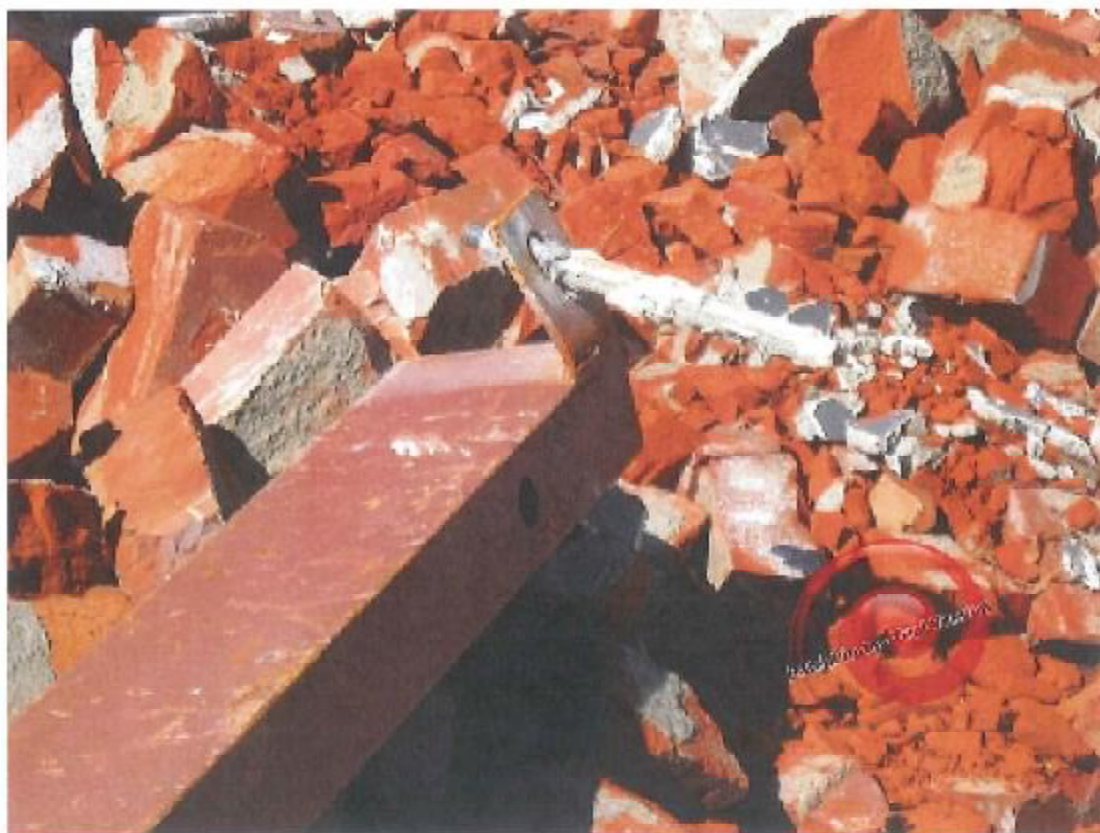
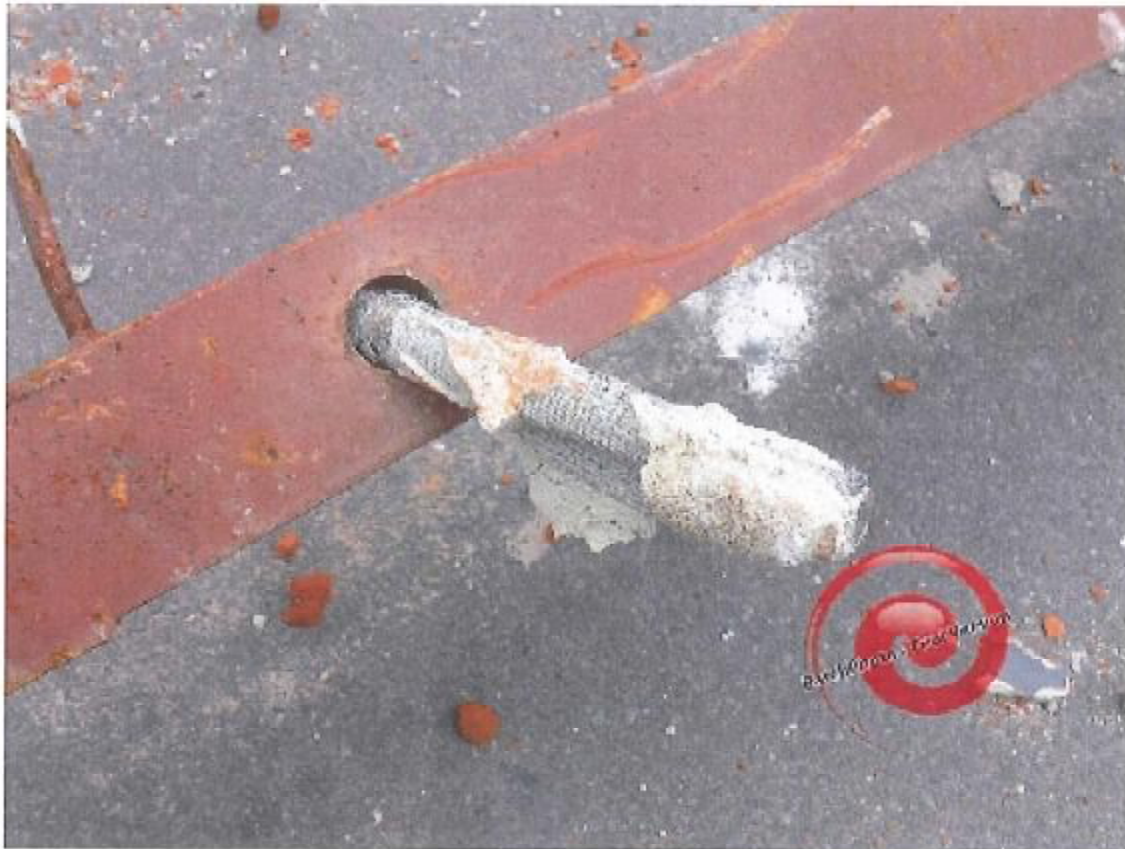
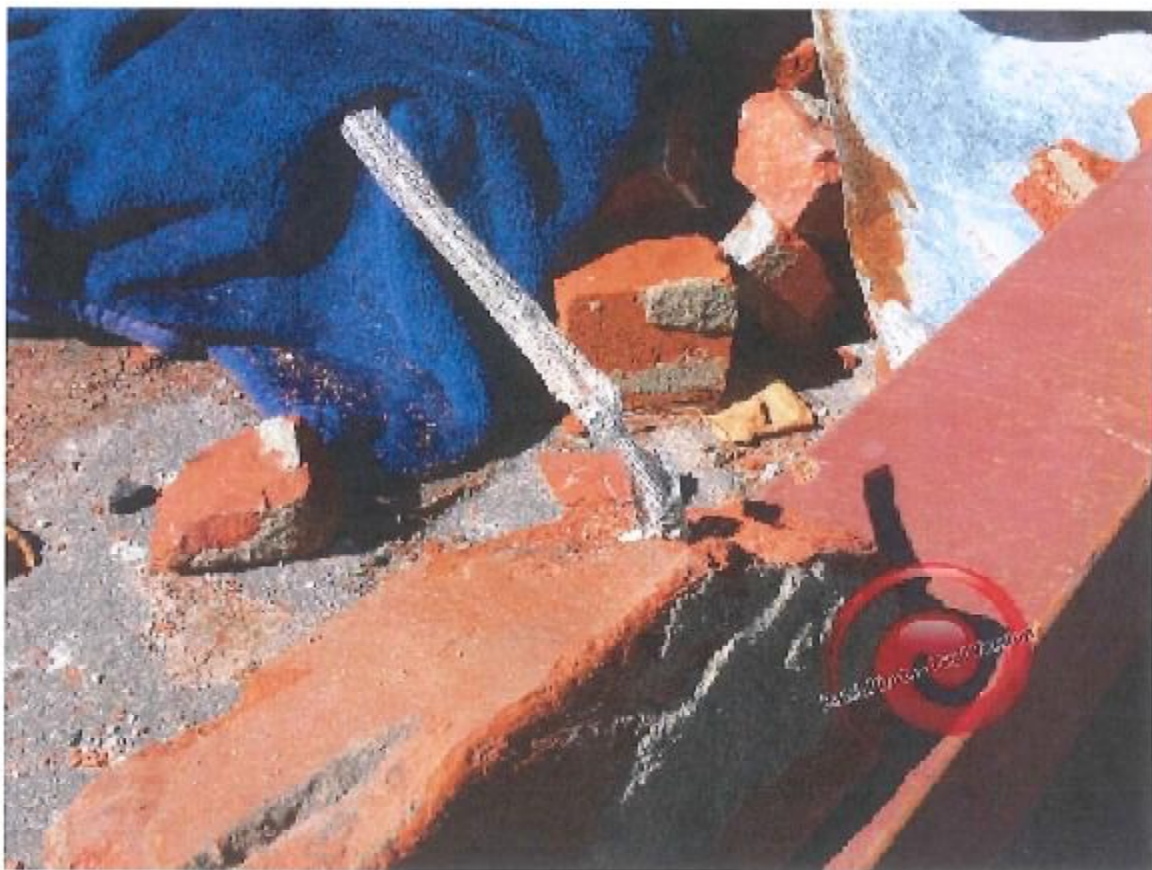
Photos of building after 22 February, 2011 earthquake

- *Collapse of the unreinforced masonry (URM) parapets from the North, West & South elevations.*
- *Collapse of the URM North façade at first floor level including two-thirds of reinforced concrete (RC) roof level bond beam.*
- *Collapse of the East URM parapet and fire wall at first floor level of North façade back to first steel portal frame.*
- *Collapse of southern external URM double skin cavity wall and its east return wall at first floor and outer skin at ground floor.*
- *Collapse of single level URM wall on south side of rear courtyard (area housed a cool room).*
- *Damage to the lightweight roof at north end.*

- *Breaks and damage to first floor URM corner columns in NW & SW corners.*
- *Additional cracking to the plasterwork of all remaining URM columns indicating distress to the brickwork however movement has been limited.*

O'Loughlin Taylor Spence Ltd commented that there was little other damage or distress to the remaining structure (Refer to the photos in Appendix 4).

The photos taken by Dr Jason Ingham clearly show that the epoxy anchored steel dowels were left projecting from the steel members. Noticeably, the steel members were relatively straight and the majority of dowels did not have any masonry attached, but the epoxy surrounding the dowels is clearly evident. (Refer Appendix 4).

The separation of some of the epoxied dowels from the un-reinforced masonry wall appears to have occurred with minimal distress to the steelwork indicating that the fixings either had a low strength or that the wall effectively disintegrated under the severity of shaking.

If the Chemset epoxy was not placed in accordance with the manufacturers installation requirements, workmanship may have contributed to the failure of the north and west walls. Heightened industry awareness of the importance of workmanship and temperature in the use of epoxy fixing systems is required and increased construction monitoring or proof testing for quality assurance of these fixings seems justified.
