**INDEPENDENT ASSESSMENT ON EARTHQUAKE PERFORMANCE
OF
204 Manchester Street
(Iconic Bar)**

**FOR
Royal Commission of Inquiry into building failure
caused by the Canterbury Earthquakes**

**Report prepared by Peter C Smith and Jonathan W Devine
OF
Spencer Holmes Ltd**

December 2011

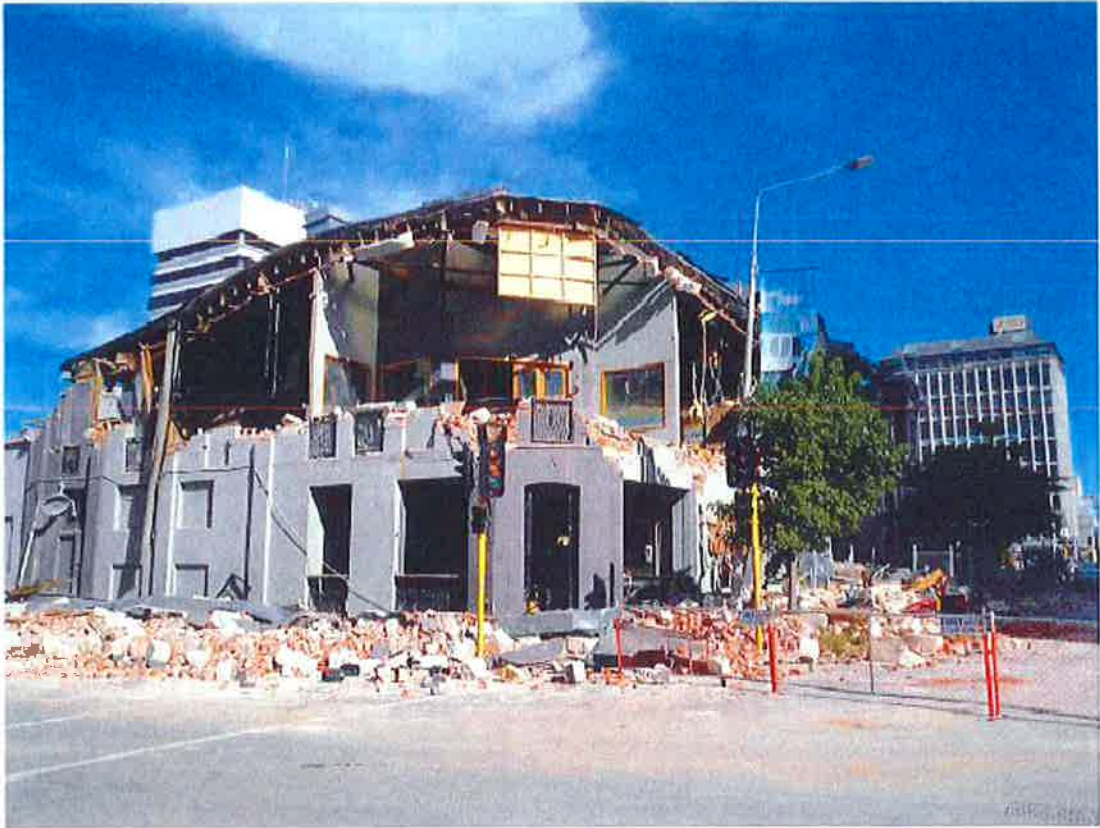
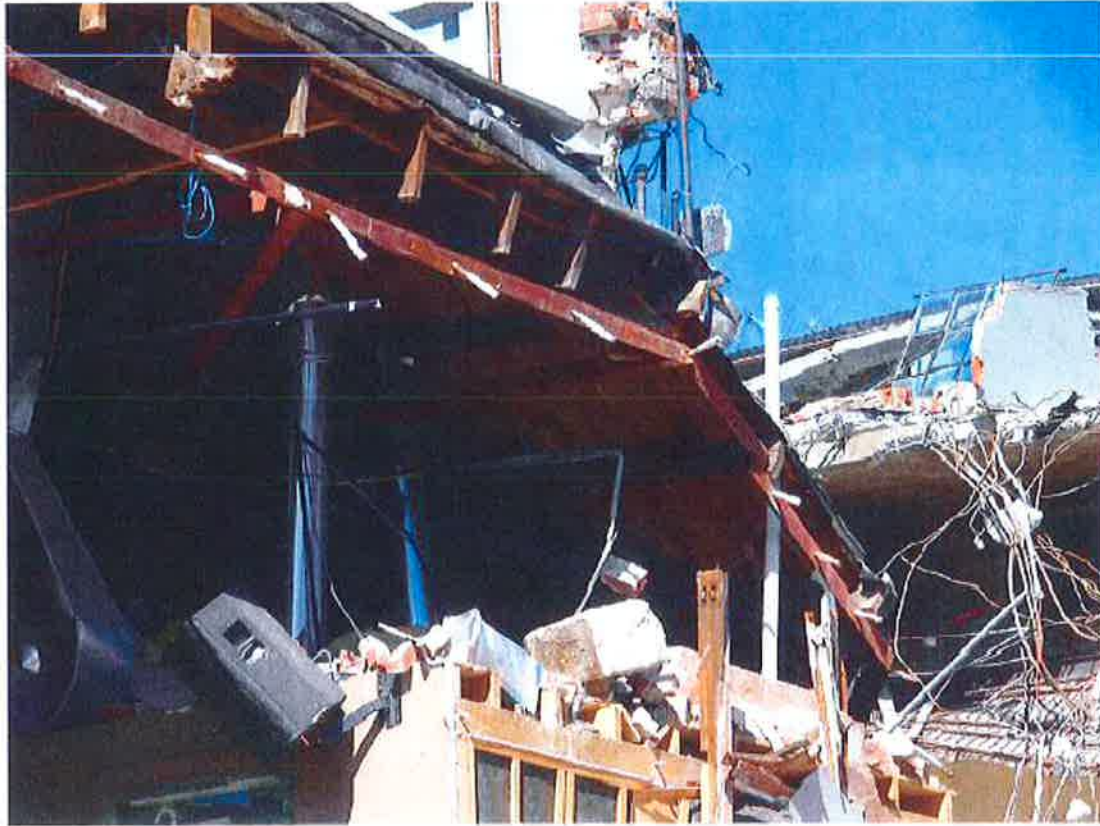
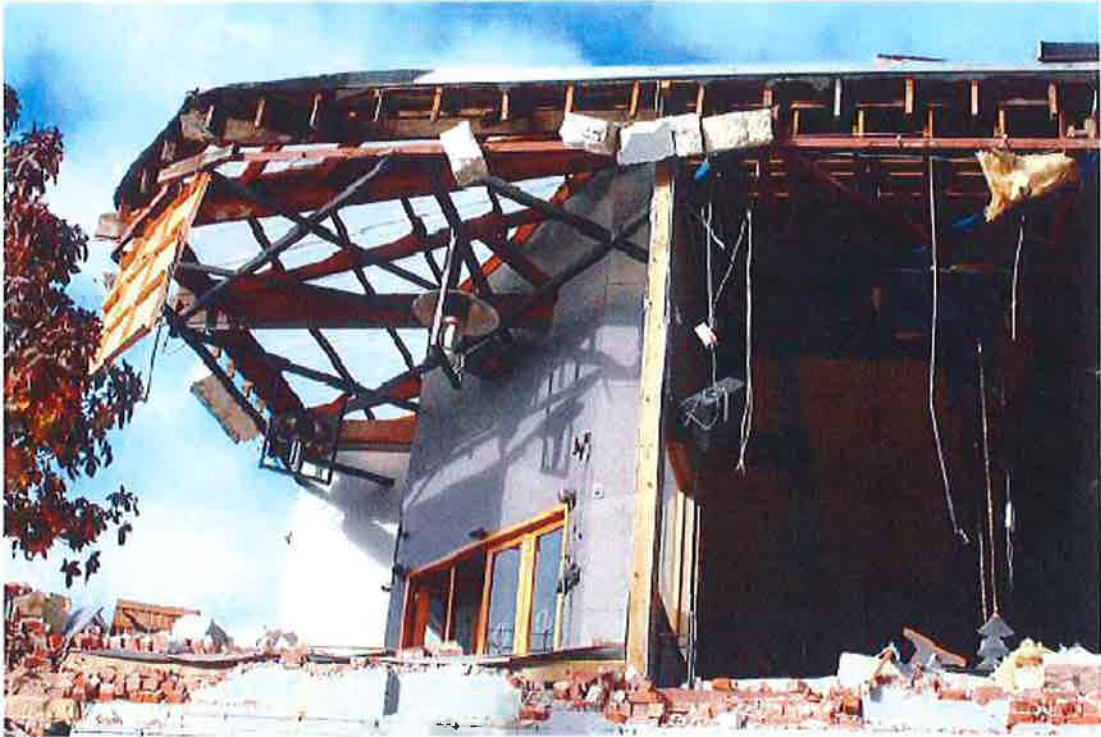
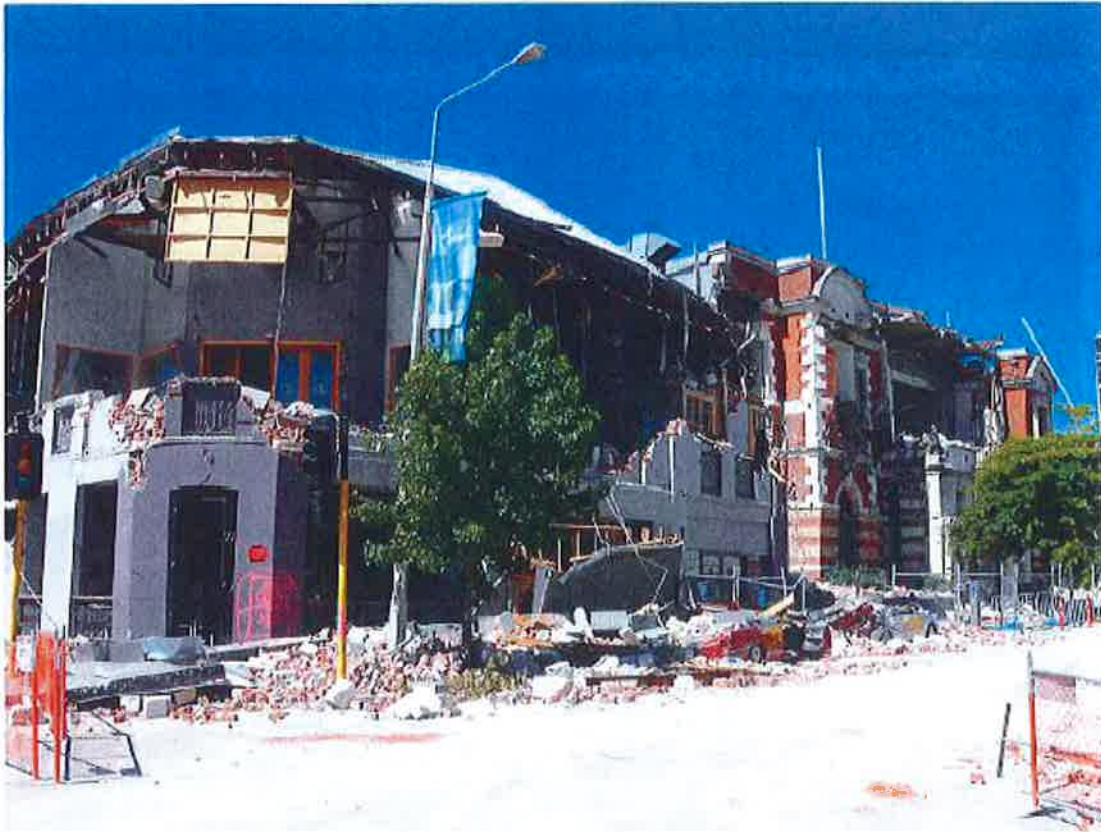
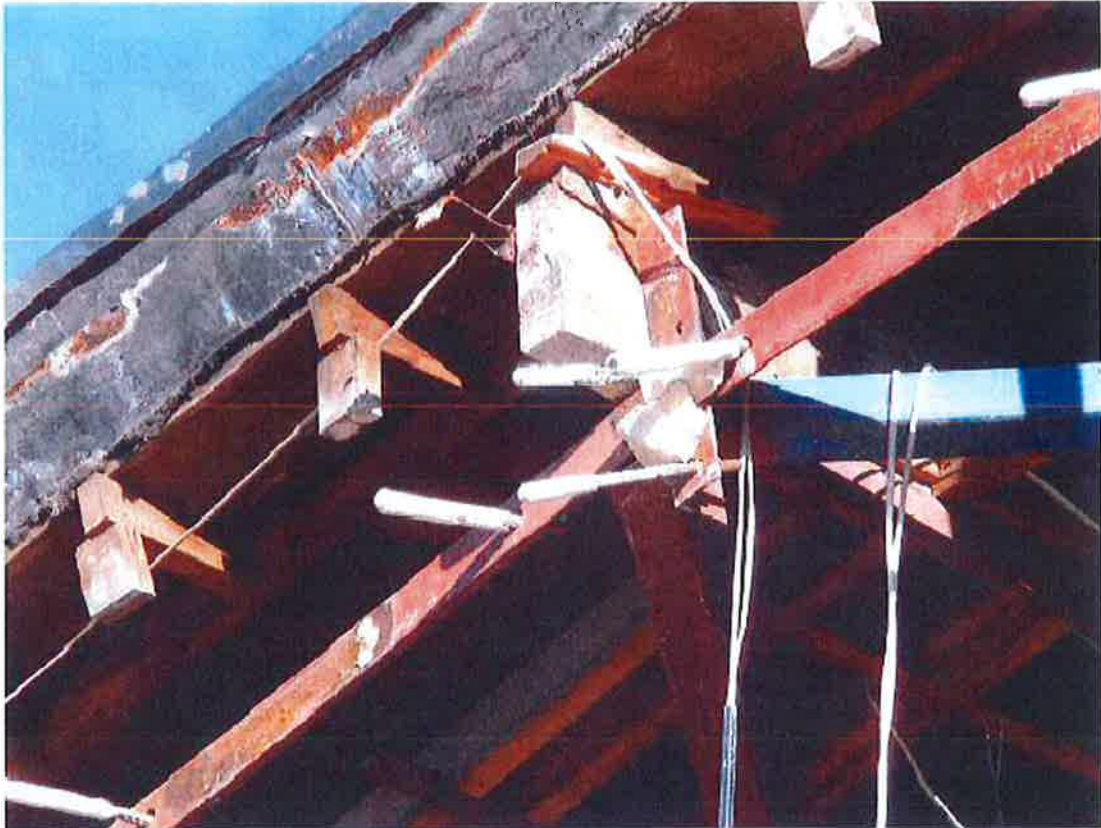
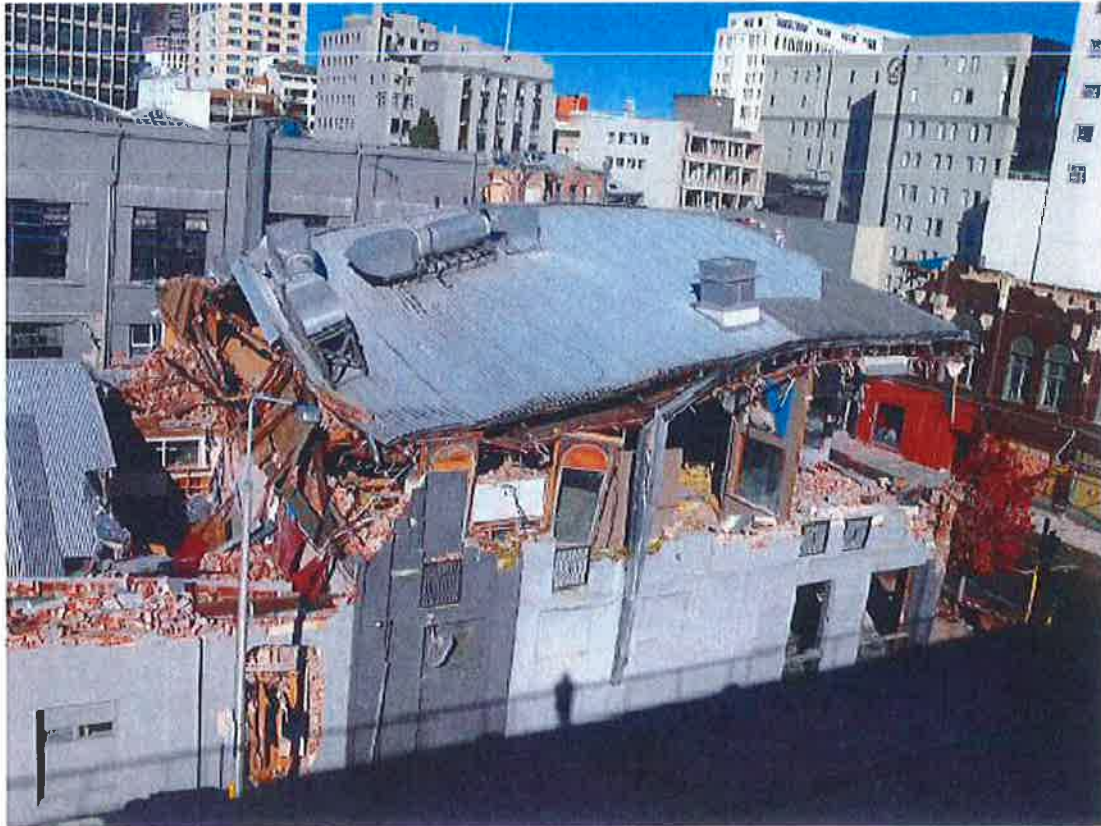
Photos Taken for 22nd February, 2011 Earthquake

The external walls above first floor level to the Manchester Street (West) and Gloucester Street (North) facades fell outward under the severity of shaking that occurred during the 22nd February, 2011 earthquake. It is unclear from the photos of the extent of damage to or failure of the east wall. The north, and west walls appear to have disintegrated under the severity of shaking leaving the epoxy fixings projecting from the steelwork at roof level. This failure mechanism varies from that of the section of south wall alongside the ladies toilet which appears to have slipped off its supports largely intact. The east wall appears to have collapsed through the roof of the single storey building.

The 100 x 100 x 6 MS angle spanning between the trusses or the horizontal 100 x 100 RHS bracing around the perimeter of the roof space was insufficiently stiff to develop the tensile strength of the anchors. A progressive failure of the anchors, commencing at the connection of the chords of the bracing elements and migrating towards the centre span of the angles would be expected under face loading of the wall. Examination of the photos taken after the 22nd February, 2011 earthquake indicates that this mode of failure was evident along the south wall. The mode of failure does not appear evident to the north or west walls. Significantly, the steel angle to the north and west walls is still relatively straight with the connecting bolts left exposed in the angle.

From the photographic evidence available it would appear that the north and west walls (apart from the section of wall by the ladies toilet) essentially disintegrated under the severity of shaking on the 22nd February, 2011, leaving the fixings exposed in the angle without the distortion of the angle.

The photos in the Police Operation Earthquake records clearly show that the dowels that connected the perimeter 100x100x6 MSL along the Manchester Street and Gloucester Street frontages to the brick façade were left projecting from the 100x100x6 MSL. Noticeably, the steel angle is relatively straight and the majority of dowels do not have any masonry attached, but the epoxy surrounding the dowels is clearly evident.

Note: Several dowels closest to the corner of the building do have masonry attached. (Refer photos Appendix 4)

The separation of the epoxied dowels from the un-reinforced masonry wall appears to have occurred with minimal distress to the 100x100x6 MSL at roof level indicating that the fixings either had a low strength or that the wall effectively disintegrated under the severity of shaking. Unfortunately the Police photos were taken after the debris from the failed wall had been removed, so that the integrity of the failed wall, and therefore the failure mechanism cannot be reliably established. It is appropriate to record that the axial load in the upper floor un-reinforced masonry walls is relatively low and that these walls are more susceptible to vertical acceleration effects under out of plane failure.

Heightened industry awareness of the importance of workmanship and temperature in the use of epoxy fixing systems is suggested and increased construction monitoring or proof testing for quality assurance of these fixings seems justified.
