**INDEPENDENT ASSESSMENT ON EARTHQUAKE PERFORMANCE
OF
116 Lichfield Street**

**FOR
Royal Commission of Inquiry into building failure
caused by the Canterbury Earthquakes**

**Report prepared by Peter C Smith and Jonathan W Devine of
Spencer Holmes Ltd**

December 2011

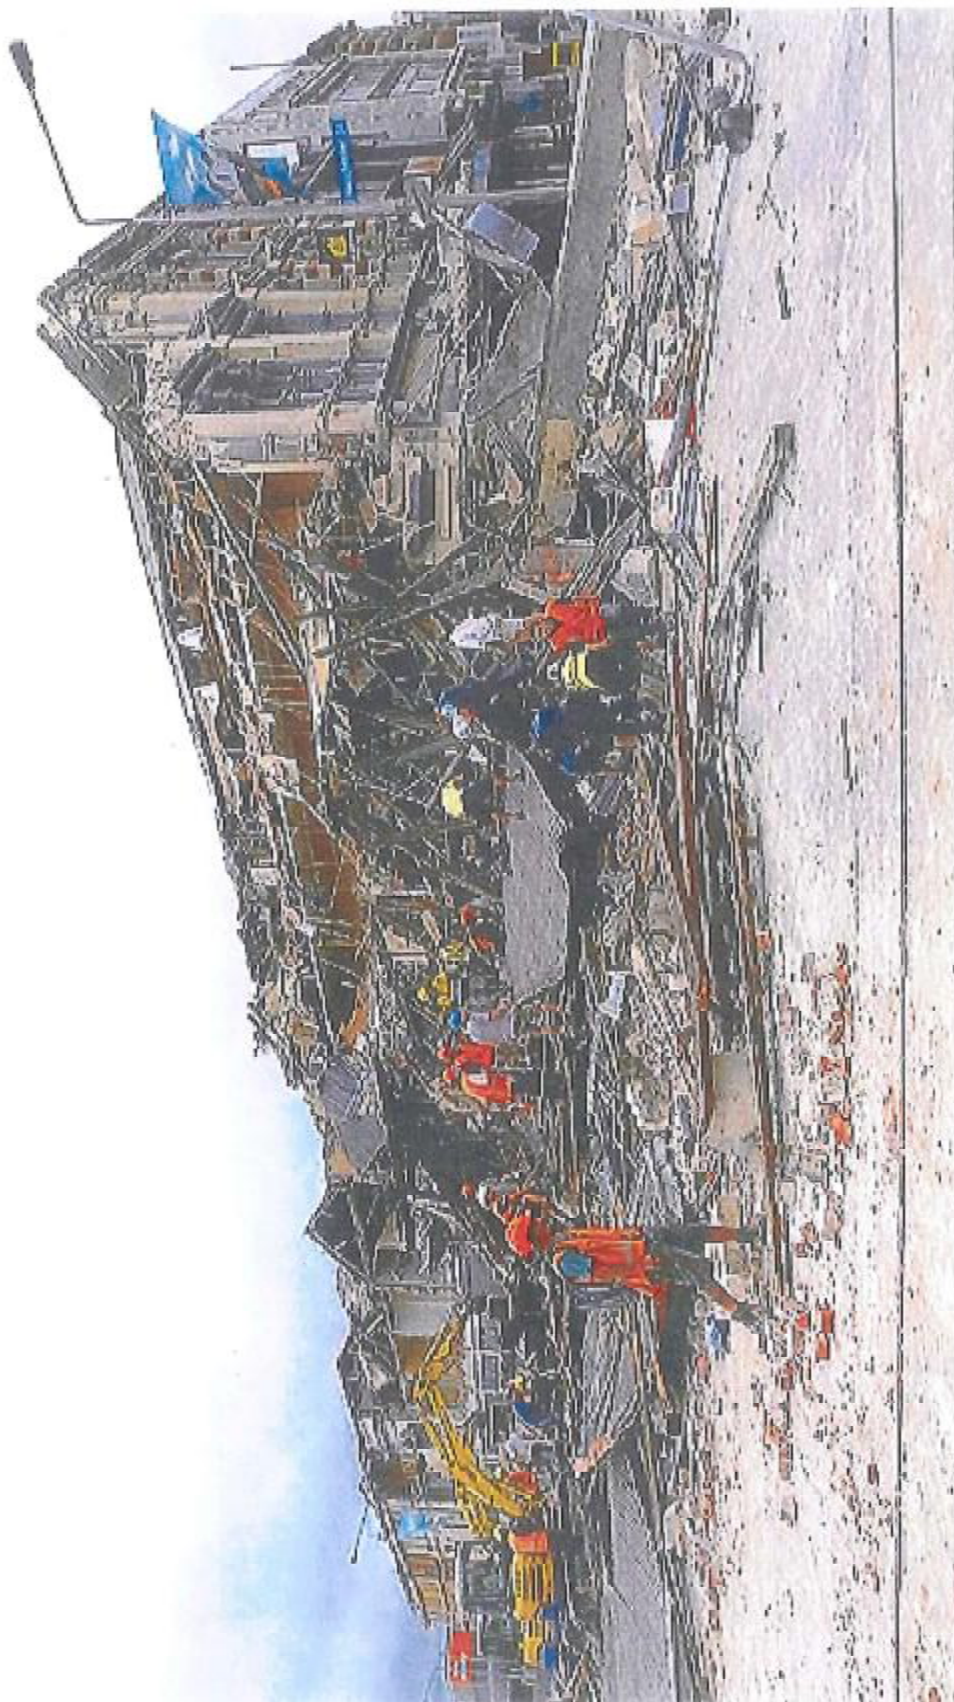
Photo 116-0018-016: The building shown with a view

The photos taken after the earthquake indicated that the building failed through an outward collapse of the Manchester Street façade due to inadequate restraint at the level of each elevated floor and the roof. (Refer photos Appendix 3). It is likely that the collapse was progressive.
