**INDEPENDENT ASSESSMENT ON EARTHQUAKE PERFORMANCE
OF
91 Cashel Street**

**FOR
Royal Commission of Inquiry into building failure
caused by the Canterbury Earthquakes**

**Report prepared by Peter C Smith and Jonathan W Devine of
Spencer Holmes Ltd**

December 2011

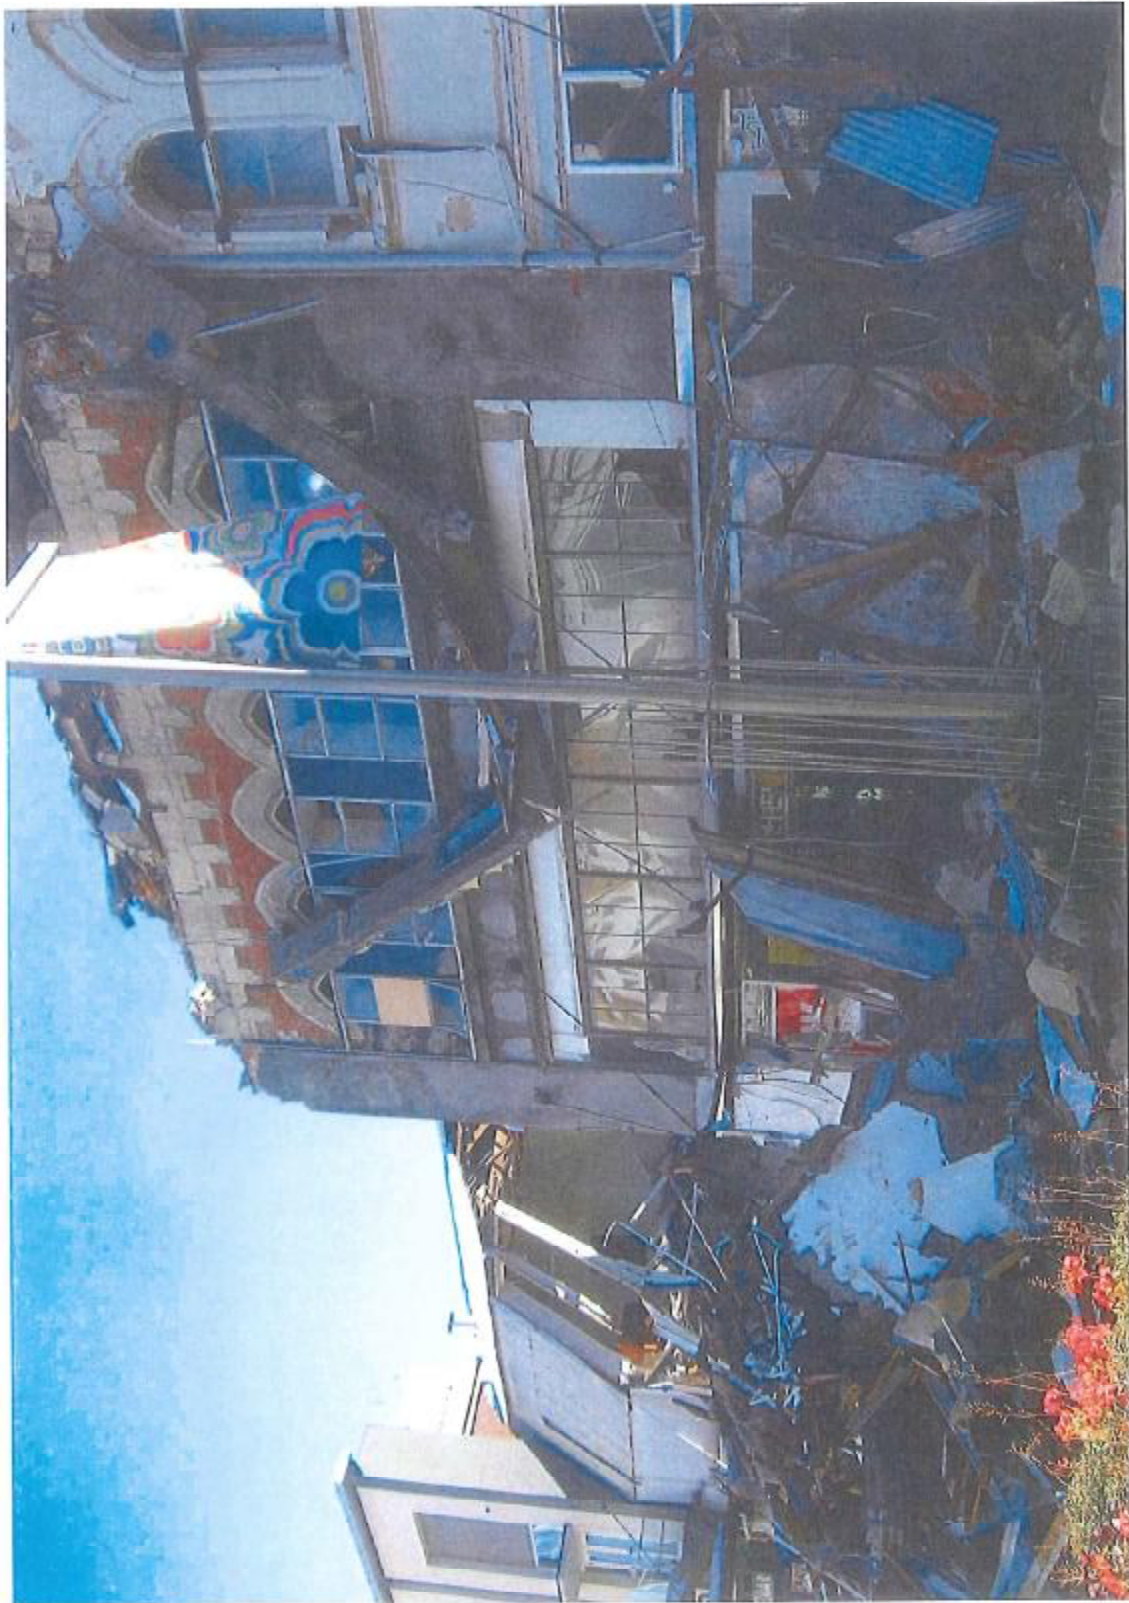
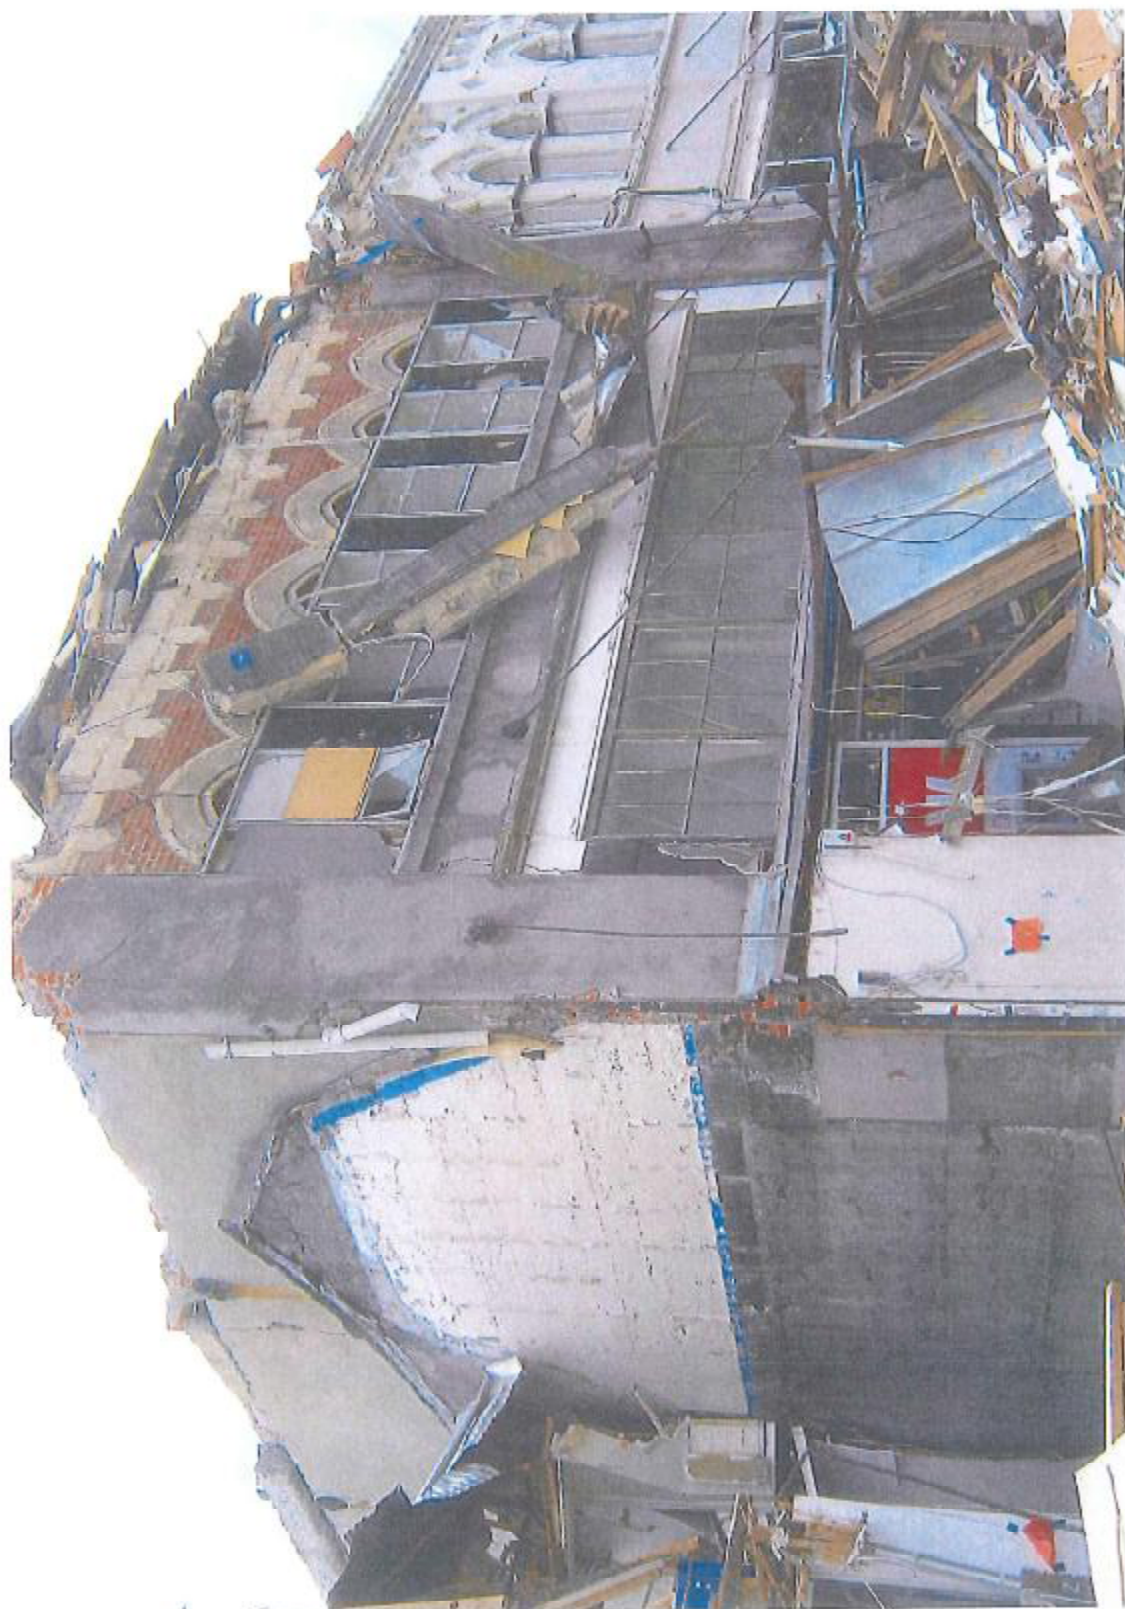
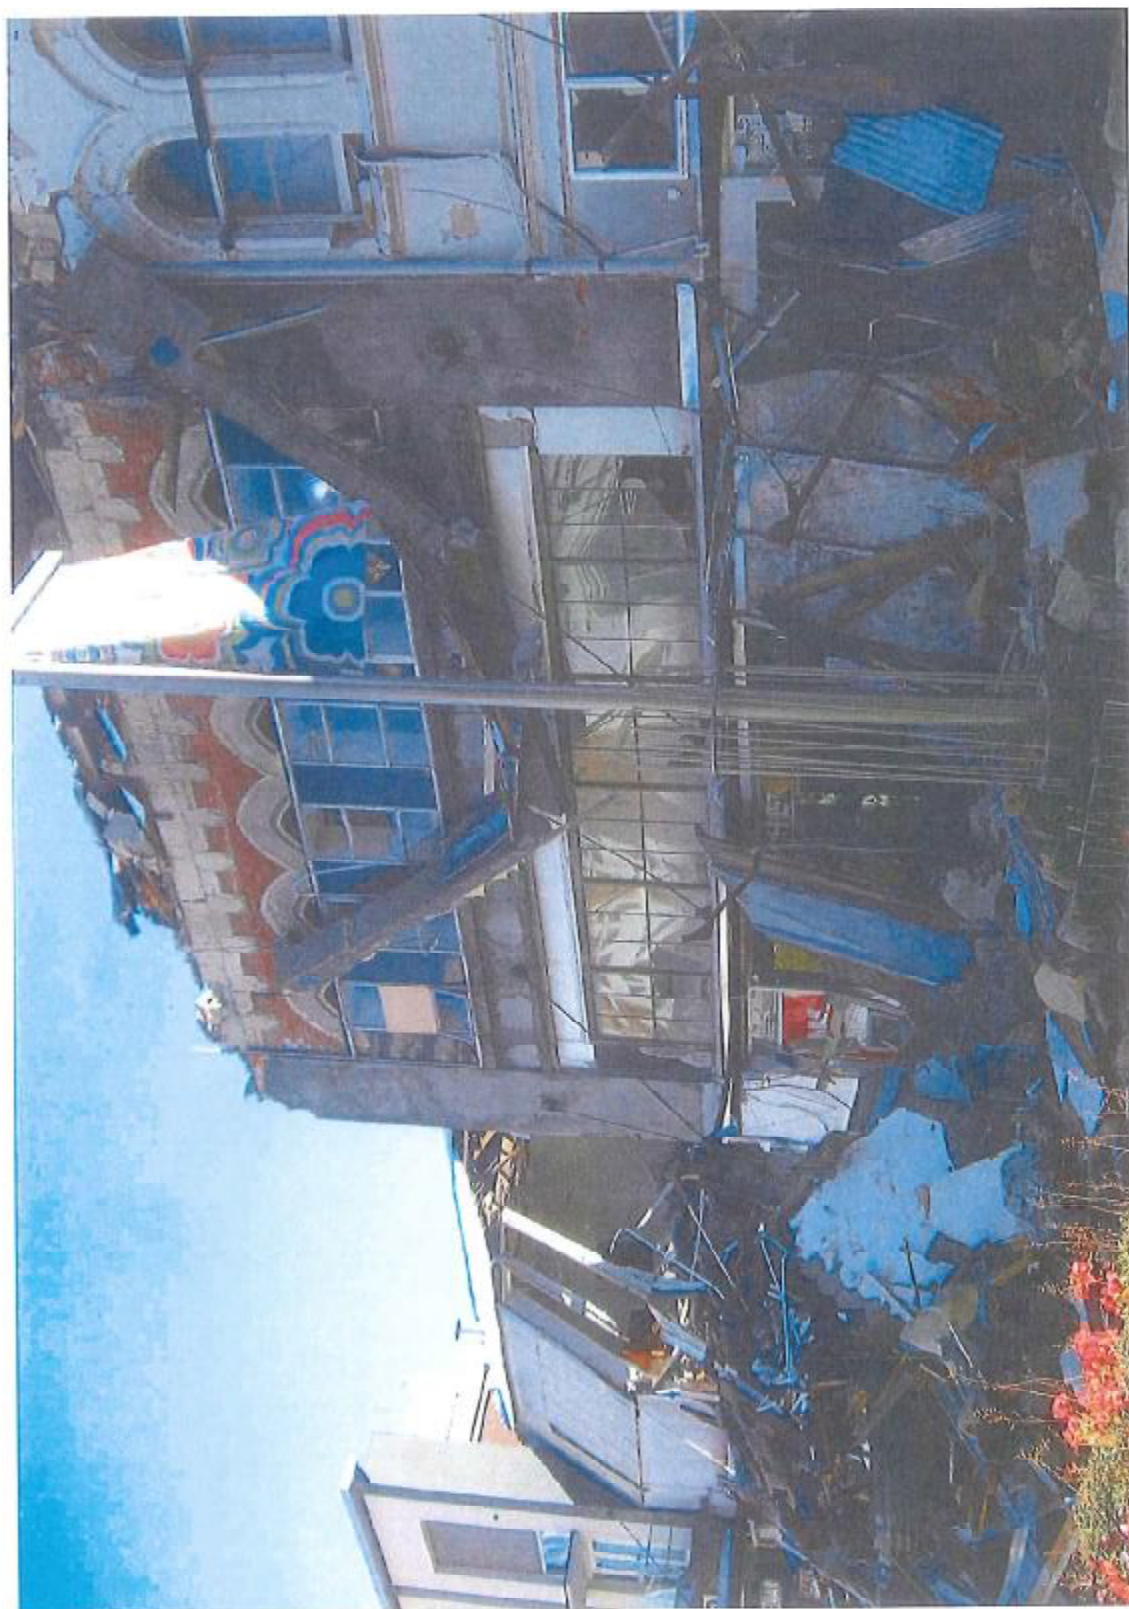
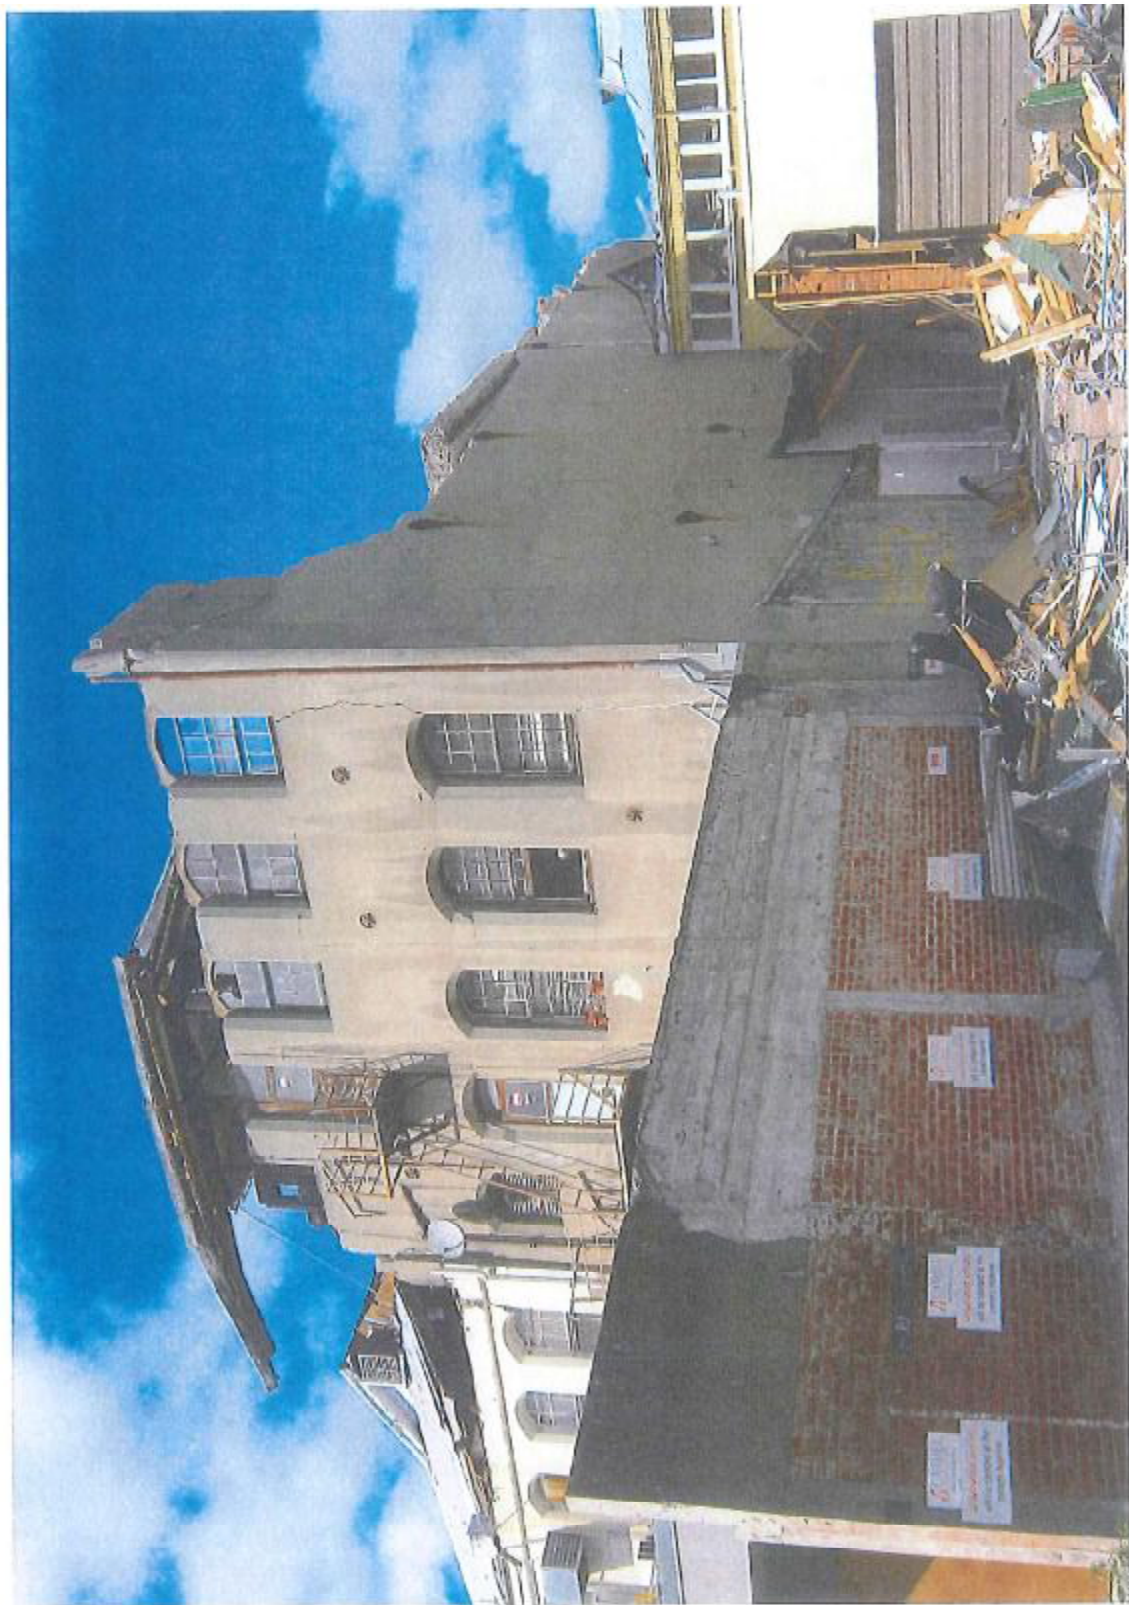
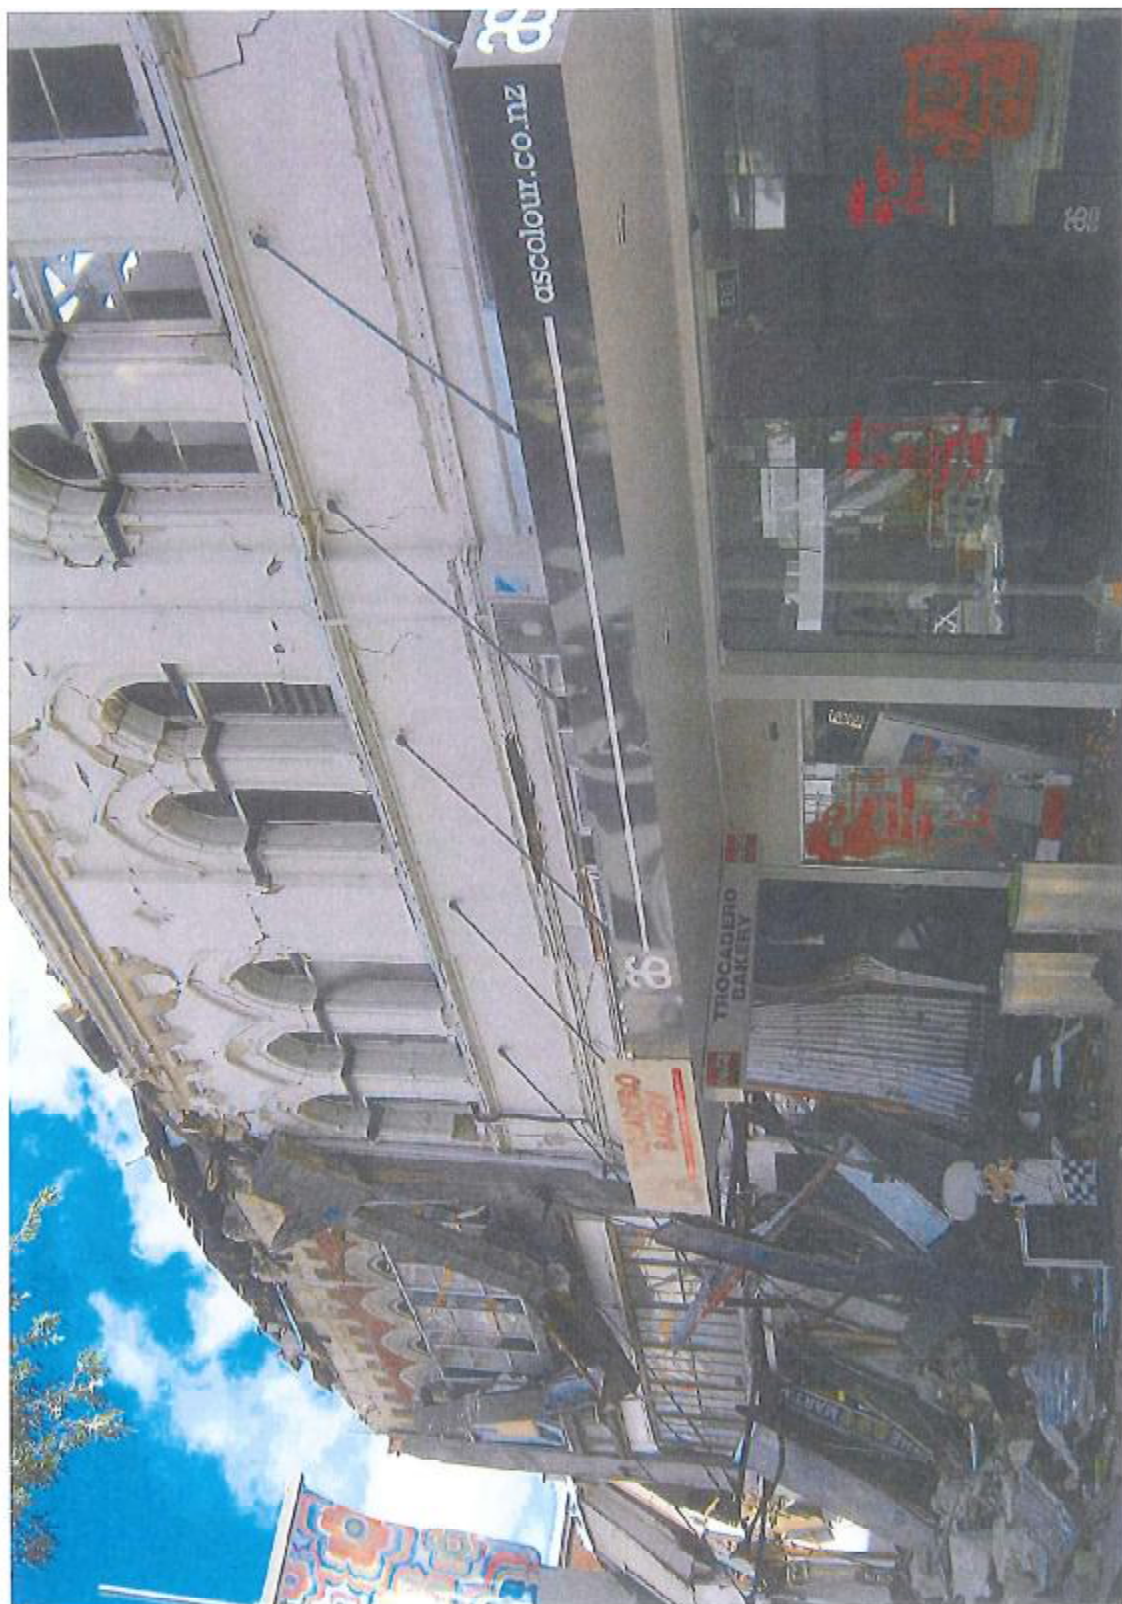
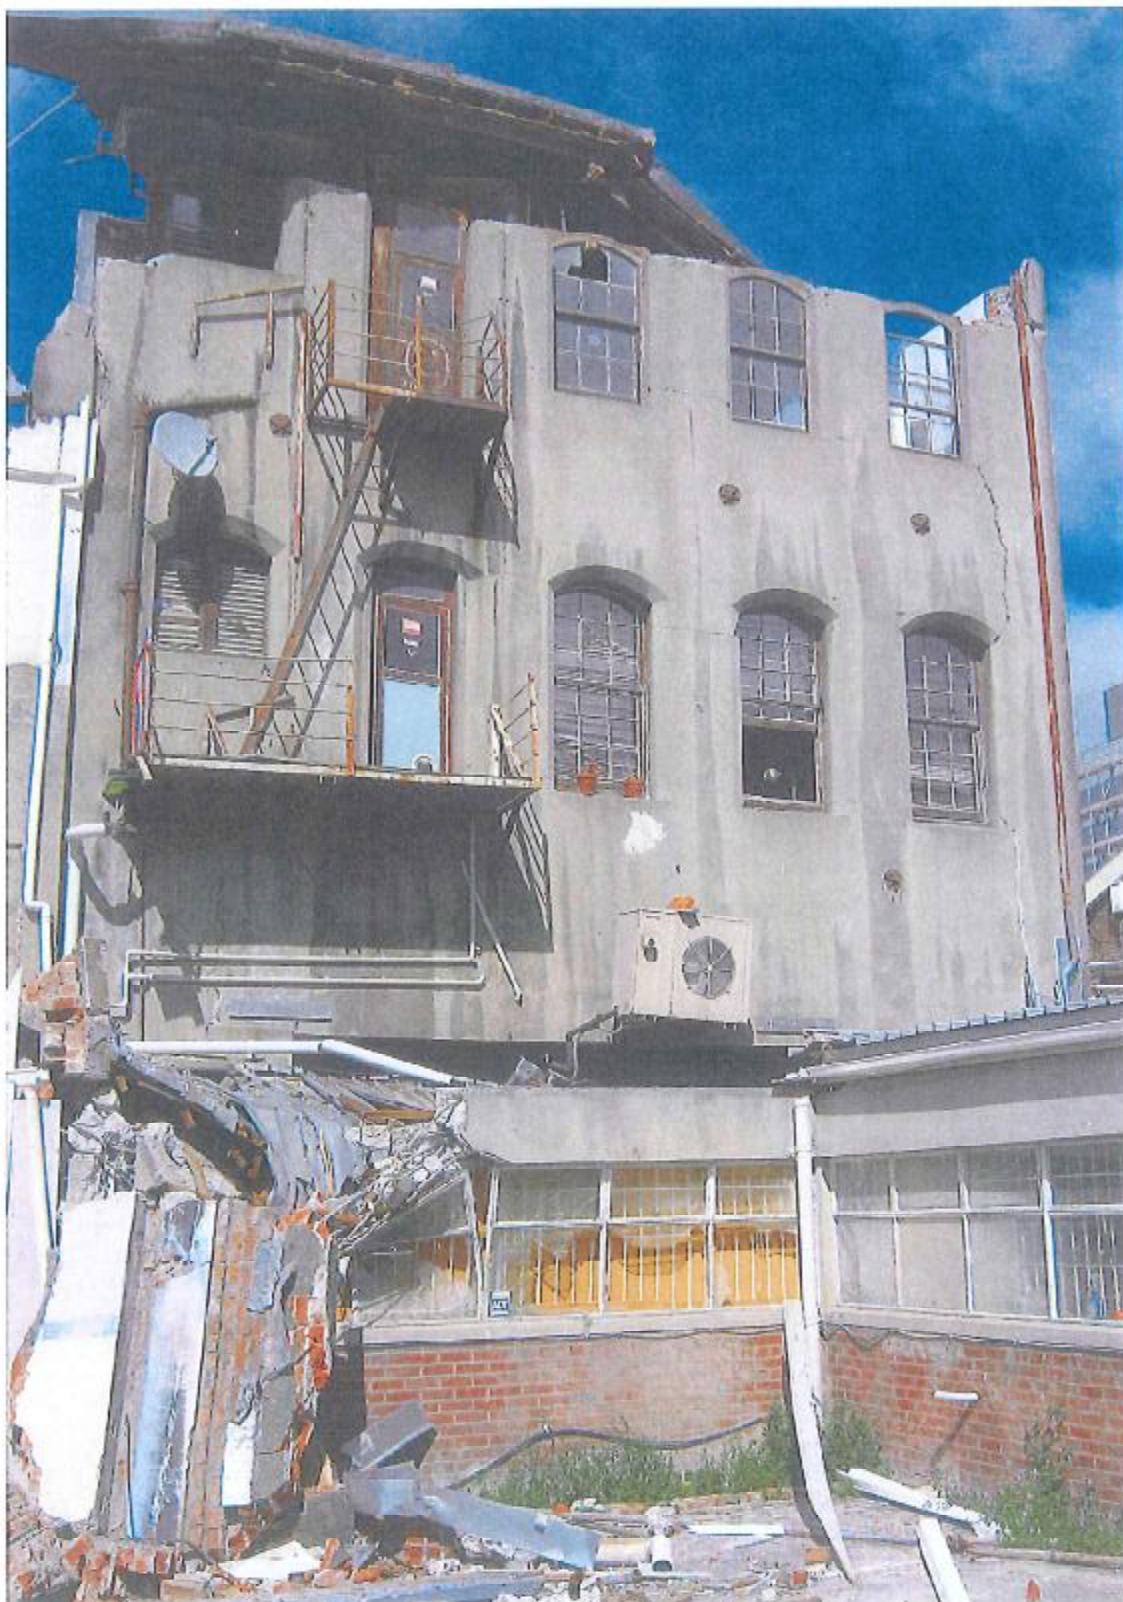
Photographic record of damage following 22nd February 2011 earthquake

The building was significantly damaged in the 22nd February, 2011 earthquake. The top level walls on the east, west and south facades and the parapet of the north face all collapsing. The eastern wall collapsed onto No. 93-95 Cashel Street. The western wall collapsed out No. 89 Cashel Street and the south wall largely onto Cashel Street.

The upper level walls of the building at 91 Cashel Street became disconnected from the roof structure and collapsed primarily outwards with masonry elements falling onto the buildings to either side and onto Cashel Street. The east and west walls above third floor level rotated outwards and landed on the adjoining buildings at 93 – 95 Cashel Street and 89 Cashel Street

respectively. The south wall (Cashel Street façade) failed above second floor level and collapsed into Cashel Street. The north wall façade appears to have failed above the window head at level 3.
