Christchurch City Council

BUILDING CONDITION REPORT SEPTEMBER 2009

32 Cathedral Square –
URGENT REMEDIAL WORKS

DAMAGE SURVEY - 16-09-10

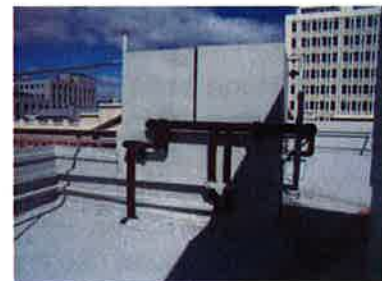
There are a series of concrete water towers (which show on the original drawings) above the toilets. These appear in fair condition with aging plumbing.

Original Water Towers

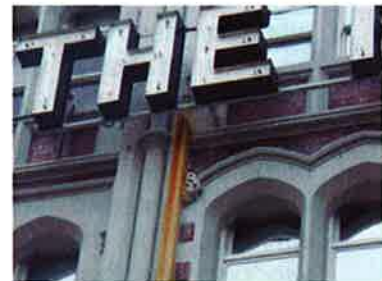
There are a three locations where there are bad rust stains streaking down the façade. At first these appear to be coming from behind the large 'The Press' sign. However closer inspection suggests that they are caused by some previous steel fixings that are now badly rusting. The rusting steel needs to be cut back from the surface, and sealed with a rustproof coating.

Rusting connections behind 'The Press' Sign

- *Investigate the 'best case scenario' of removing the paint work, reinstating and repairing the original stone façade*
- *In the meantime, ensure the ongoing repainting programme is maintained*
- *Investigate and repair the cause of visible rust staining by removing and plugging the offending metal fixings*
- *Remove any redundant surface fixings and seal the original fabric*
- *Repair damaged brick work with repointing and brick replacement as necessary*

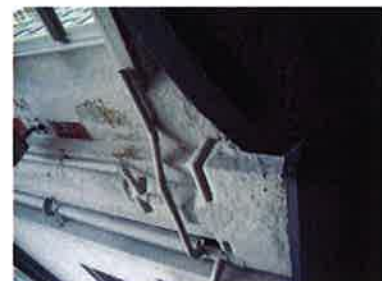
Other less obvious elements are fixed to the façade most of which have been painted. All penetrations into the original material need to either be removed if redundant, or maintained to ensure they do not allow moisture into the original fabric.

Painted modern penetrations

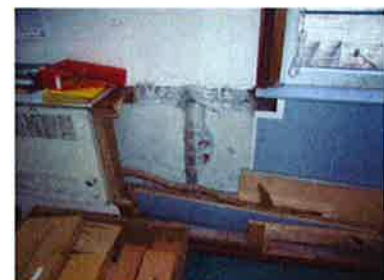
There were only two areas of visible minor damage to the original internal fabric, one in the Northern stair, and one on the first floor Eastern wall where a section of wall linings had been removed.

Damaged to Internal Wall showing original brickwork

- *Rustproof and paint any exposed metal surfaces*
- *Repair any damaged fabric and protect identified original fabric*

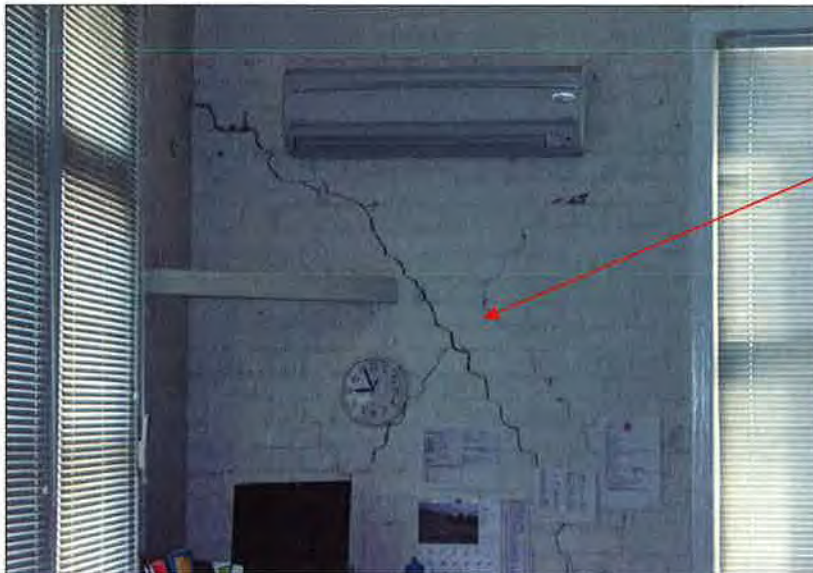
Damage:

Diagonal shear cracking to the internal exposed brickwork.

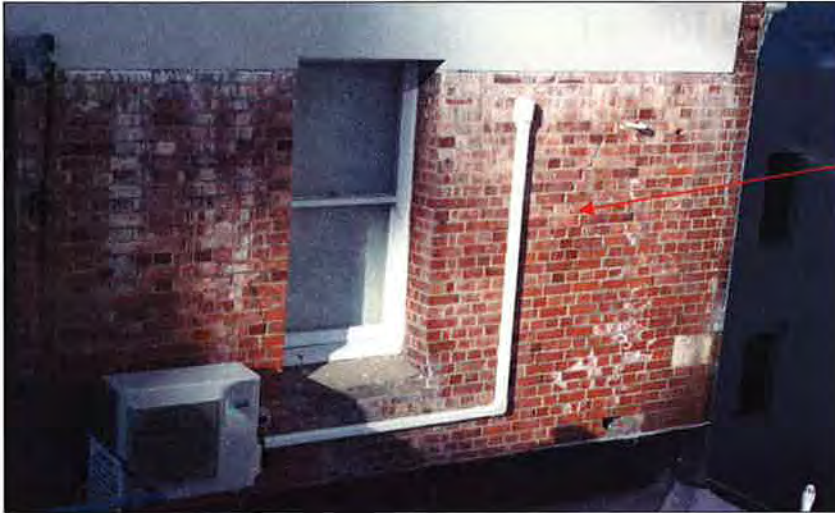
Damage:

Diagonal shear cracking to the external exposed brickwork.

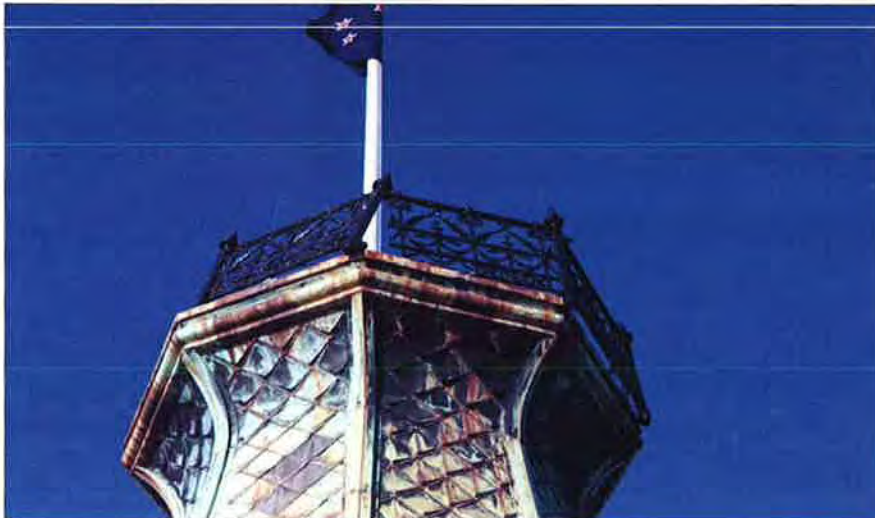
Damage:

Dislodgement of the iron railing. Note footings are hanging over edge of turret.

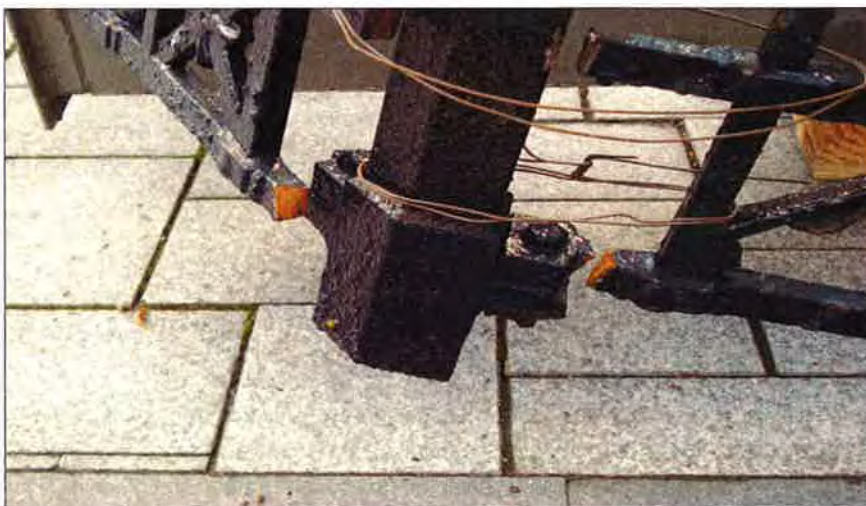
Damage:

Sheared section of the Iron railing.

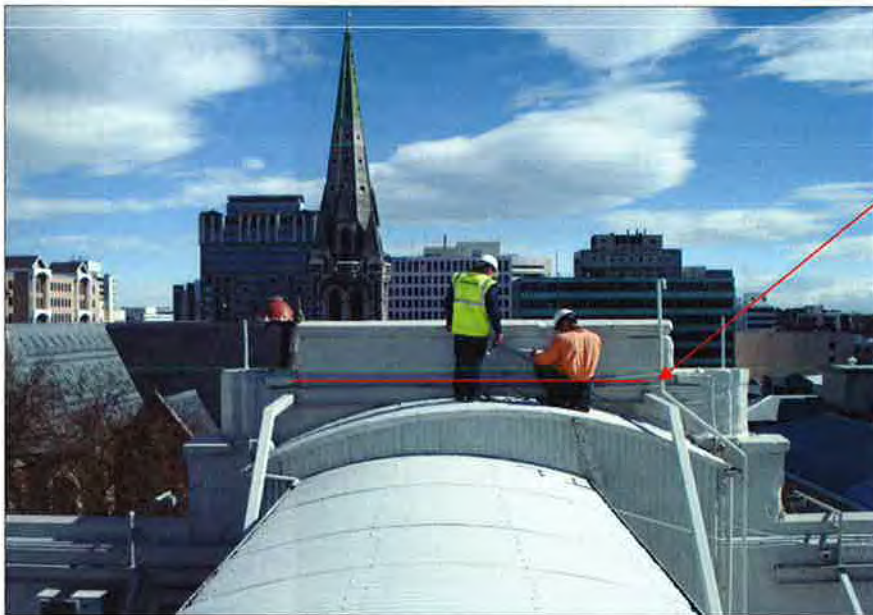
Damage:

Horizontal cracking to the top segment of the stone parapet wall.
