THE PRESS HERITAGE BUILDING

STRUCTURAL DAMAGE REPORT FOLLOWING 4/9/10 EARTHQUAKE

October 2010

Project N°: 110117

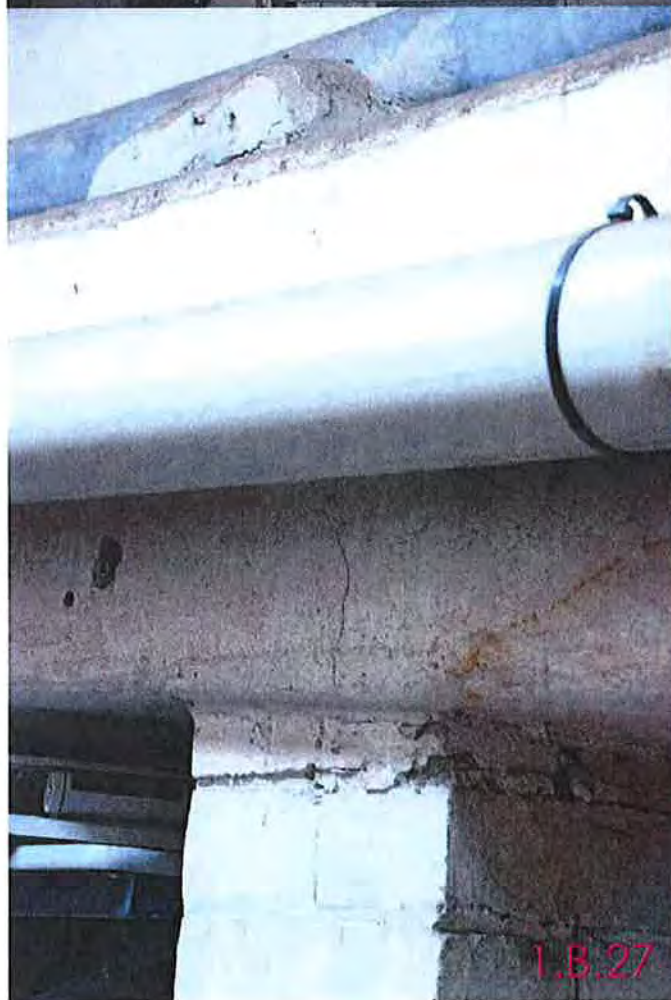
1.B.27

- B10** Historic vertical cracking in two locations to eastern concrete wall and brick column appears to have widened/lengthened with earthquake [1.B.27 to 1.B.33] **(Repair C1/B4)**

Repair C1

Significant cracking to existing concrete element. Carefully clean out existing crack and remove loose debris. Epoxy inject crack in strict accordance with Sika (or similar approved) specification and details. All epoxy grouting to be by approved contractors only. Repaint to match existing if required.

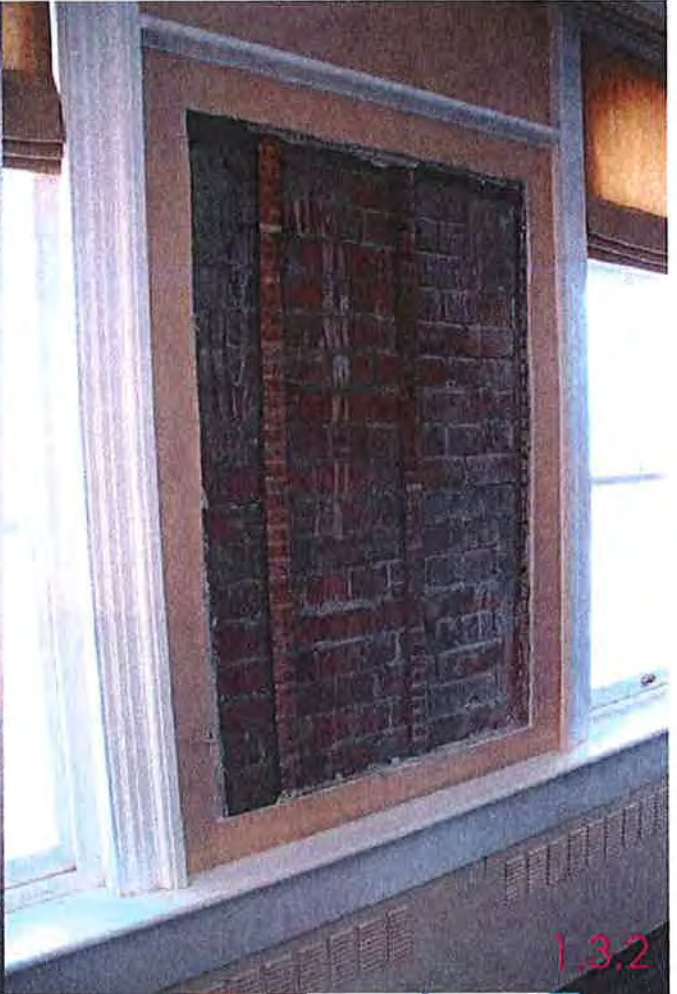
1.3.2

- T3 Cracked linings to southern wall [1.3.1] **(Repair A)**
- T9 Portion of wall lining removed for further structural investigation. No structural damage observed to brickwork. Refer Appendix E for stonework damage [1.3.2] **(Repair A)**

Superficial repair work required, non-structural elements.

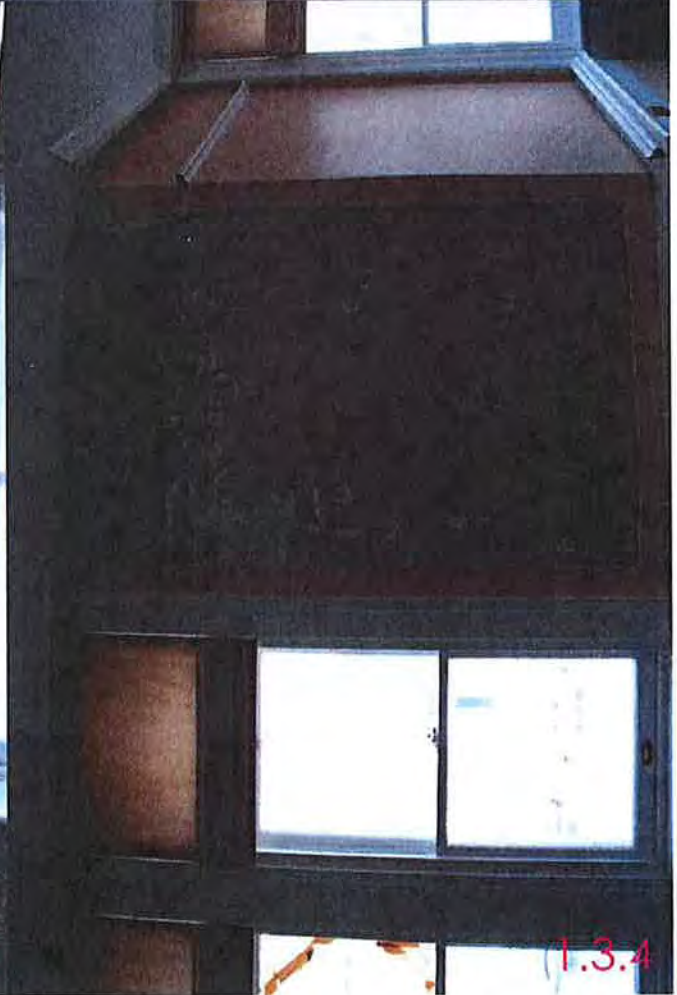
1.3.4

- T11 Portion of wall lining removed for further structural investigation. Cracking observed to upper section of wall. [1.3.4 & 1.3.5] **(Repair B3)**
- T14 Cracking to linings over brick wall at door lintel location through to T16 [1.3.6] **(Repair A)**

Repair B3

Cracking to existing brickwall element. Carefully clean out crack surface and remove all loose debris. Locally rake out existing mortar either side of crack for full brick width into wall on both sides of wall. Remove all loose bricks. Remortar all exposed joints and replace loose bricks. Point all new mortar surfaces to both sides of wall. All brickwork and repairwork to be completed by experienced bricklayer.

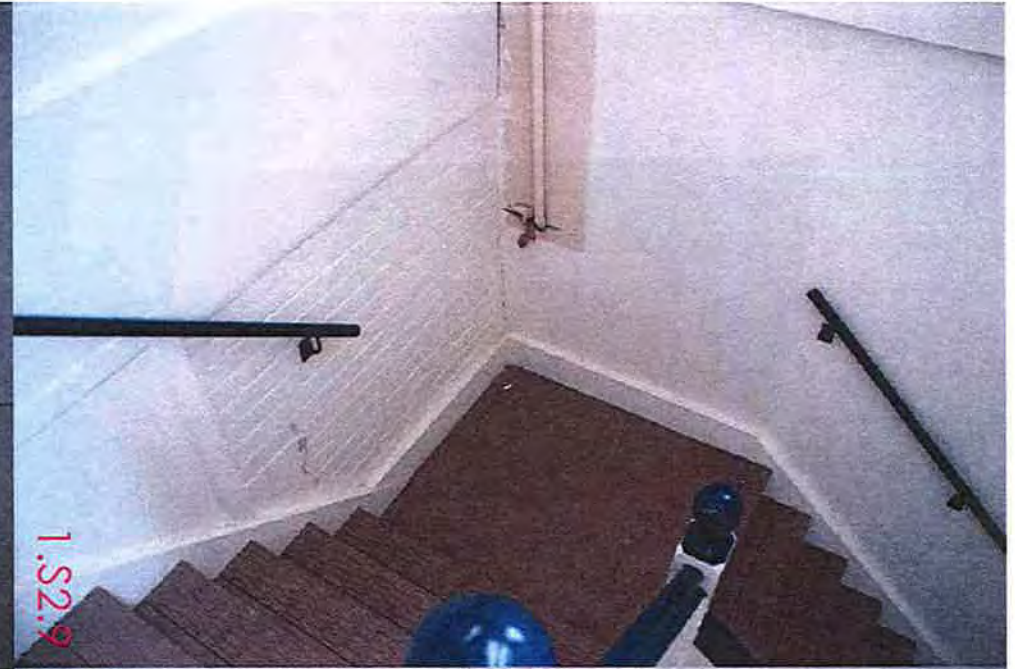
1.S2.9

North-western corner photos from top to bottom [1.S2.9 to 1.S2.17] **(Repair A)**

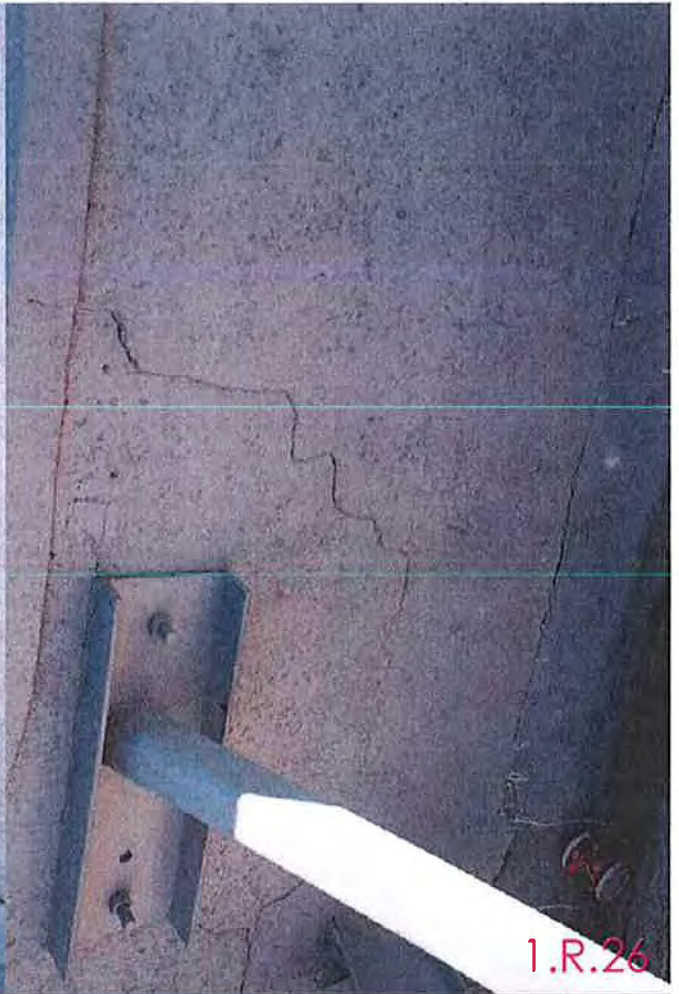
1.R.26

Horizontal cracking to joint in tanking membrane [1.R.16 & 1.R.17] **(Repair T1)**
 Membrane cracking to parapet [1.R.18] **(Repair T1)**
 Existing membrane cracking [1.R.19 & 1.R.20]
(Repair T1 – though not caused by earthquake)
 Membrane cracking to parapet [1.R.21] **(Repair T1)**
 Cracking to brickwork parapet and membrane [1.R.22] **(Repair T1 & B3)**
 Cracking to brickwork parapet and membrane [1.R.23] **(Repair T1 & B3)**
 Horizontal cracking to joint in tanking membrane approximately 10m long [1.R.24]
(Repair T1)
 Membrane cracking to parapet [1.R.25] **(Repair T1)**
 Membrane and wall cracking around corner steelwork [1.R.26 & 1.R.27]
(Repair T1 & B3)
 Membrane cracking to parapet [1.R.28] **(Repair T1)**
 Horizontal and vertical membrane cracking to parapet [1.R.29 & 1.R.30] **(Repair T1)**
 Cracking to stonework/brickwork parapet and membrane [1.R.31] **(Repair T1 & B3 & S2)**
 Vertical cracking to membrane at junction with R8 [1.R.32] **(Repair T1)**

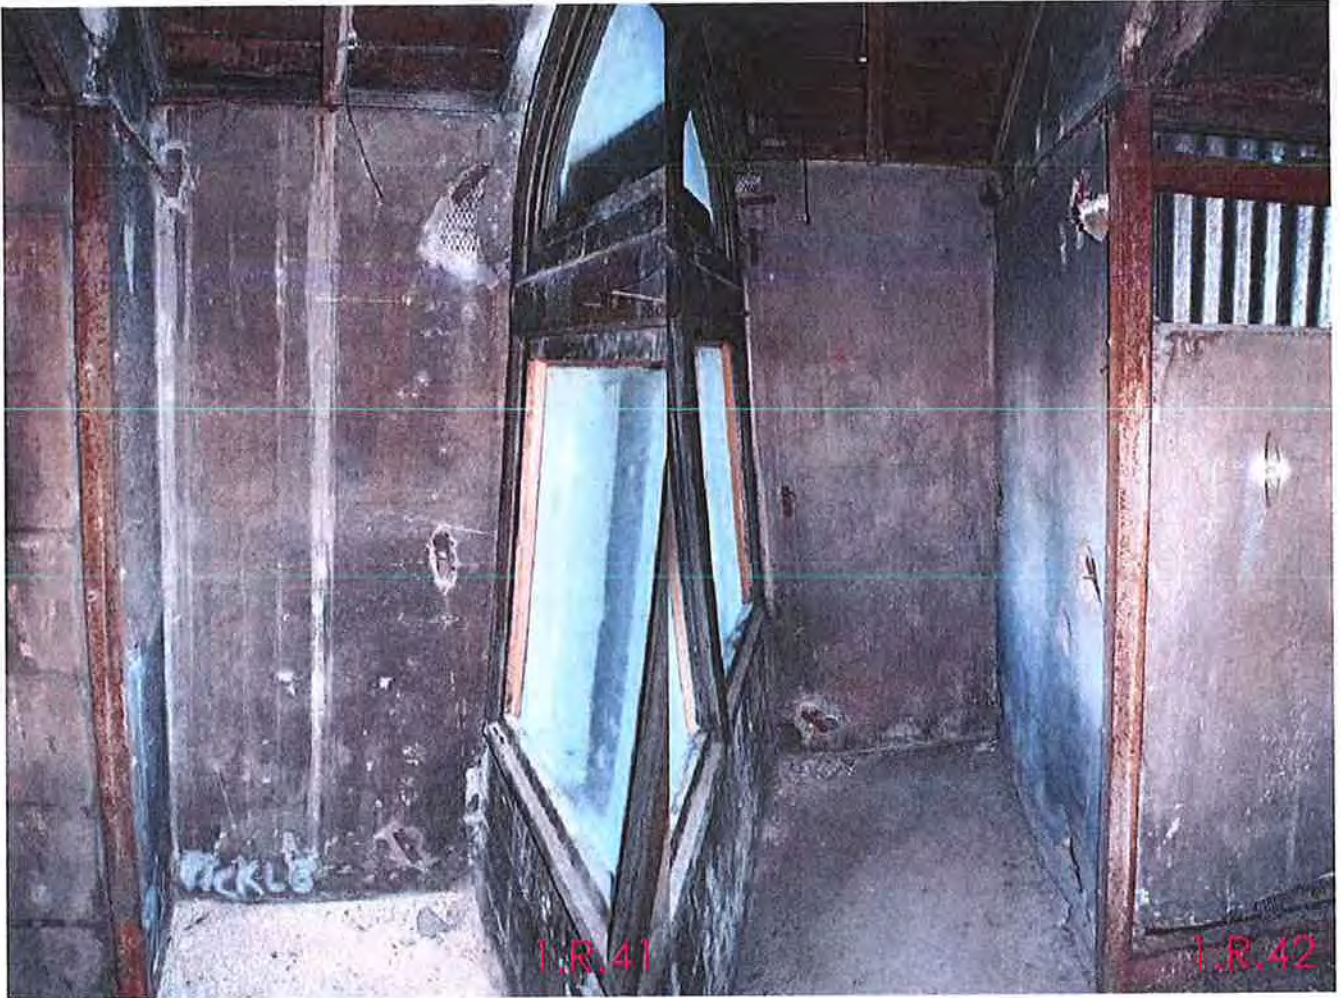
I.R.40

Membrane cracking to parapet [1.R.33] **(Repair T1)**
 Cracking above steelwork [1.R.34] **(Repair T1)**
- R6 Extensive cracking to capping stones [1.R.35, 1.R.36, 1.R.37, 1.R.38 & 1.R.39]
(Repair S1 & S2)
 Emergency remedial steelwork to support parapet [1.R.40]
 Plasterwork damaged [1.R.41 & 1.R.42] **(Repair A)**
