THE PRESS BUILDING  
32 CATHEDRAL SQUARE  
CHRISTCHURCH

## Damage Report, JANUARY 2011

Project Title The Christchurch Press Complex  BUILDING ONE  Cathedral Square Christchurch	Drawing Title EXISTING BASEMENT FLOOR PLAN  Scale Scale 1:200 @ A3	Issue <b>SKETCH</b> Date C.A.D file Project No.	Sheet No. <b>SK 1.0</b> Rev
---	--	---	-----------------------------------

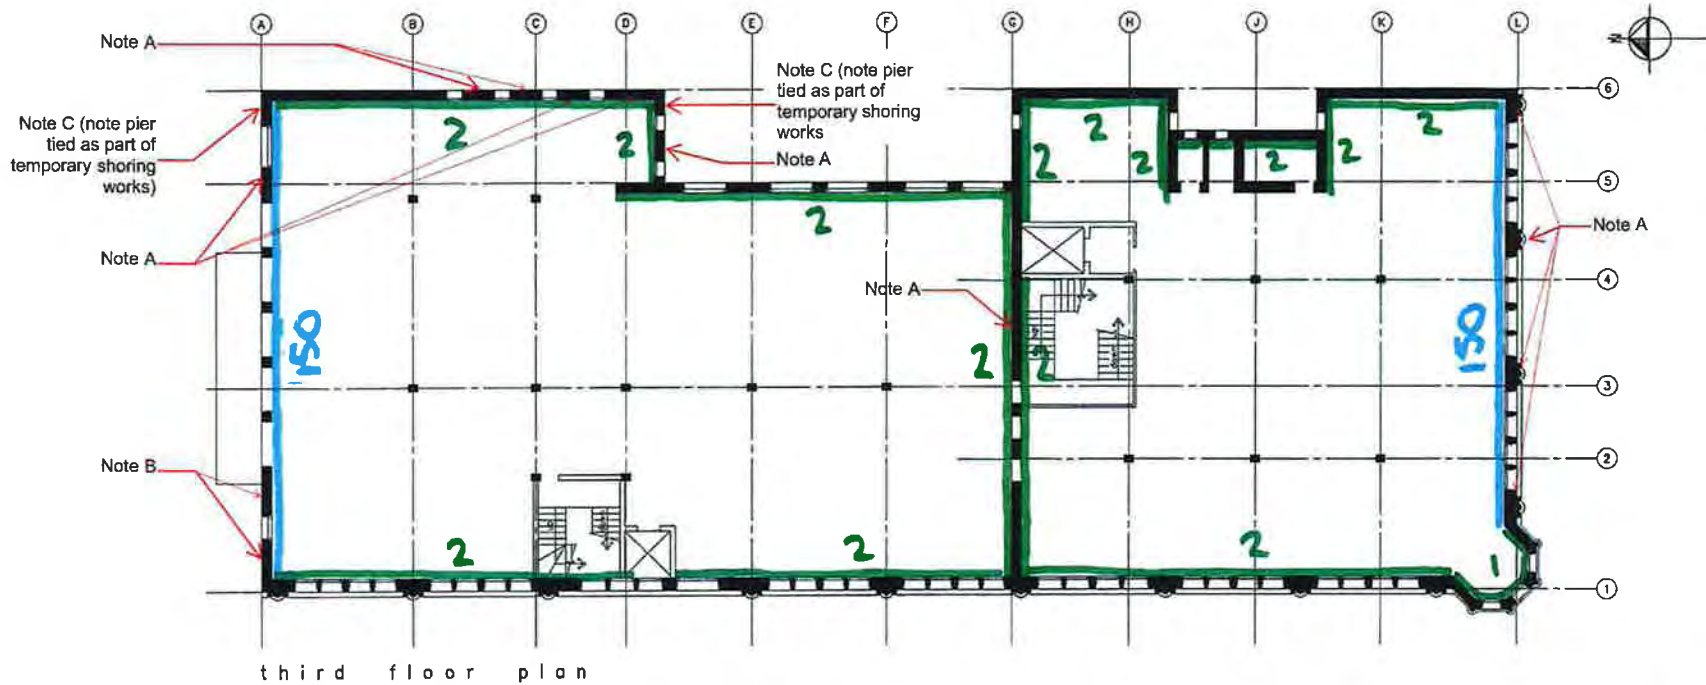
SIKAWRAP  
100G or TYFO  
SEH-51  
**2 # LAYERS**  
**SHOTCRETE**  
**150 THICKNESS**  
Allow 125 kg/m3 reinforcement with additional D12-600, ew L-bar anchors to be drilled and epoxied to the existing masonry wall.  
**PARAPET BRACING**  
**POSSIBLE BRACING ADDED.**

**B** Existing damaged brick piers to be demolished and rebuilt prior to strengthening. Prop adjacent roof area to floor below while completing demolition and rebuild.

**C** Grout cracks in pier in accordance with specification

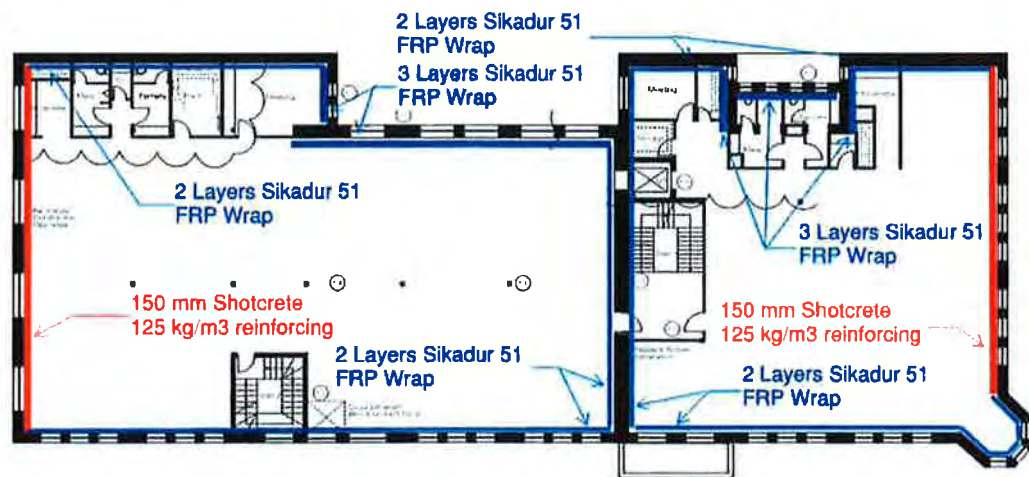
### Typical Plan view of Strengthening Solution

An illustration of the strengthening solution for a typical floor is illustrated below.

It is recommended that the proposed remedial works and strengthening methodology for the existing building be adopted. Providing these recommendations are completed the analysis work described herein indicates that the building will have sufficient capacity to meet 67% of the current design level earthquake, as defined by NZS 1170.5 for the site.

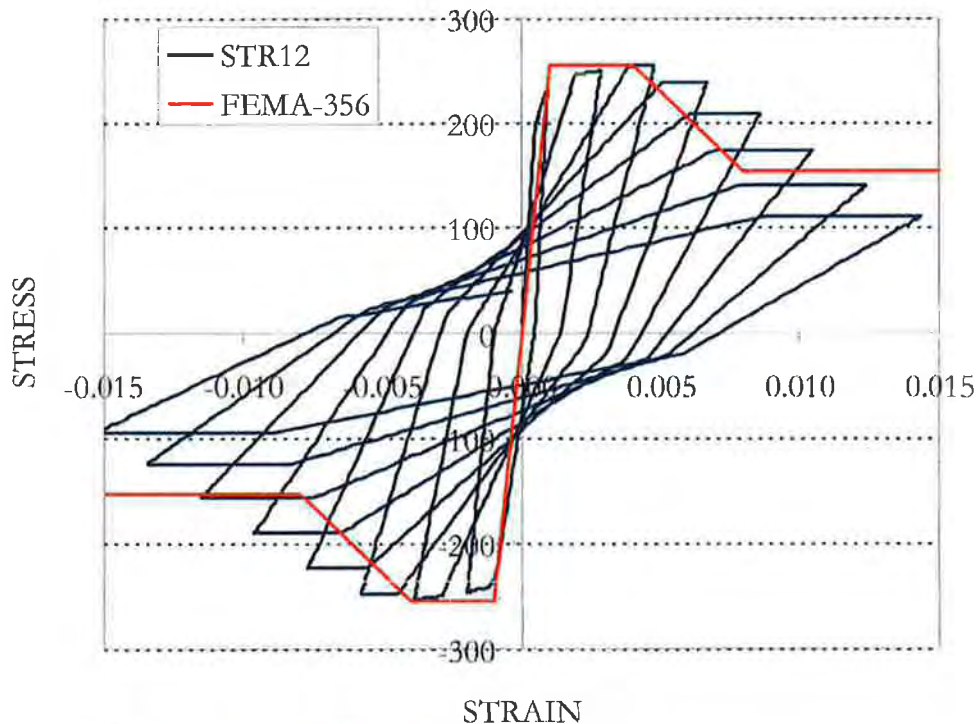
Figure 3-1 URM Element for Cyclic Loads

To model this brittle behaviour, the element shear stress – shear strain similar to the function shown in Figure 3-1 is used. The element shown in Figure 3-1 undergoes cracking at a shear stress of 230 kPa (plus a contribution from the vertical stress). After cracking, the strength of the element is initially maintained but the element stiffness reduces under cyclic loading. Once the shear strain exceeds 0.004 strength degradation occurs and the strength reduces to a residual level represented by friction alone.

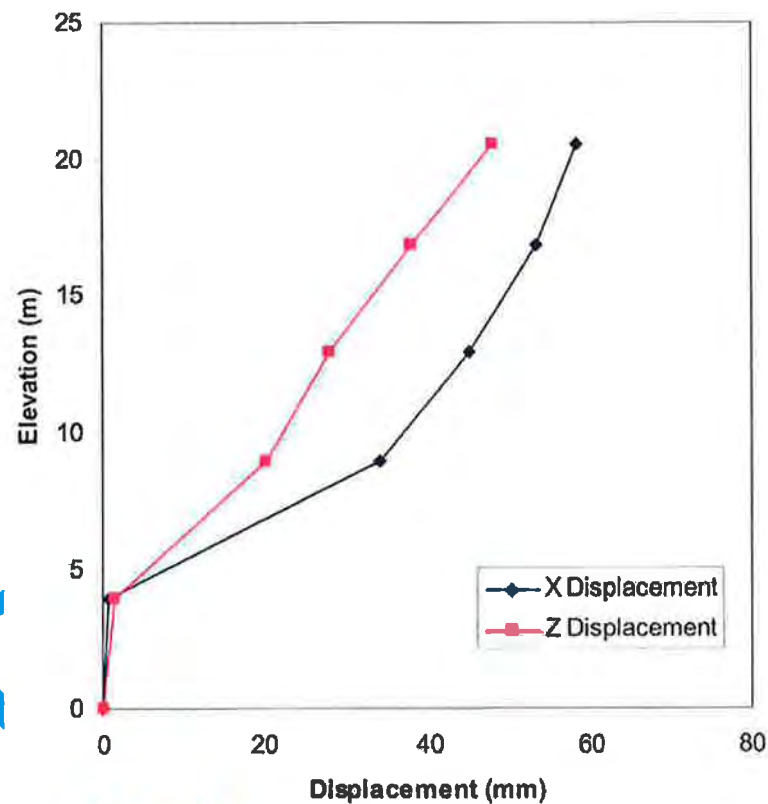
Figure 5-2 Peak Floor Level Displacements

As noted in Table 5-2, the building completed the full earthquake duration for 5 of the 6 analyses. Note that the maximum displacement corresponds to the tower. At this level of earthquakes the building has suffered shear failure in a significant number of the shear panels

Figure 3-5 illustrates the resulting peak displacements recorded at the main floor levels in the model.

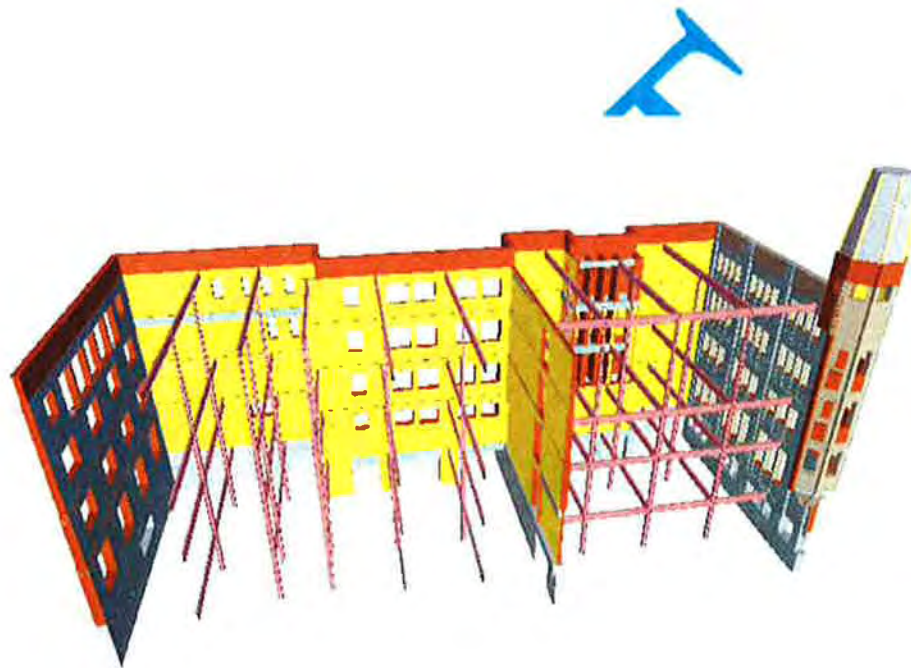
Figure 6-1 Interior View of Strengthening Solution (West Wall Cutaway)

Seismic strengthening of deficient elements is an iterative process in that the first elements to fail, in this case the Un-Reinforced Masonry (URM) shear walls on the perimeter and through the centre of the building running east-west, may act as a fuse to prevent further damage occurring. This proved to be the case for this building. The first items of strengthening were the north and south URM walls, which were strengthened using 150mm of shotcrete. Subsequently Fibre Reinforced Polymer (FRP) sheets were added to the east, west and central URM walls, providing additional shear strength without significantly altering the stiffness of the structure.
