Press Building

Preliminary Seismic Assessment Report

3 March 2011

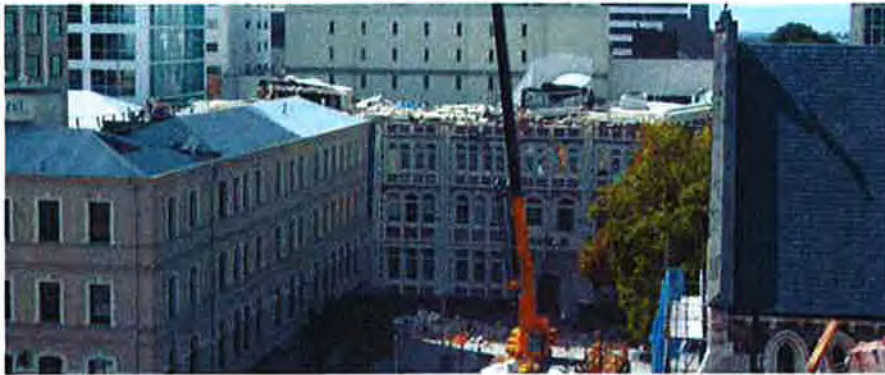
- The upper level has collapsed entirely onto the fourth floor.
- Most of the parapets were immediately dropped, with the exception of the south wall parapet, which has subsequently been removed by USAR.
- The corner tower roof has toppled back onto the fourth floor, with the masonry under it completely collapsed.
- The south facade has suffered further cracking and damage.
- The west facade has also cracked, and has an outwards lean over the central portion above the roof level.

**Figure 1: View of roof/fourth floor from above**

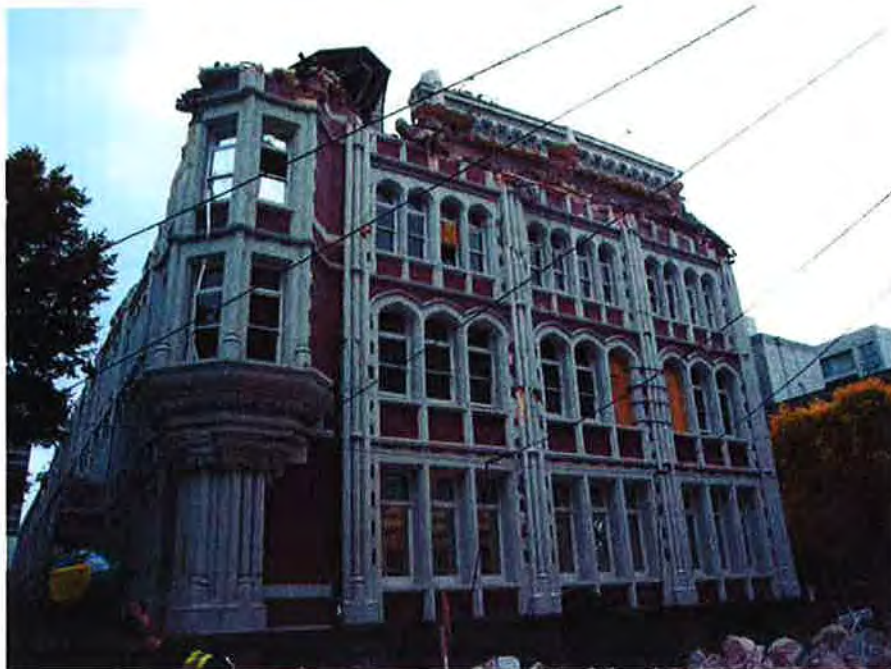
**Figure 2: South facade. Note parapet since removed**

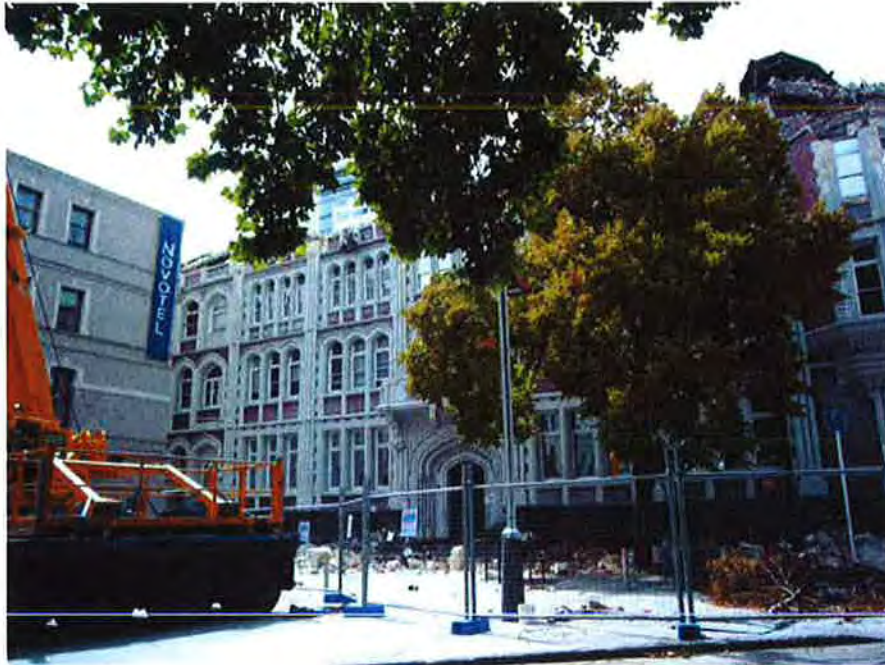
Figure 3: West facade

1. The parapet and the whole upper storey have been lost. This has affected the scale of the building, and the parapet was one of the major heritage items of the building.
2. The interior of the building is so severely damaged that only the facade can really be retained, comprising the south and west walls. In order to do this, a gantry will be required outside the building. Half the length of the west facade is on Press Lane and therefore there is not sufficient room for a reasonable gantry. The south facade is on Worcester Street, and hence a gantry is unlikely to be acceptable there either.
3. The west facade appears to have separated from the third floor over the central portion of its length.
