BUILDING SURVEY		Date	Report No.	File																								
NAME & ADDRESS	Name of Building Street		No.	9/2																								
OWNERSHIP	Owned <u>Leasehold</u> <u>Leased</u>		Area	2555 sq. ft.																								
PLANS	Occupancy		8 hr / 24 hr	5 day / 7 day																								
USED AS	Office, Workroom, Factory, Commercial, Storage, Other																											
STRUCTURE	No. of Storeys <u>Part II</u> Mass <u>Basement</u> Building Dimensions: Width <u>35'</u> Length <u>73'</u> Height Foundation Type: Strip Footing <u>_____</u> Ratt <u>_____</u> Column pads <u>_____</u> Piles <u>_____</u> Caissons <u>_____</u> Ground Conditions: Rock <u>_____</u> Gravel <u>_____</u> Sand <u>_____</u> Silt <u>_____</u> Clay <u>_____</u> Fill <u>_____</u> Frame: Steel <u>_____</u> R.C. <u>_____</u> Partial <u>_____</u> Exterior Panels: Brick <u>_____</u> Wood <u>_____</u> Other <u>_____</u> Exterior Wall Veneers: Brick <u>_____</u> Stone <u>_____</u> Other <u>_____</u> Remarks <u>_____</u> Condition <u>_____</u> Bearing Wall: Brick <u>_____</u> Stone <u>_____</u> Other <u>_____</u> Masonry wall bands <u>_____</u> Floor: R.C. <u>_____</u> Wood <u>_____</u> Other <u>_____</u> Eff. Diaph.

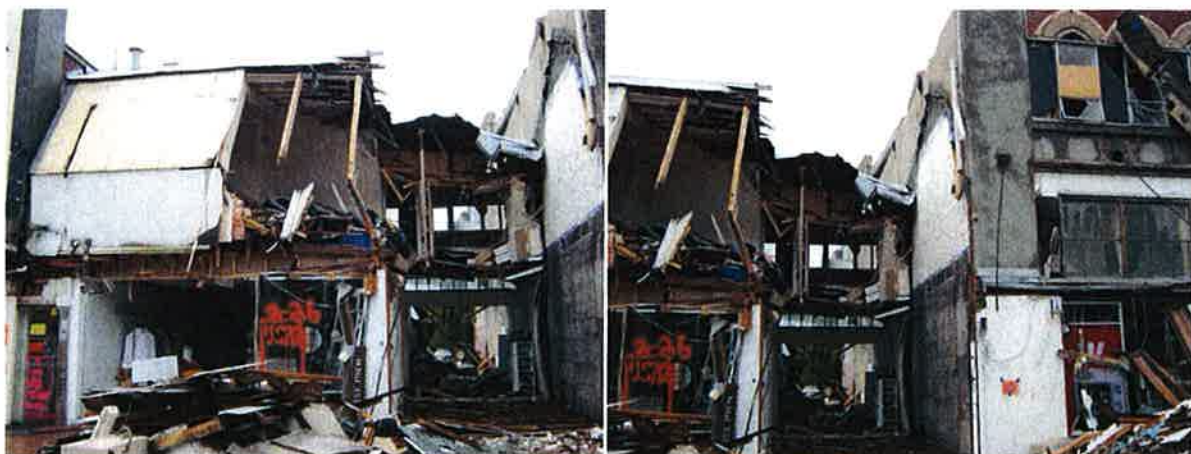
The building has sustained severe damage, most notably the loss of the building frontage and side adjacent to 91 Cashel St; refer photographs following. It is evident that this damage has been caused by the partial collapse of 91 Cashel St. The roof support has also been removed along most of the front of the building.

At present, 91 Cashel Street presents an overhead falling hazard to your building.

Photos 87-89 Cashel St, 28/03/11 – Showing loss of building

front and damage to adjacent buildings

On the basis that the building is unstable, unsafe to approach or enter, presents a public safety risk and is not economic to repair, we recommend that this building should be demolished. This work should be carried out in conjunction with works on the adjacent buildings to minimise risk to workers involved in the demolition.

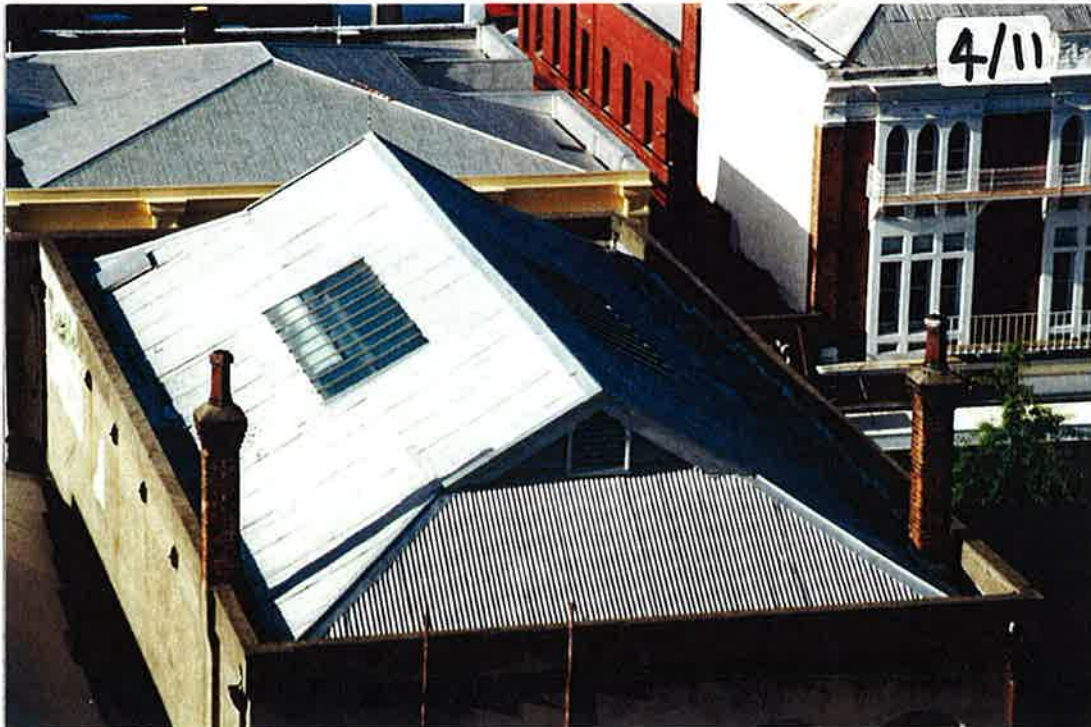
4/11 Two hazardous Chimneys.

Comments: Although not an EPB, its chimneys are, nevertheless, hazardous appendages.

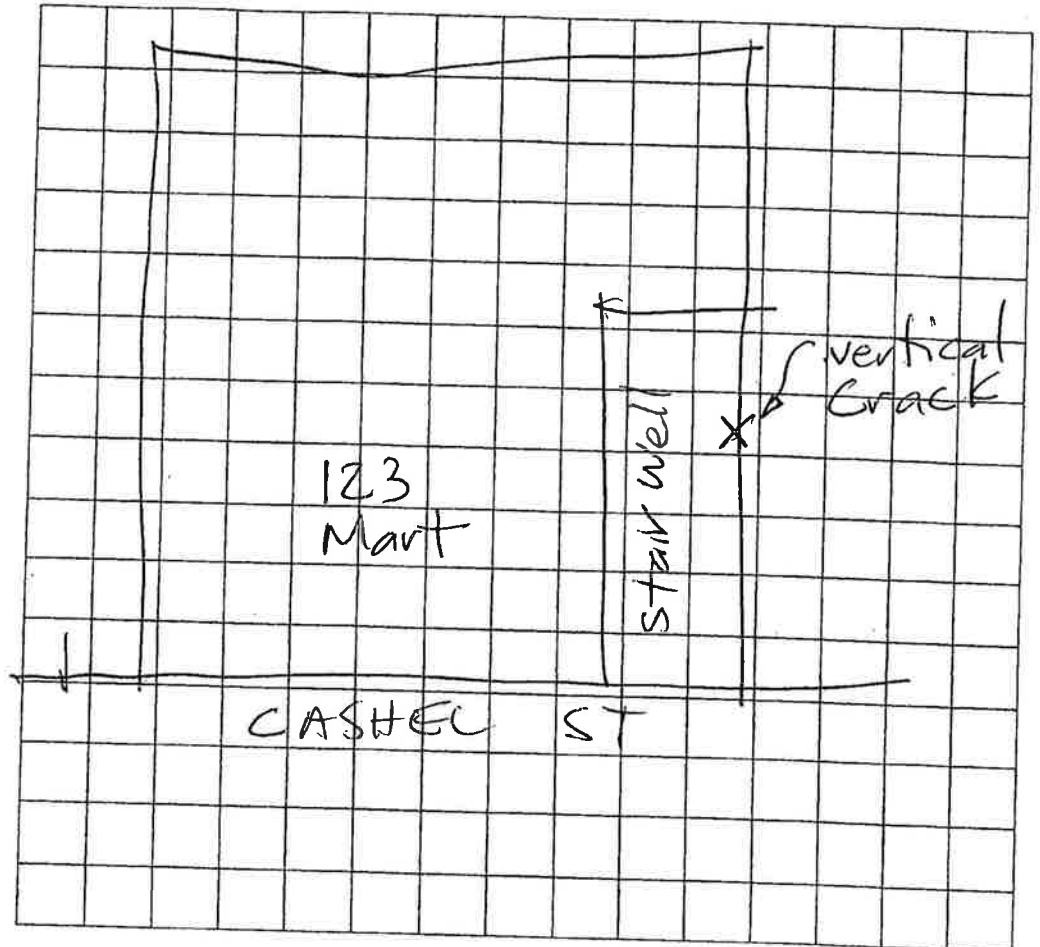
vertical crack the full height of external wall in staircase

cracking in stairwell needs to be checked by CPEng

check by engineer - hairline crack in structural wall

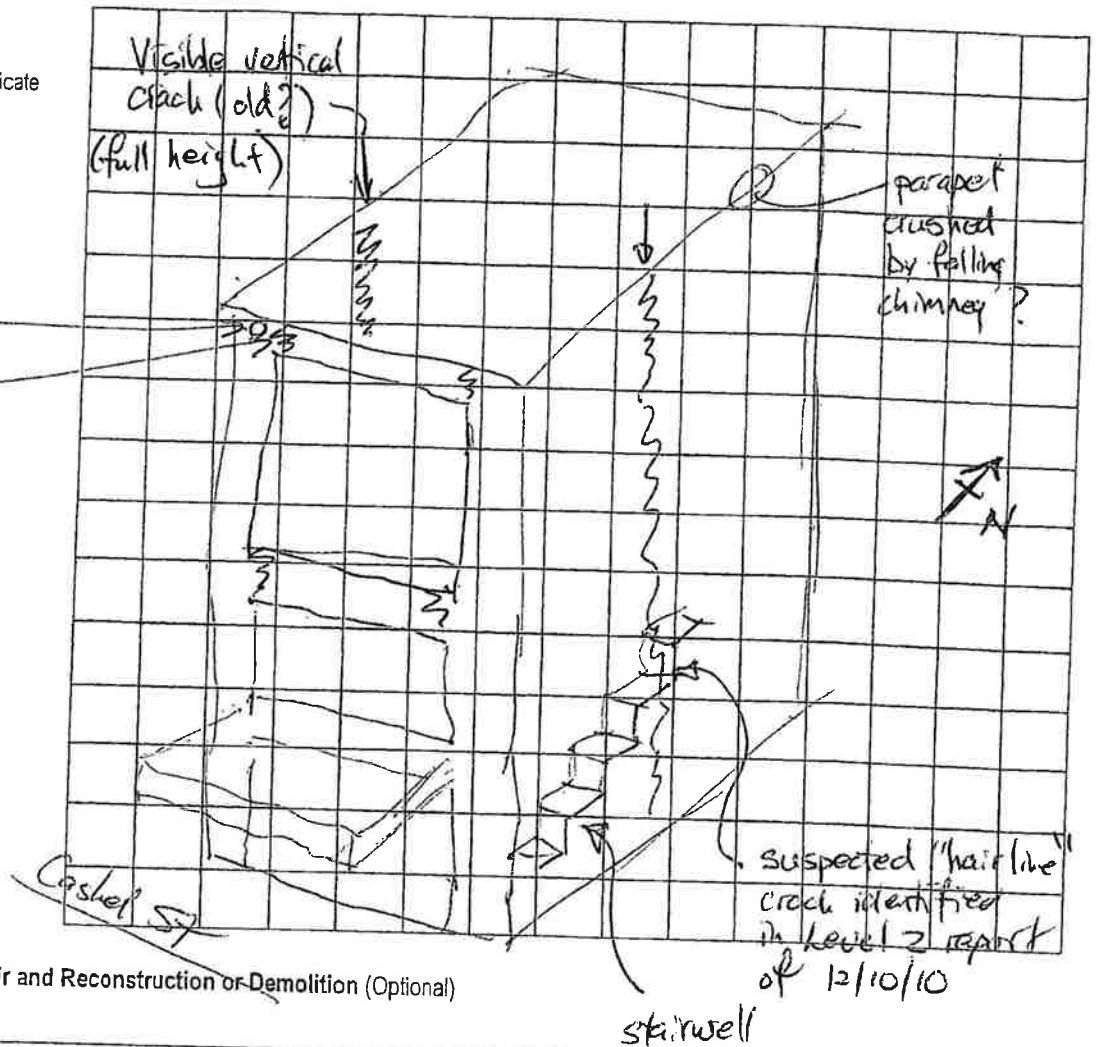
General Comment Request was to inspect vertical crack in stairwell east side, but not accessible (previous level).  
 Noted, vertical crack in west wall similar location to inferred east wall.  
 Other cracks in street frontage at joint between walls and horizontal members.  
 Brickwork exposed beneath plaster (a lot of work to find these exposures, so examine photos carefully). How building ~~from~~ works structurally not clearly understood and requires further study.

exposed face  
brick  
(see photo)  
cracks  
(see photo)

Called to inspect "hairline" crack in stairwell, but could not gain access.  
Phone contact for access given as Tracy Gough Ph 355 9566  
Suspect mechanism for this crack same as crack observed on opposing side of bldg.

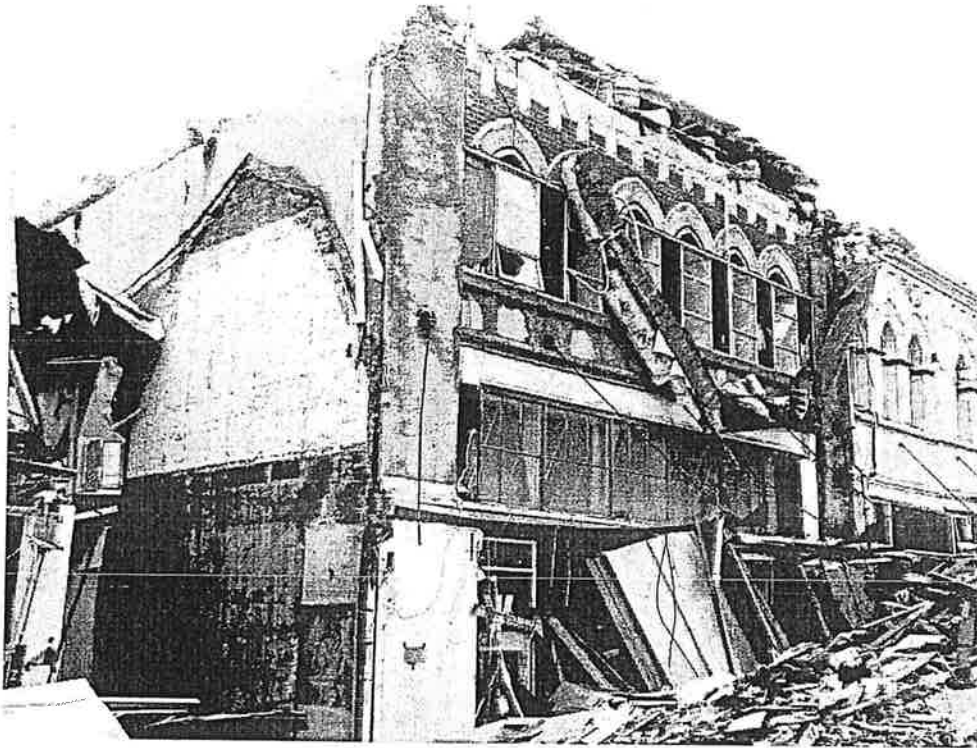
Photo 1: Southwest corner of building show loss of 3rd floor, façade glazing and canopy.

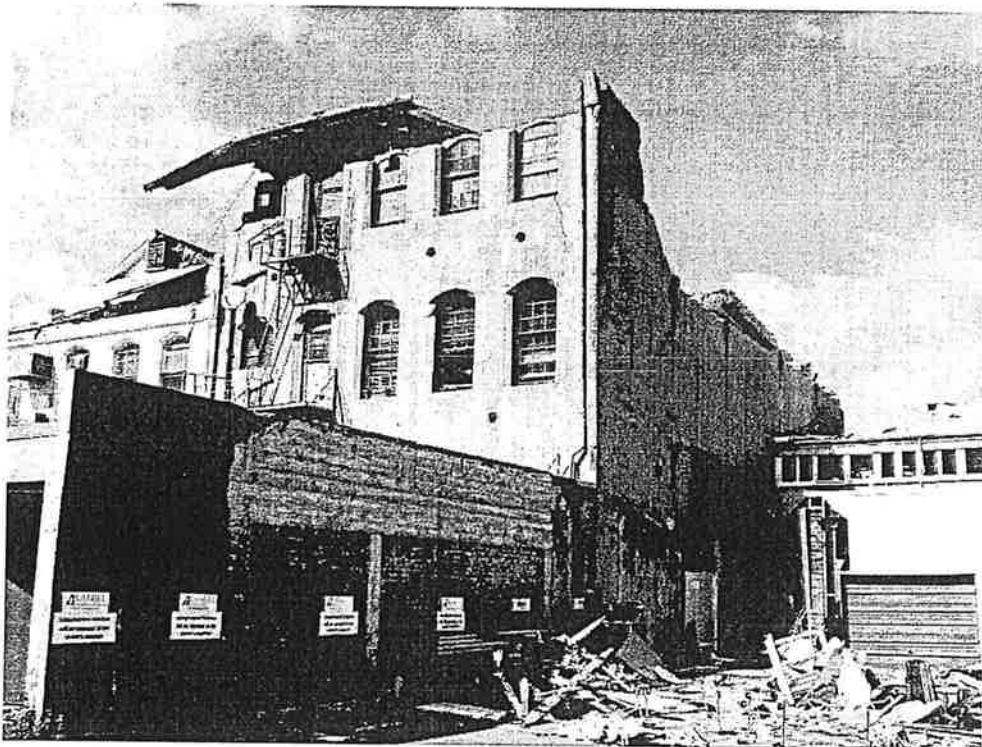
Photo 2: Northwest corner of building showing only remaining 3rd floor walls and roof.

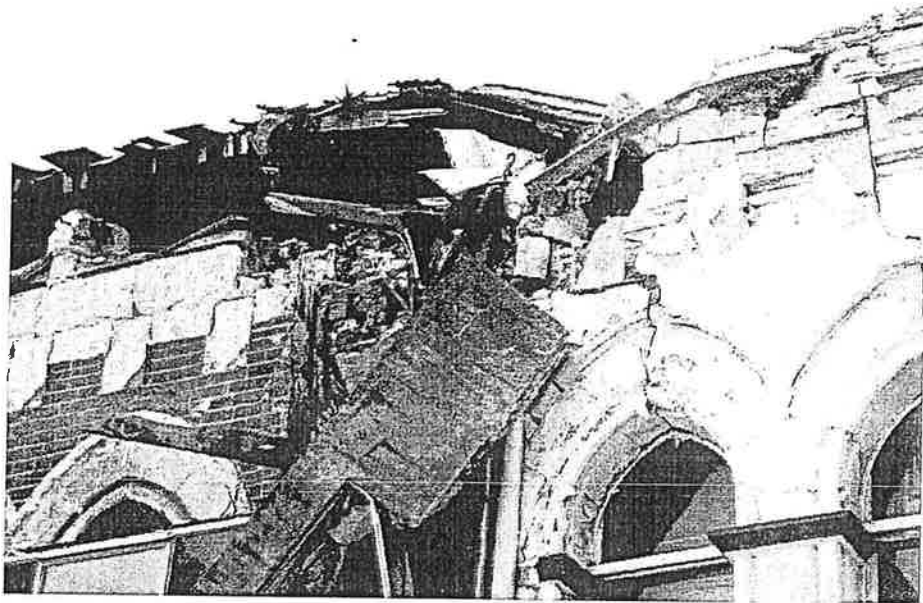
Photo 3: Pounding damage with adjacent building at 2nd floor

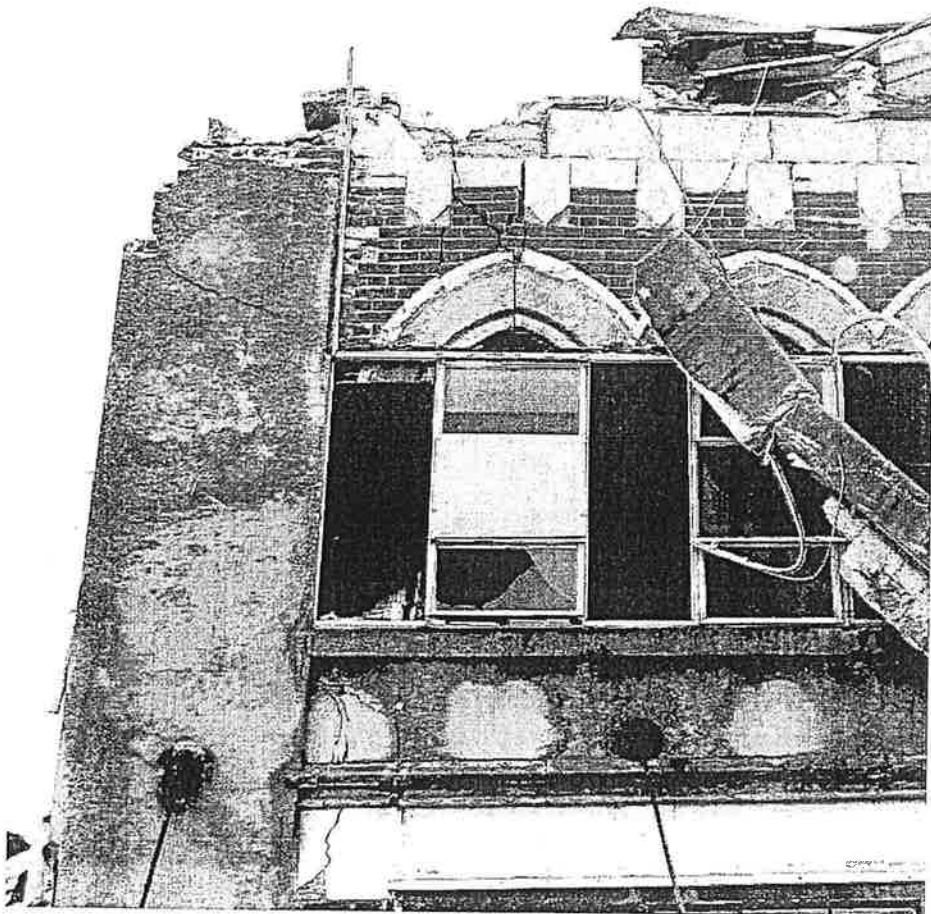
Photo 4: Damage to 1st floor and 2nd floor spandrels

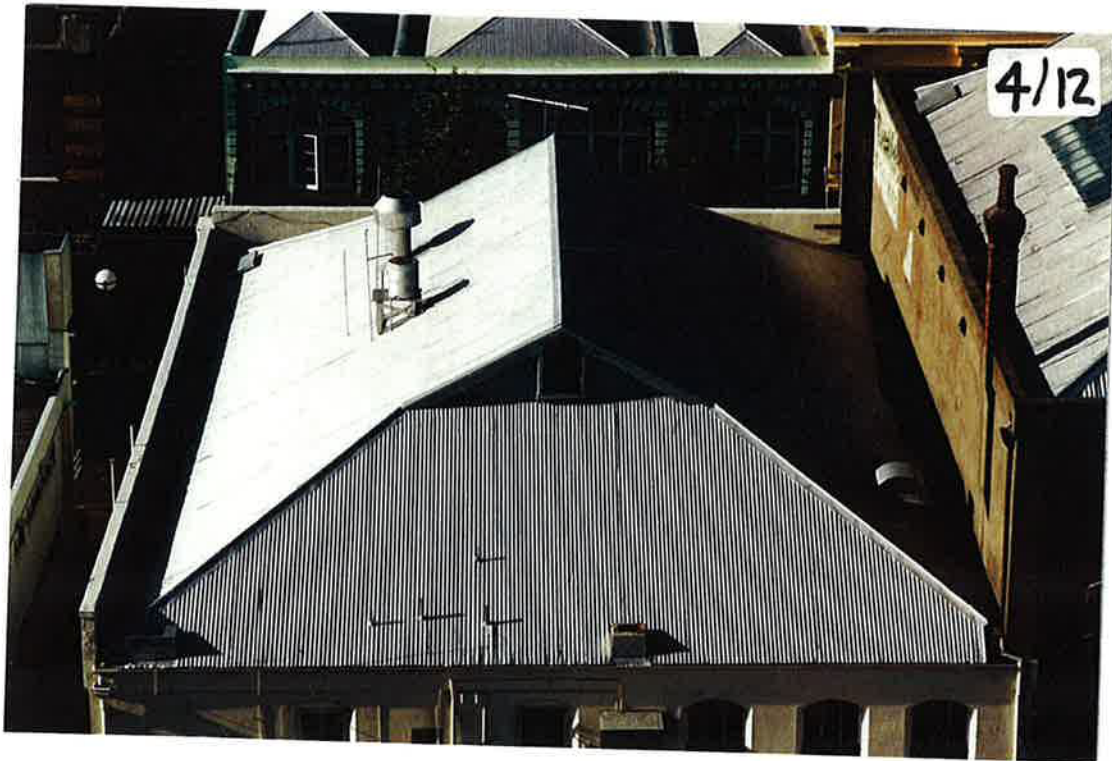
4/12. Parapet on Alley and Mall Elevations.

Comments: Hazards: the parapet seems likely to topple (in an earthquake) onto heavy pedestrian traffic below.
