**IN THE MATTER OF ROYAL COMMISSION OF INQUIRY INTO BUILDING
FAILURE CAUSED BY CANTERBURY EARTHQUAKES**

**STATEMENT OF EVIDENCE OF STEPHEN JAMES MCCARTHY IN RELATION TO 116
LICHFIELD STREET**

DATE OF HEARING: 23 JANUARY 2012

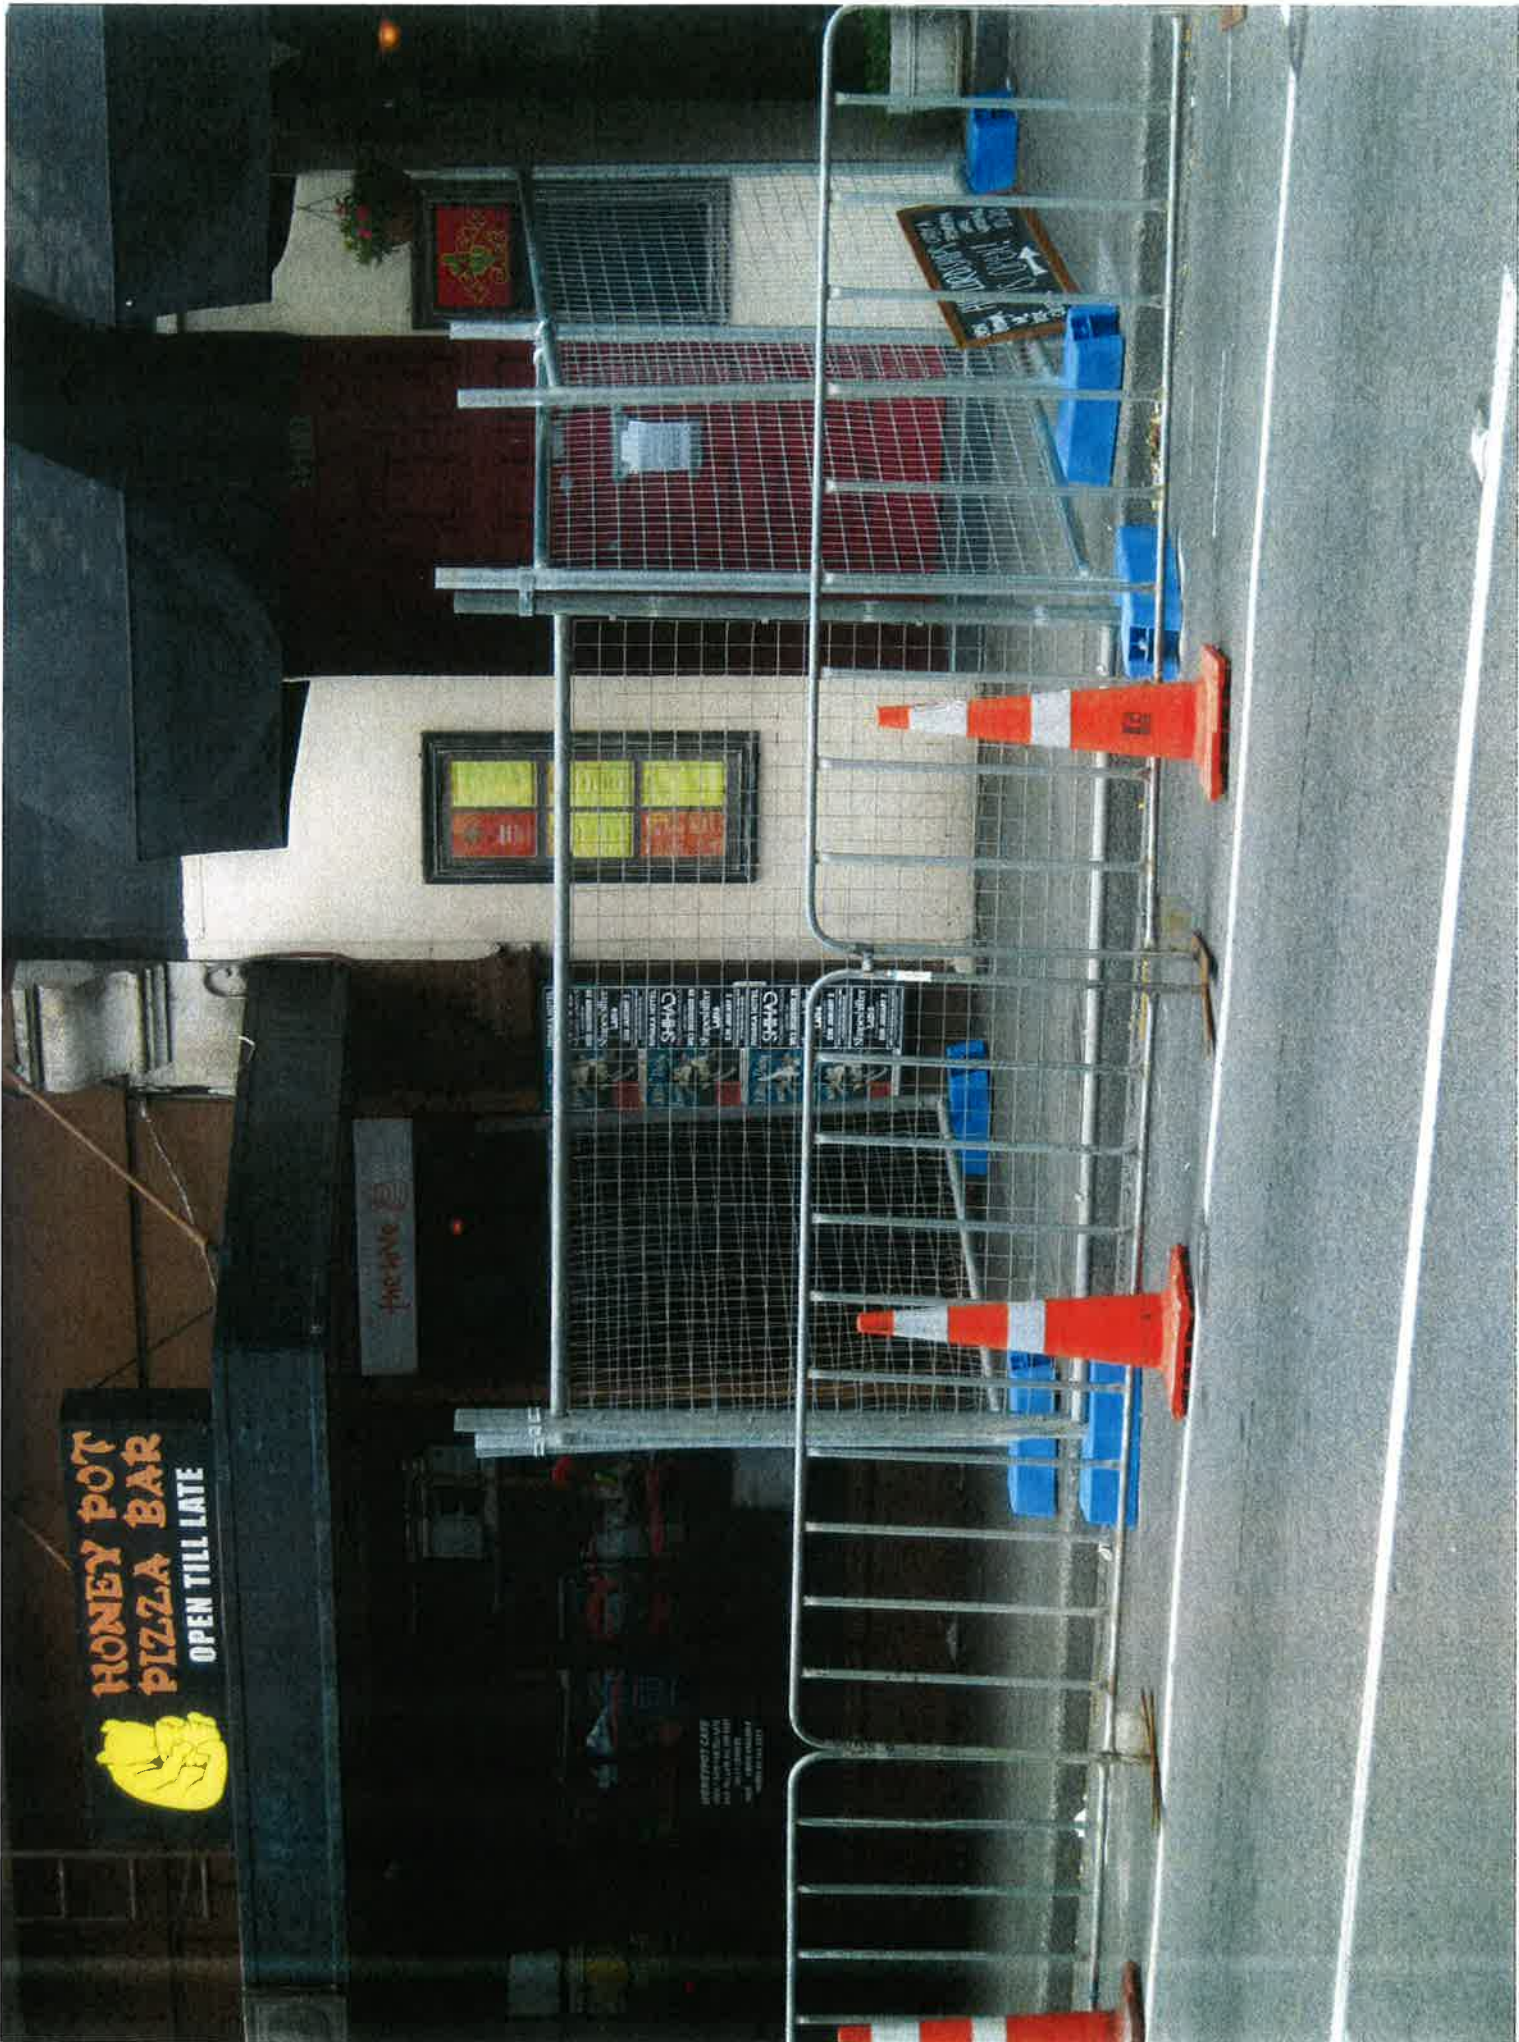
"A"

12. The Council's records also indicate that at 30 December 2010 a cordon had been installed on the Lichfield Street frontage of 116 Lichfield Street (**Annexure "A"**). The Council does not have a record of the date of installation of this cordon.
