**IN THE MATTER OF ROYAL COMMISSION OF INQUIRY INTO BUILDING
FAILURE CAUSED BY CANTERBURY EARTHQUAKES**

**STATEMENT OF EVIDENCE OF STEPHEN JAMES MCCARTHY IN RELATION TO 32
CATHEDRAL SQUARE**

DATE OF HEARING: 30 JANUARY 2012

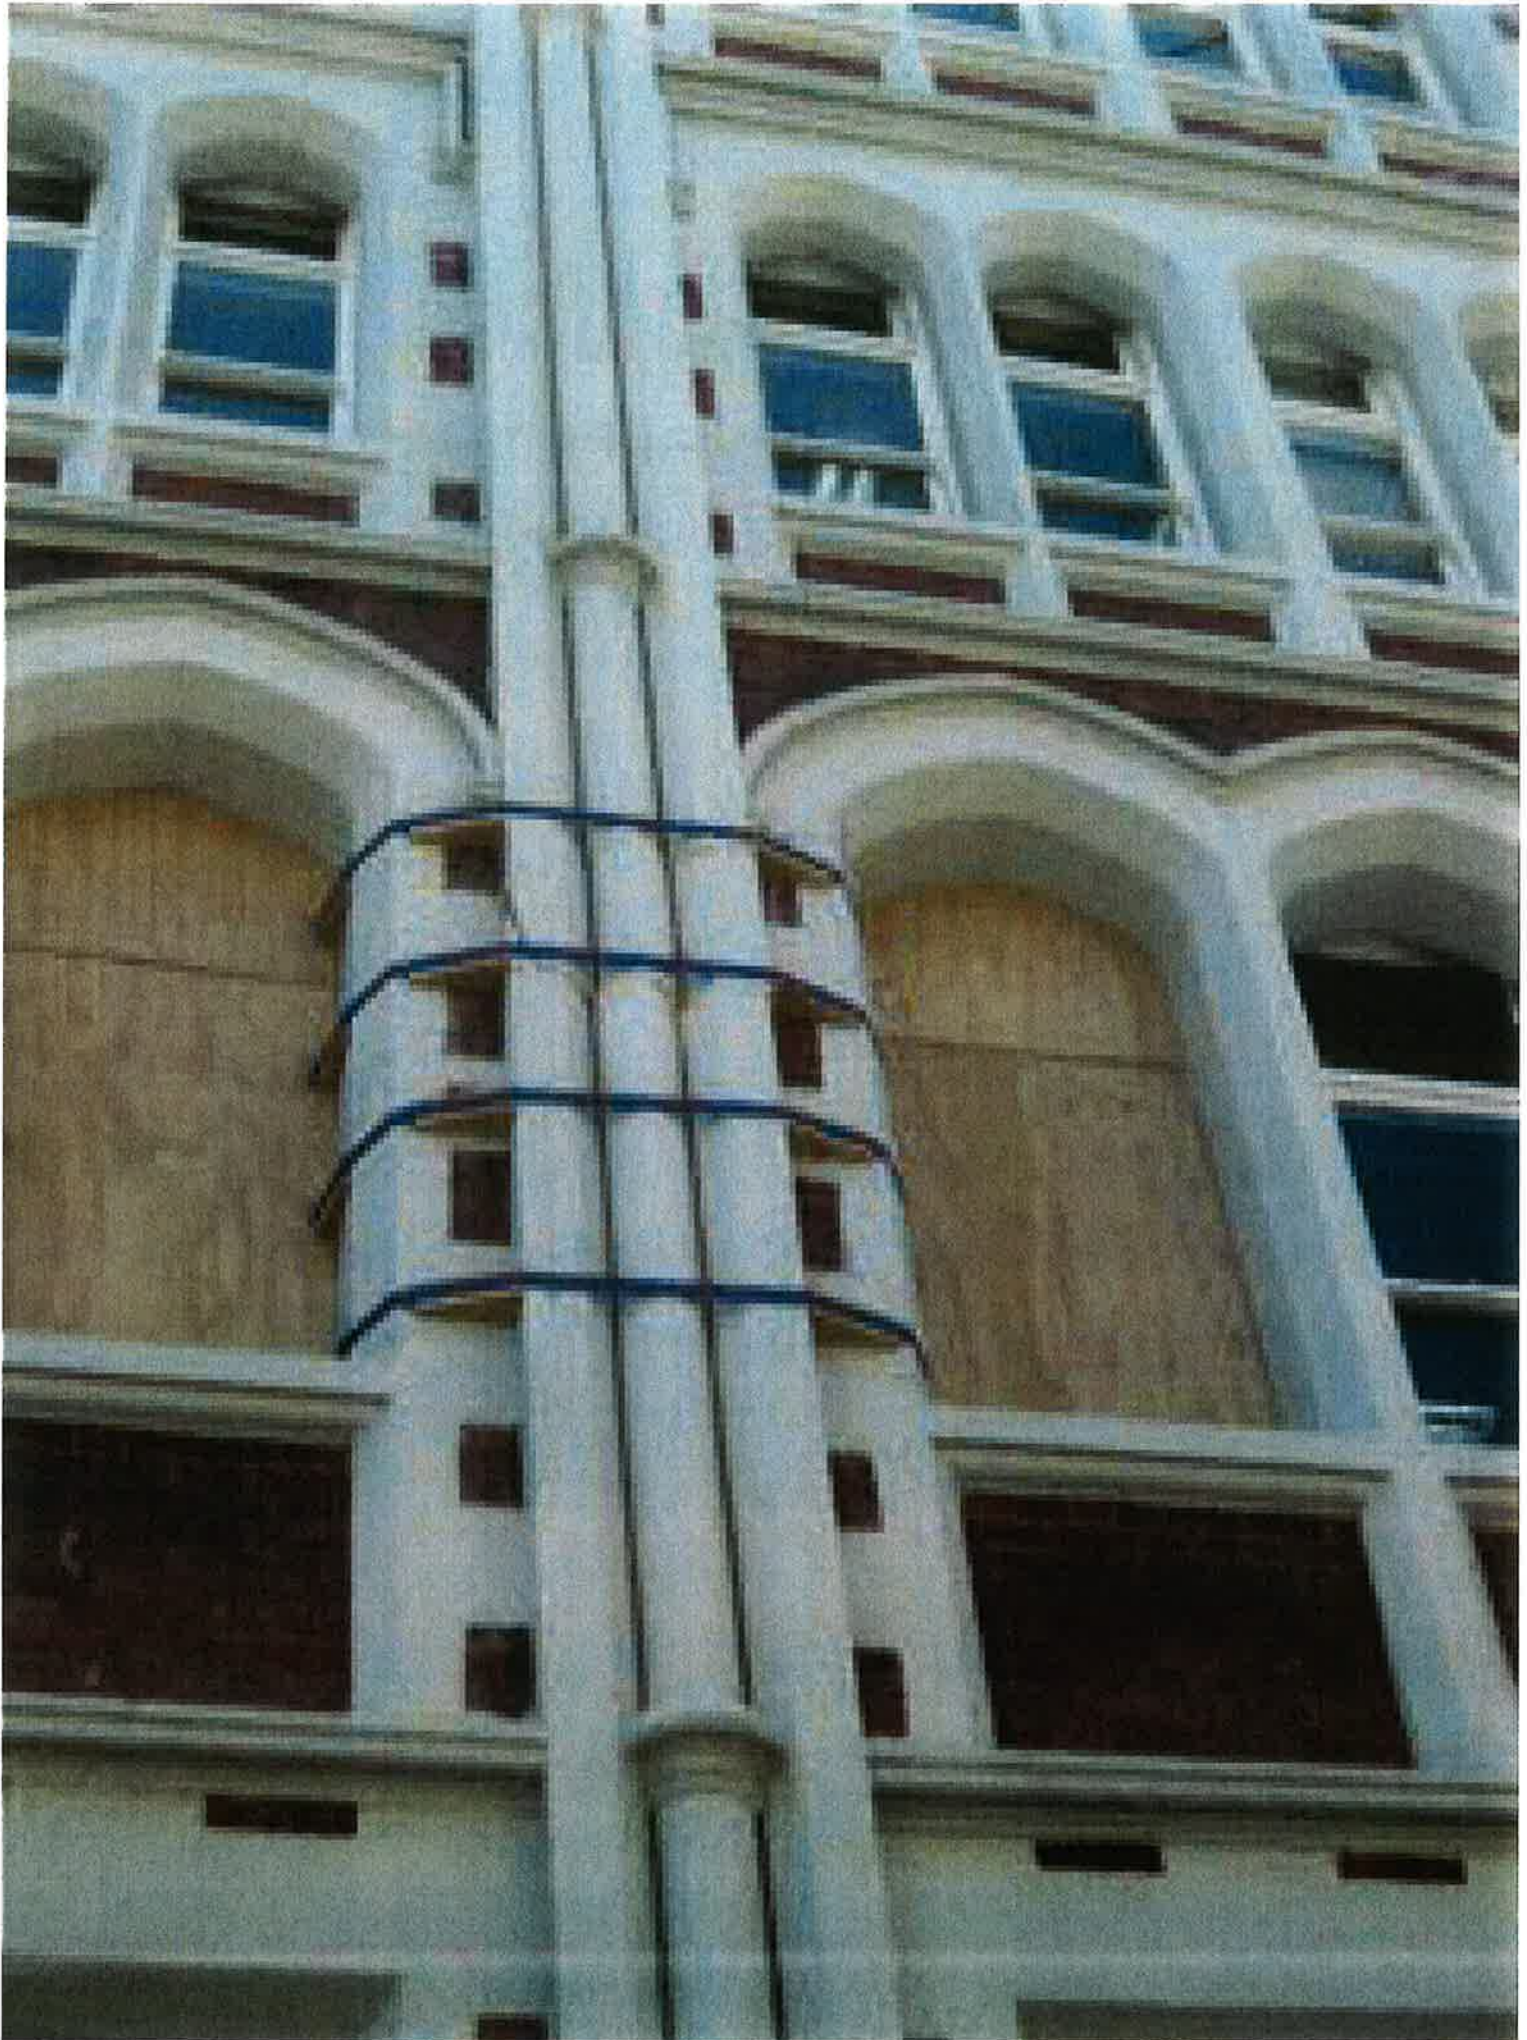
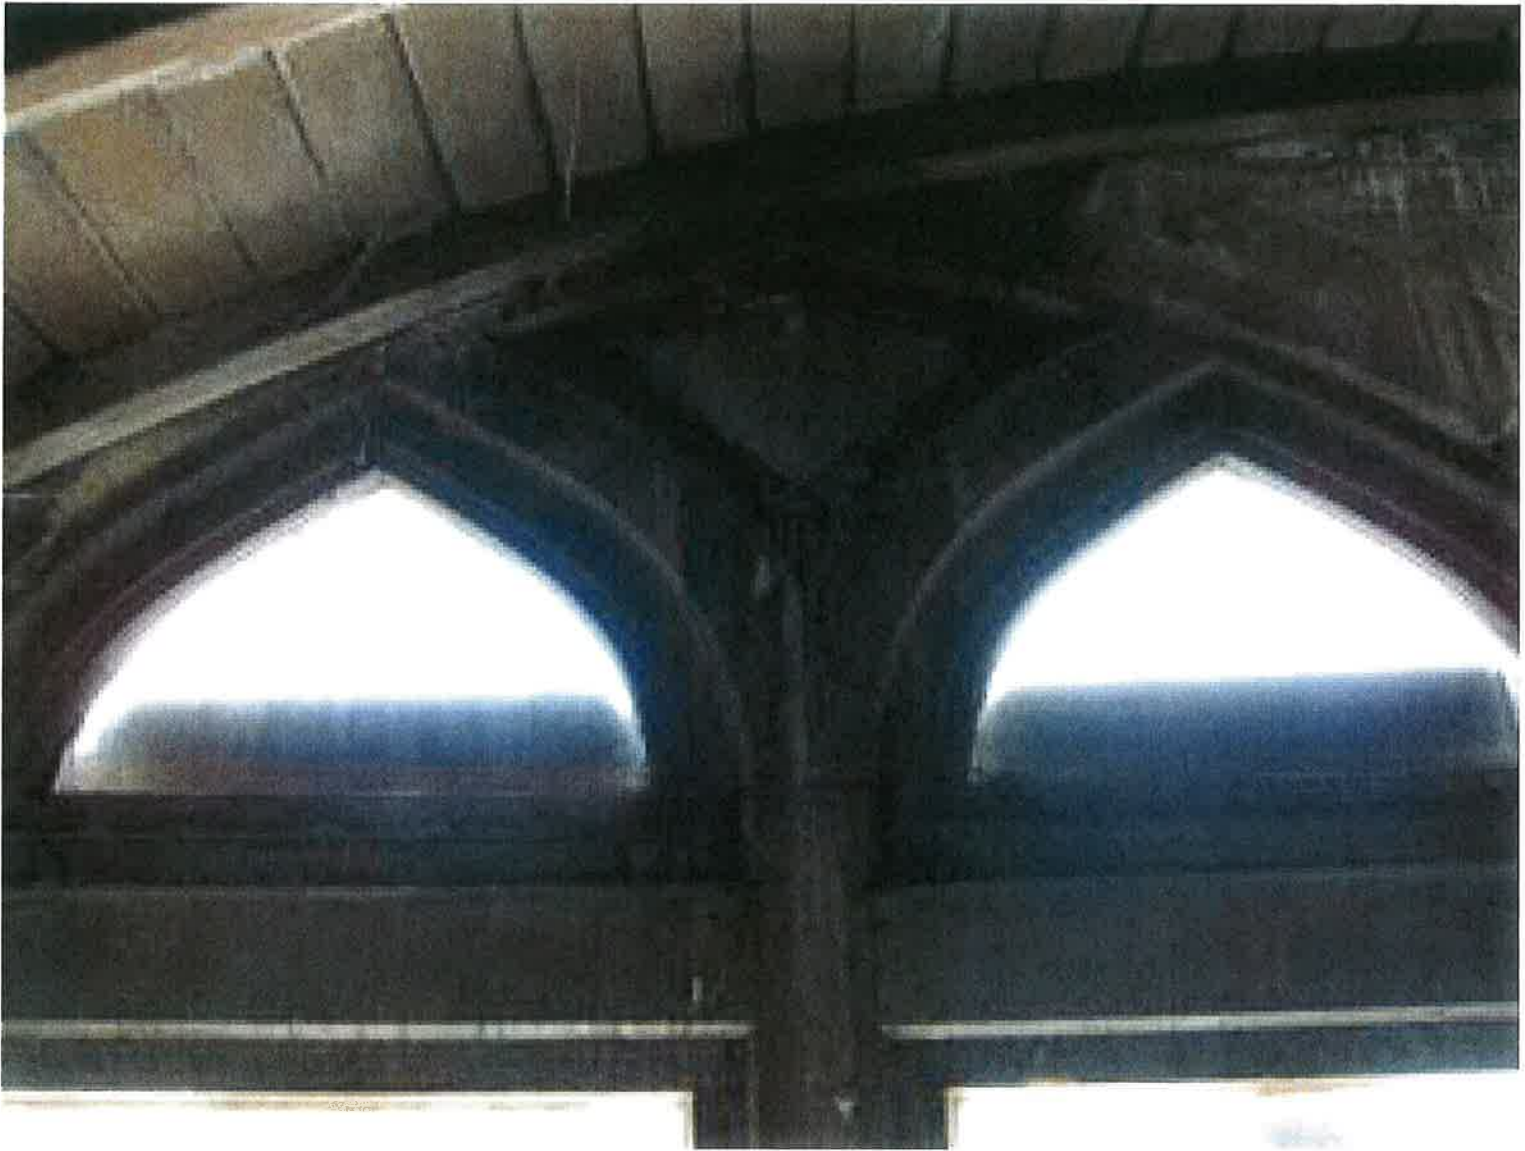
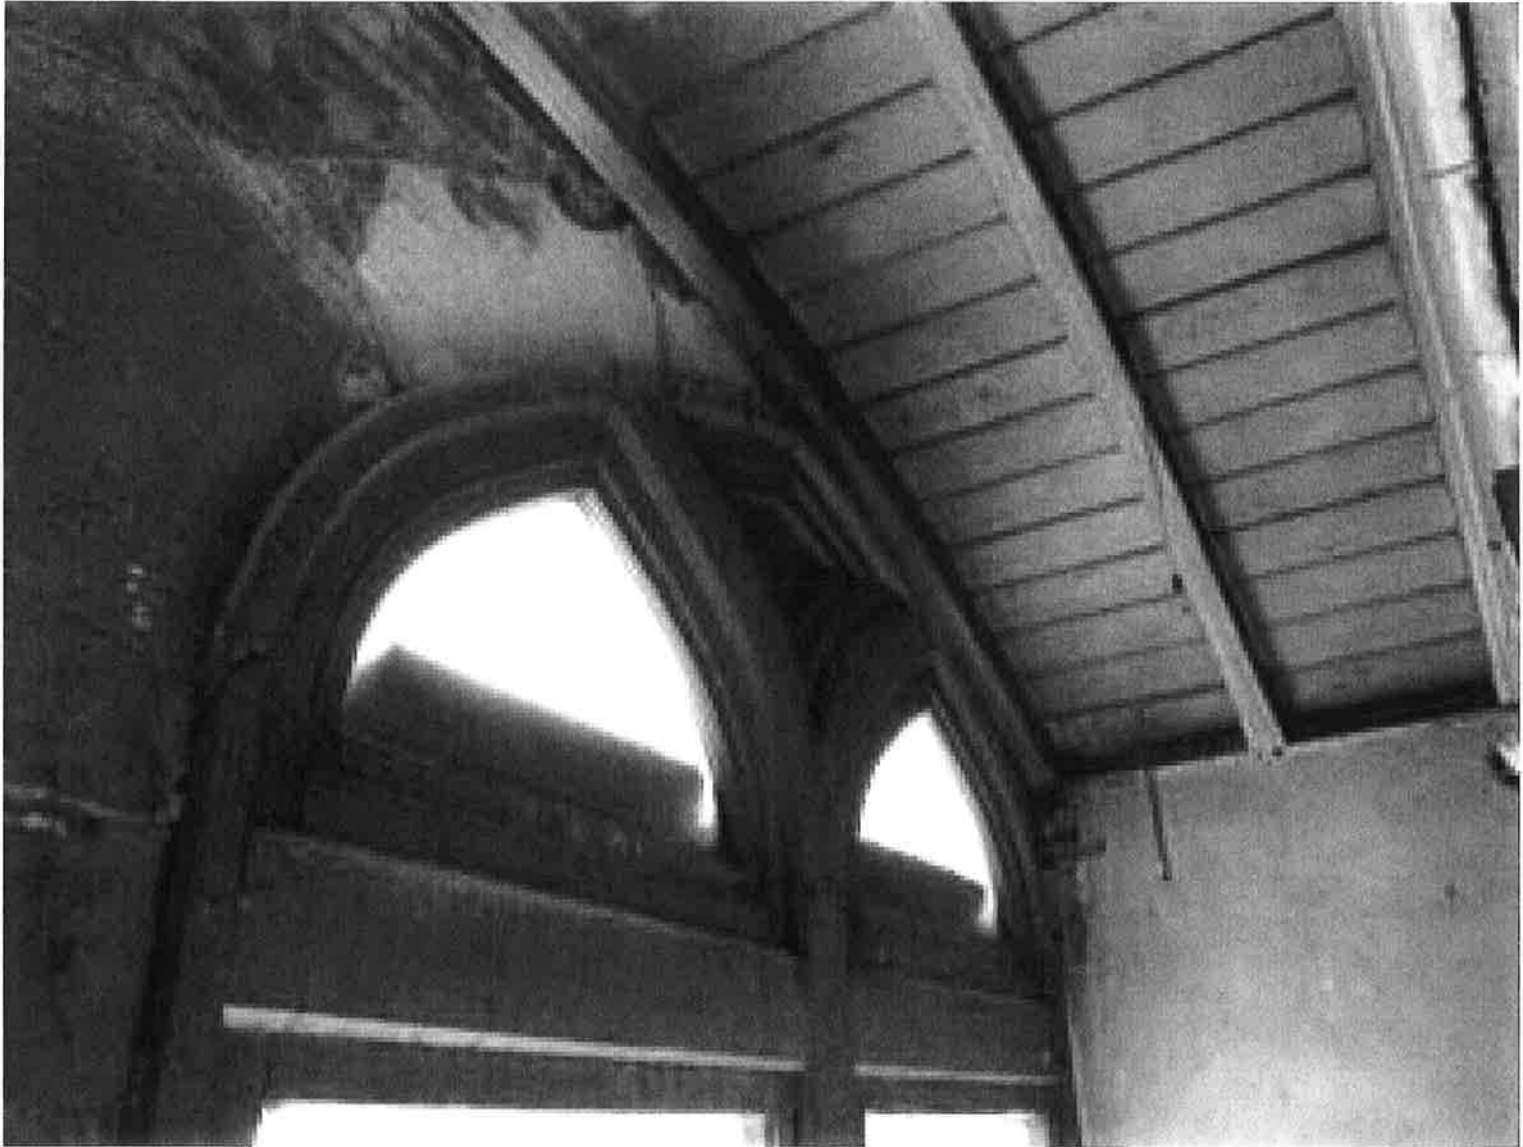
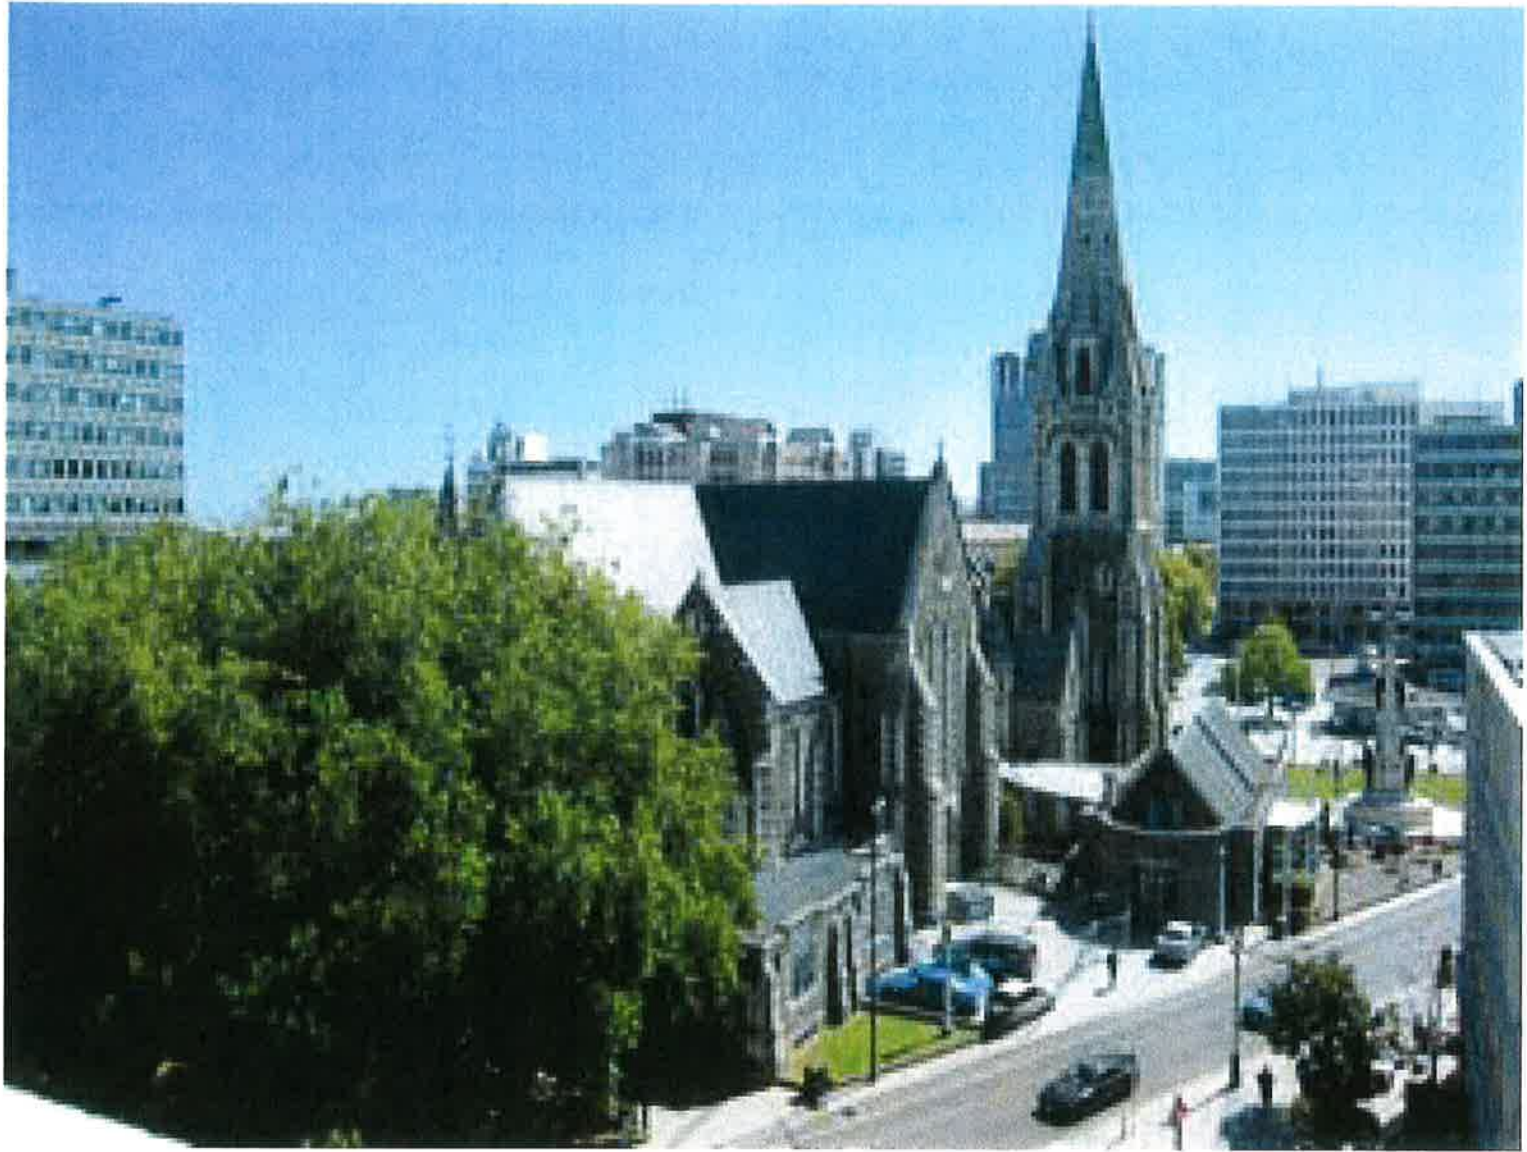
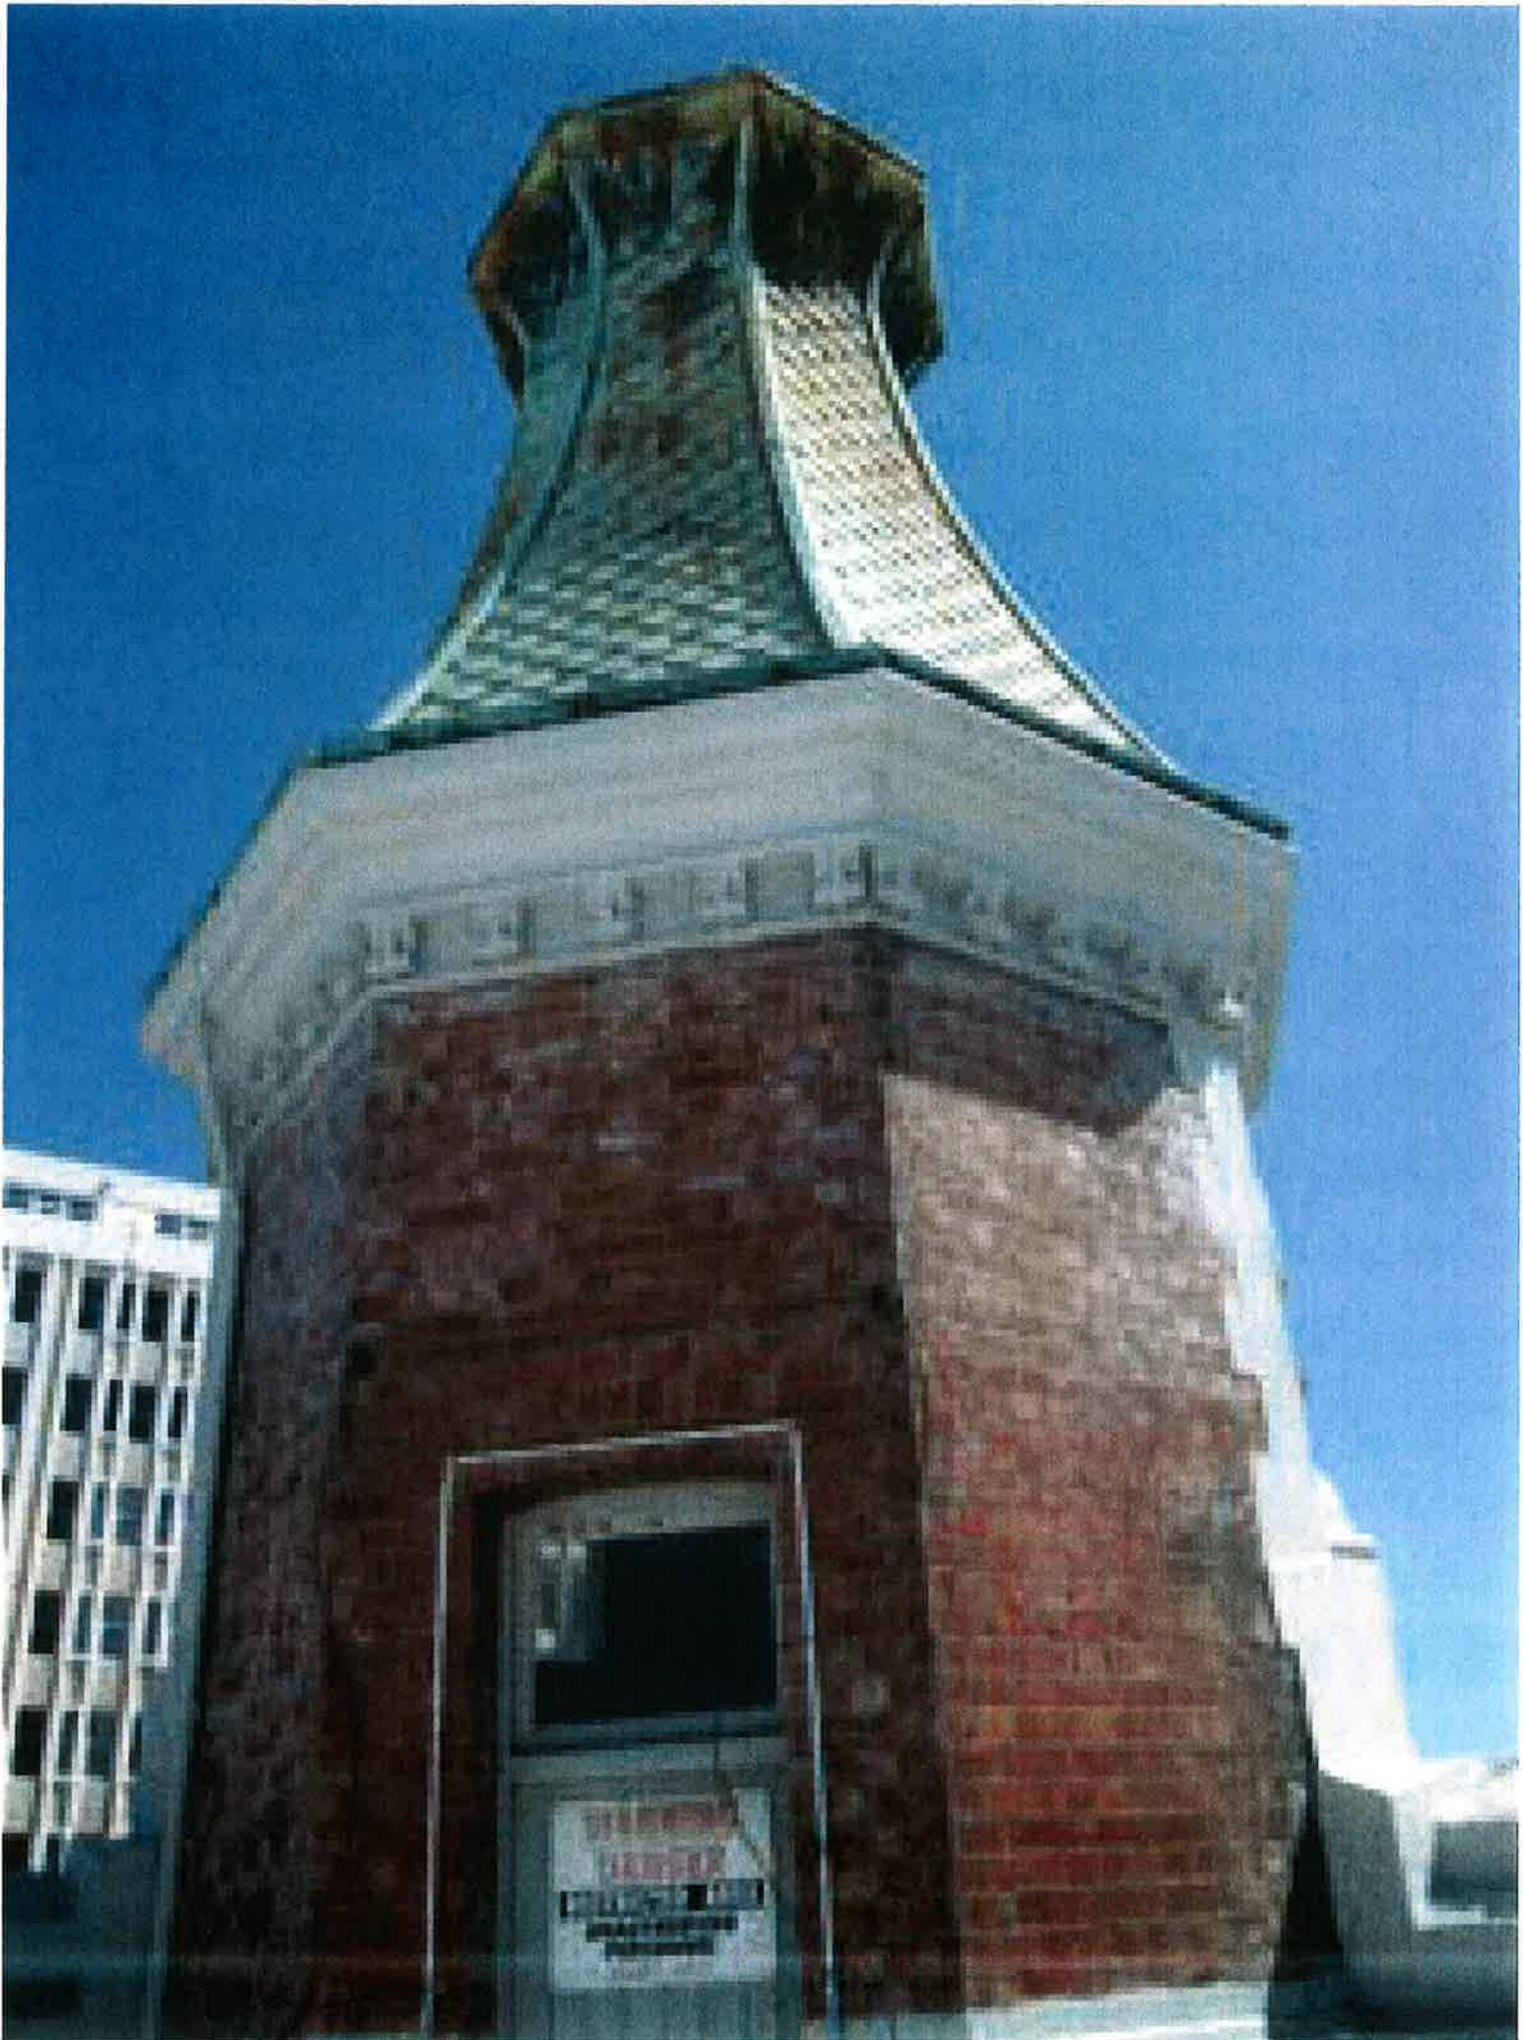
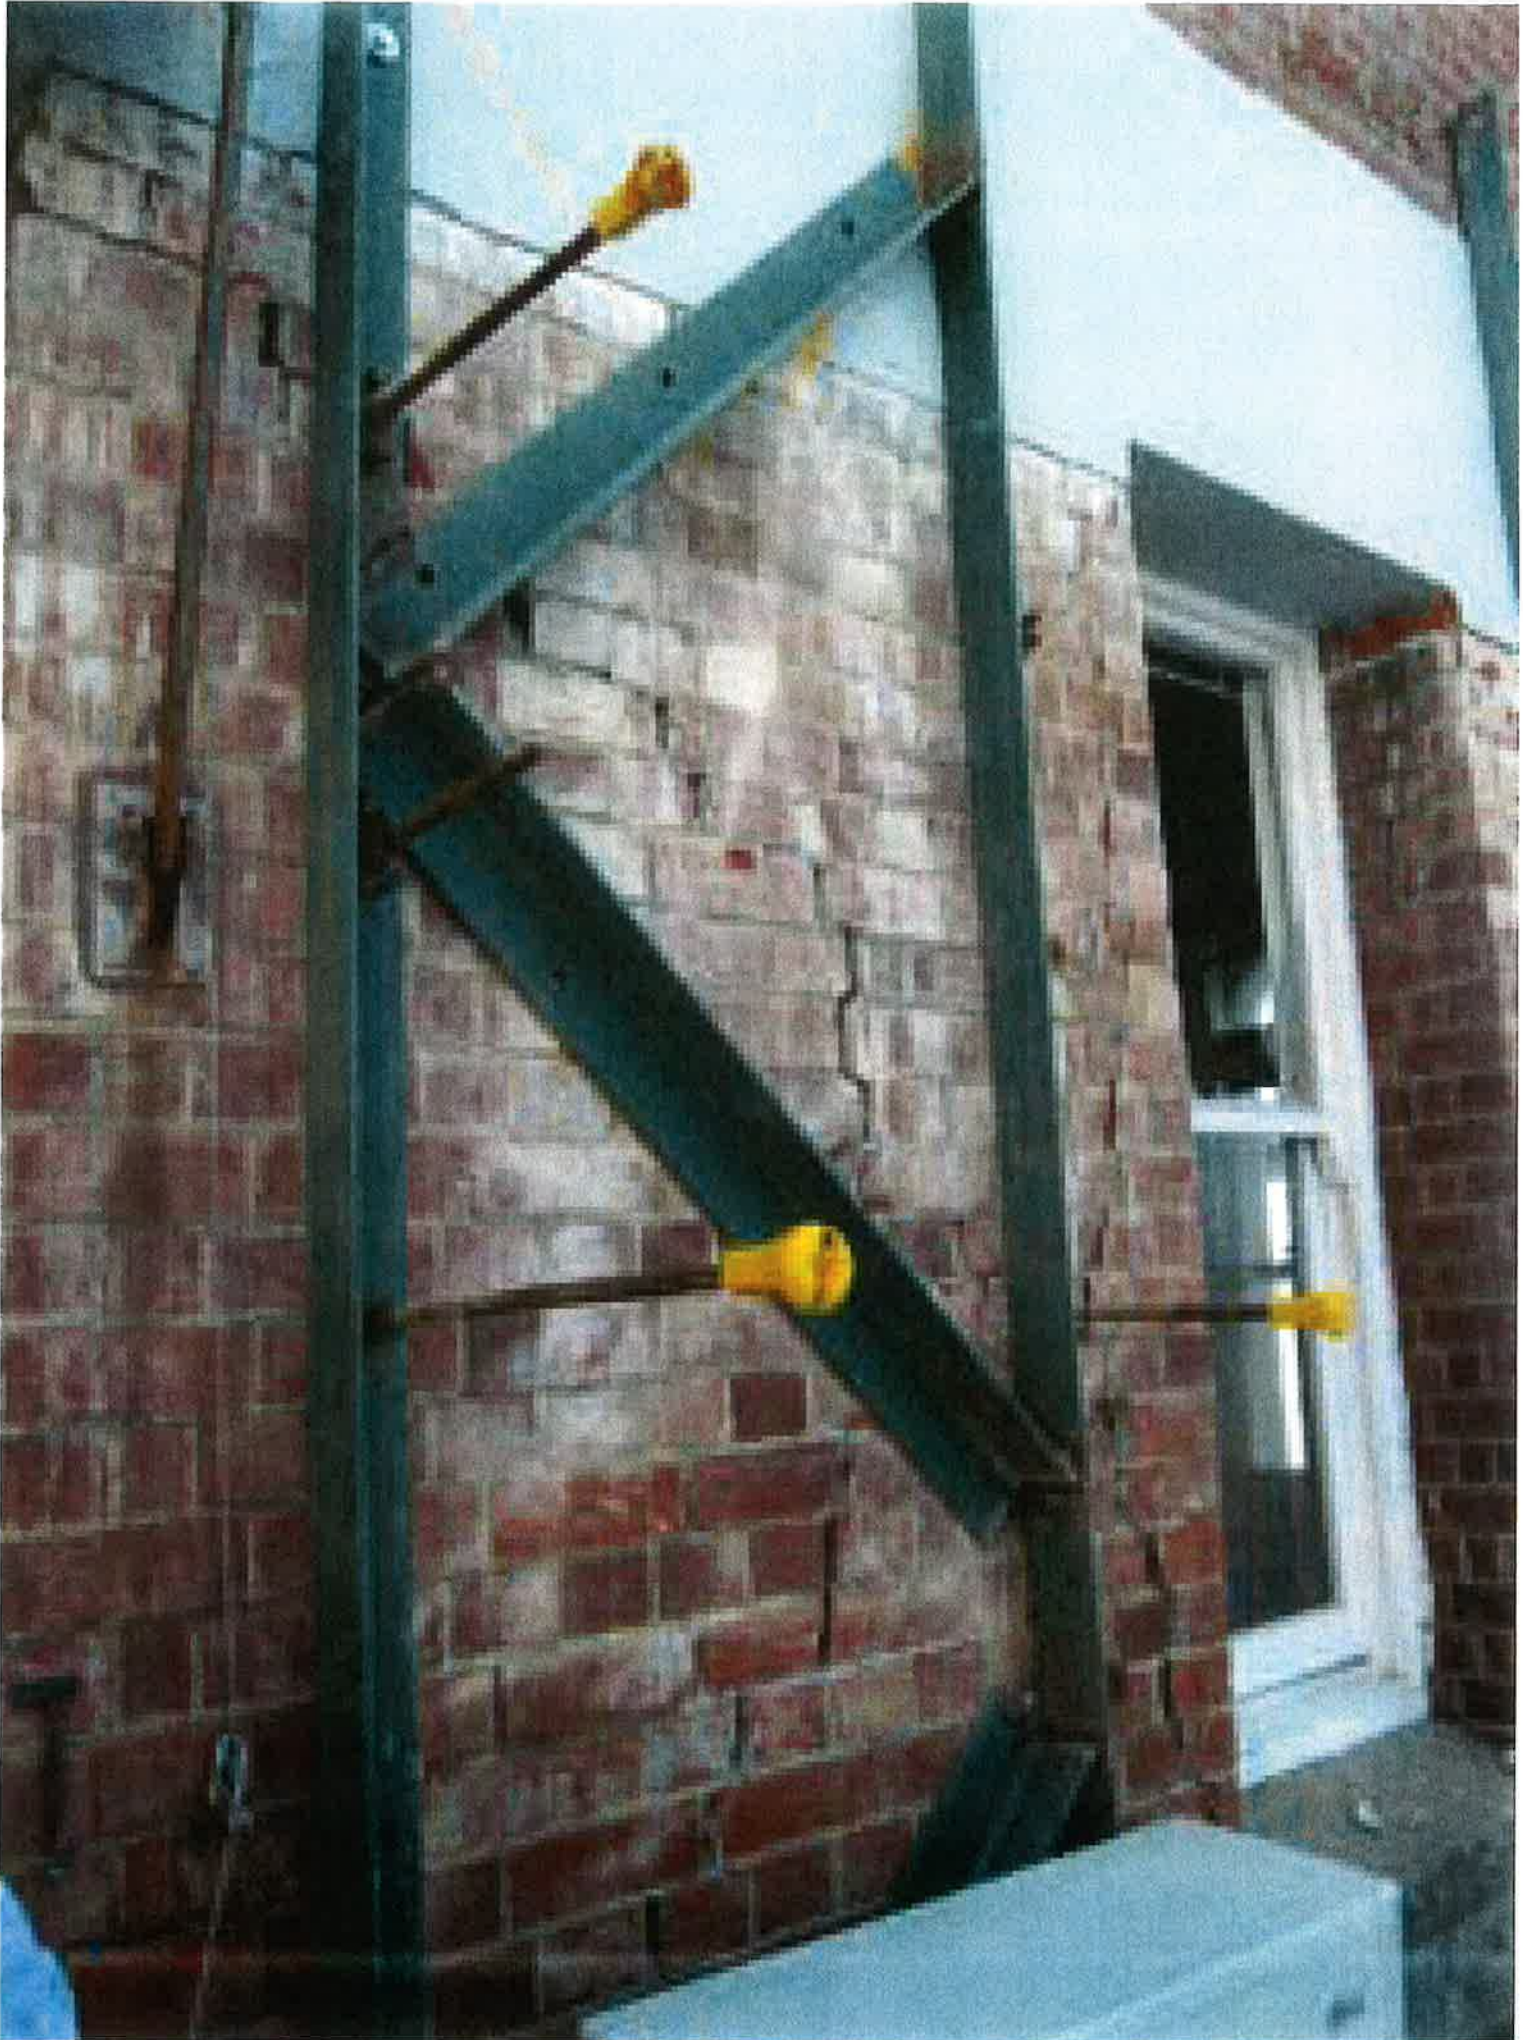
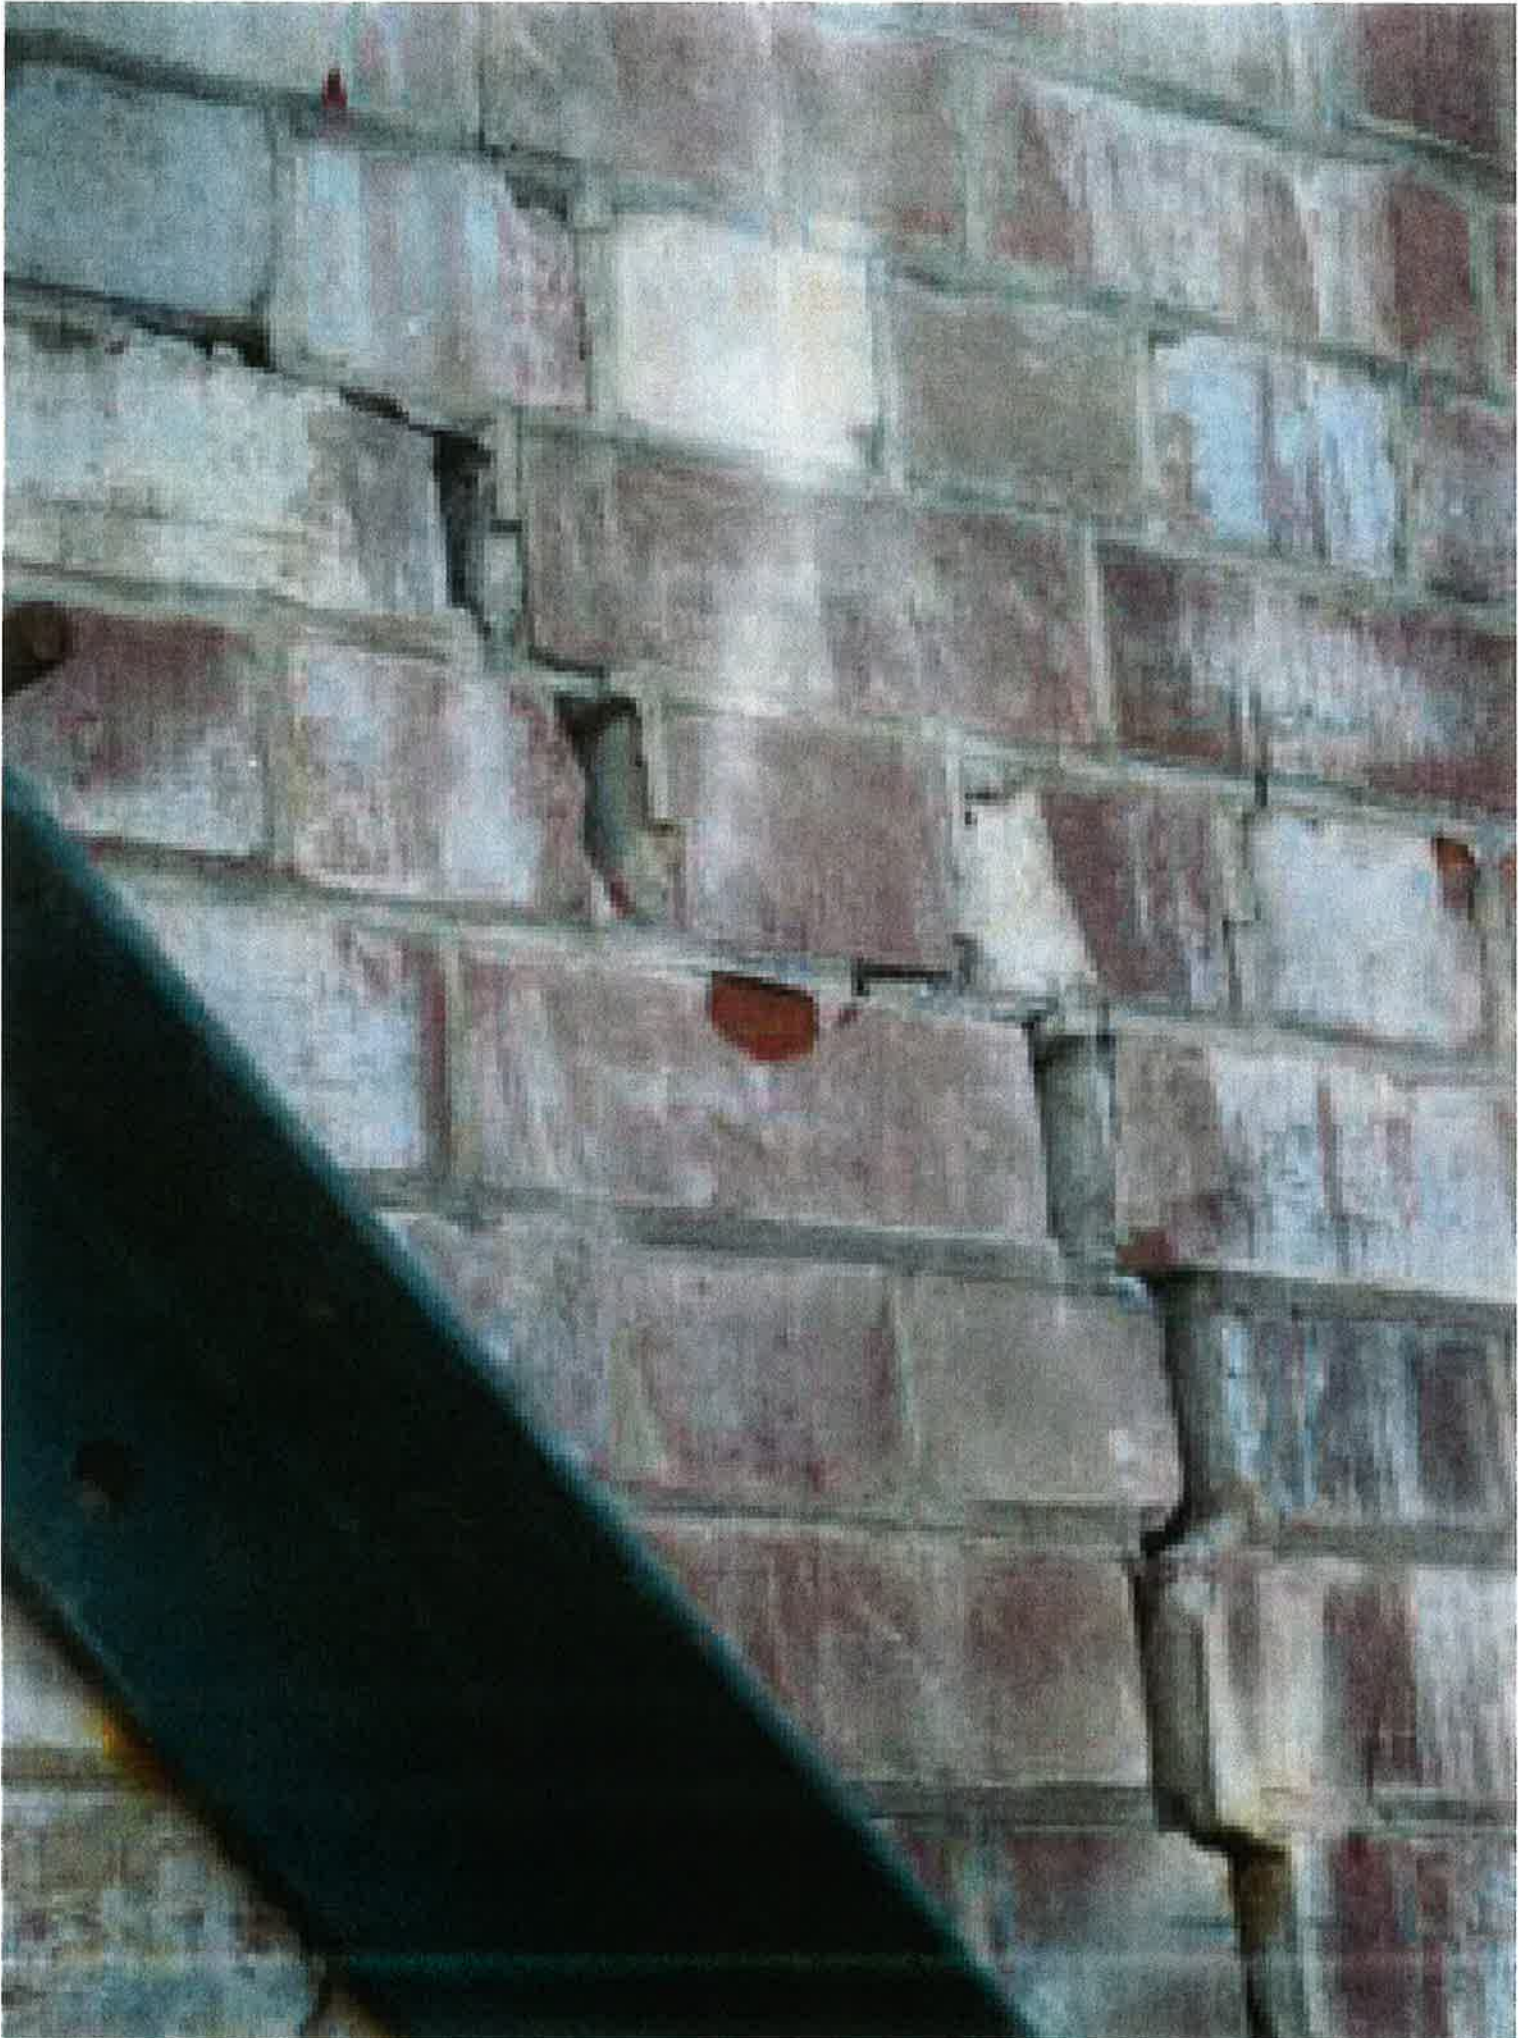
"D"

18. I understand that the section 124(1)(c) notice was affixed to the building (**Annexure "C"**). I attach a photograph which shows the Building Act notice affixed to the building (**Annexure "D"**). A copy of the notice, along with a cover letter dated 29 December 2010, was posted to the building owner's property manager, Ganellen Property Limited (**BUI.CAT032.0010.377-379**).
