**Christchurch Earthquake
CBD Building Performance Technical Investigation**

**Report on the Structural Performance
of the
Hotel Grand Chancellor
in the
Earthquake of 22 February 2011**

Prepared By:
Dunning Thornton Consultants Ltd

Final: 26 September 2011

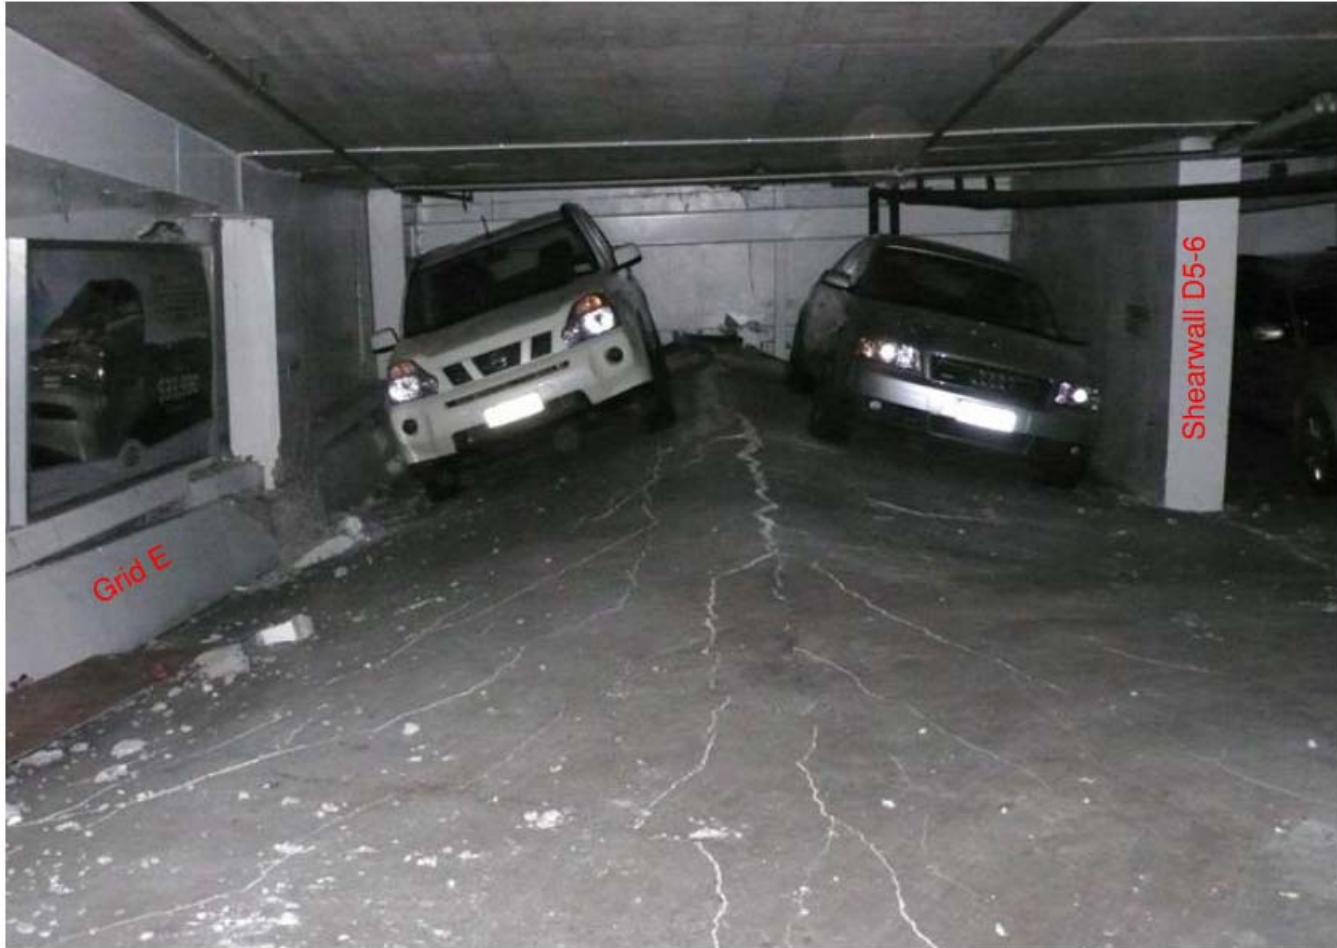
Photo 13 - Folded slab at level 2

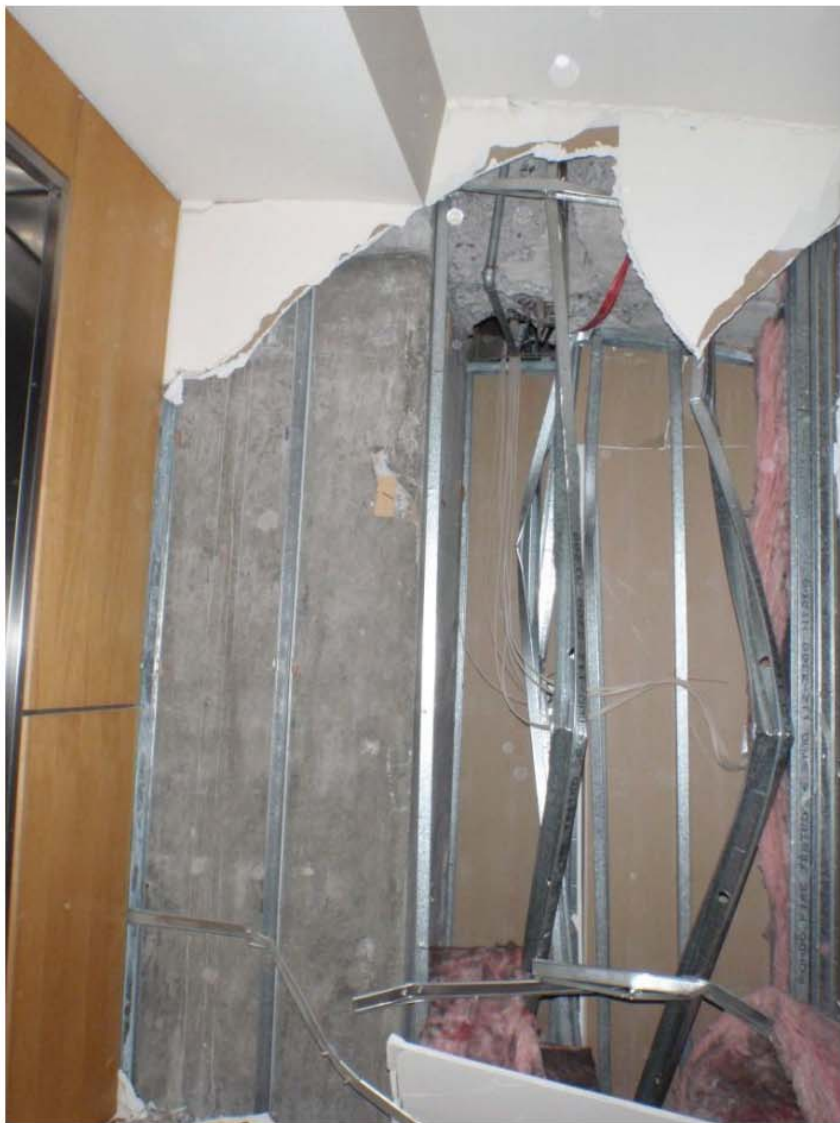
Photo 17 - Hinging in grid D tower beams

Photo 18 - Hinging in grid D tower beams

Photo 19 - Hinging in grid D tower beams

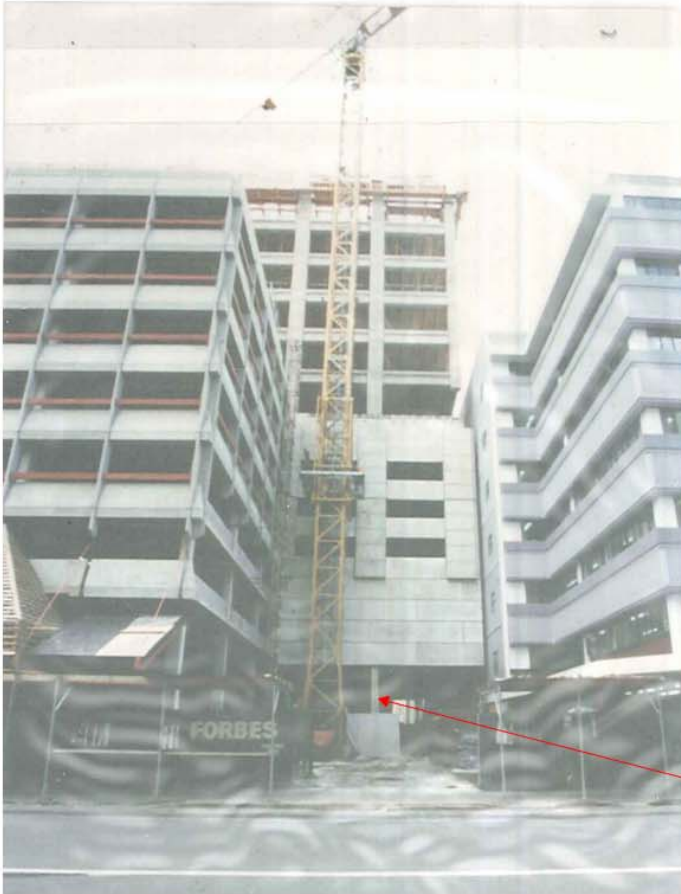
Photo 1 - Southern Elevation - During Construction

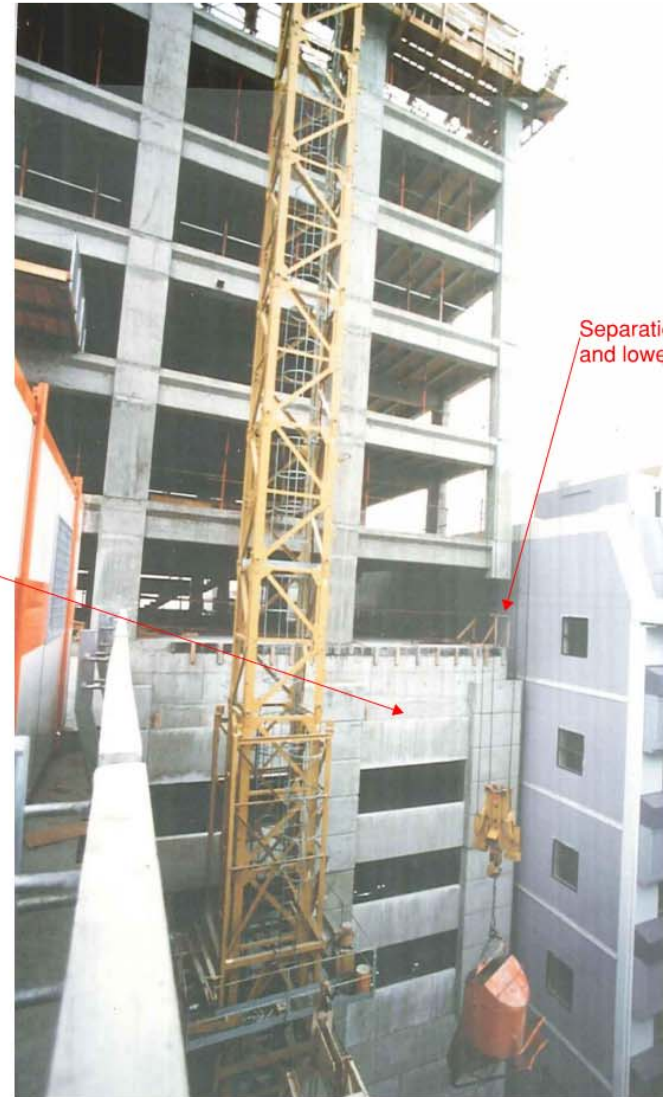
Cantilever
Transfer beam
on Grid 5

Separation between upper
and lower frames on grid E

Shearwall D5-6

Photo 2 - Southern Elevation - During Construction

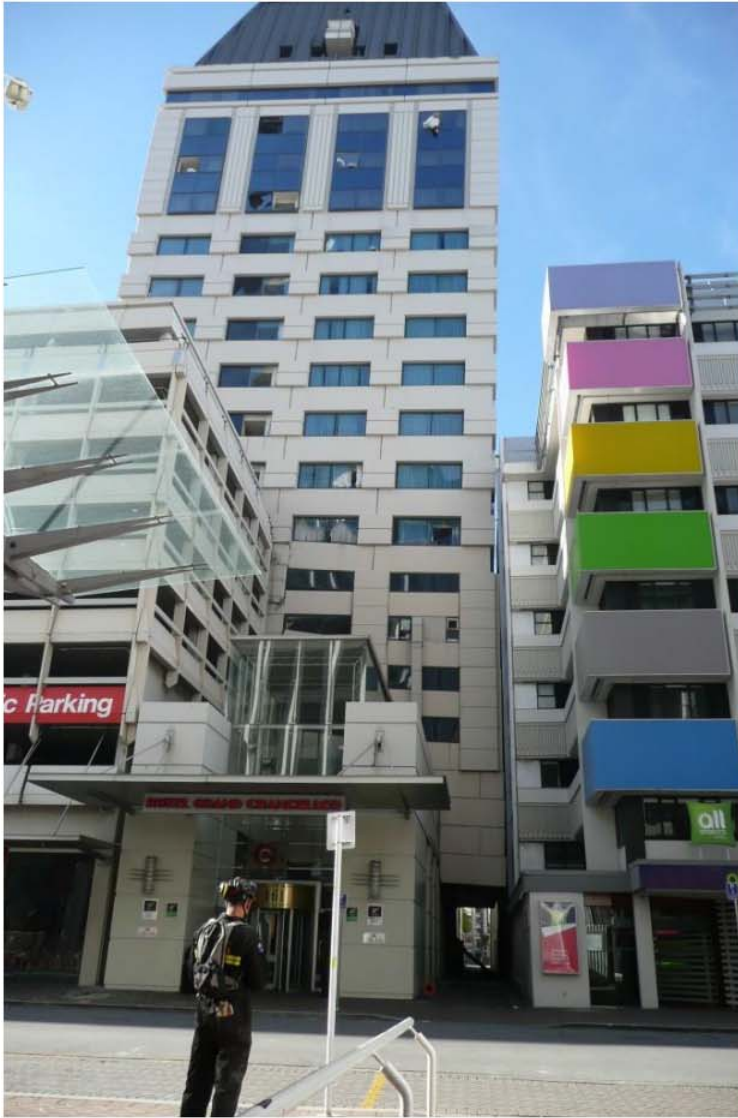
Photo 3 - Southern Elevation - Post February

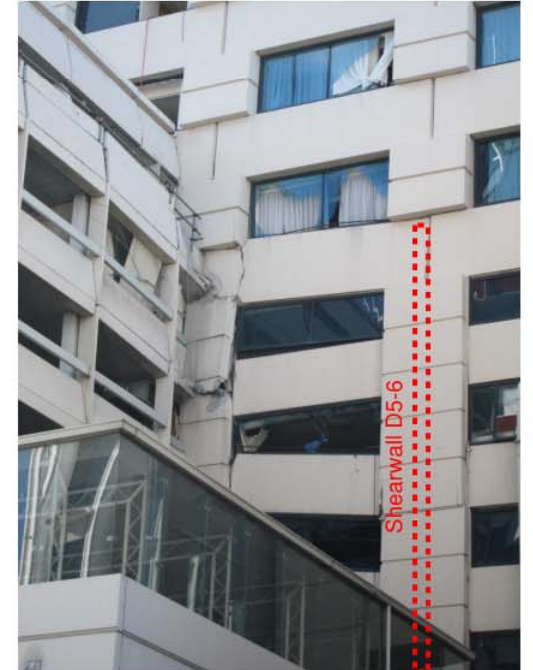
Photo 5 - Damage at junction
between podium and tower -
not related to pounding

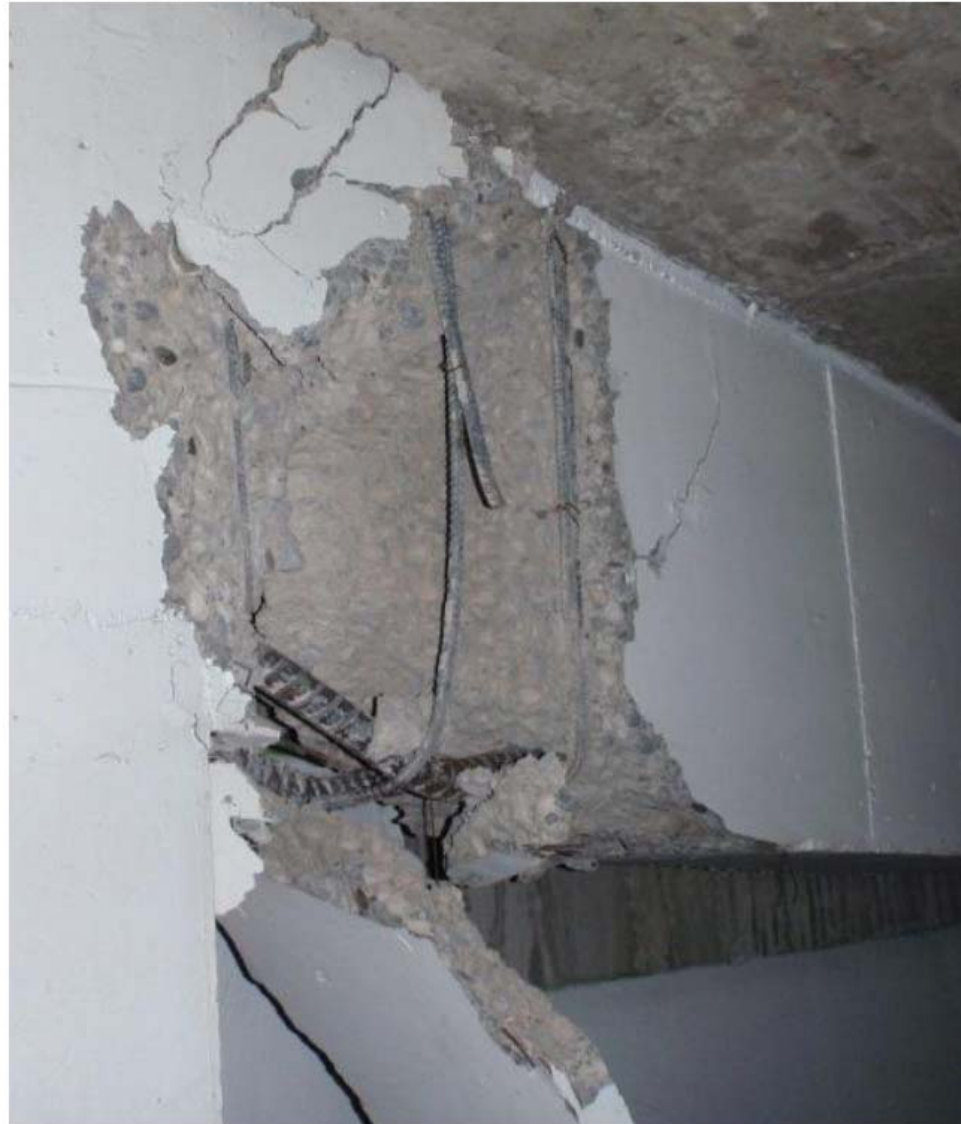
Photo 14 - Hingeing in grid E beams 6-7

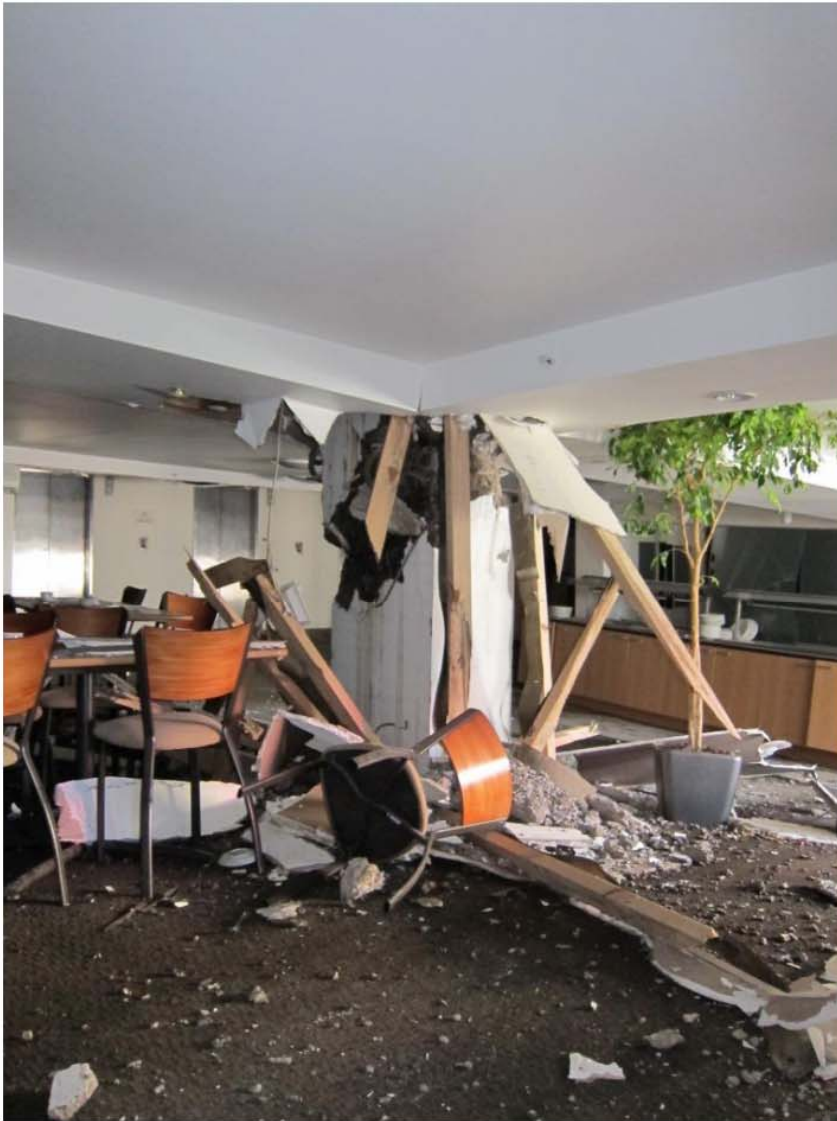
Photo 20 - Crushed columns at level 10, lines 5 & 6

Photo 21 -
Crushed
columns at level
10, lines 5 & 6

Photo 22 -
Crushed
columns at level
10, lines 5 & 6

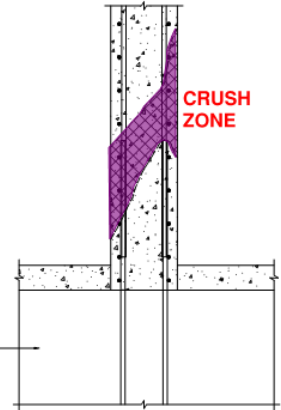
CROSS-SECTION SHOWING FAILURE MODE

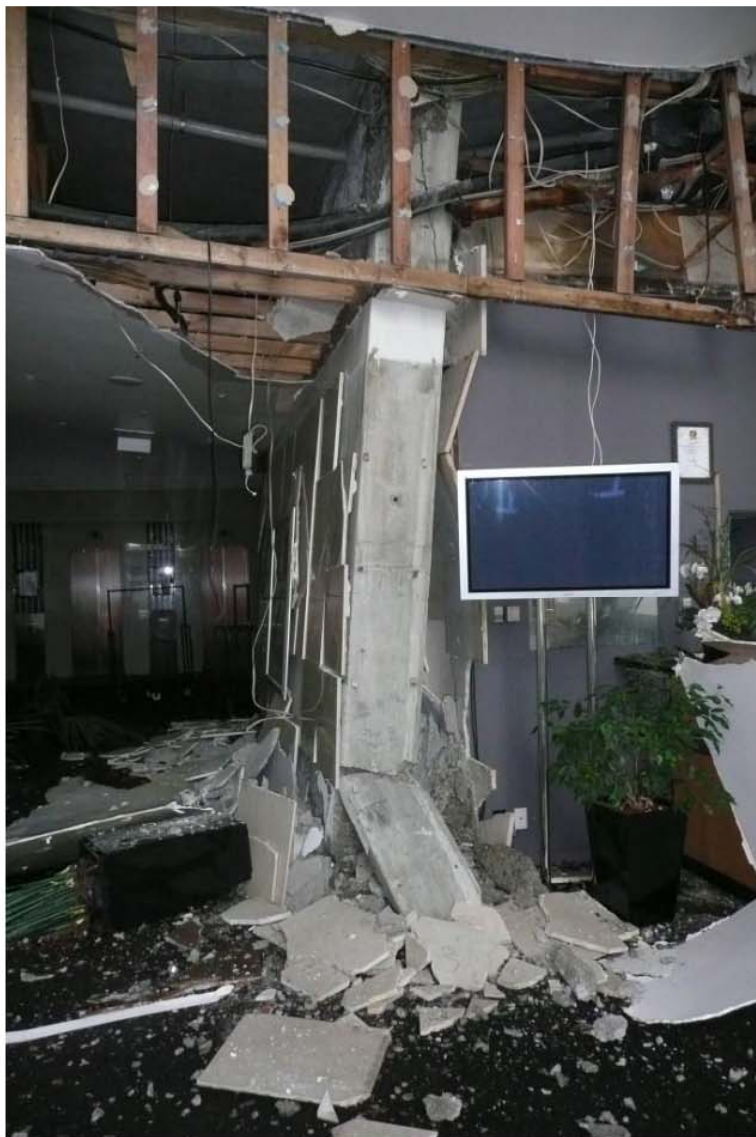
Photo 6 - Shearwall D5-6 - Base Failure

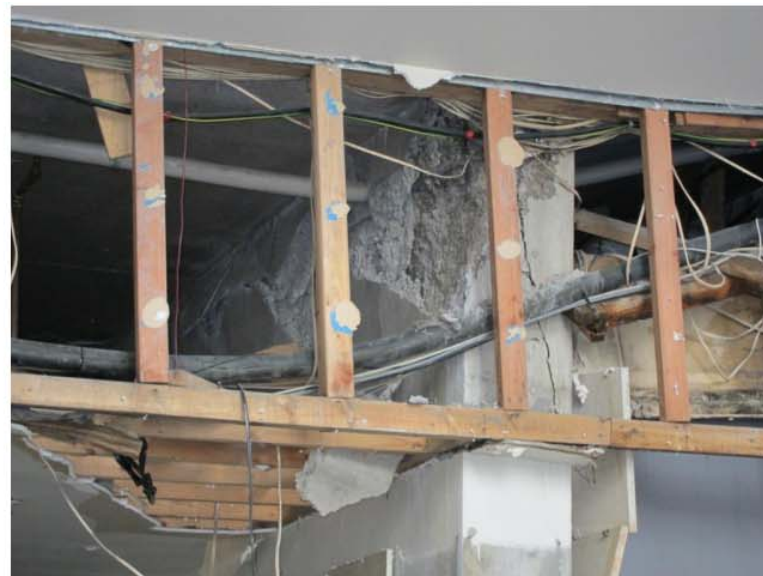
Photo 7 - Shearwall D5-6 - Hingeing at top of ground floor

Photo 8 - Shearwall D5-6 - Hingeing at top of ground floor

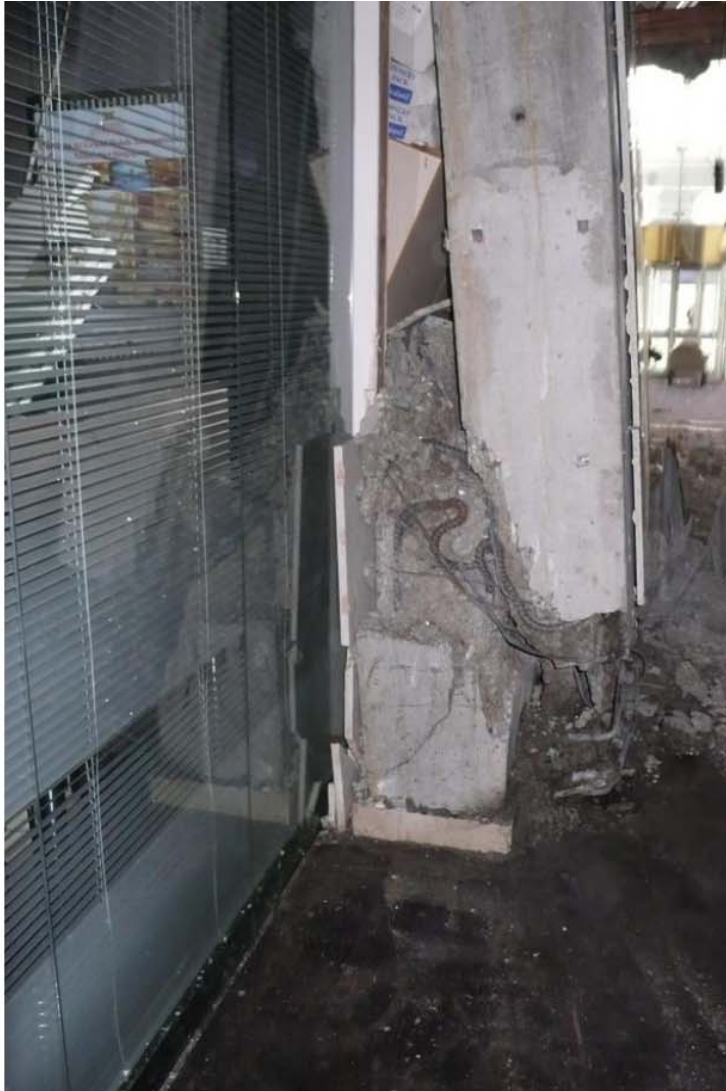
Photo 9 - Shearwall D5-6 Failure - End View

Brittle, transverse failure,
absence of confinement

Lapped reinforcing

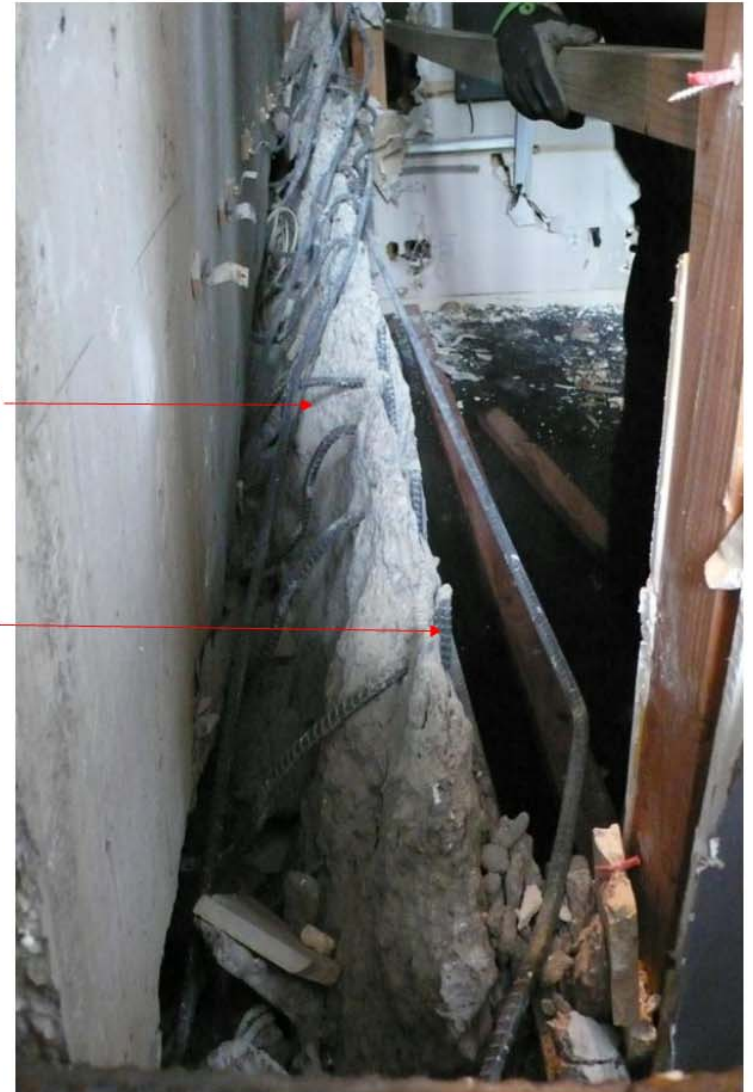
Photo 10 - Shearwall D5-6 Failure - Close-up

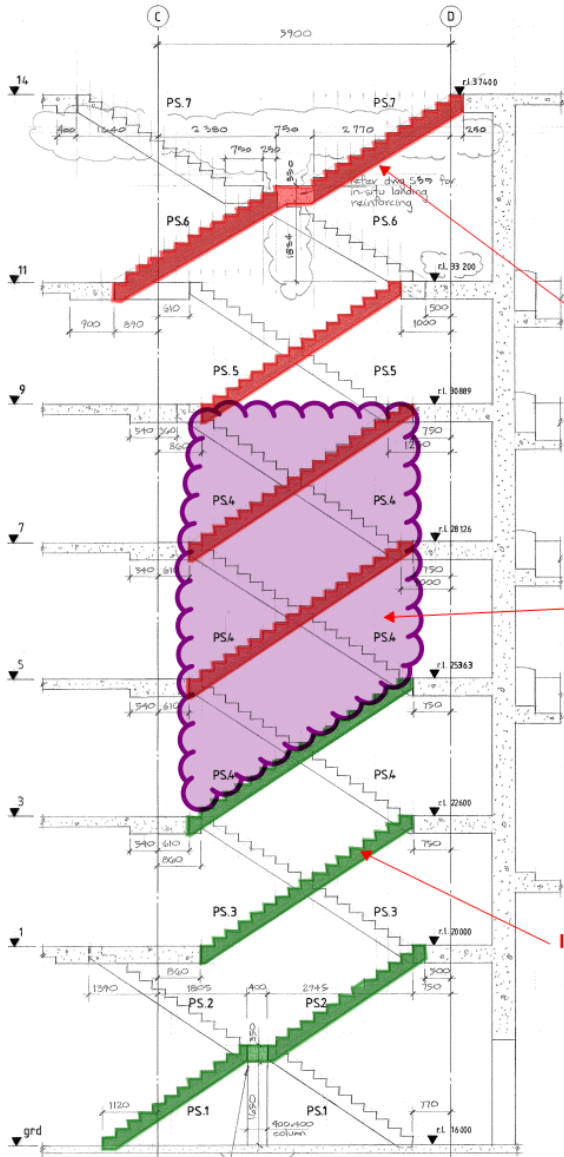
COLLAPSED STAIR
FLIGHTS

STAIR FLIGHT
DEBRIS

INTACT STAIR
FLIGHTS

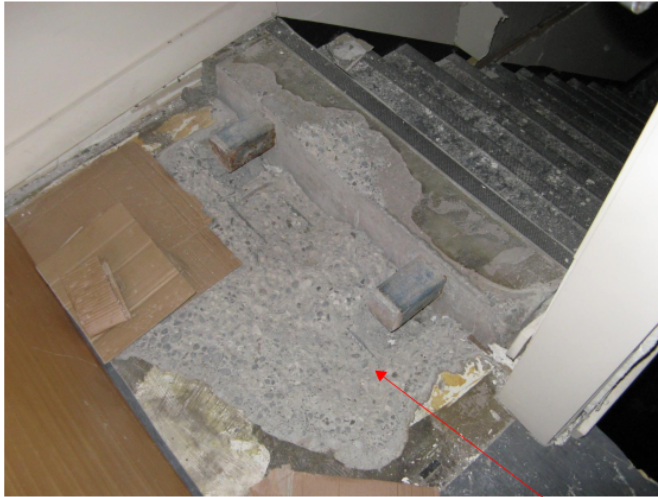
Photo 23 - Top of intact stair flight

Landing damage

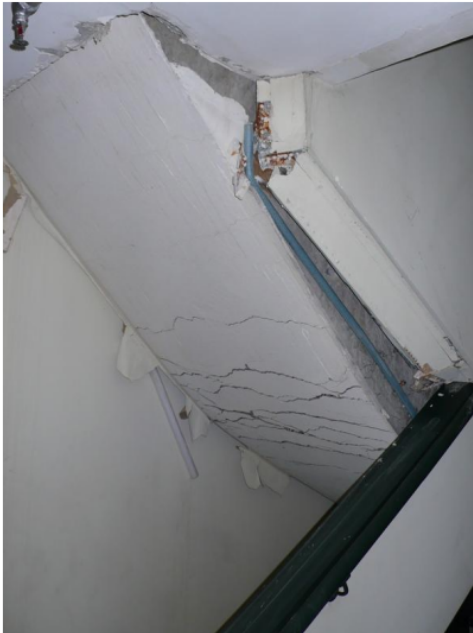
Photo 24 -
Highest surviving
stair, supporting
debris

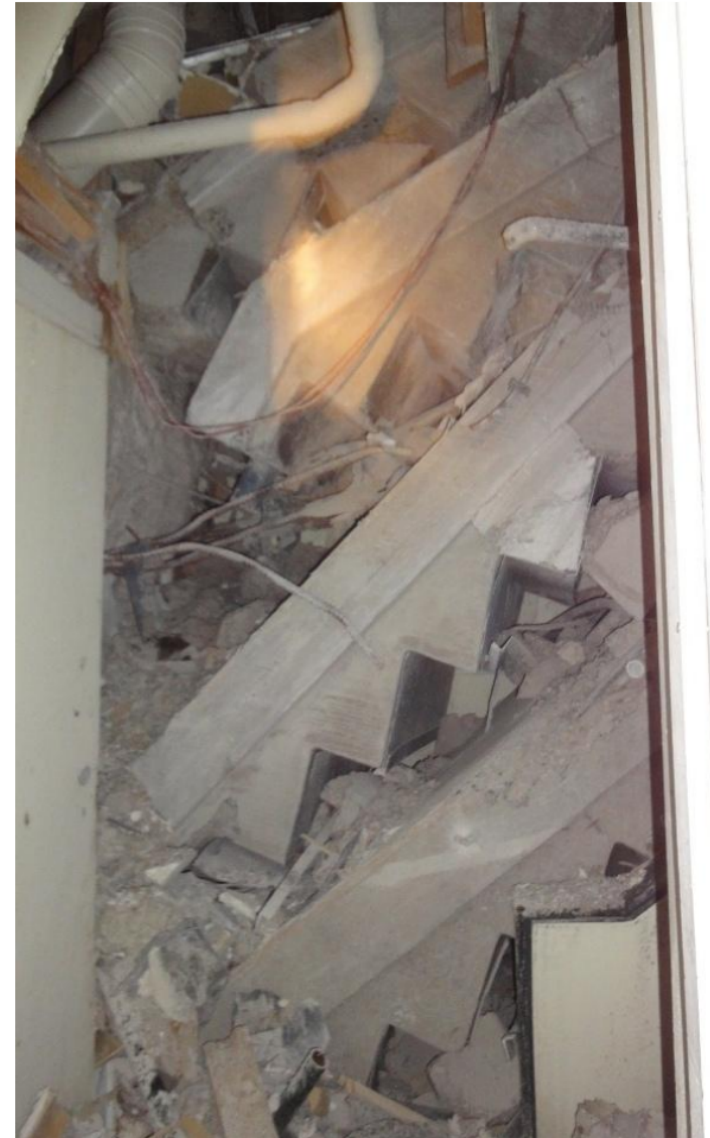
Photo 25 - Stair Debris
