**From:** Glen McConnell [ | ]  
**Sent:** Wednesday, 18 January 2012 12:04 a.m.  
**To:** Mark Zarifeh  
**Subject:** Report for Commission

Hi Mark, the following is a summation of my involvement in the events leading to the collapse of 116 Lichfield st (Reuben Blades)

## engineer's instruction

project 116 Lichfield St.

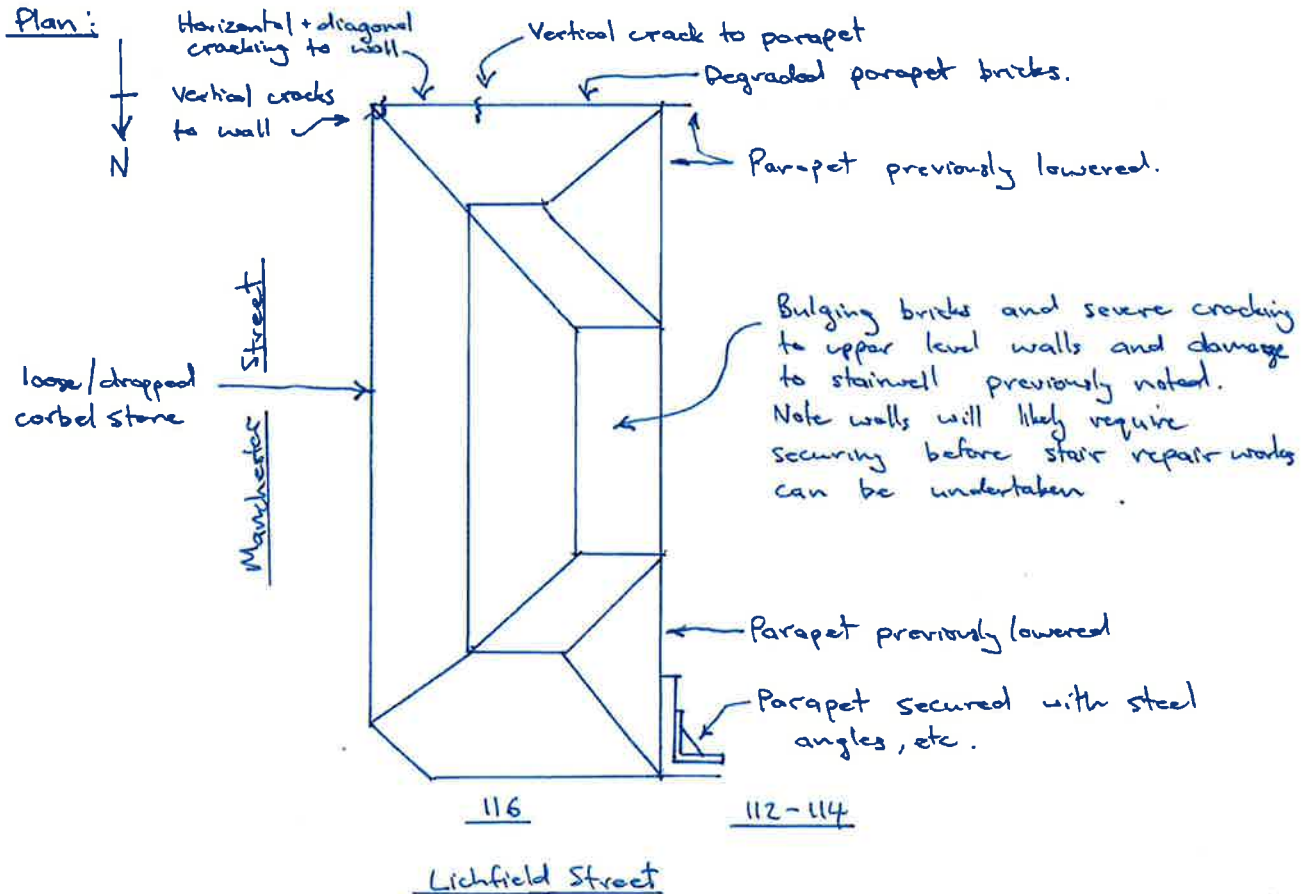
Following advice from contractor we have revisited the property to view further damage from recent earthquakes.

These high level bricks and stone blocks are potential fall hazards to the areas directly adjacent and should be secured as soon as possible, (or the fall areas cordoned off).

We suggest securing works be undertaken as per attached (contractor to wait for insurer approval).

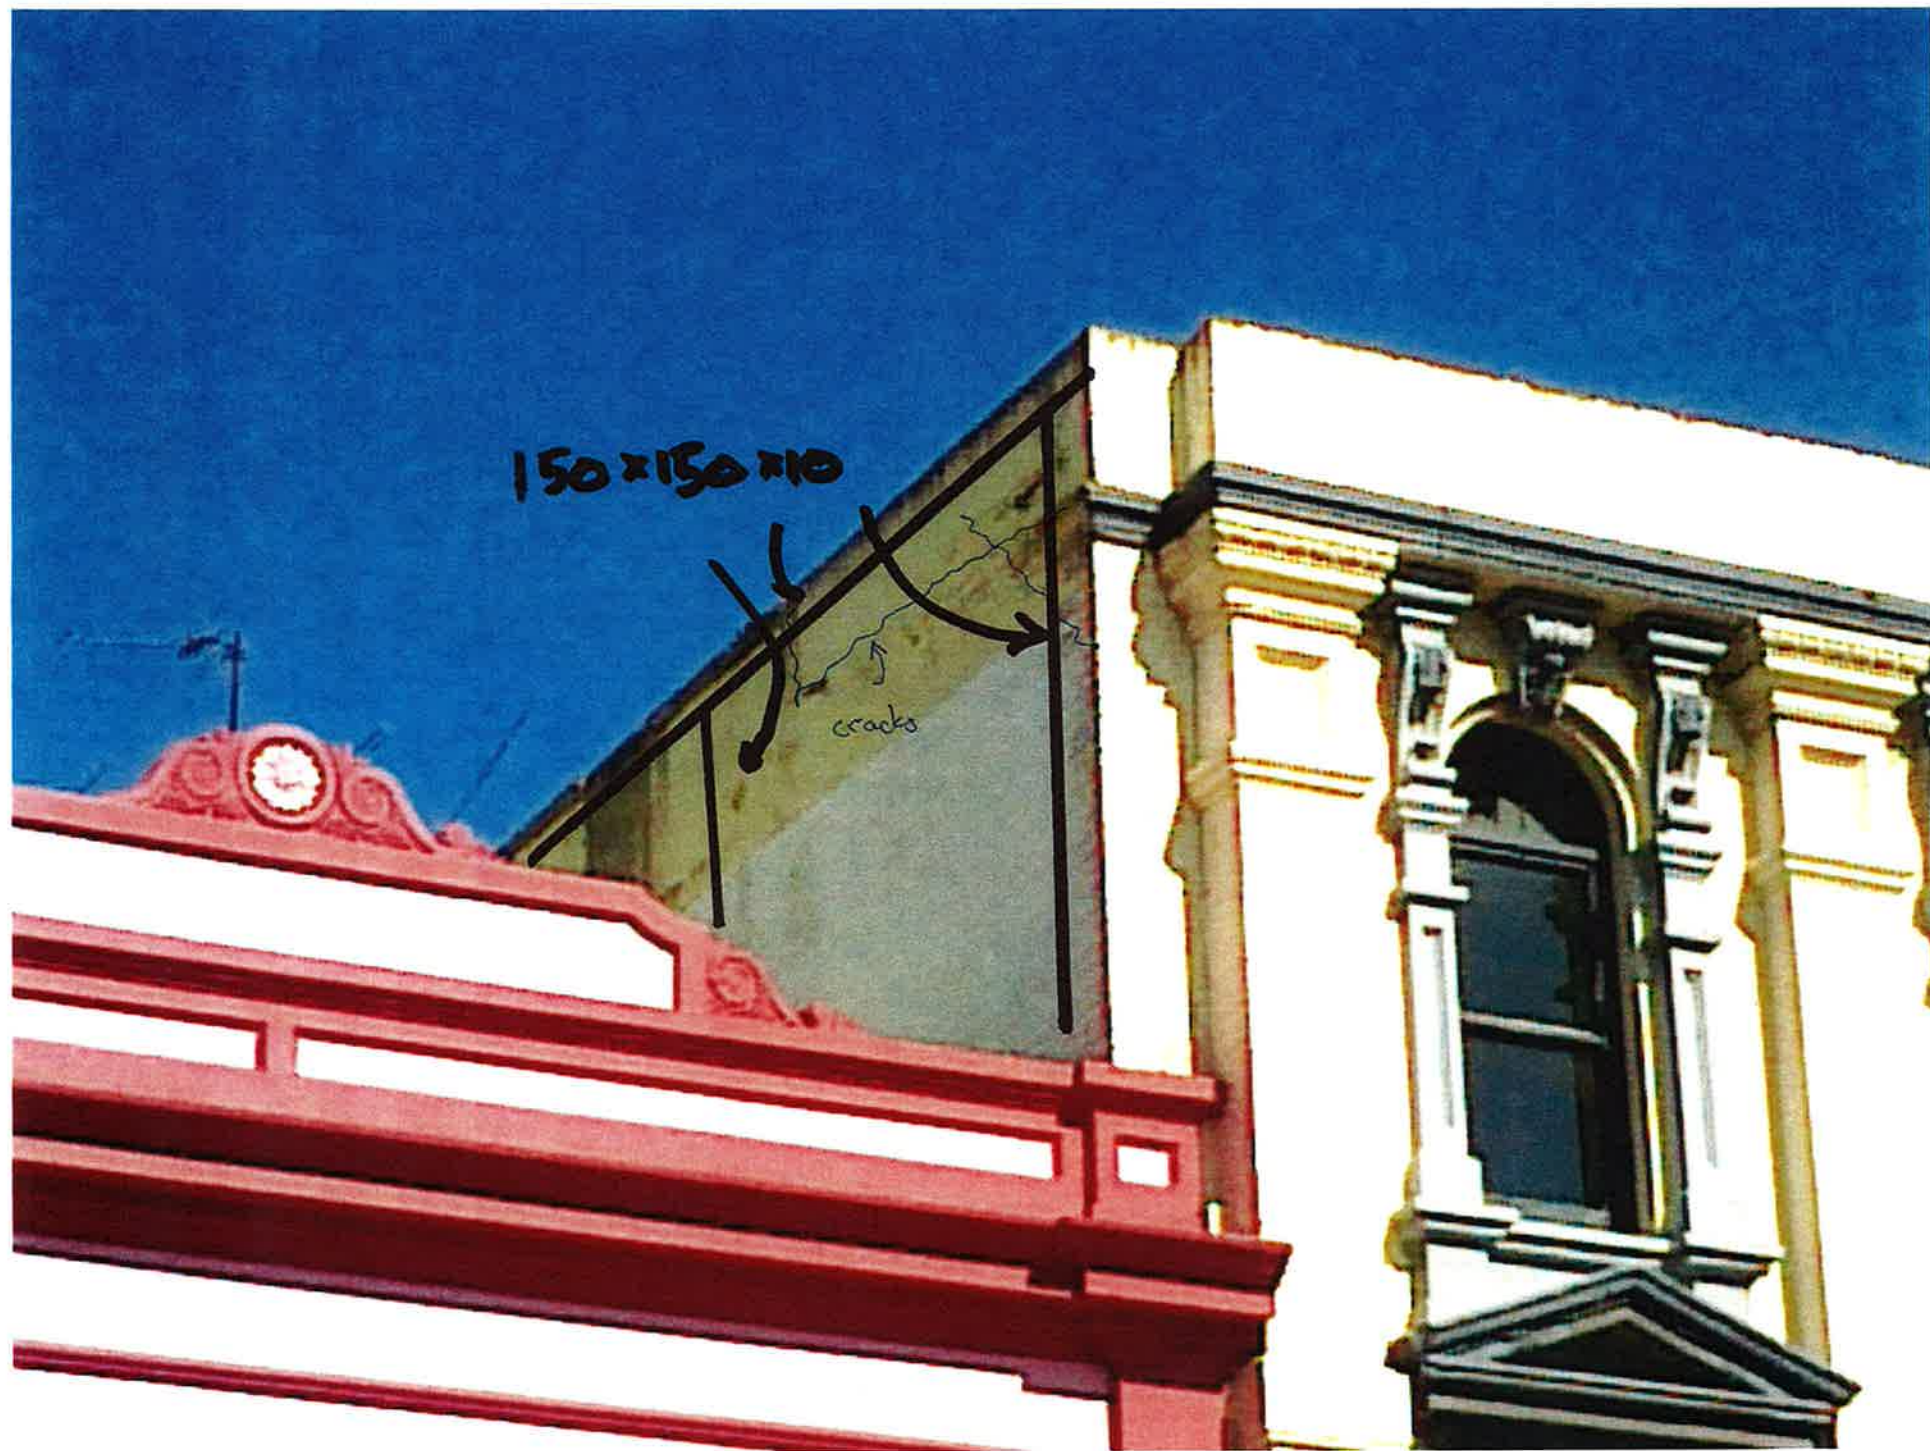
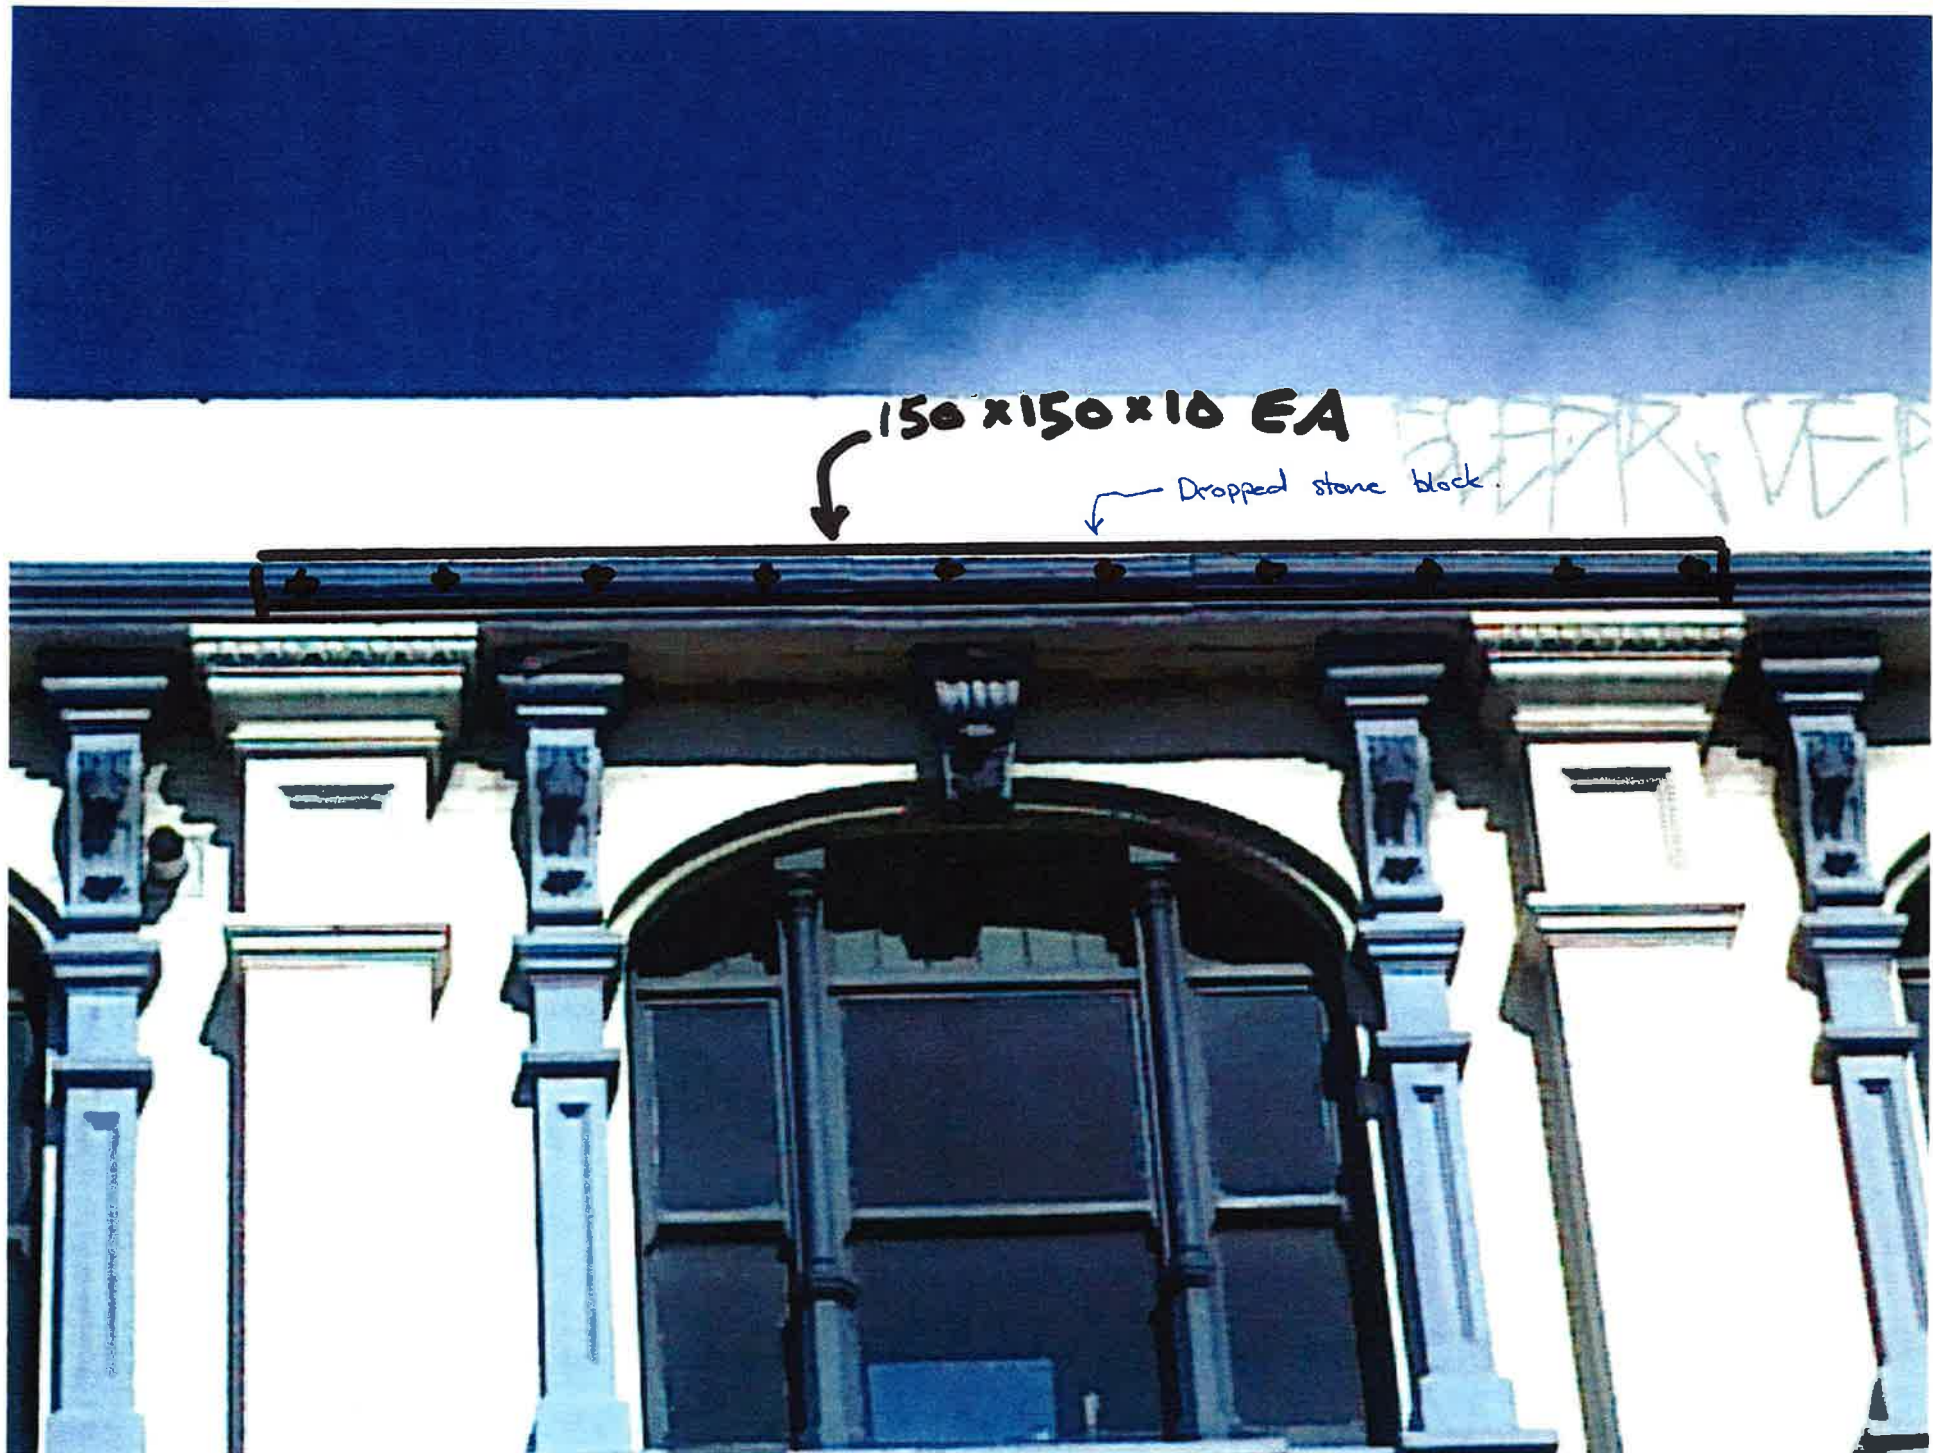
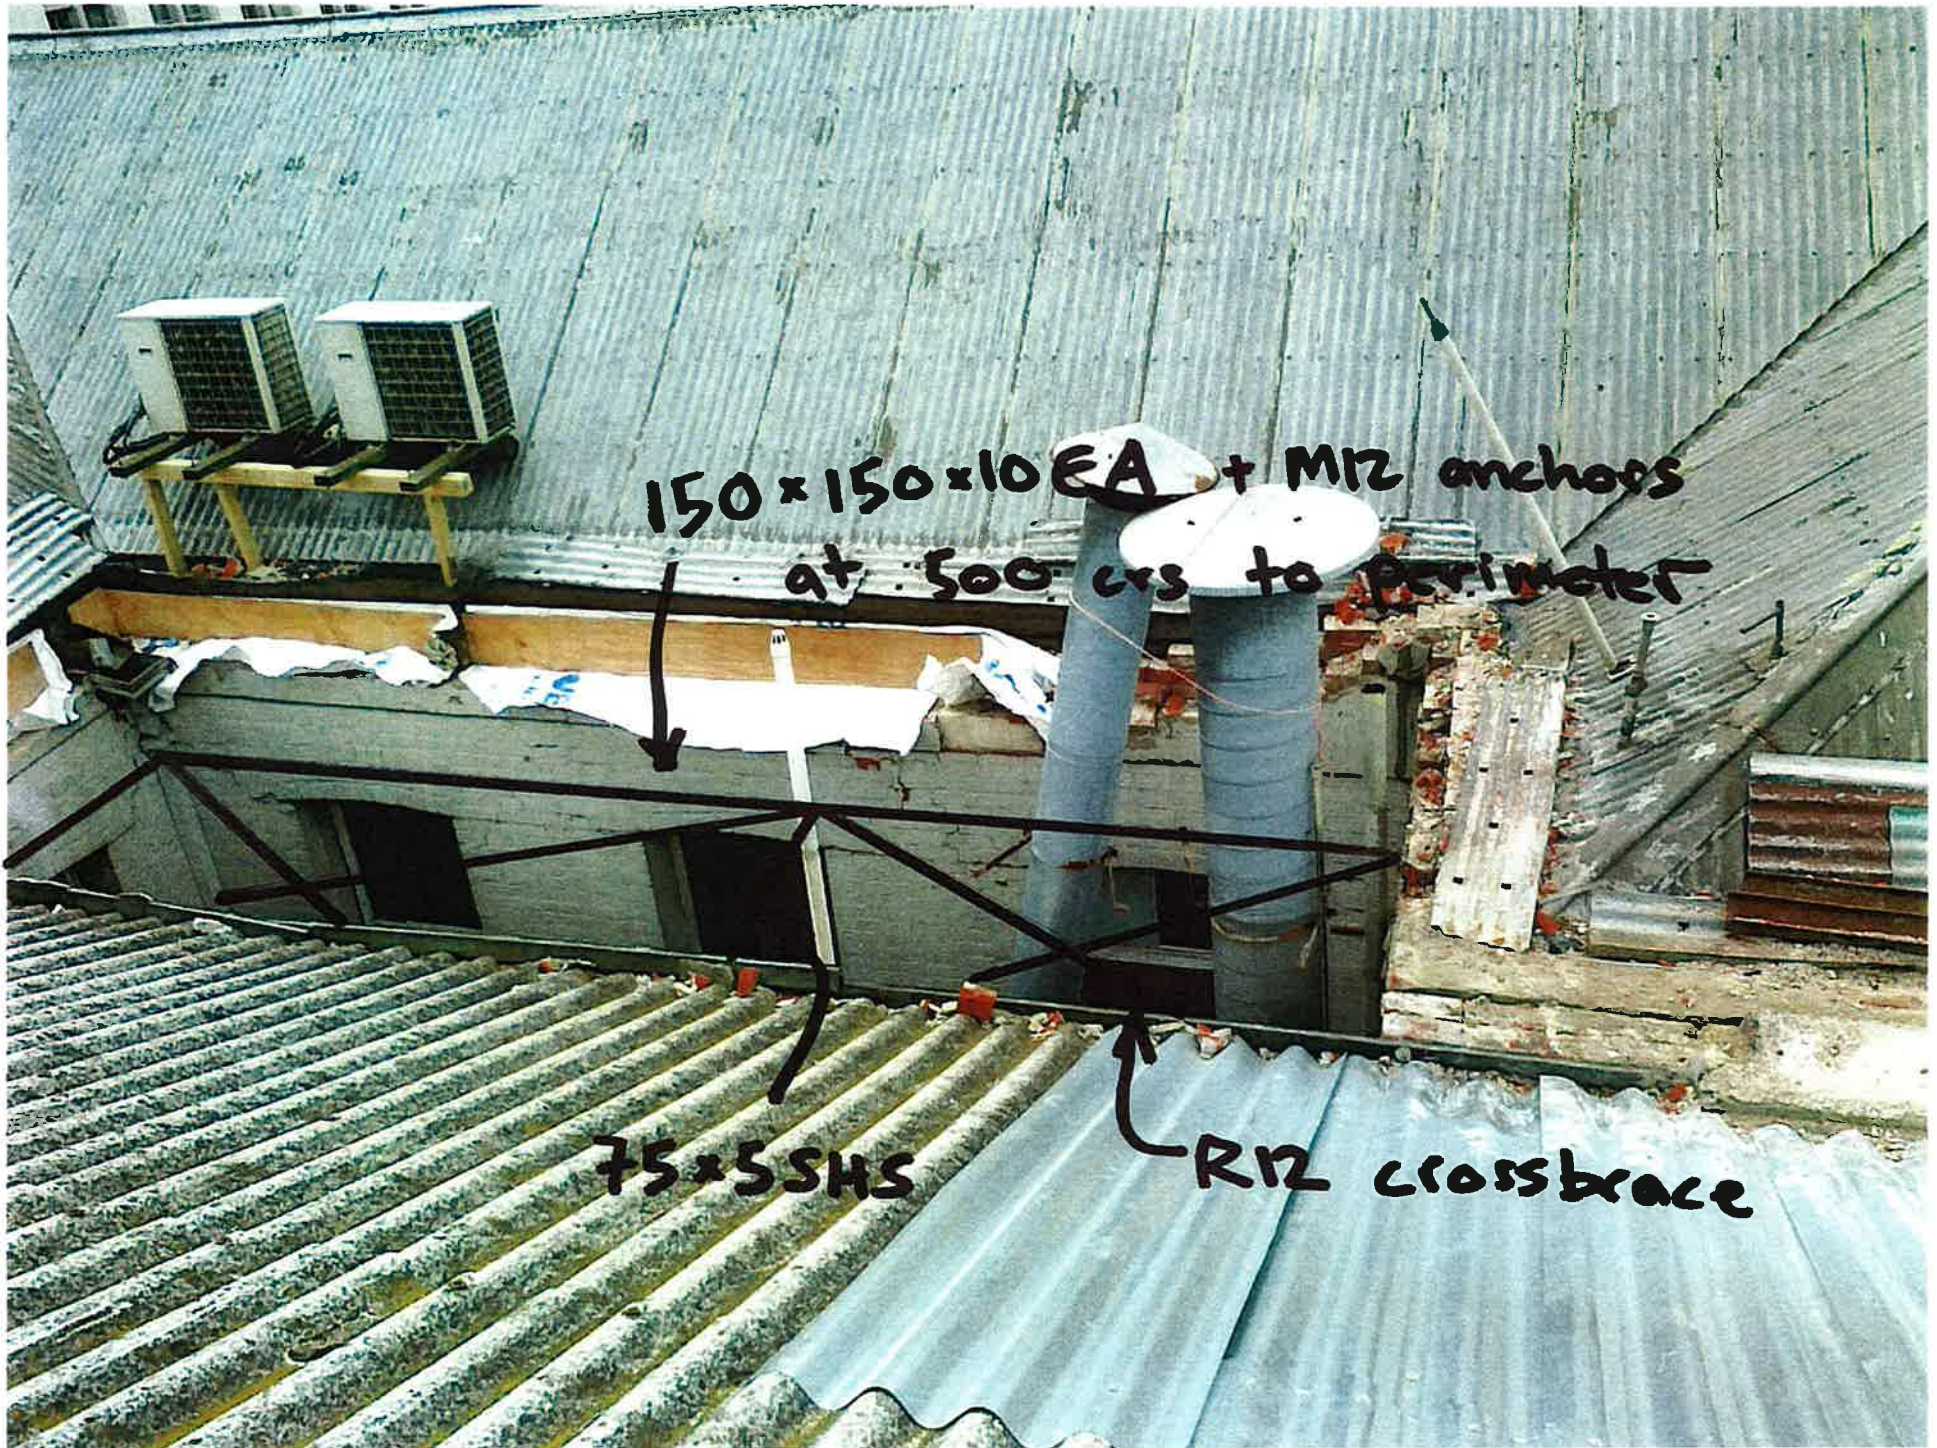
cracks

Refer also to marked up photos

150 x 150 x 10

150 x 150 x 10 EA + M12 anchors  
at 500 c/s to perimeter

75 x 5 SHS

R12 crossbrace

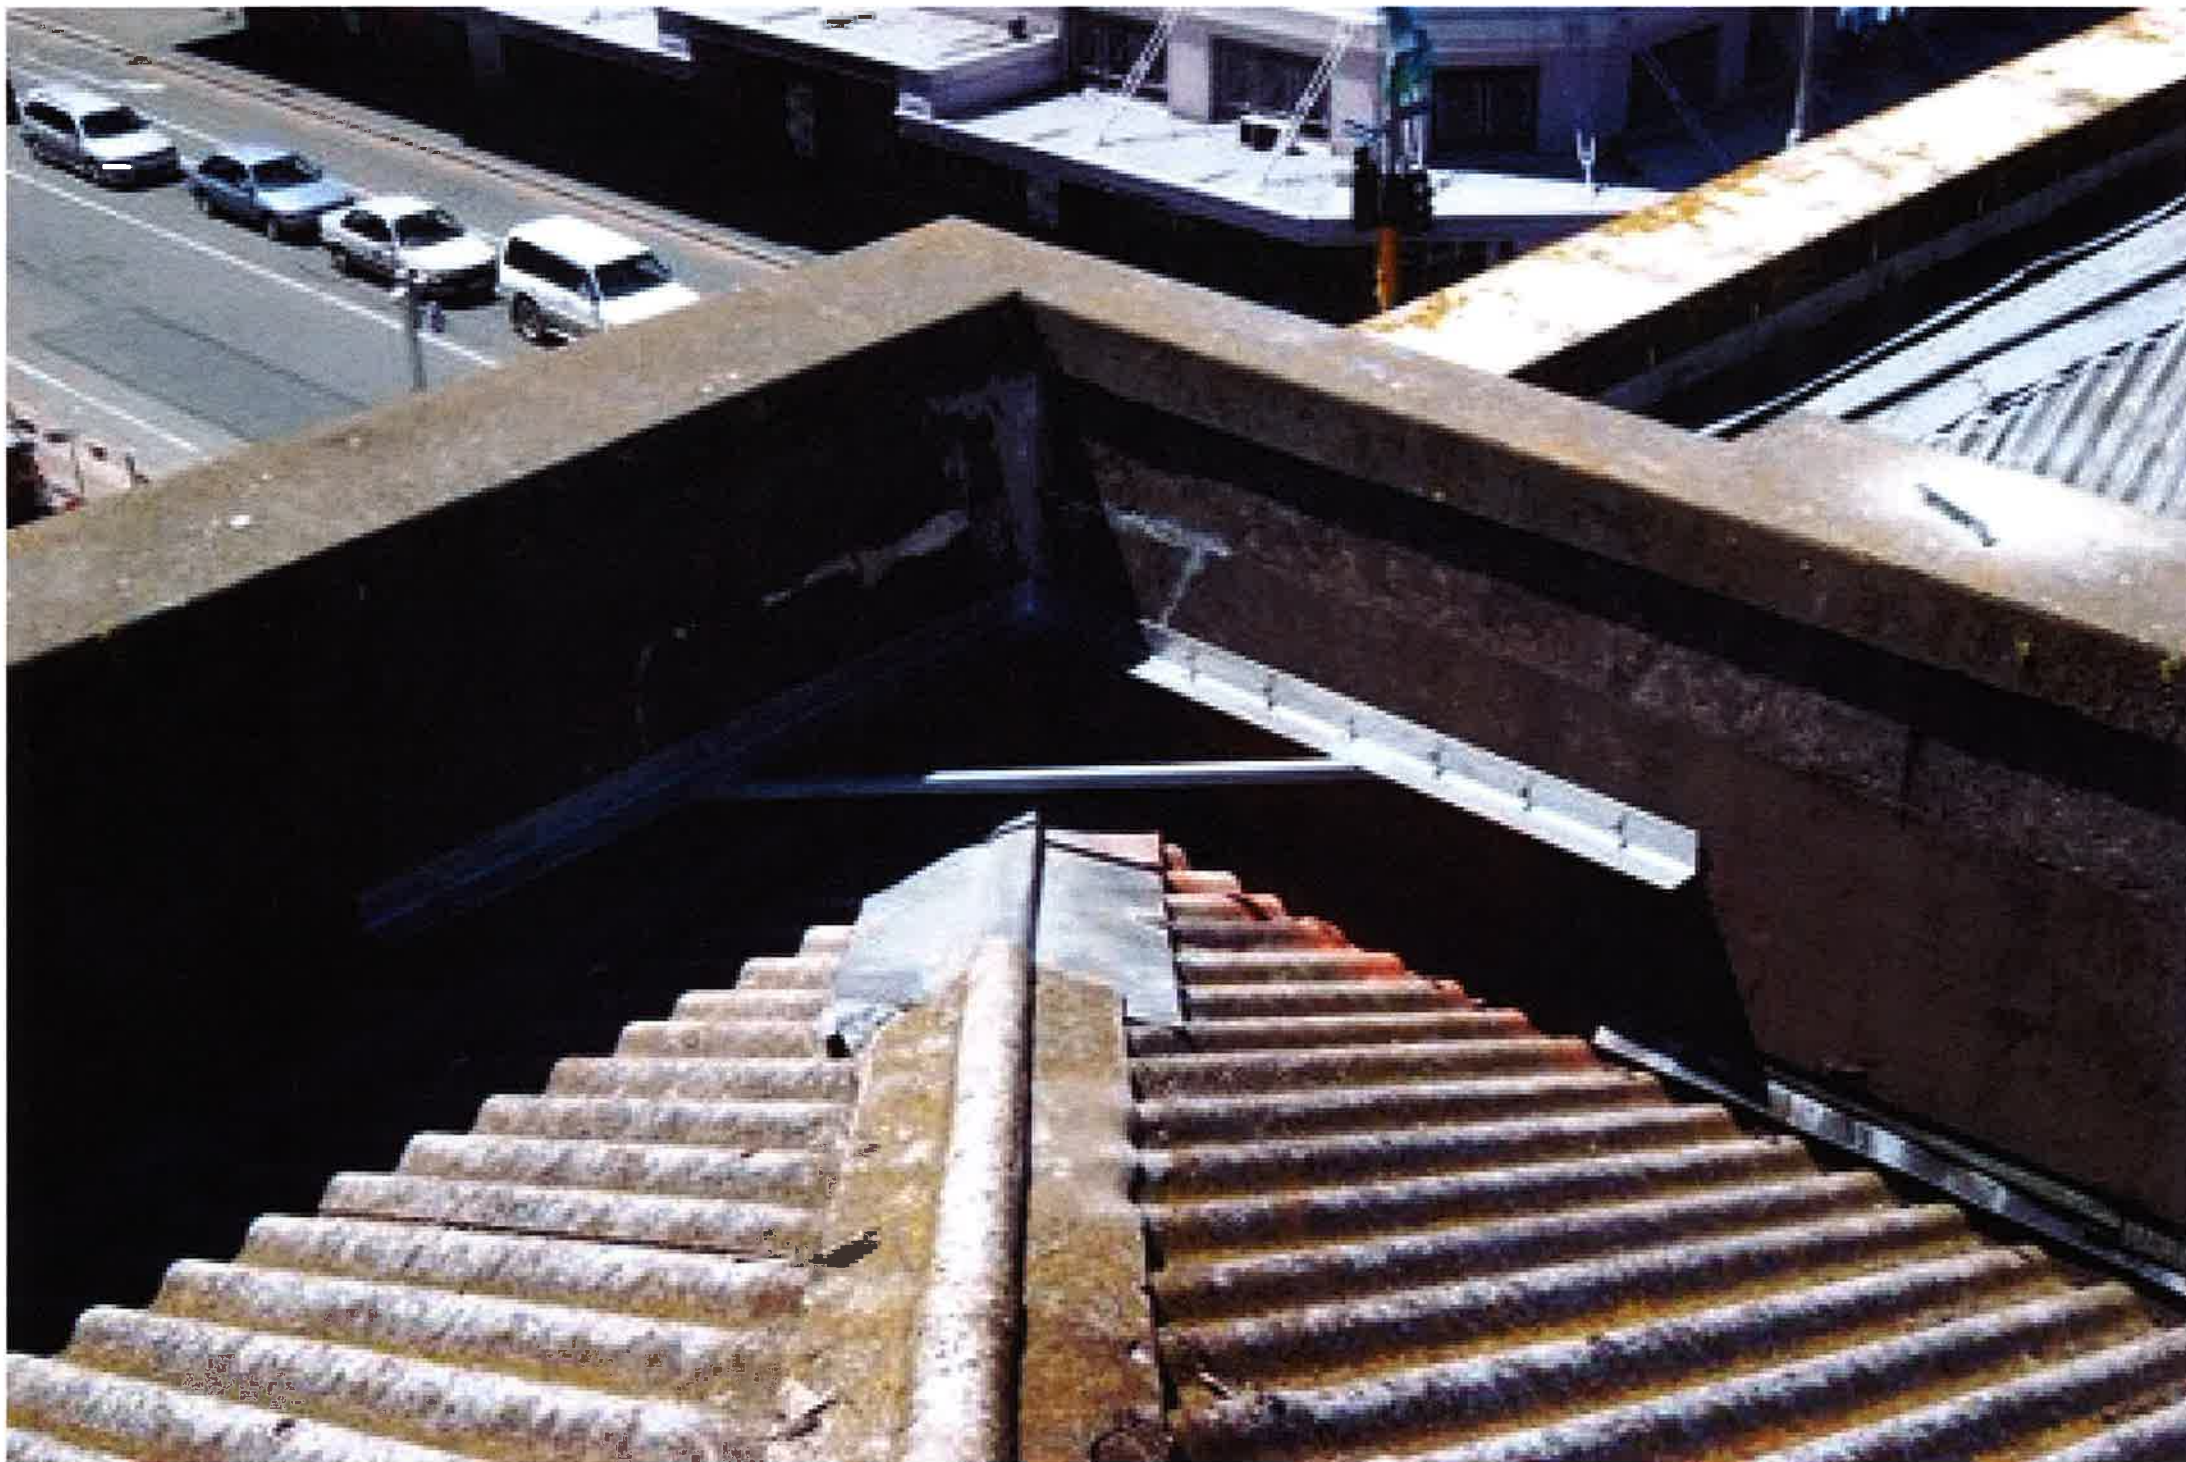
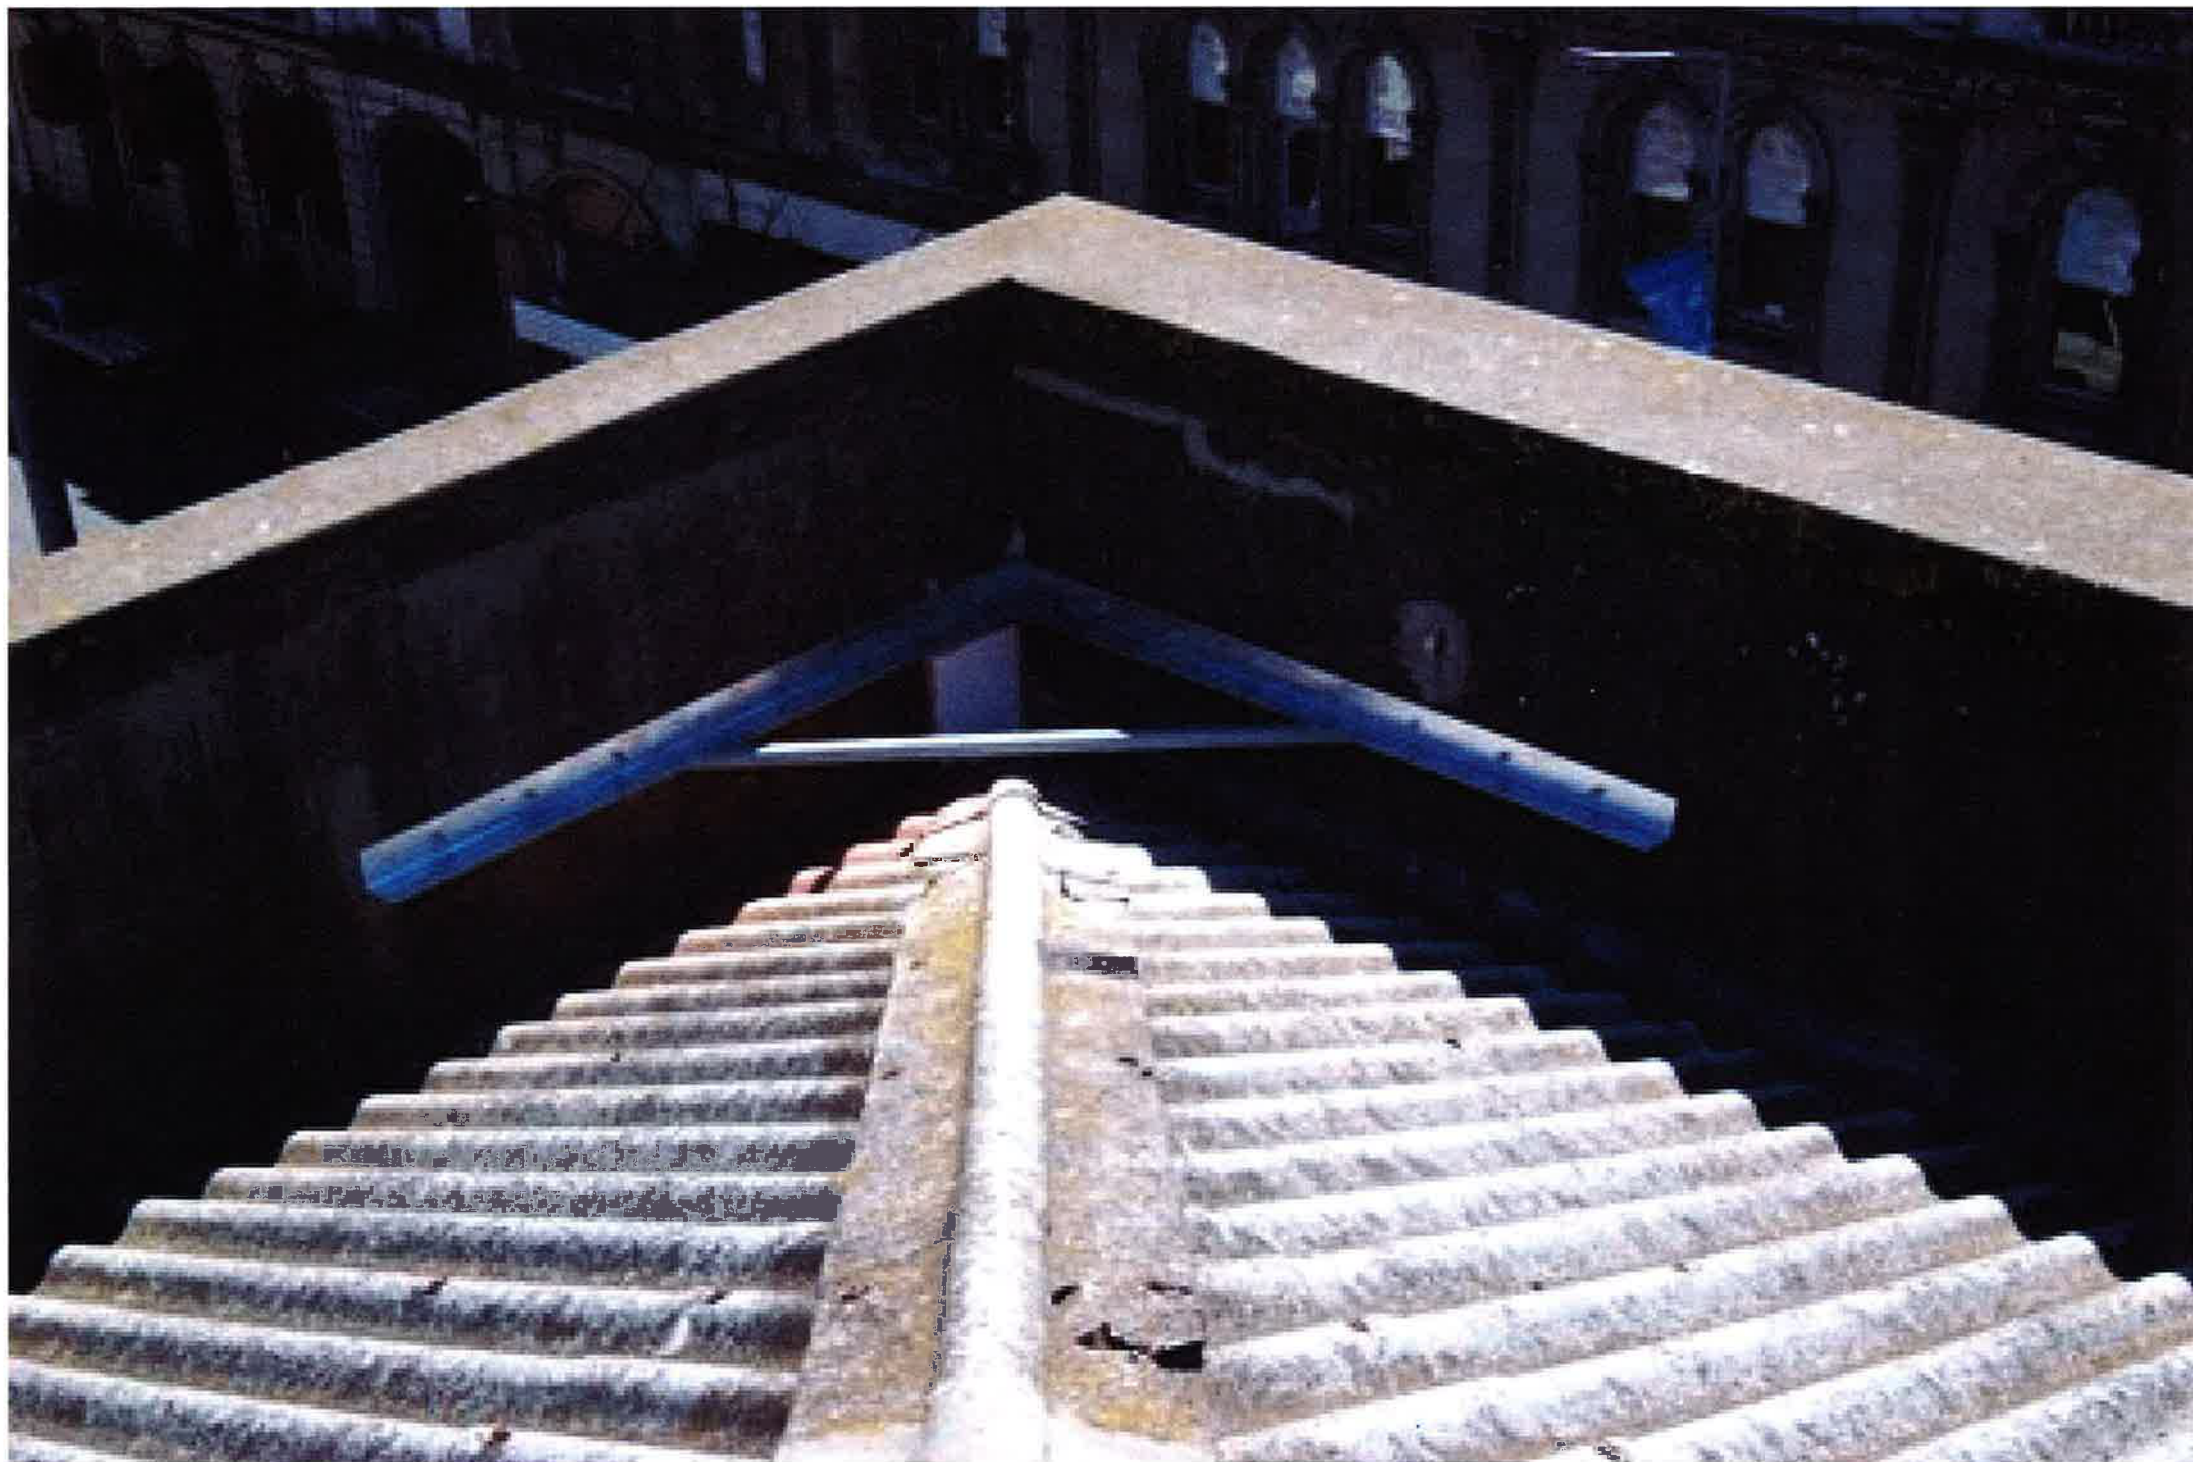
Mark, this may have some relevance - its an email showing the strengthening we had completed on the party wall between 112 & 116 Lichfield St. This held in the quake & was later pulled apart by Southern Demolition as they removed 116 (Reuben Blades)

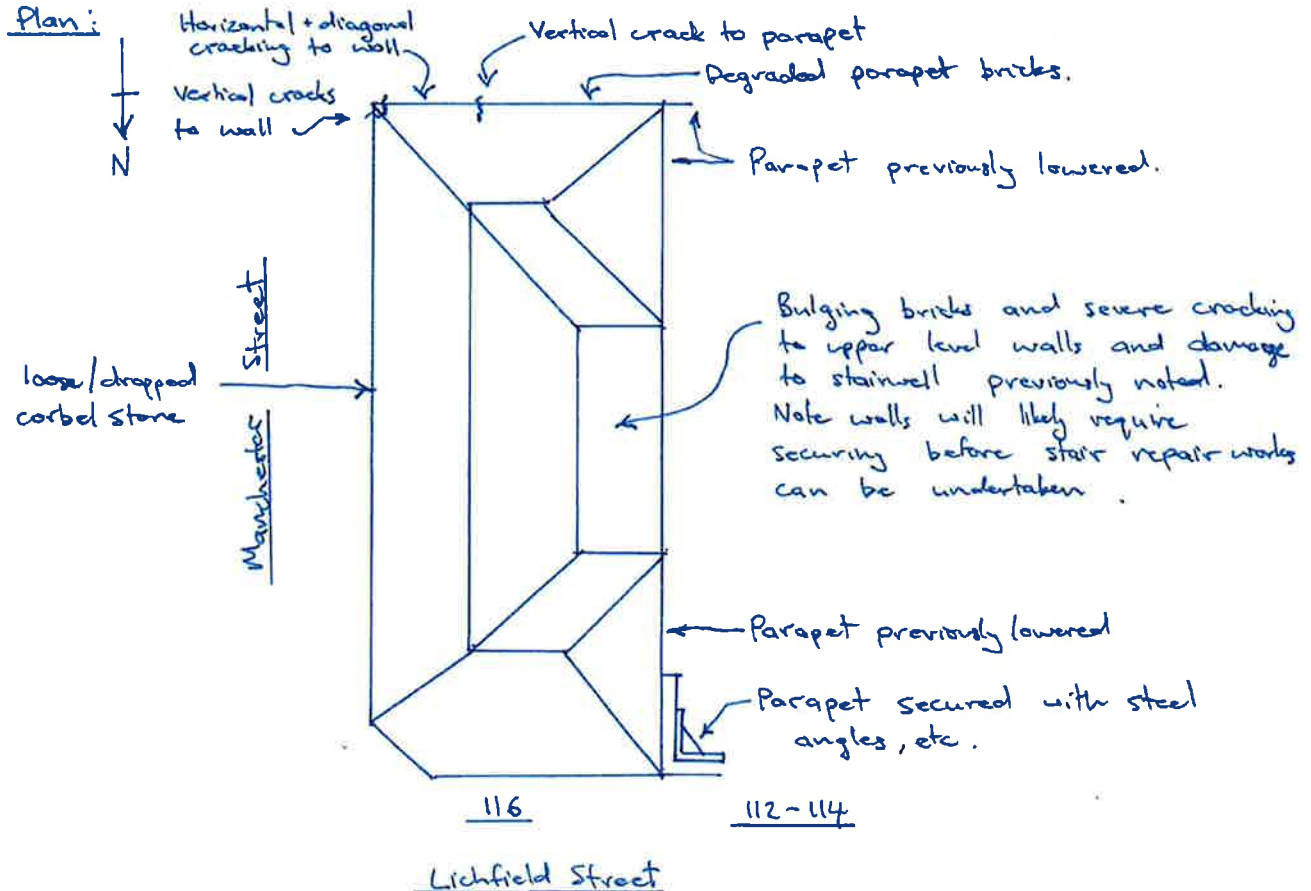
Following advice from contractor we have revisited the property to view further damage from recent earthquakes.

These high level bricks and stone blocks are potential fall hazards to the areas directly adjacent and should be secured as soon as possible, (or the fall areas cordoned off).

We suggest securing works be undertaken as per attached (contractor to wait for insurer approval).
