Brief of evidence of Andrew Brown - 91 Cashel Street

3. On 27 December 2010 I was orally instructed by the owner of buildings at 93 and 89 Cashel Street, to inspect and design securing work for the parapets to 91 Cashel Street (the '**Building**') which had been identified as hazardous by Christchurch City Council. Building Act notices had been served on 89A and 95 Cashel Street due to the danger posed from the 91 Cashel Street roof parapet over the Cashel Street elevation. The scope of my work

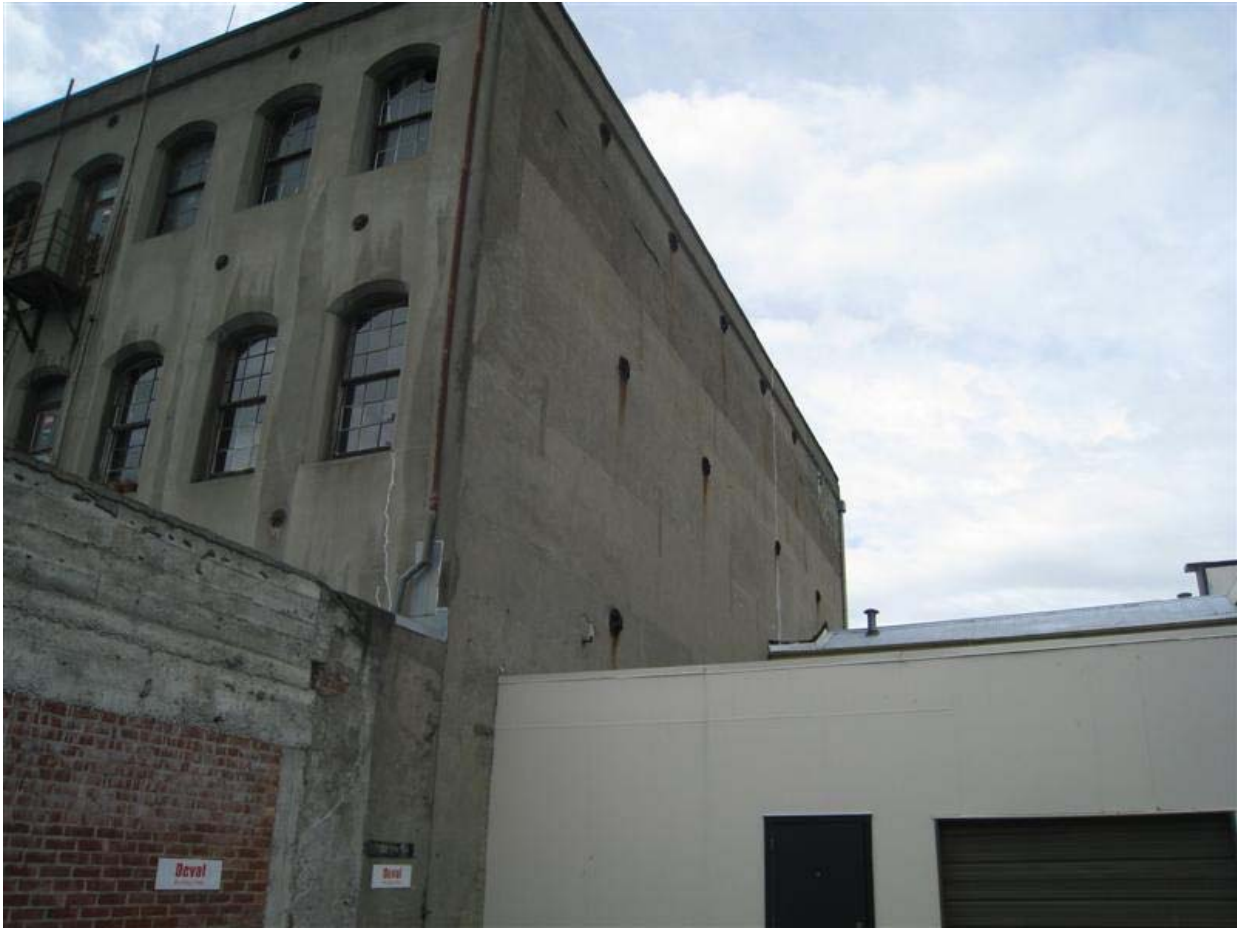
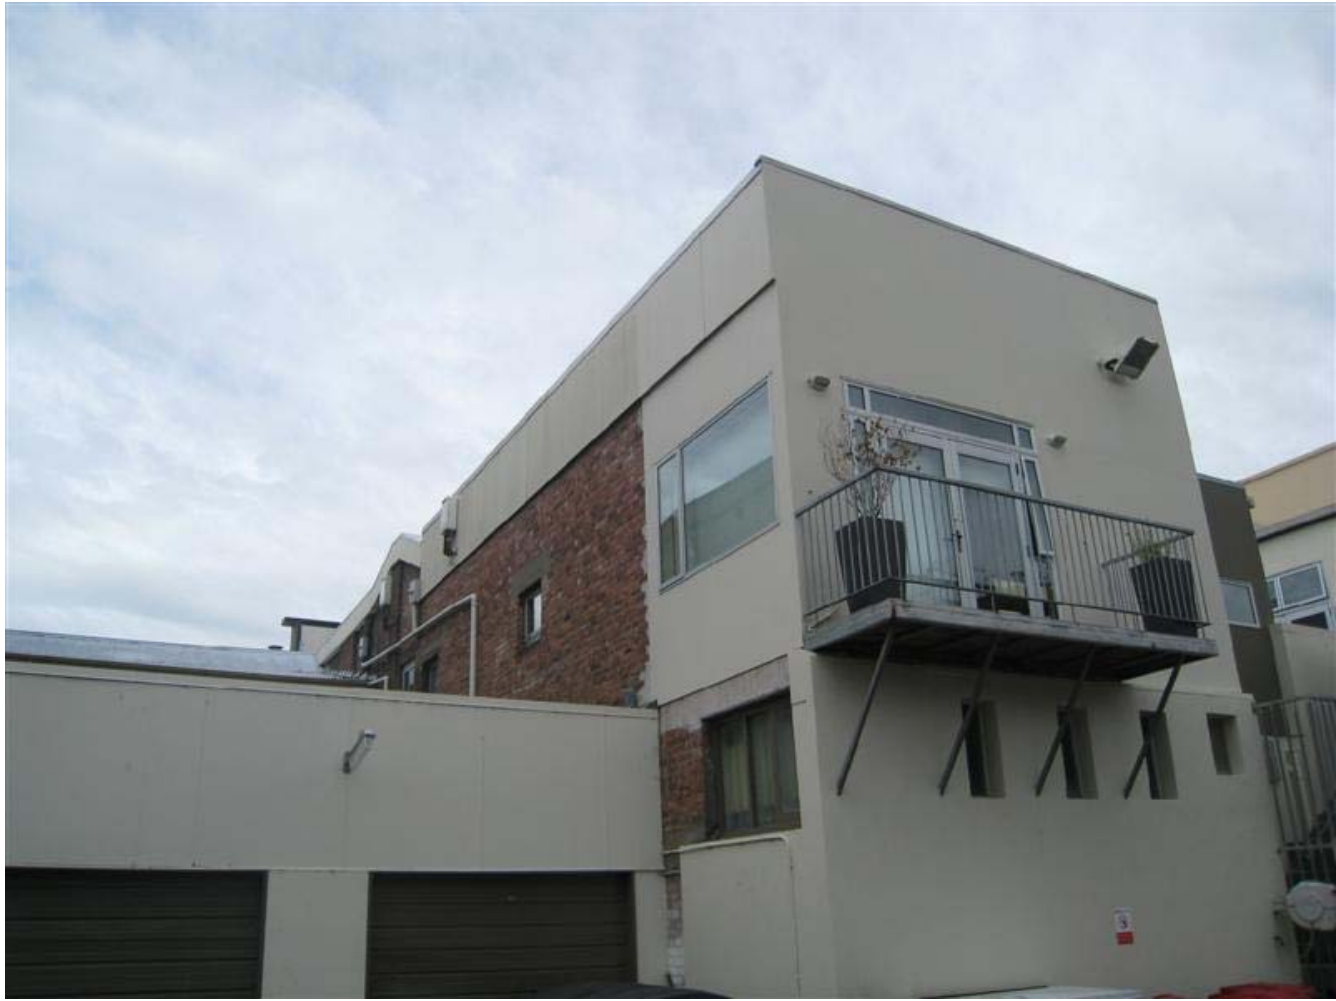
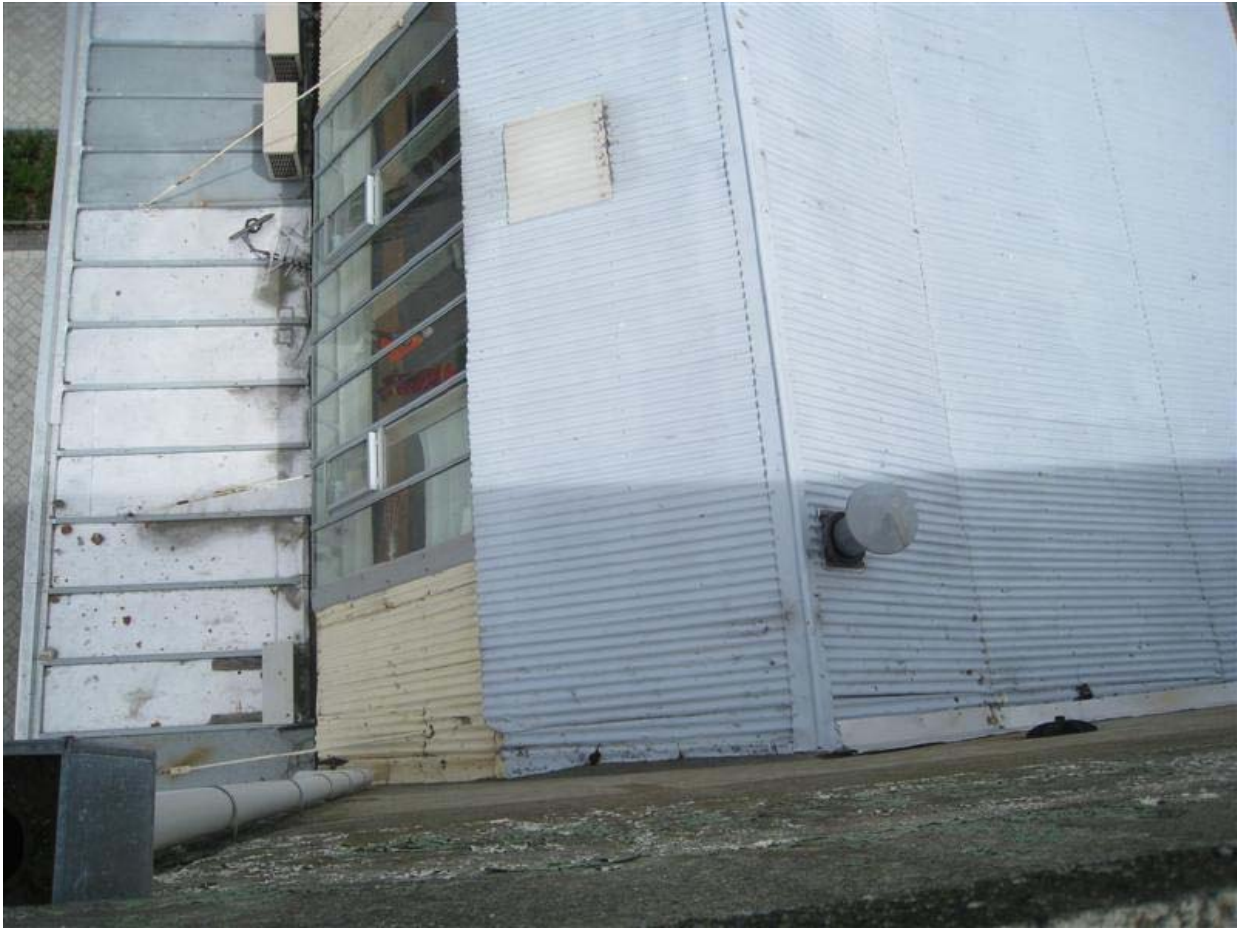
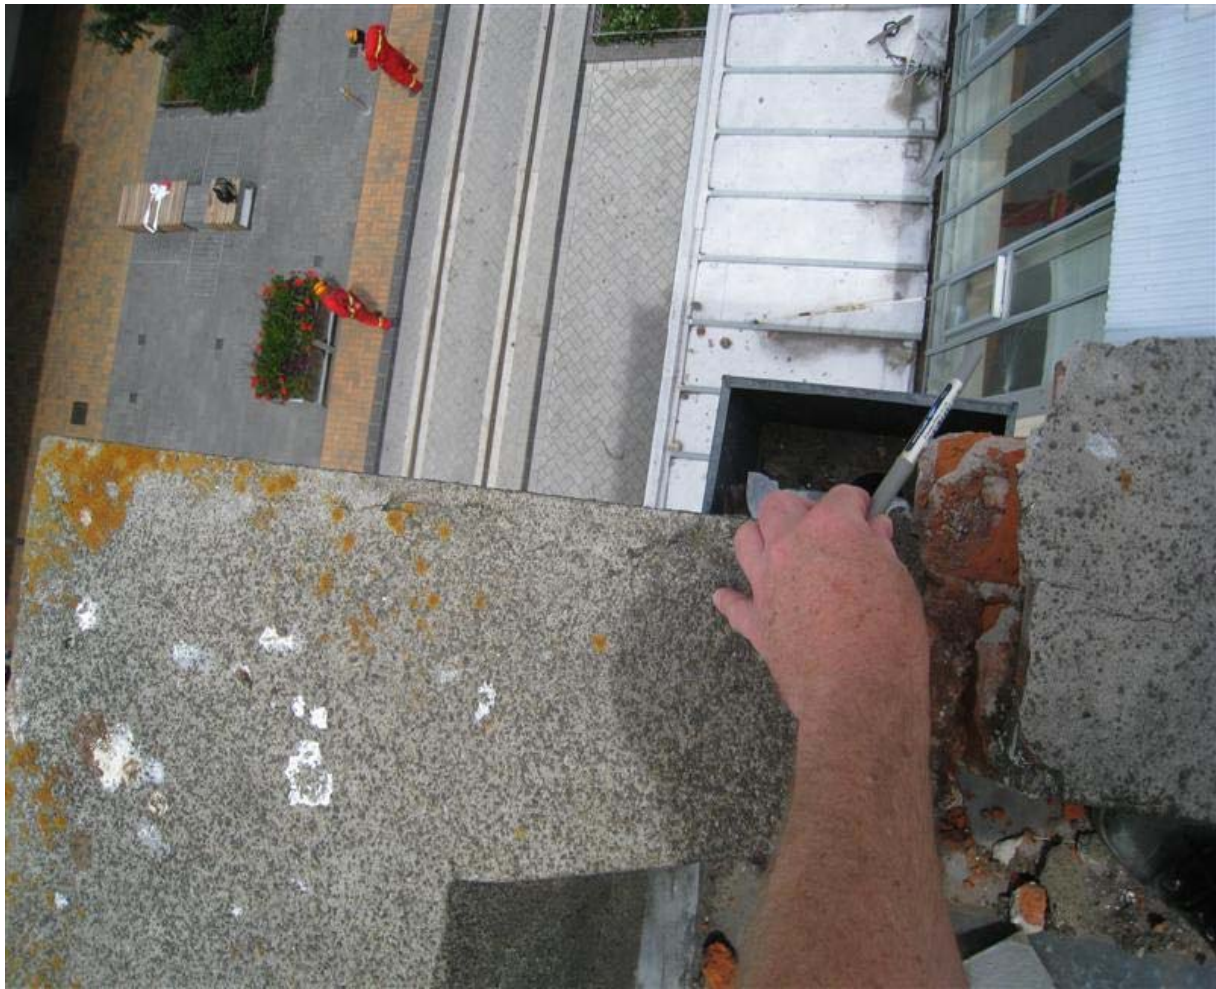
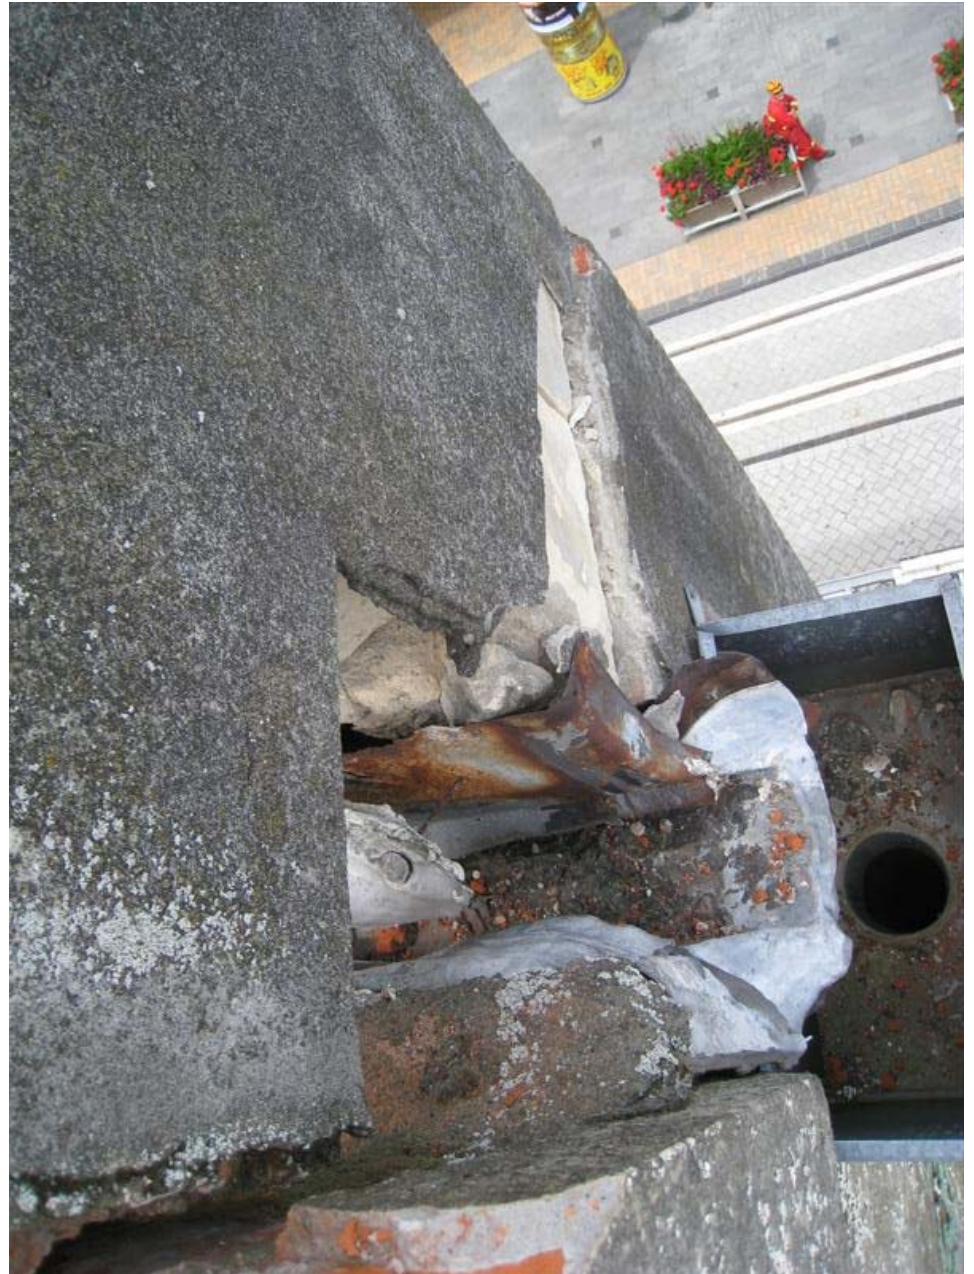
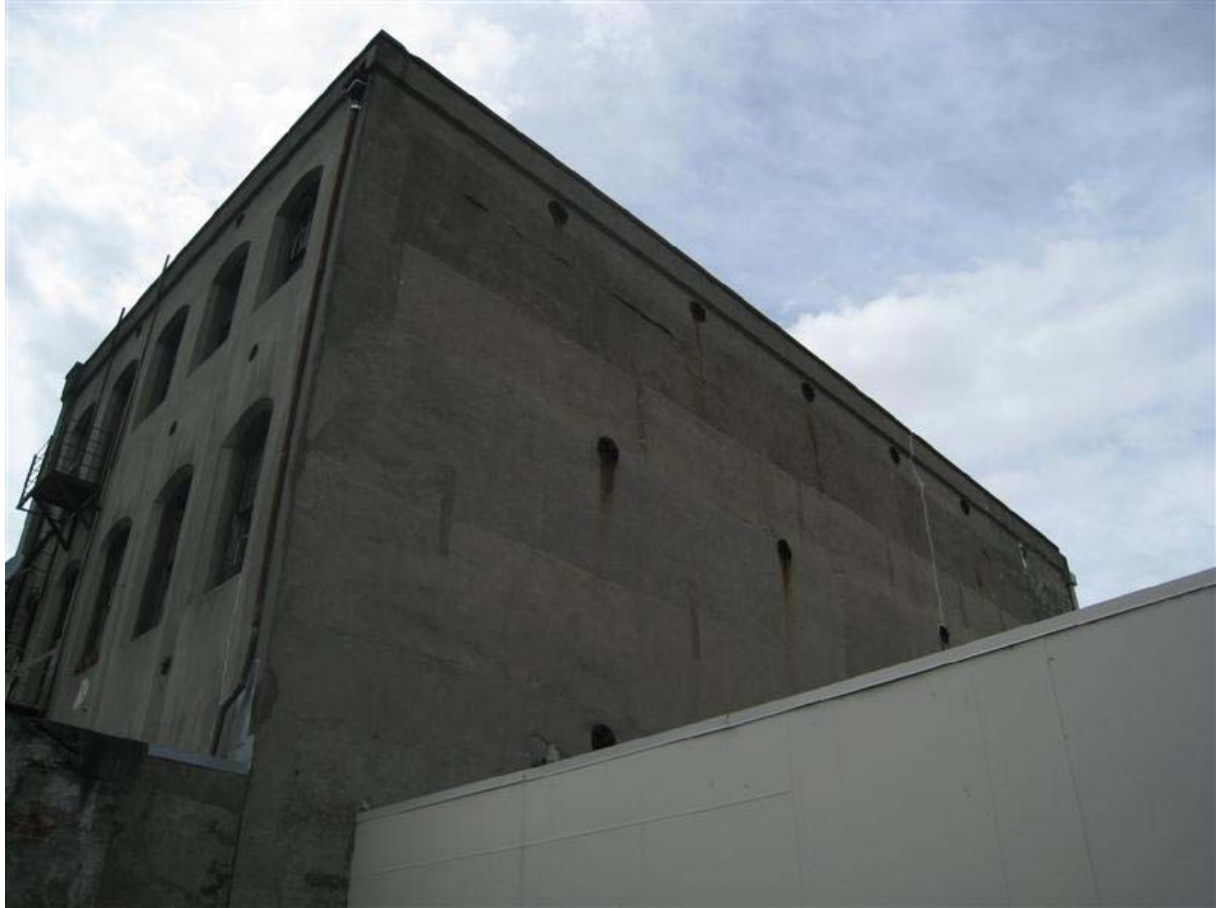
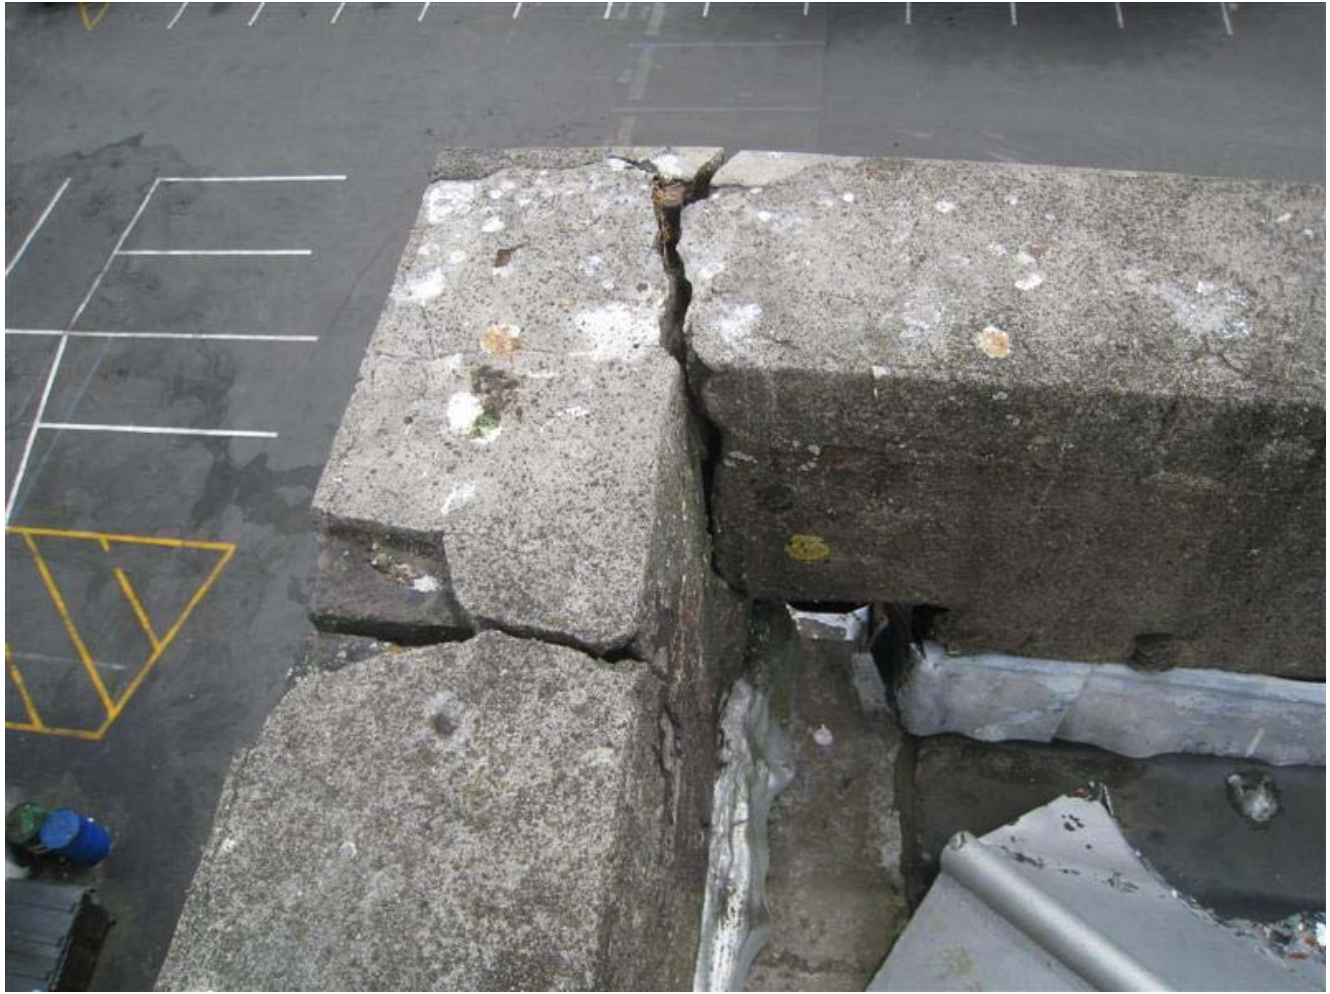
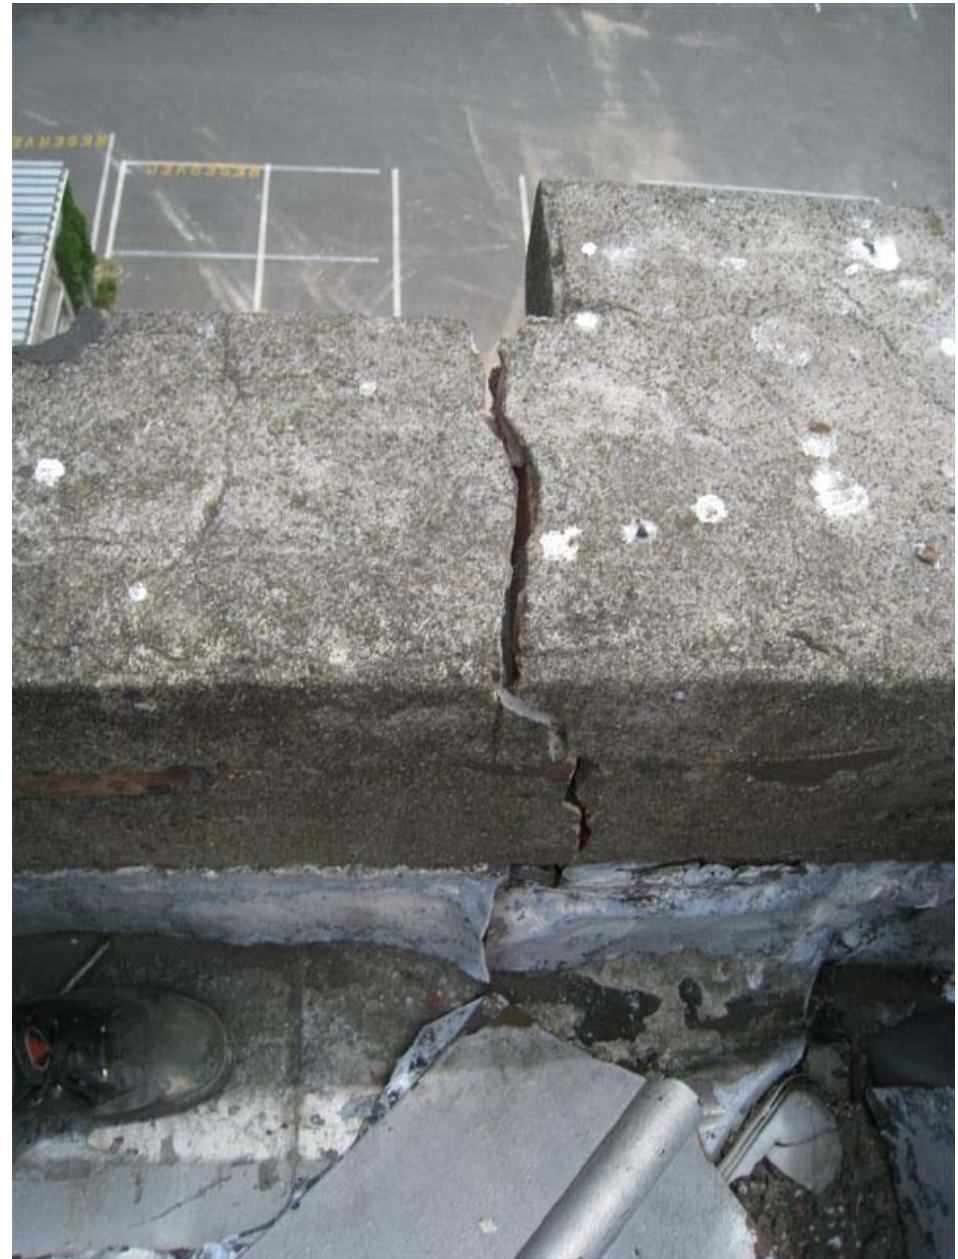
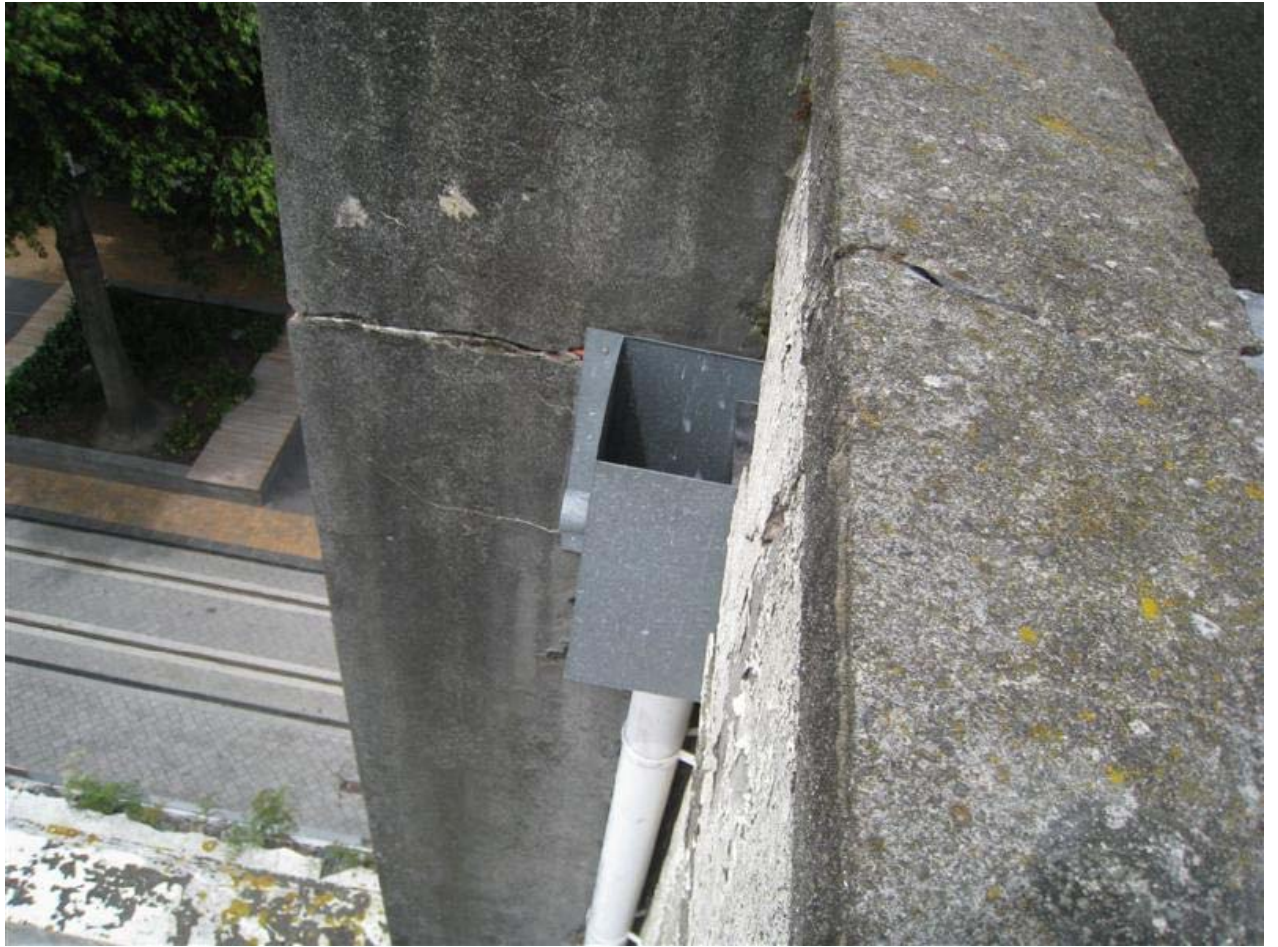
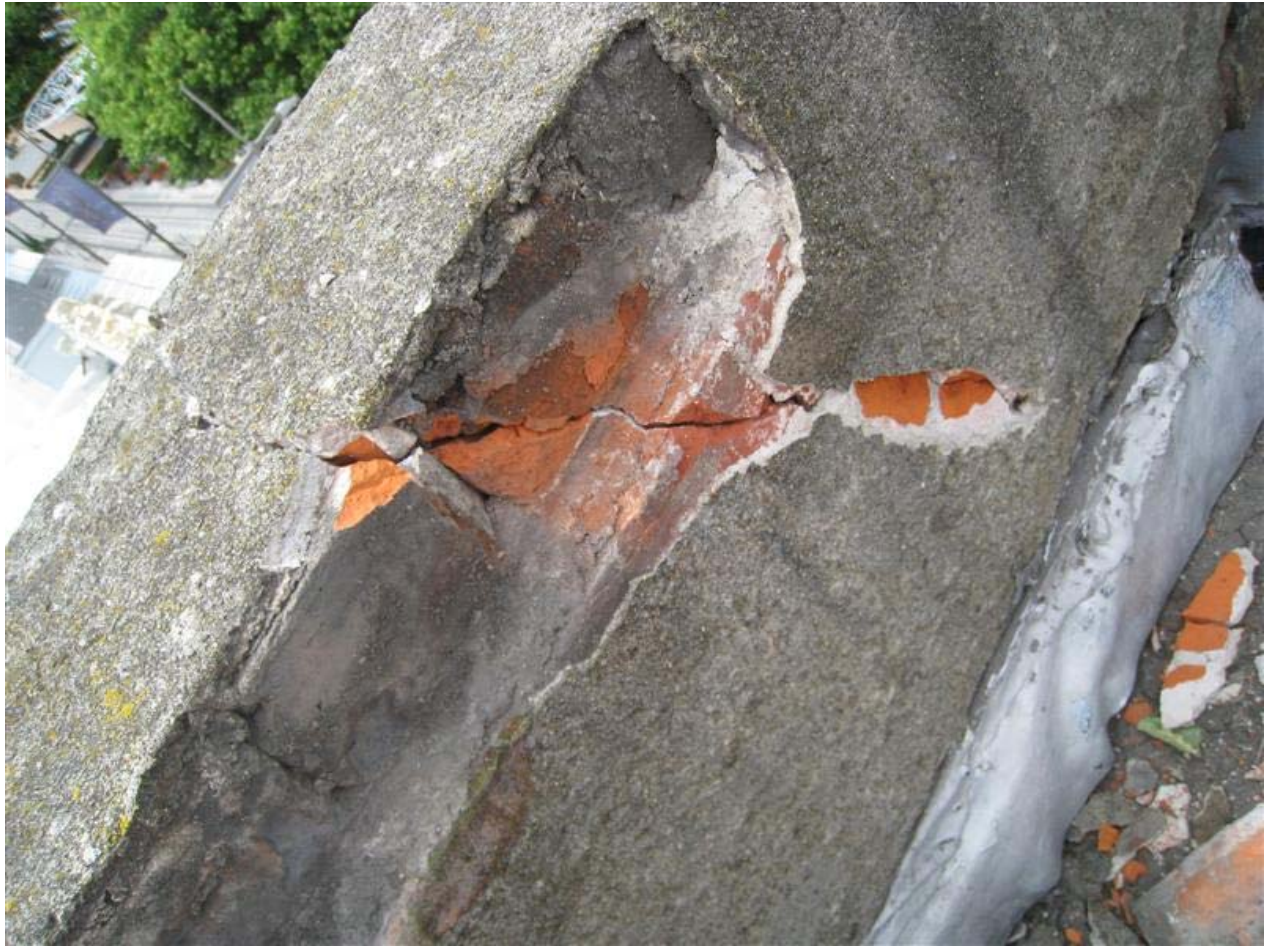
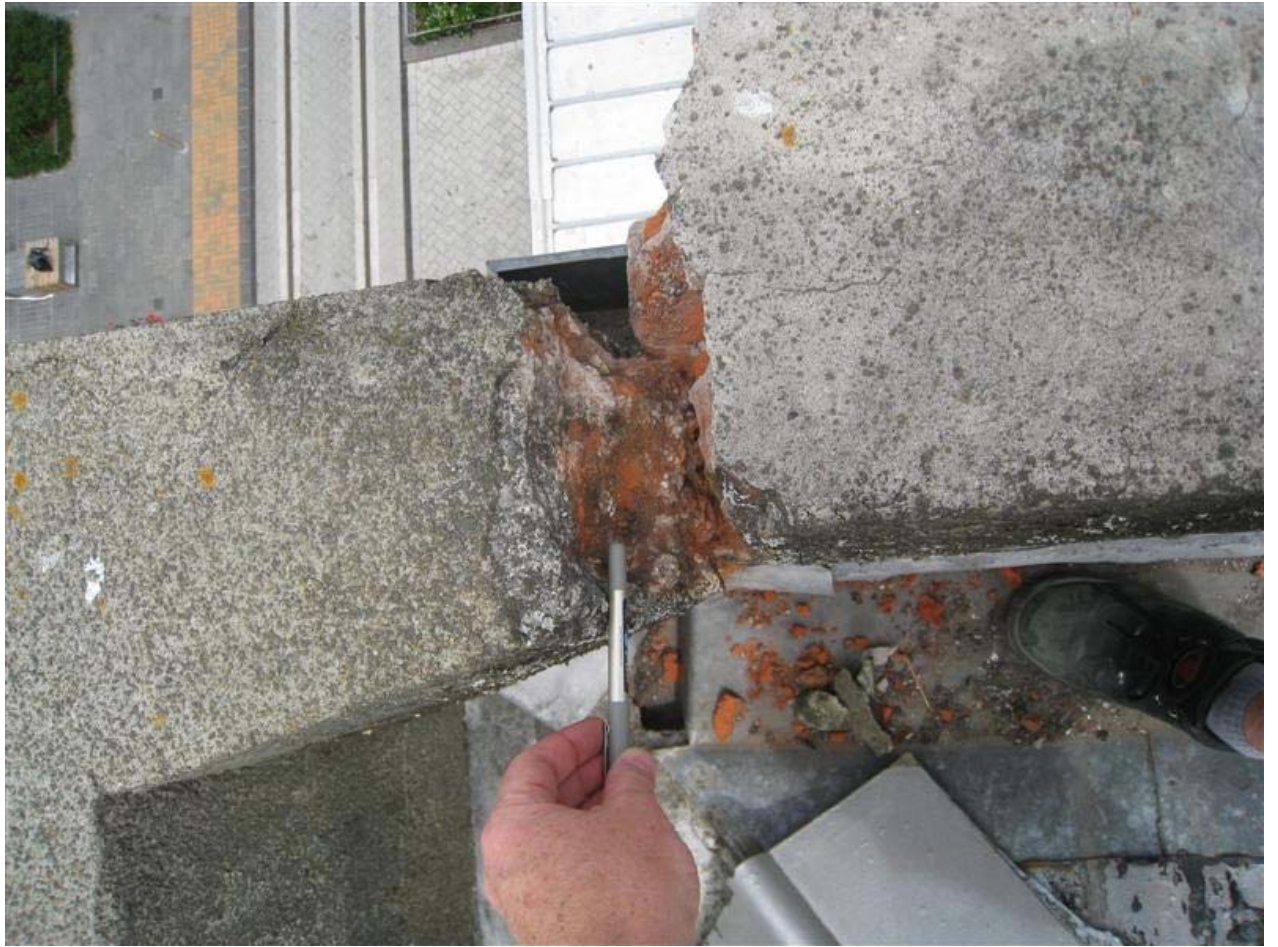
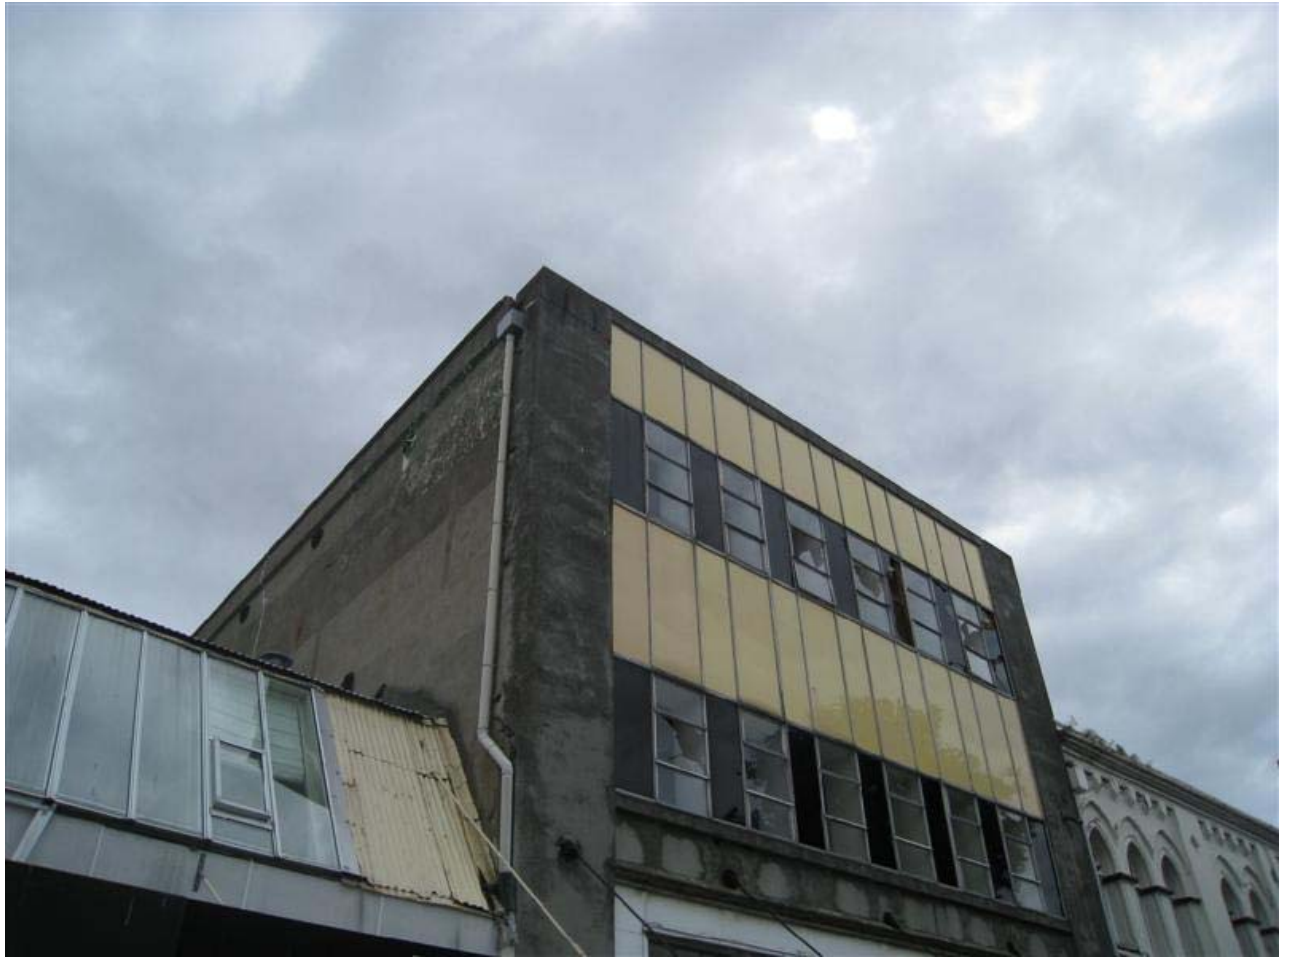
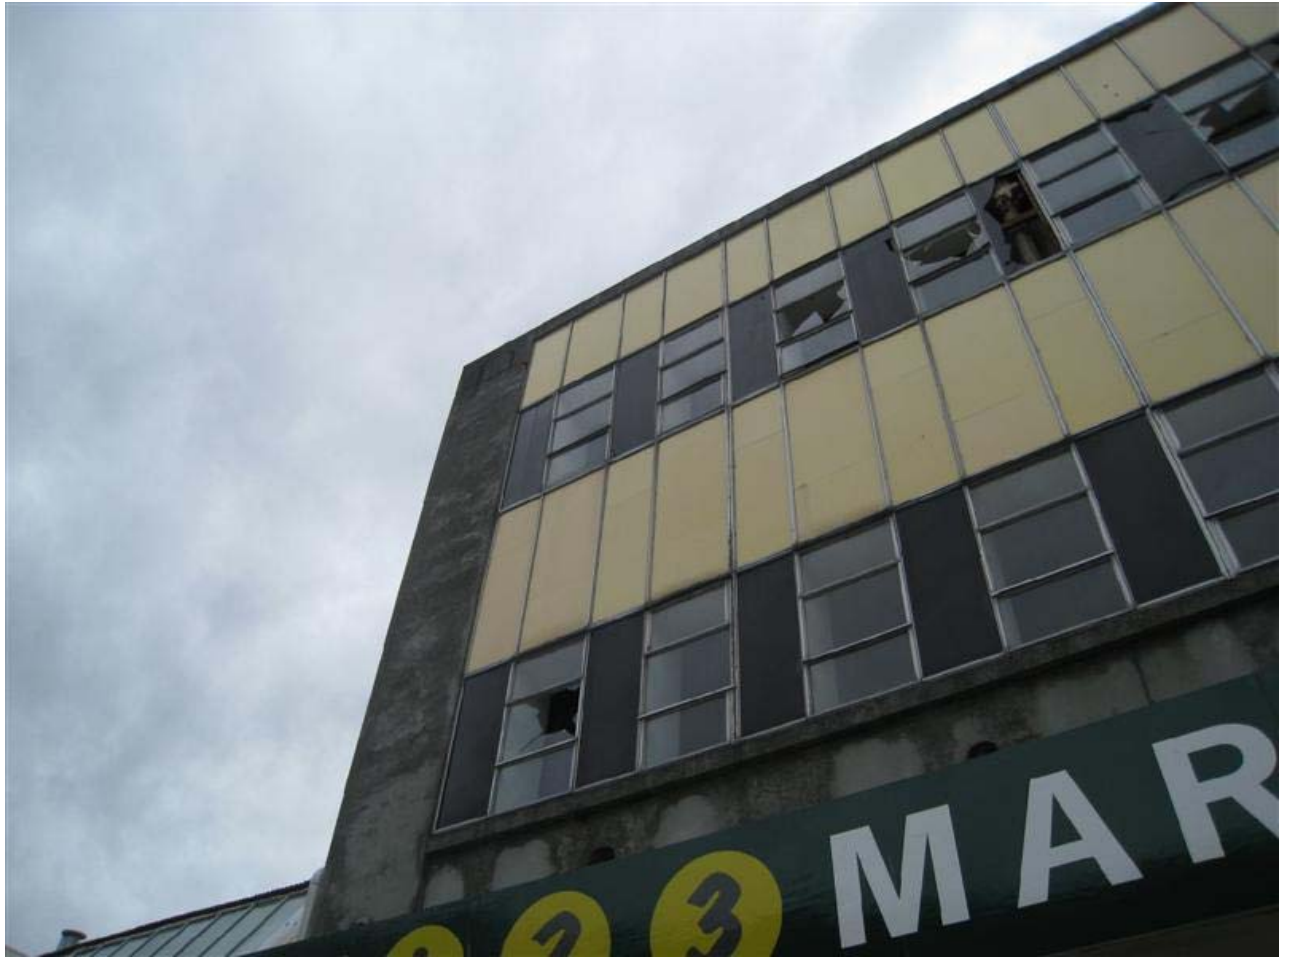
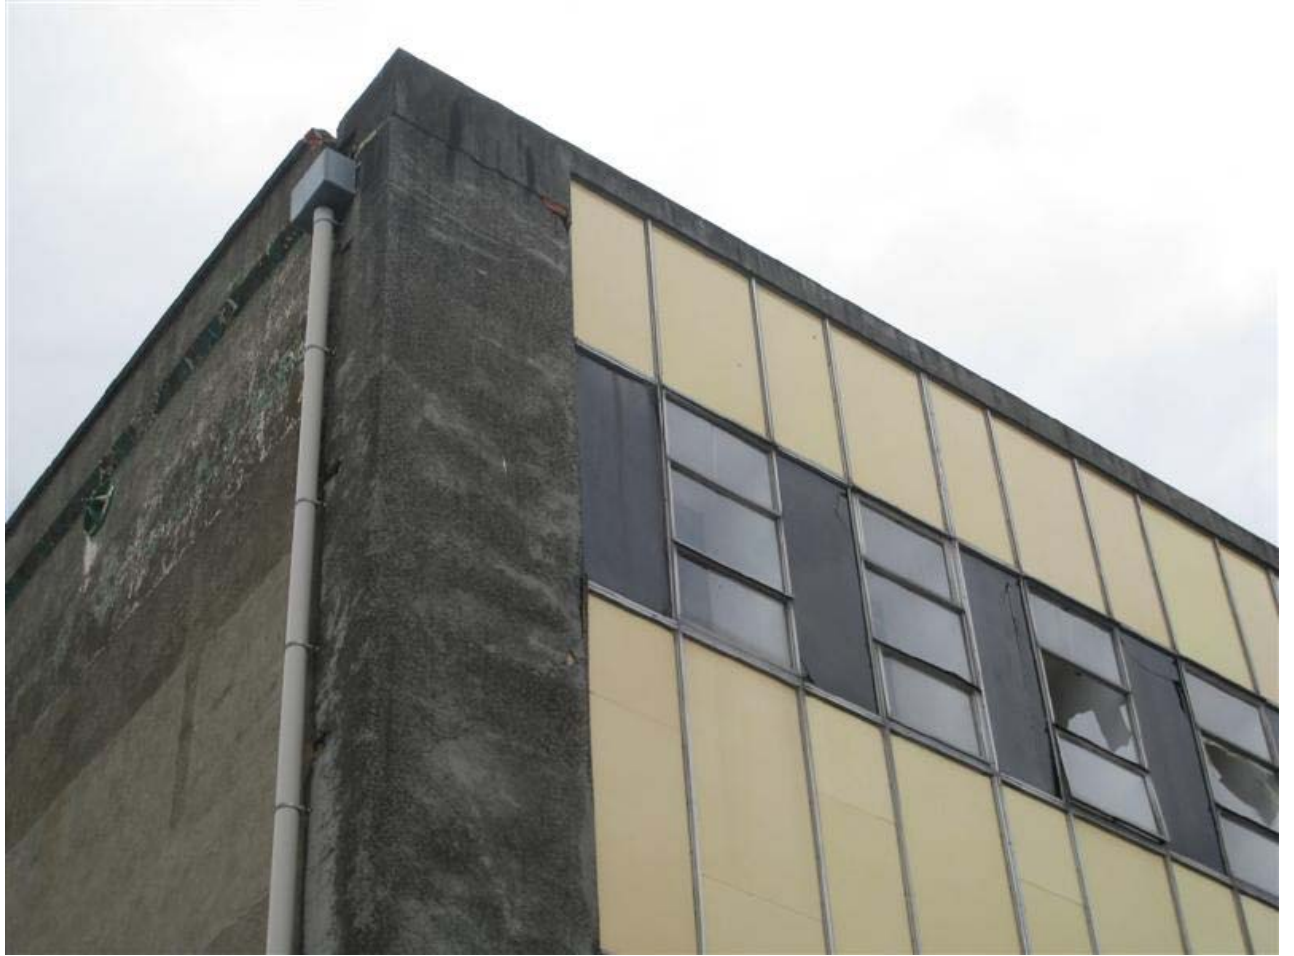
12. The cracked roof level parapets were considered to be a potentially dangerous feature of the building. The only damage observed to the parapets was to the Cashel Street elevation and the rear elevation. No other damage to other parapets was observed from either ground or roof level.

13. At the rear of the building both corners of the parapet were loose, and the unsecured brick posed a falling hazard to the area below. An approximately 0.5m length of the parapet was removed in each direction at these two corners to remove the overhead falling hazard.

14. At the front of the building the concrete lintel beam above the windows was displaced slightly towards the street and was no longer secured to the return walls. This presented a falling hazard to Cashel Mall, and the shops below and either side of 91 Cashel Street, which resulted in all three buildings being red placarded by the Council.

15. I took a series of photographs showing the damage to the parapets of 91 Cashel [**Annexure 1**].
16. I designed a temporary securing system to restrain this front parapet from falling by tying this parapet back to the side parapets with a reinforcing bar (called a "Reidbar") that was drilled and anchored through the front parapet and slightly tensioned [**BUI.CAS91.0012.2**]. This securing was a short-term measure only designed to be in place for less than six months.

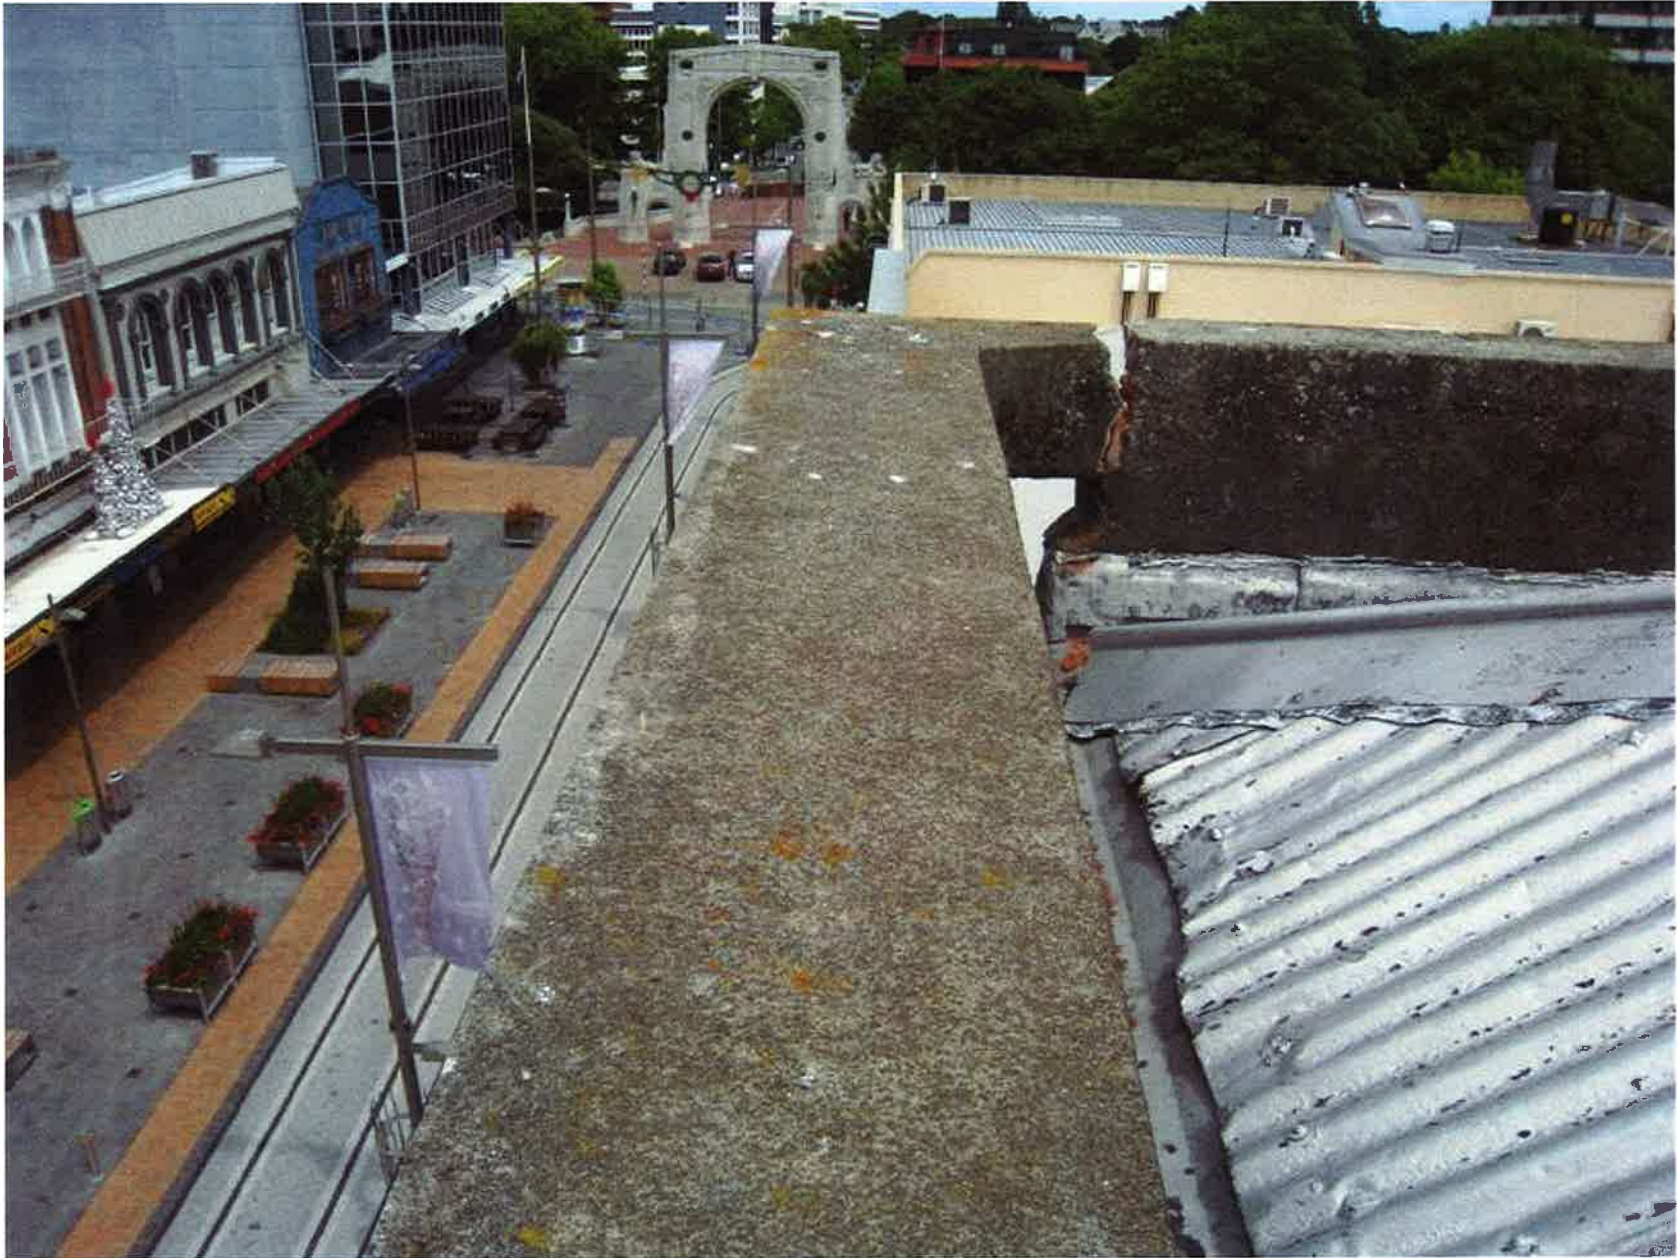
22. The securing works for the parapet performed as intended, and, despite the collapse of the floor below, the concrete parapet on Cashel Street was prevented from falling by the securing works installed and certified on 31 December 2010 as can be seen in photographs [**BUI.CAS91.007.40**].
