Brief of evidence of Anthony Francis Raper

Photographs of 605 Colombo Street taken by A F Raper on 26 December 2010

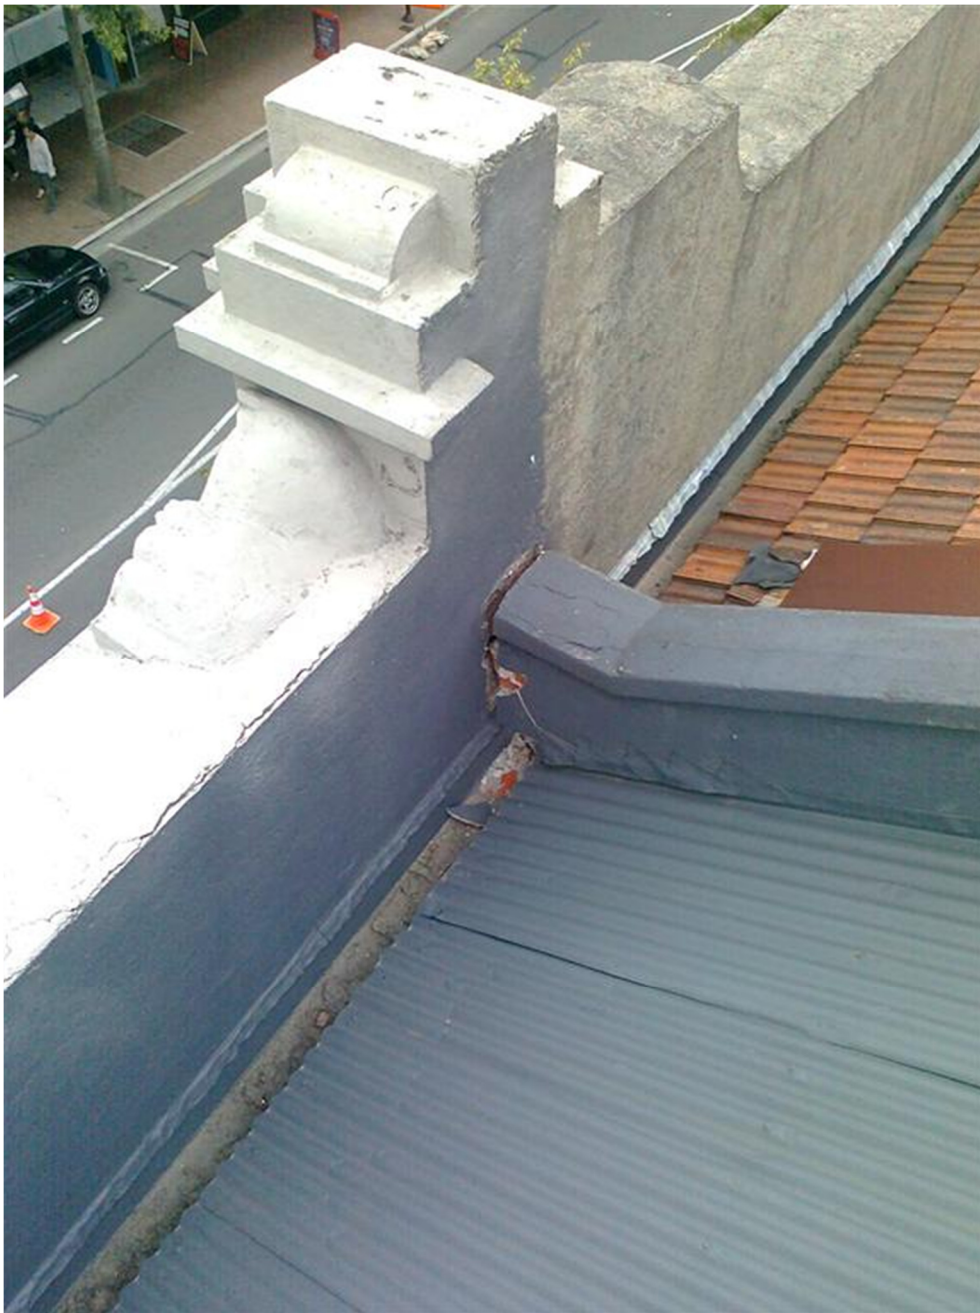
Photo 0017.jpg

7. The arrival of the NZFS snorkel appliance enabled me, with the assistance of the SAR representative who operated the snorkel arm and platform, to view the external parapet from both the Colombo Street side and from above the roof line of 605 Colombo Street. No horizontal cracking was observed in the parapet itself above roof height, and the parapet was not considered at risk of separating from the facade. Separation between the mutual transverse cross wall between 603 and 605 Colombo Street was observed **[Annexure 2 Photograph 0017]**.

605 – 603 Colombo Street parapets and mutual transverse cross wall

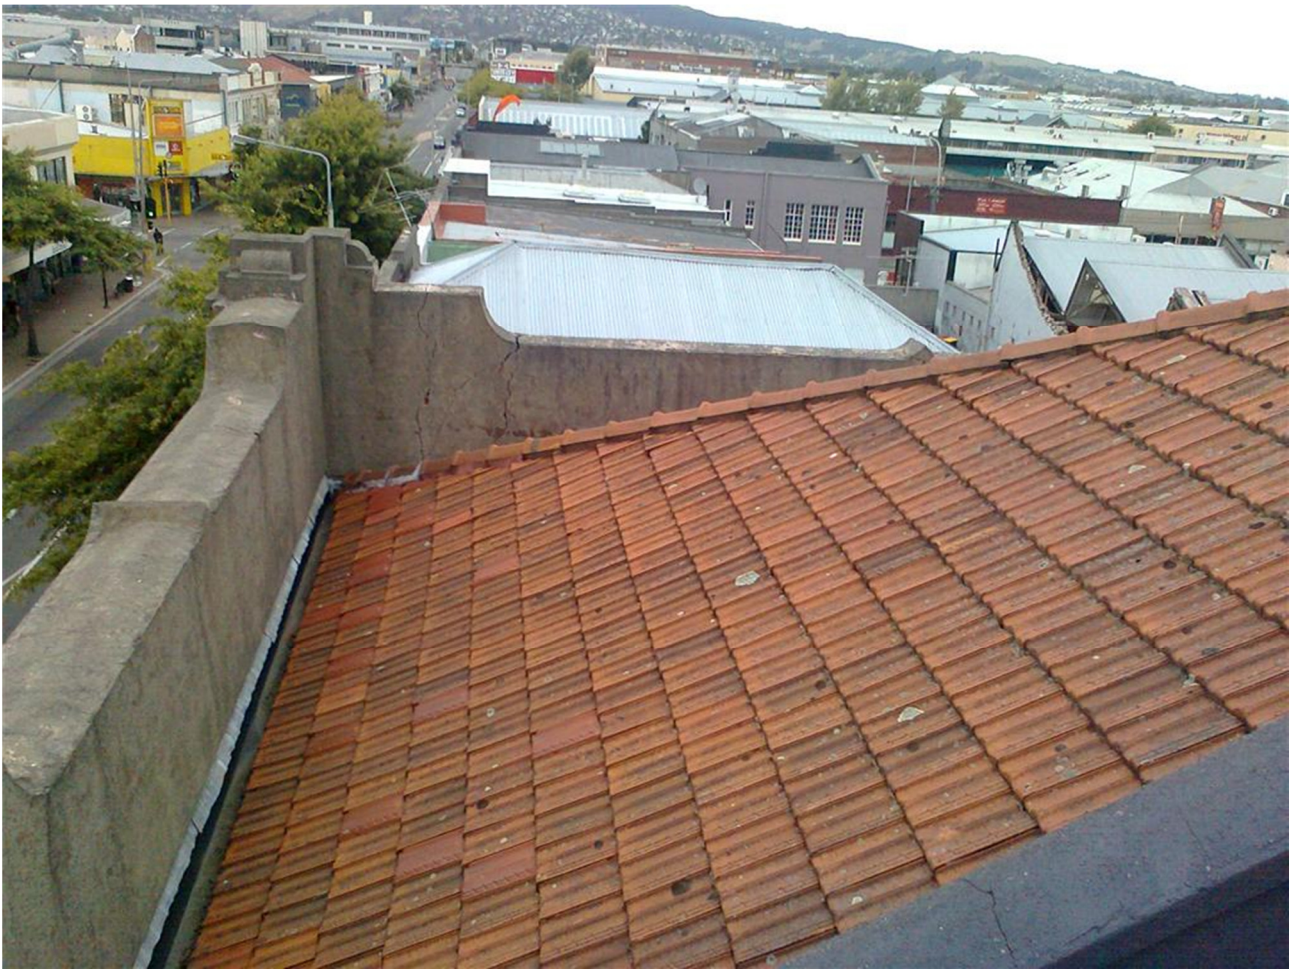
Photo 0018.jpg

Roof of 603 Colombo Street parapets and mutual transverse cross wall

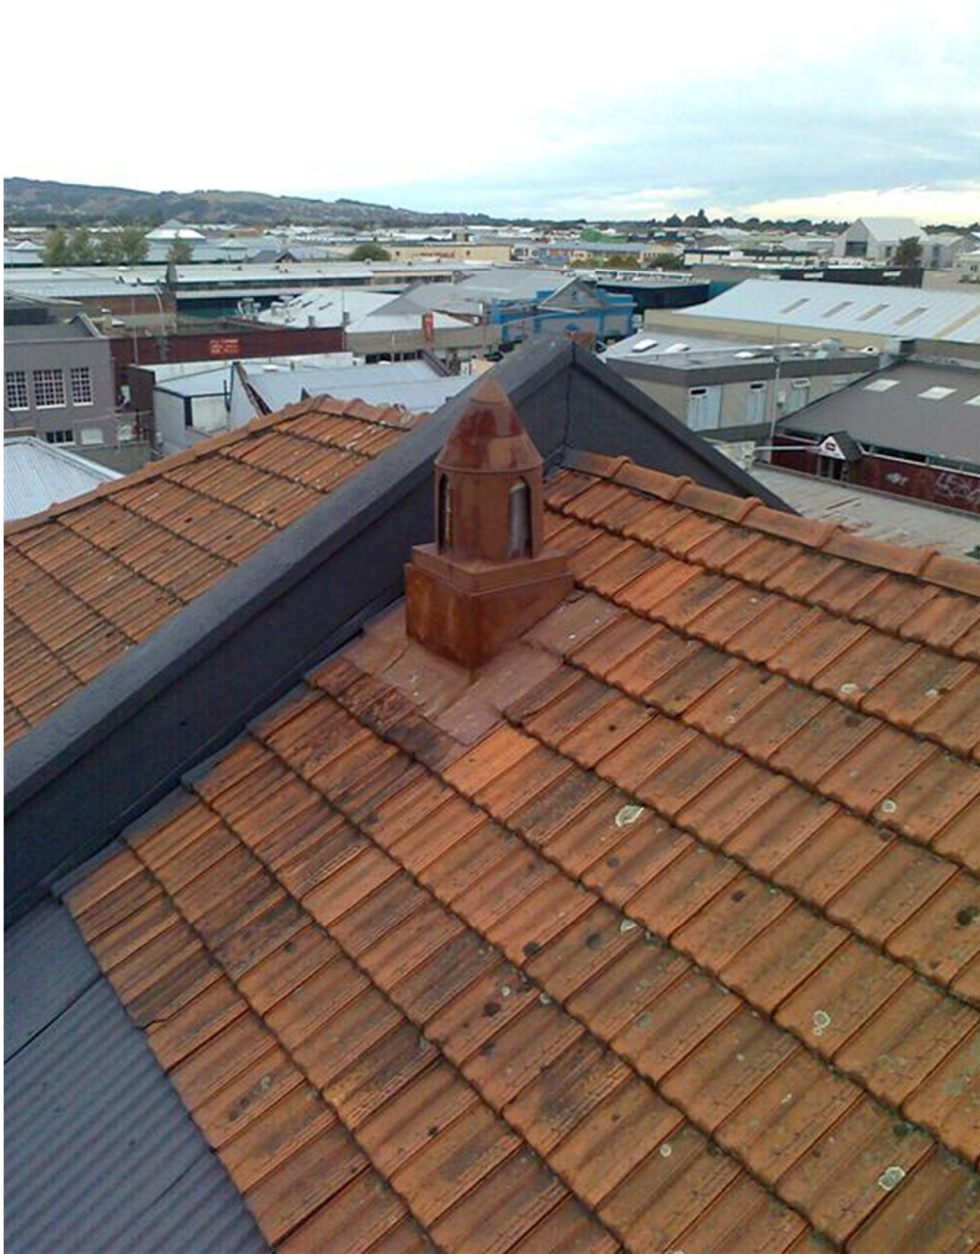
Photo 0019.jpg

605 – 603 Colombo Street roofs and mutual transverse cross wall

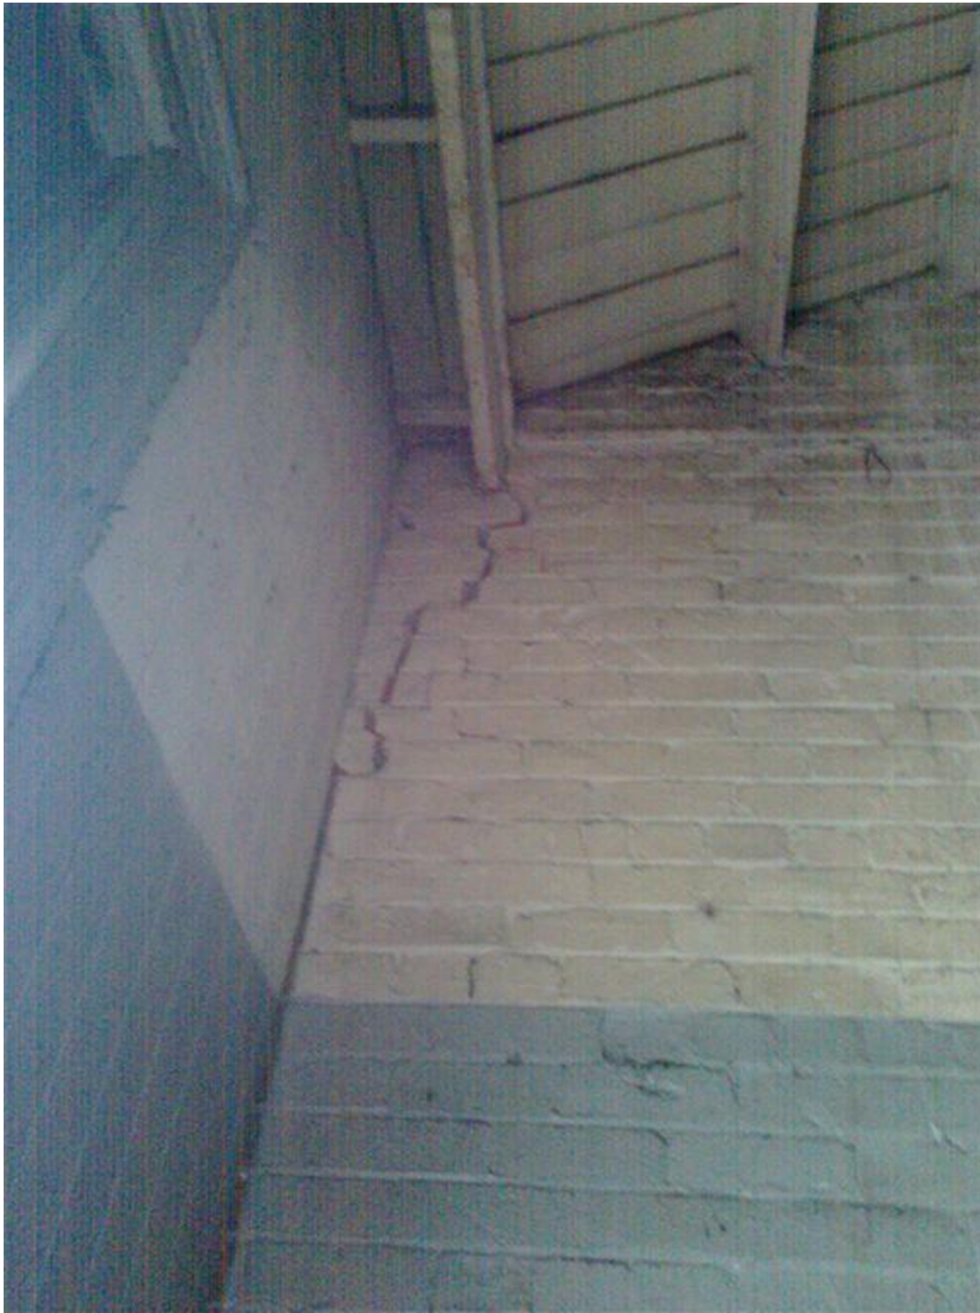
Photo 0021.jpg

8. After I examined the external parapet, Mr Tan arrived enabling an internal inspection of 605 Colombo Street. Little damage was visible on the ground floor, but cracking of the brick masonry transverse walls from first floor to roof was visible. Mr Tan advised that the cracking appeared to be no worse following the Boxing Day quake and was present after the 4 September quake. The masonry cracks were visible in the middle of the centre transverse wall and at the Colombo Street end of the transverse wall between 603 and 605 Colombo Street. My observation was that the maximum crack width was about 20mm **[Annexure 2 Photograph 0021]**.

605 Colombo Street - first floor to roof; front wall and mutual transverse cross wall

10. My professional recommendation, as recorded on the Rapid Assessment Form in the section for "Further Action Recommended", was that a detailed structural engineering evaluation was required. This was necessary to check the upper floor transverse wall and façade connections, as the masonry cracking indicated that the front façade could have been leaning outwards, as indicated by the cracking in the mutual transverse cross wall, although this was not obvious from an external view. I recorded that there was only a moderate risk of an overhead falling hazard. This was based on:
