**IN THE MATTER OF
THE CANTERBURY EARTHQUAKES ROYAL COMMISSION**

BRIEF OF EVIDENCE OF SEAN JULIAN GARDINER

engineer's instruction

project 116 Lichfield St.

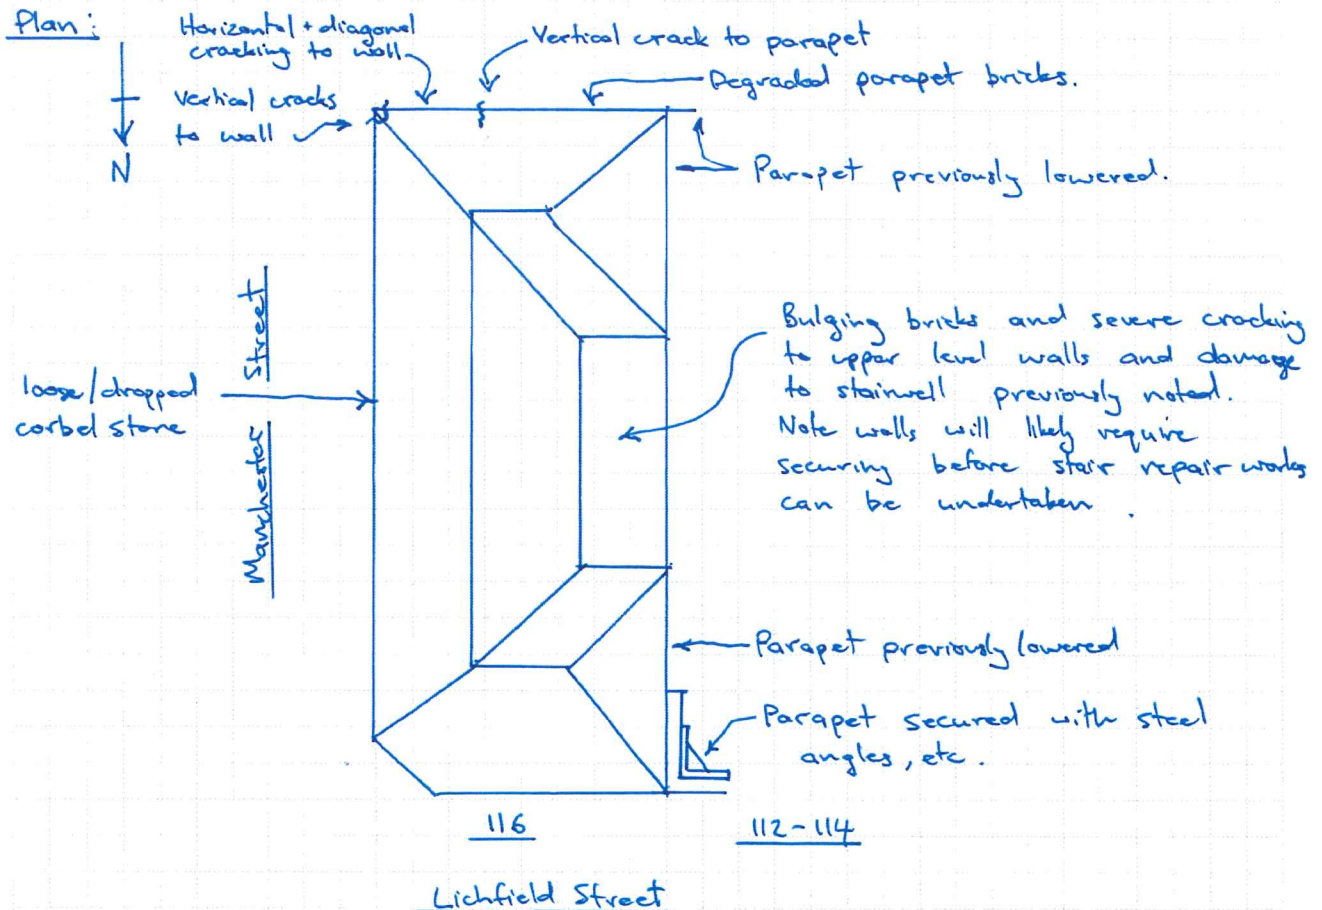
Following advice from contractor we have revisited the property to view further damage from recent earthquakes.

These high level bricks and stone blocks are potential fall hazards to the areas directly adjacent and should be secured as soon as possible, (or the fall areas cordoned off).

We suggest securing works be undertaken as per attached (contractor to wait for insurers approval).
