## The Placarding of Buildings and Barricade Location

(The Perspective of a Volunteer Chartered Engineer)

## Appendix 2 Photographs of Buildings in Dunedin

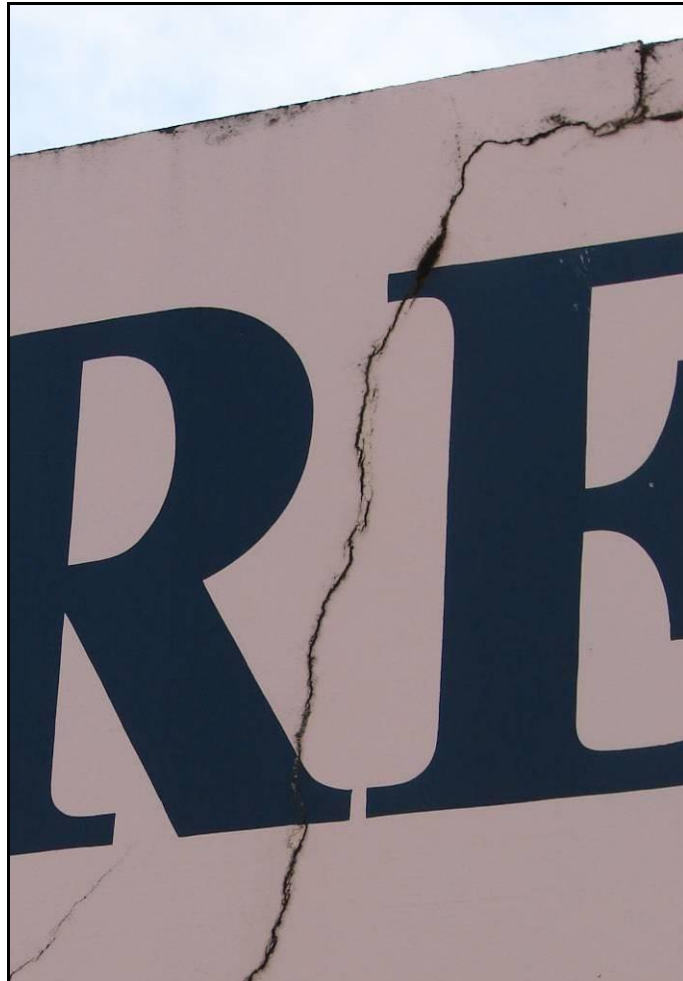
Example of cracked parapet

This is a single storied building. Observance of this crack in isolation would not be a reason not to green card this building.

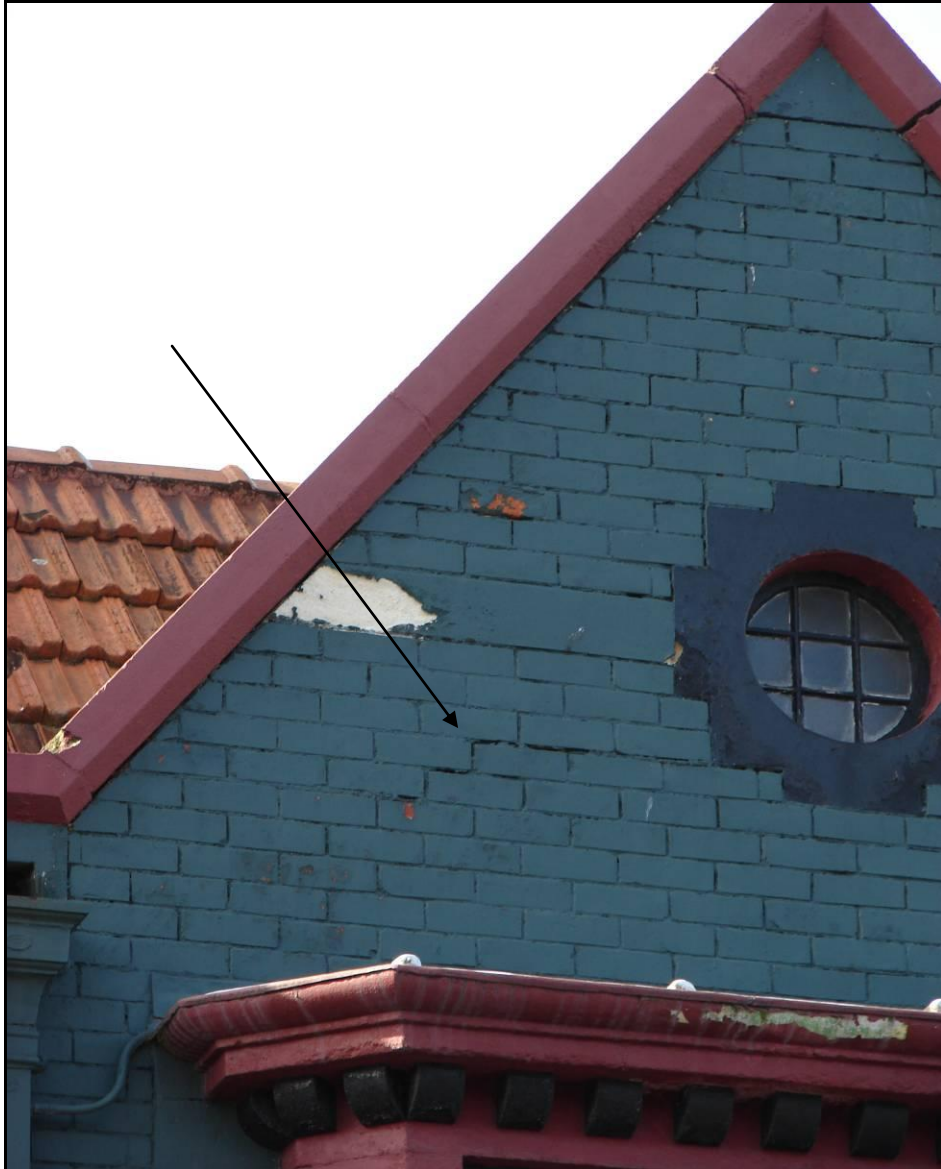
Is this masonry secure? If seen in Christchurch after the earthquakes, this building would almost certainly be green carded.

However, under the new DCC Earthquake prone building policy (33% Modern Design Standard) a building check could require strengthening works.

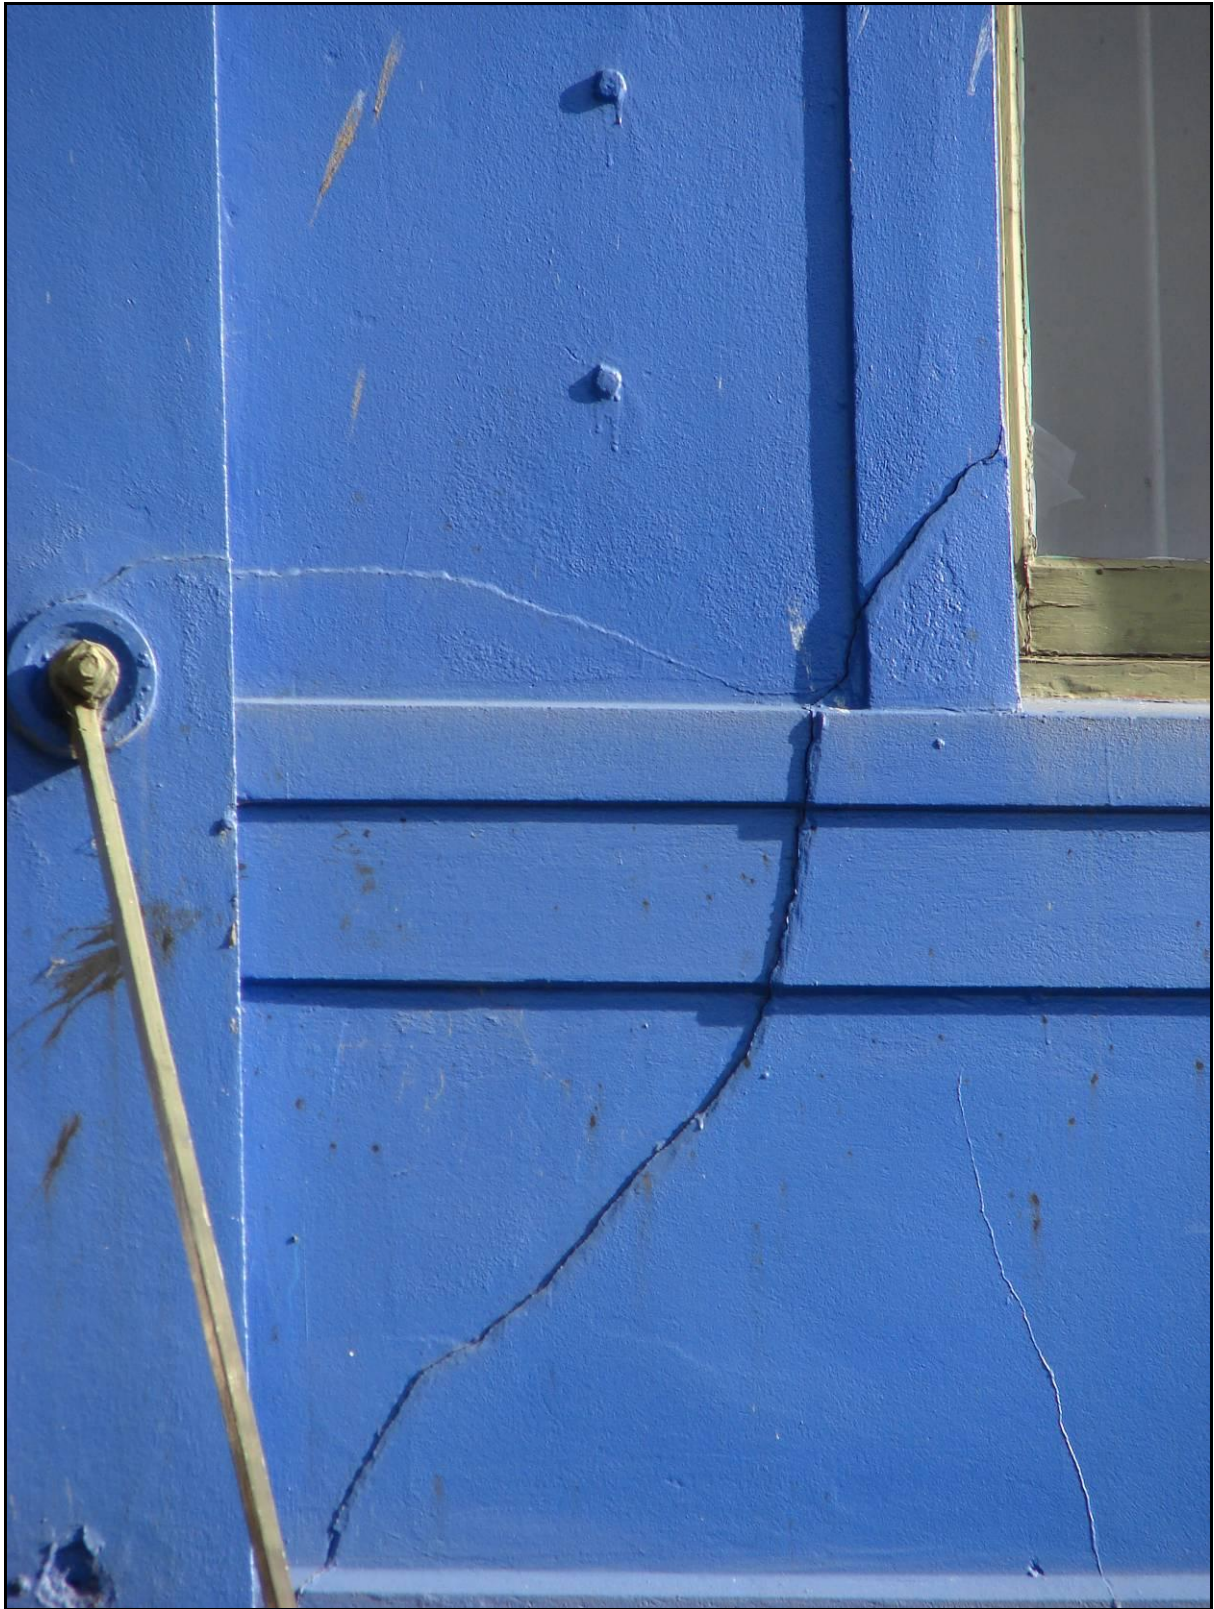
Cracks in a building; again this in isolation is not a reason not go green card this building as this building would have withstood “moderate earthquakes” in the past.

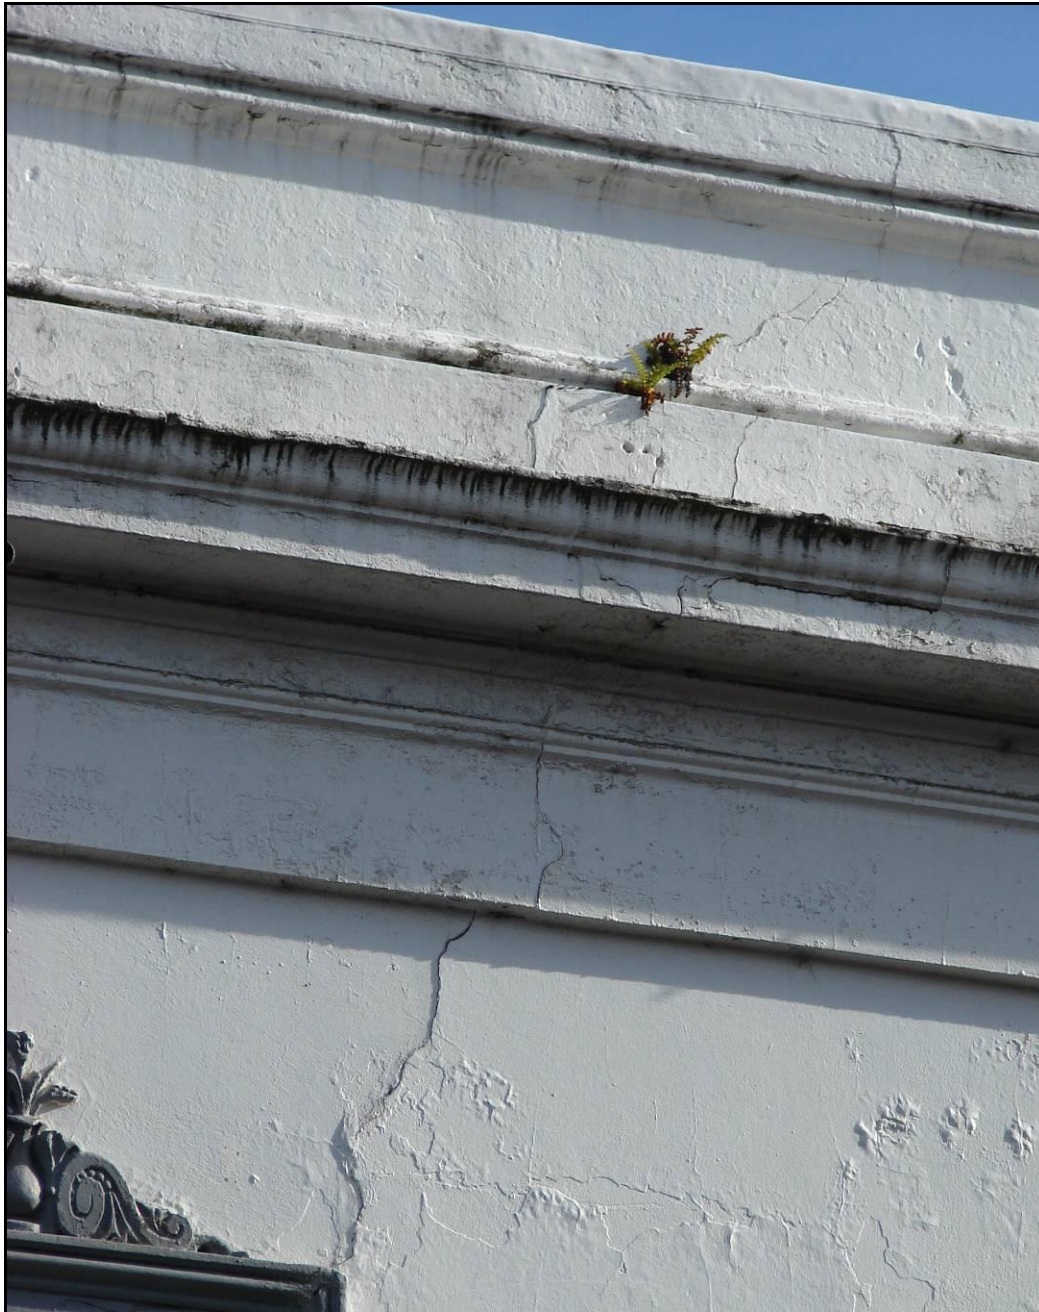
An example of cracking and vegetation growth. There does not appear to be an effective mechanism in law to ensure buildings are not neglected.

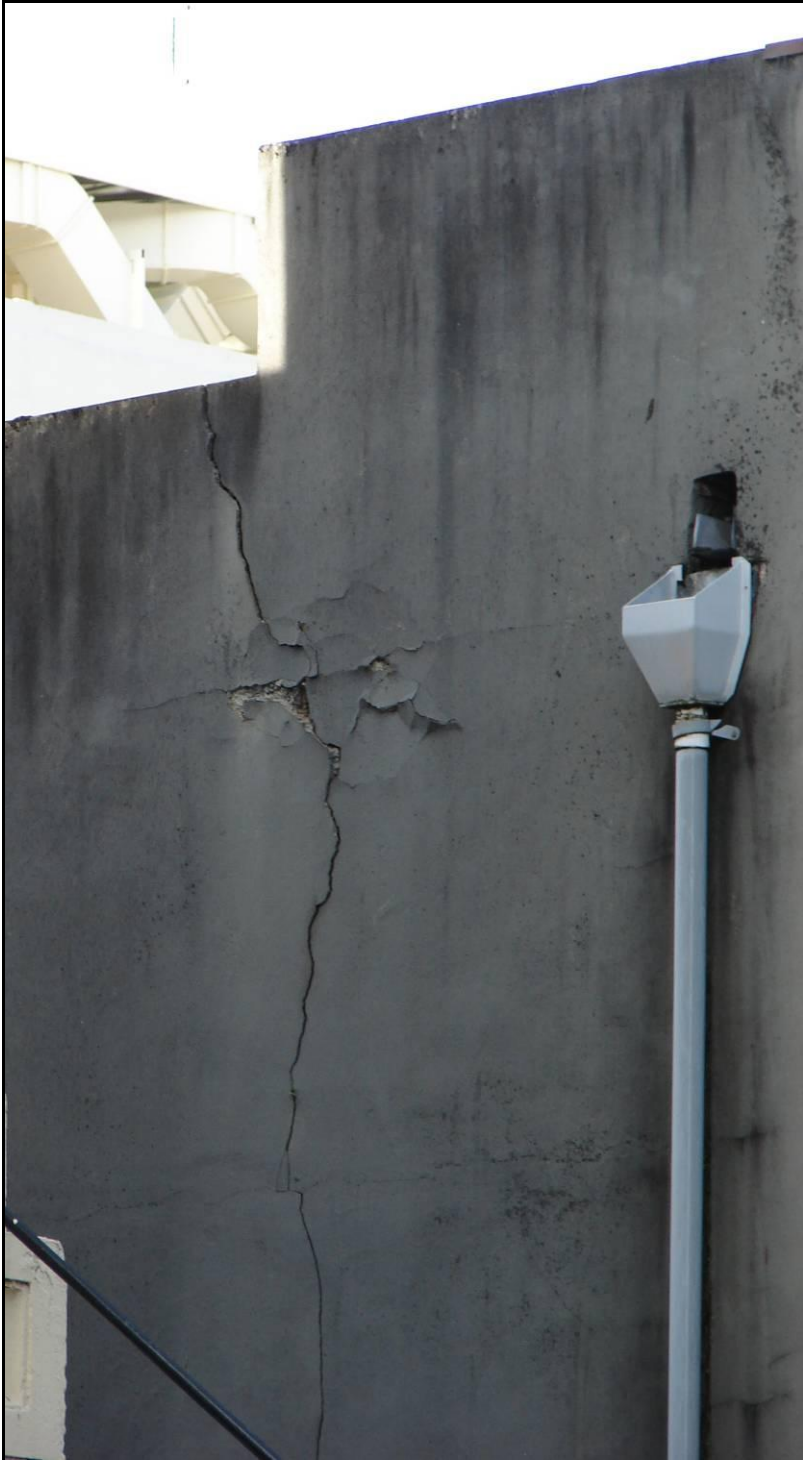
An example of long term cracking and thus presumably poor maintenance.

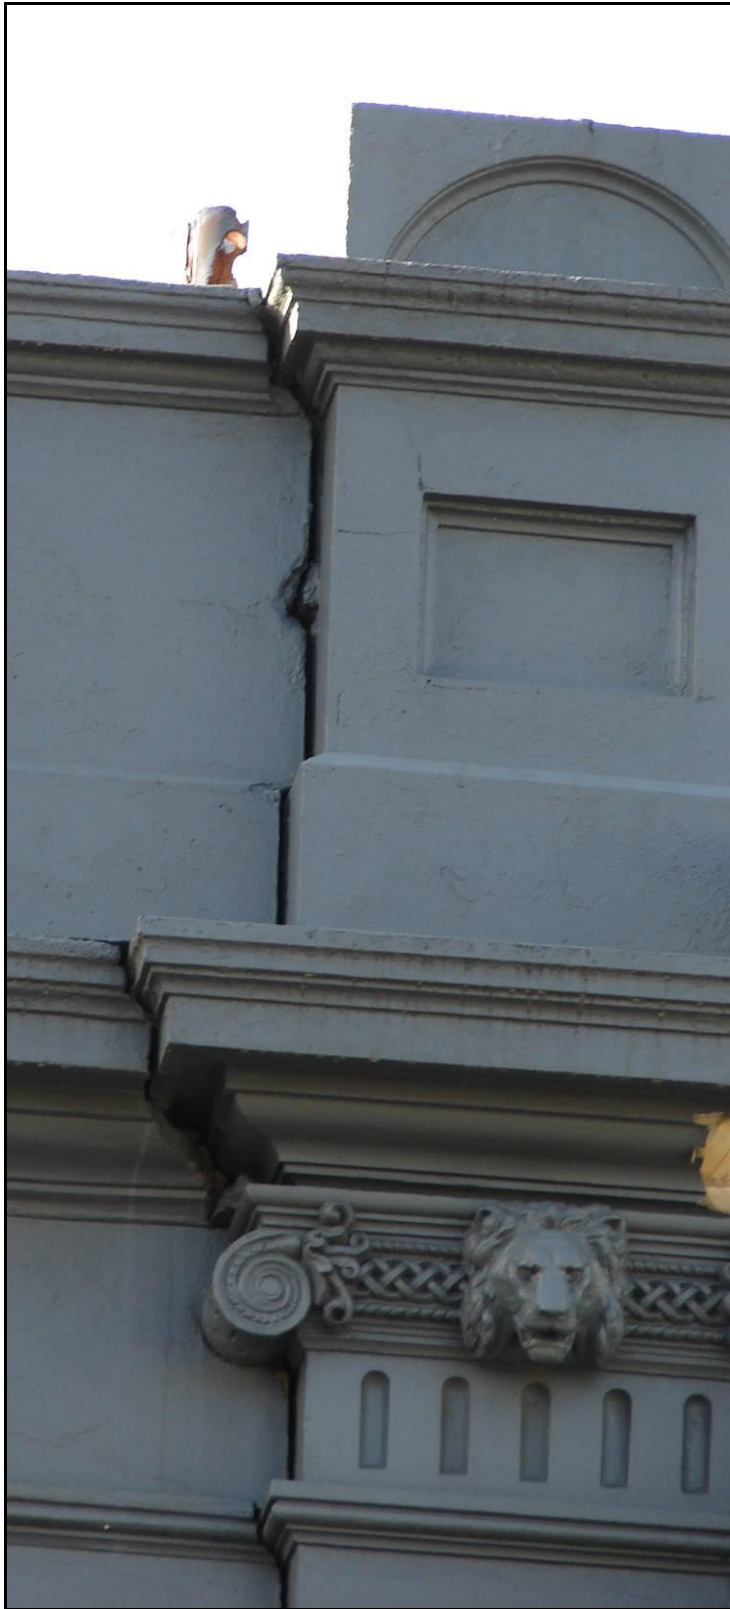
Long term building movement – green carding would still be reasonable.

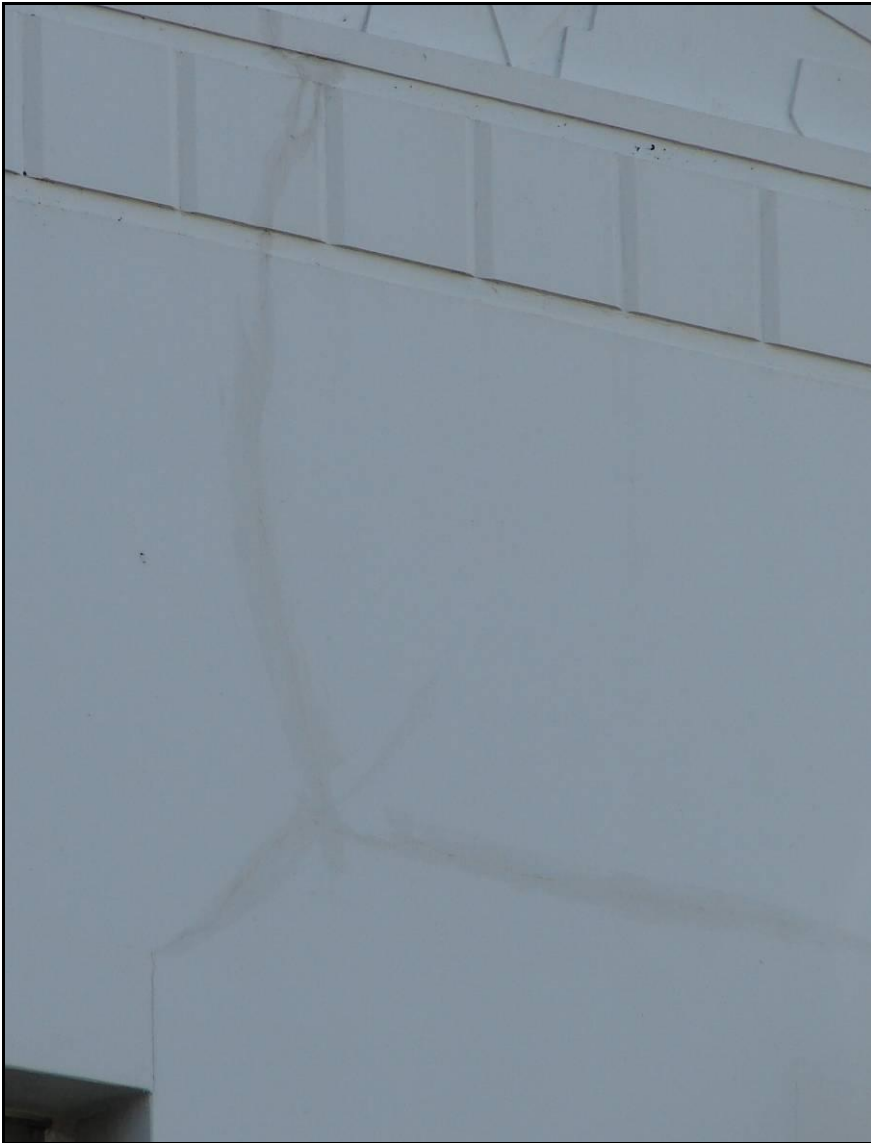
Evidence of water ingress and thus deterioration that current legislation does not appear to be able to rectify

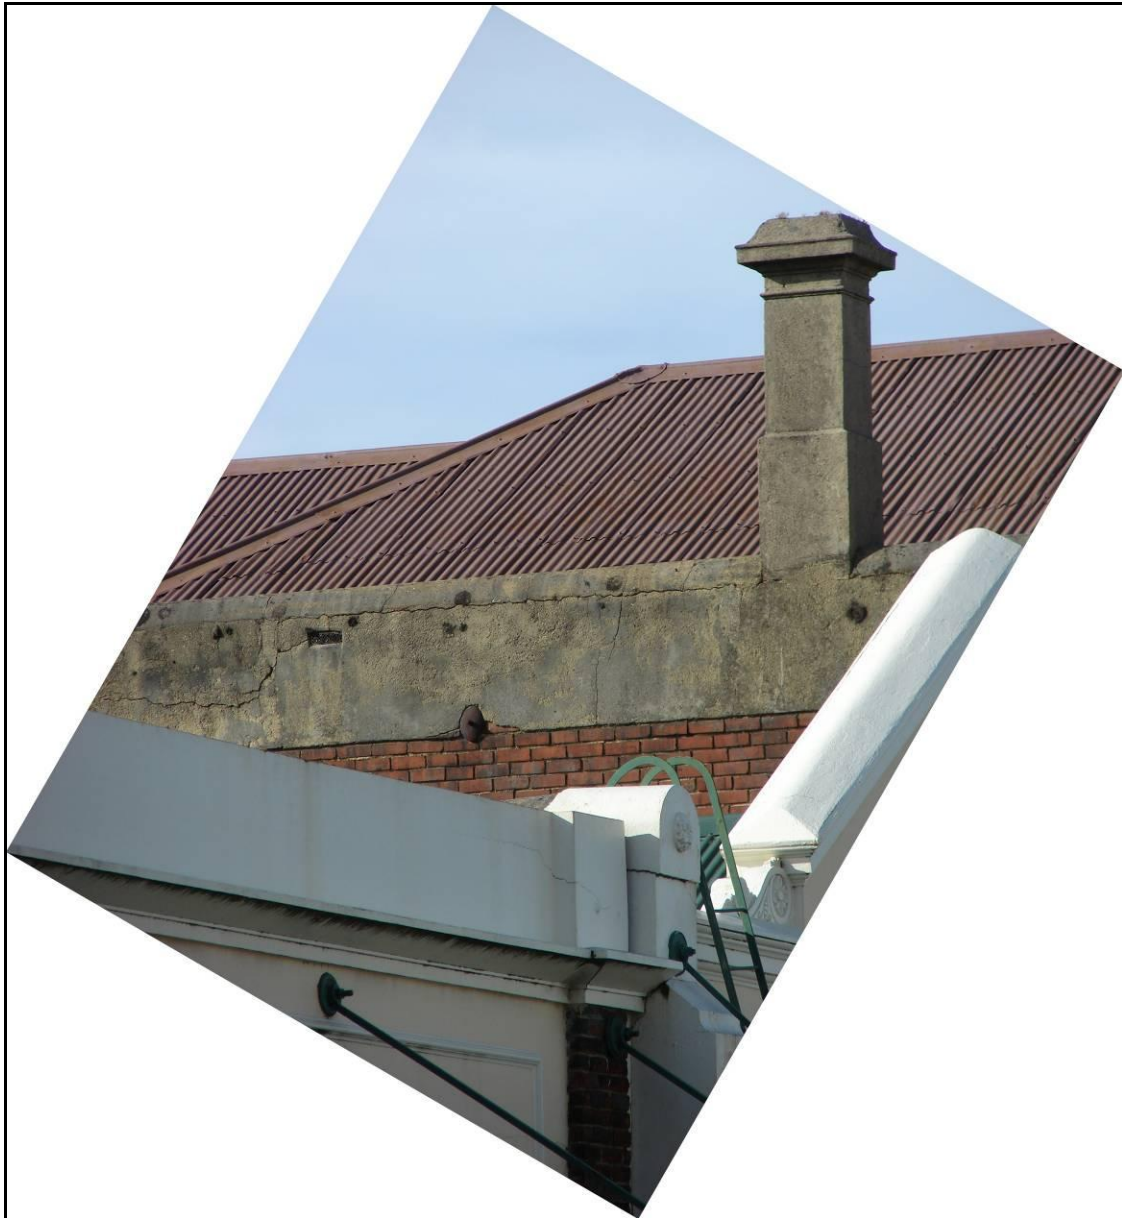
An example of what now cannot be seen in Christchurch. A chimney on a property boundary that appears to be made of unreinforced masonry
