**THE CANTERBURY EARTHQUAKES
ROYAL COMMISSION**

STATEMENT OF EVIDENCE OF TRACY OWEN GOUGH

91 Cashel Street, Christchurch

91 Cashel Street – Earthquake Damage Assessment

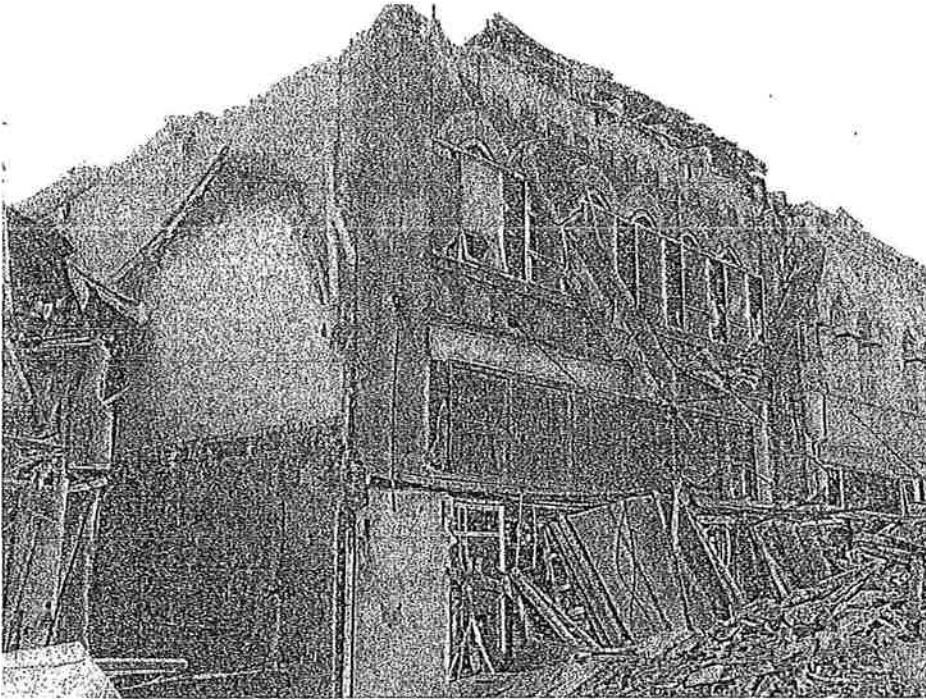
The building has sustained severe damage, most notably the complete loss of the third storey walls to the west, south and east elevations and subsequent loss of support to the roof. Refer Photos 1 and 2 following. The Cashel Street (south) glazed façade and canopy have also been destroyed. Significant damage is also visible to the spandrels on this facade due to overstress and pounding with the building to the east. Refer Photos 3 and 4 following.

The third storey walls have fallen both inwards and outward from the building. Sections of this wall visible on the ground are in the order of 500mm thick with brick masonry facing to unreinforced concrete infill. Outward falling portions have caused significant damage to the south elevation of the adjacent building to the west. Inward falling portions are still visible on top of the second floor, therefore this floor level has not collapsed however significant damage is likely given the weight of the walls (approx 900kg/m² compared to a design floor load of say 300kg/m²).

Photo 1: Southwest corner of building show loss of 3rd floor, façade glazing and canopy.

On the basis that the building is unstable, unsafe to approach or enter, presents a public safety risk and is not economic to repair, we recommend that this building should be demolished.

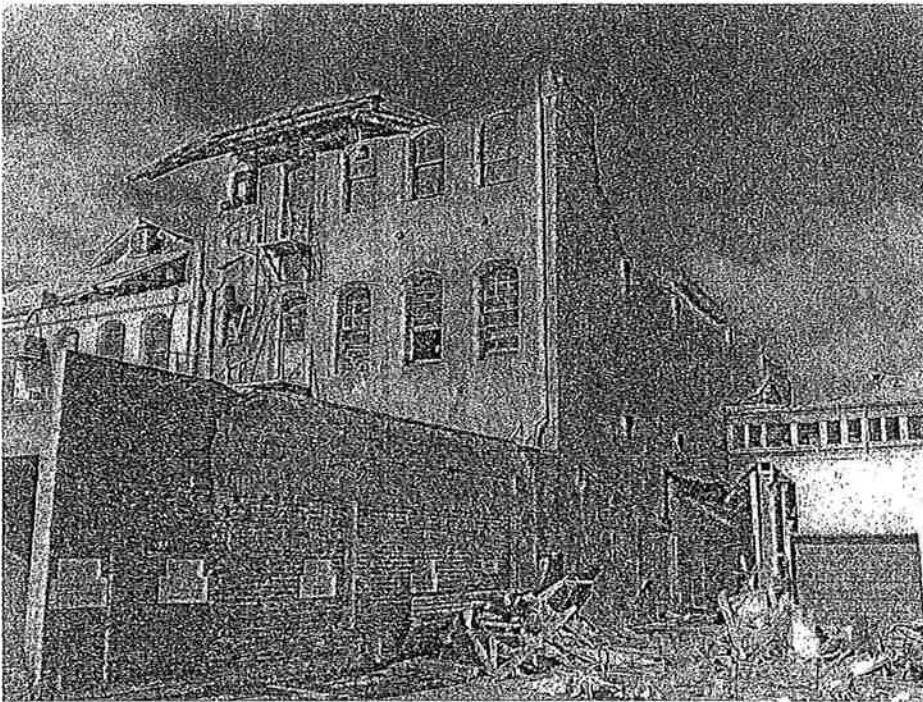
The third storey wall on the north elevation has failed above the window level. At least part of this wall has fallen outward with significant damage visible to the eastern side of the single storey extension at the rear of the building.

Photo 2: Northwest corner of building showing only remaining 3rd floor walls and roof.

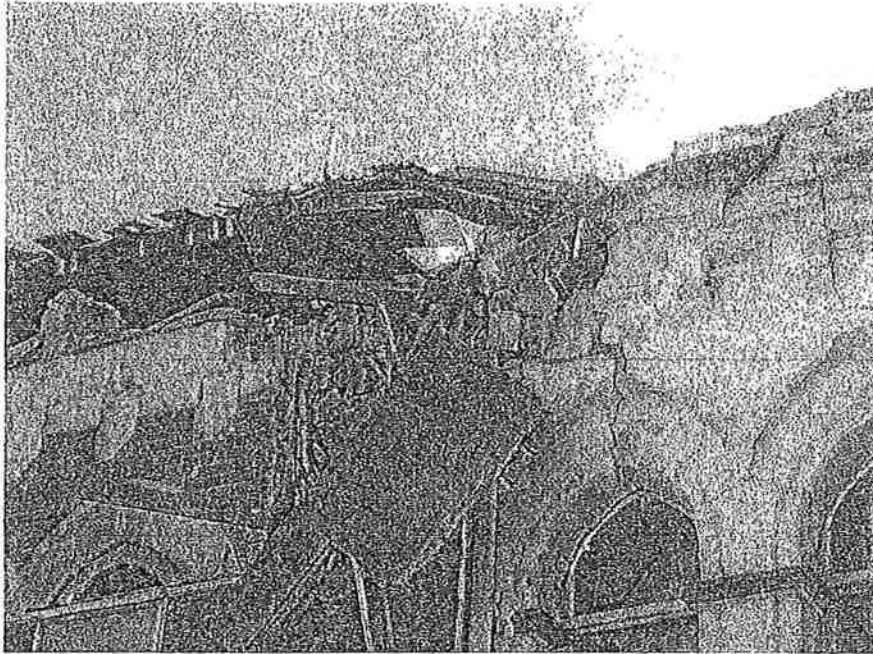
Photo 3: Pounding damage with adjacent building at 2nd floor

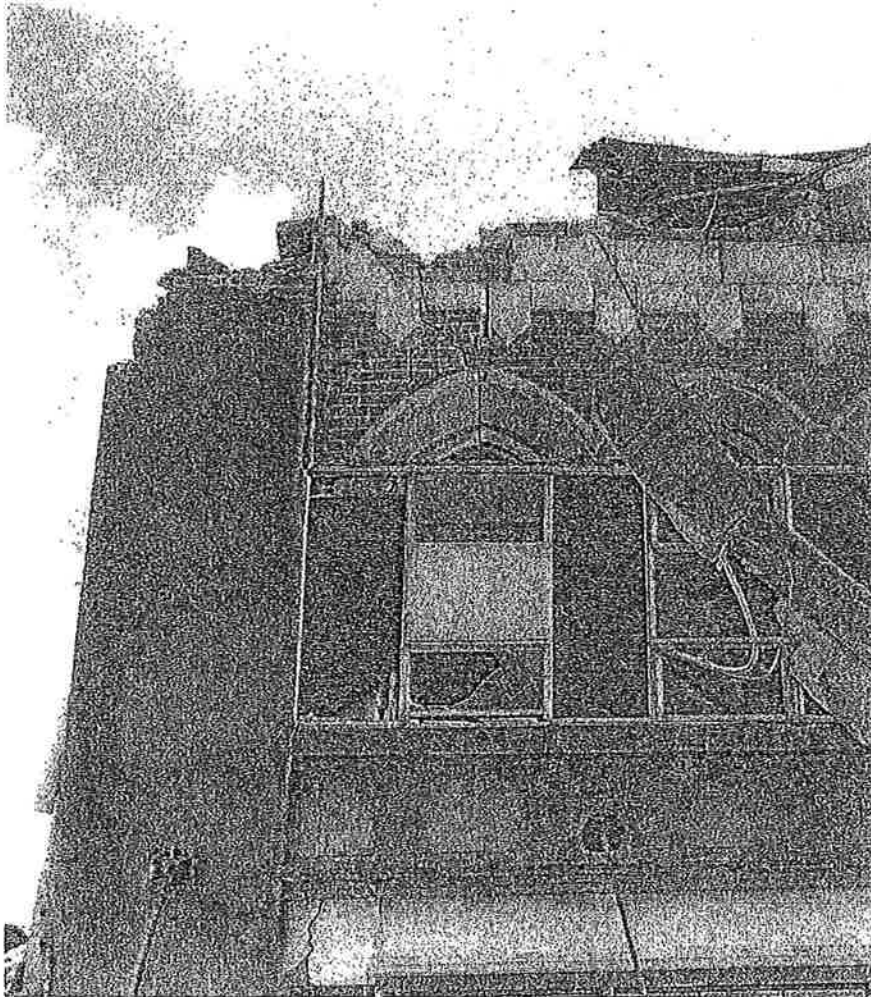
We believe that the damage visible to the spandrels on the south elevation and the collapse of the building to the west has severely reduced the lateral load resisting system of the building in the east-west direction.

Photo 4: Damage to 1st floor and 2nd floor spandrels

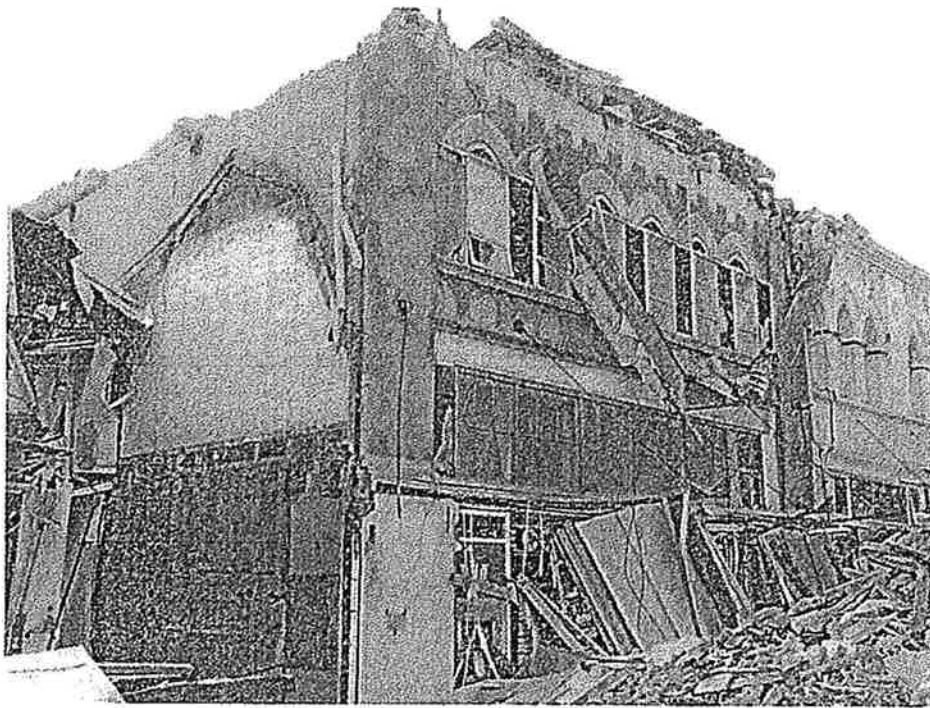
The building has sustained severe damage, most notably the complete loss of the third storey walls to the west, south and east elevations and subsequent loss of support to the roof. Refer Photos 1 and 2 following. The Cashel Street (south) glazed façade and canopy have also been destroyed. Significant damage is also visible to the spandrels on this facade due to overstress and pounding with the building to the east. Refer Photos 3 and 4 following.

The third storey walls have fallen both inwards and outward from the building. Sections of this wall visible on the ground are in the order of 500mm thick with brick masonry facing to unreinforced concrete infill. Outward falling portions have caused significant damage to the south elevation of the adjacent building to the west. Inward falling portions are still visible on top of the second floor, therefore this floor level has not collapsed however significant damage is likely given the weight of the walls (approx 900kg/m² compared to a design floor load of say 300kg/m²).

Photo 1: Southwest corner of building show loss of 3rd floor, façade glazing and canopy.

On the basis that the building is unstable, unsafe to approach or enter, presents a public safety risk and is not economic to repair, we recommend that this building should be demolished.

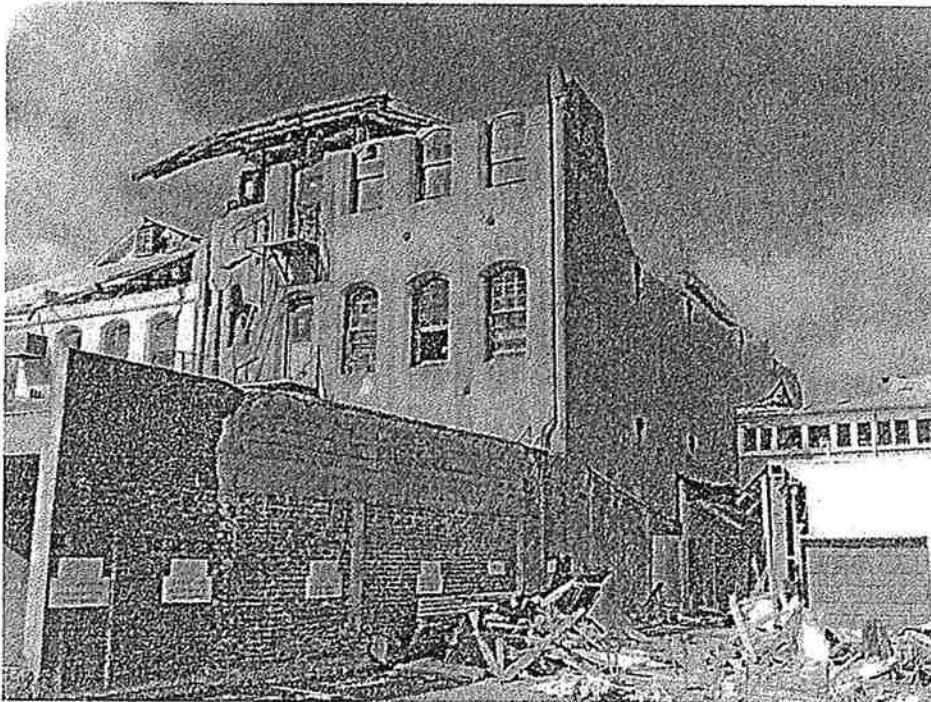
The third storey wall on the north elevation has failed above the window level. At least part of this wall has fallen outward with significant damage visible to the eastern side of the single storey extension at the rear of the building.

Photo 2: Northwest corner of building showing only remaining 3rd floor walls and roof.

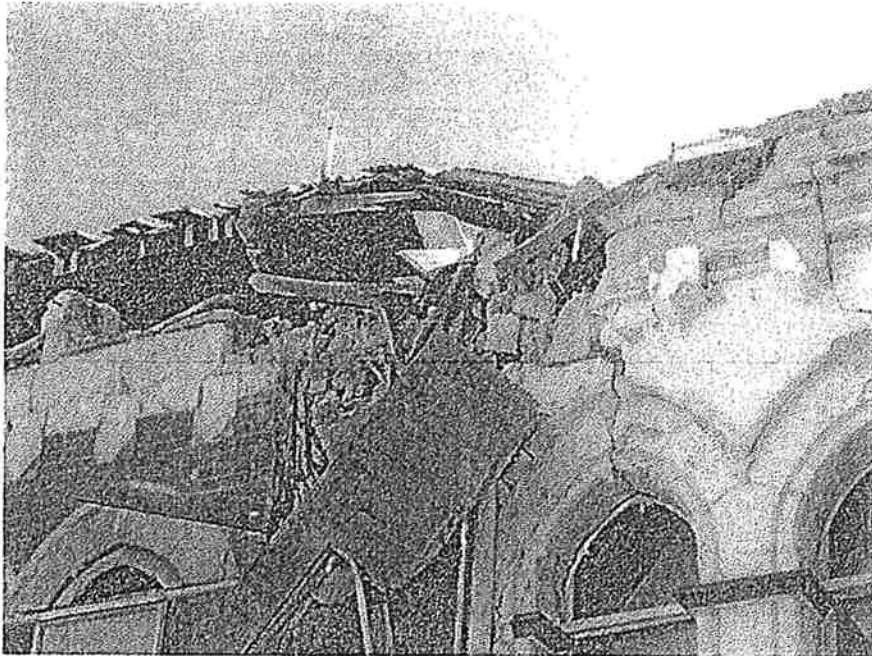
Photo 3: Pounding damage with adjacent building at 2nd floor

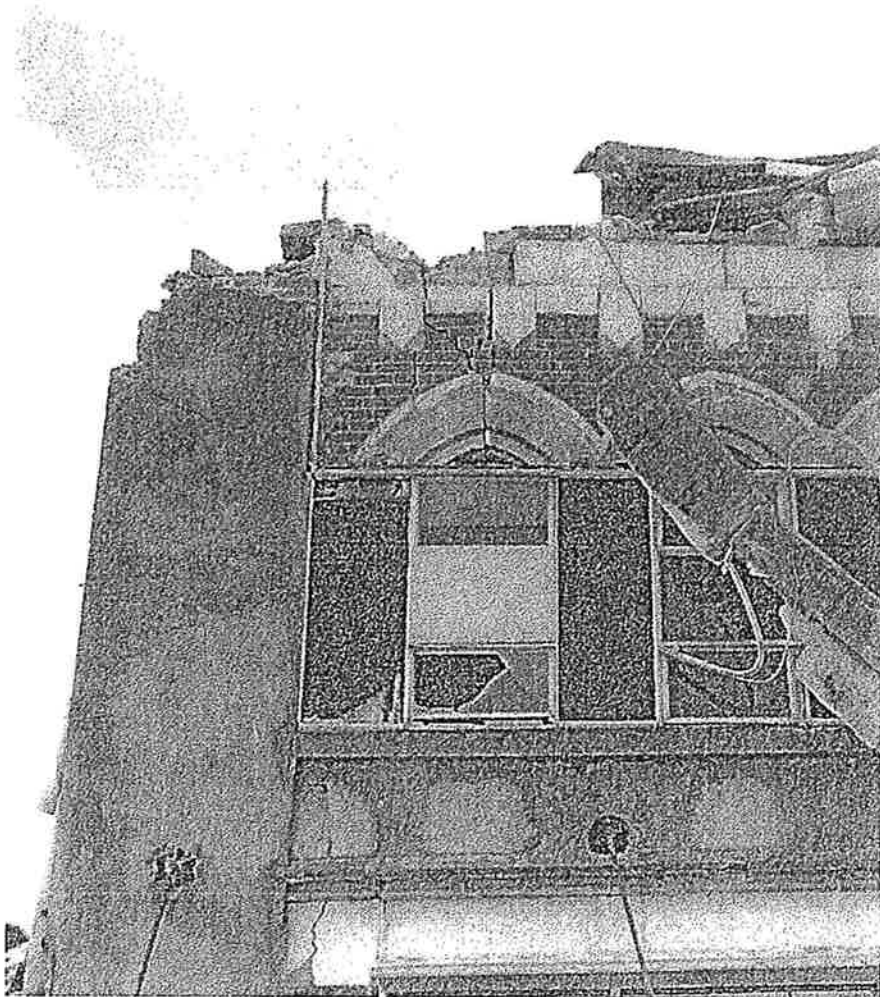
We believe that the damage visible to the spandrels on the south elevation and the collapse of the building to the west has severely reduced the lateral load resisting system of the building in the east-west direction.

Photo 4: Damage to 1st floor and 2nd floor spandrels
