**INDEPENDENT ASSESSMENT ON EARTHQUAKE PERFORMANCE
OF
595A Colombo Street**

**FOR
Royal Commission of Inquiry into building failure
caused by the Canterbury Earthquakes**

**Report prepared by Peter C Smith and Jonathan W Devine
OF
Spencer Holmes Ltd**

December 2011

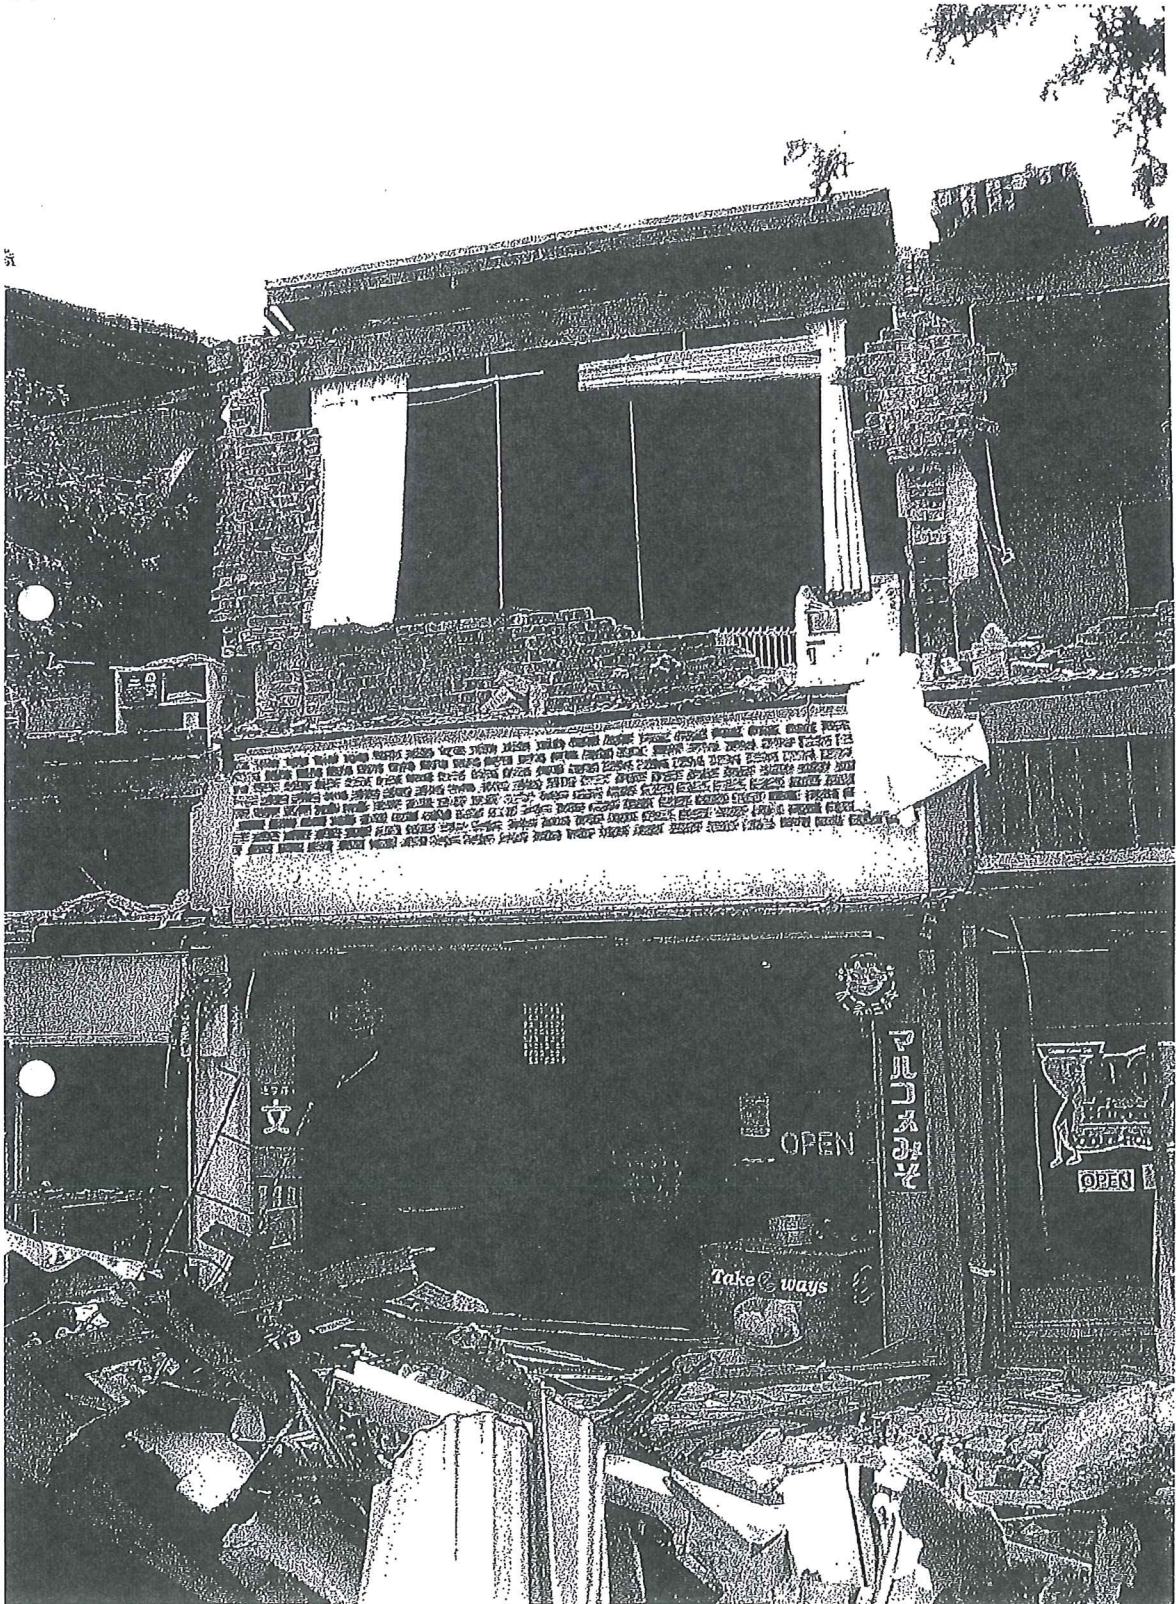
Significant portions of the first floor façade (primarily the parapet) of the building failed outwardly in the severe shaking during the 22nd February, 2011 earthquake.

A significant aspect of the earthquake damage to the building is the failure of the street facade above first floor level in the 22nd February, 2011 earthquake.

**Photos taken after 22nd February, 2011 earthquake.
- (Note Date on photos assessed 1 year out)**
