**INDEPENDENT ASSESSMENT ON EARTHQUAKE PERFORMANCE
OF**

738 COLOMBO STREET

**Royal Commission of Inquiry into building failure caused by the Canterbury
Earthquakes**

**Report prepared by Peter C Smith and Jonathan Devine
Spencer Holmes Limited**

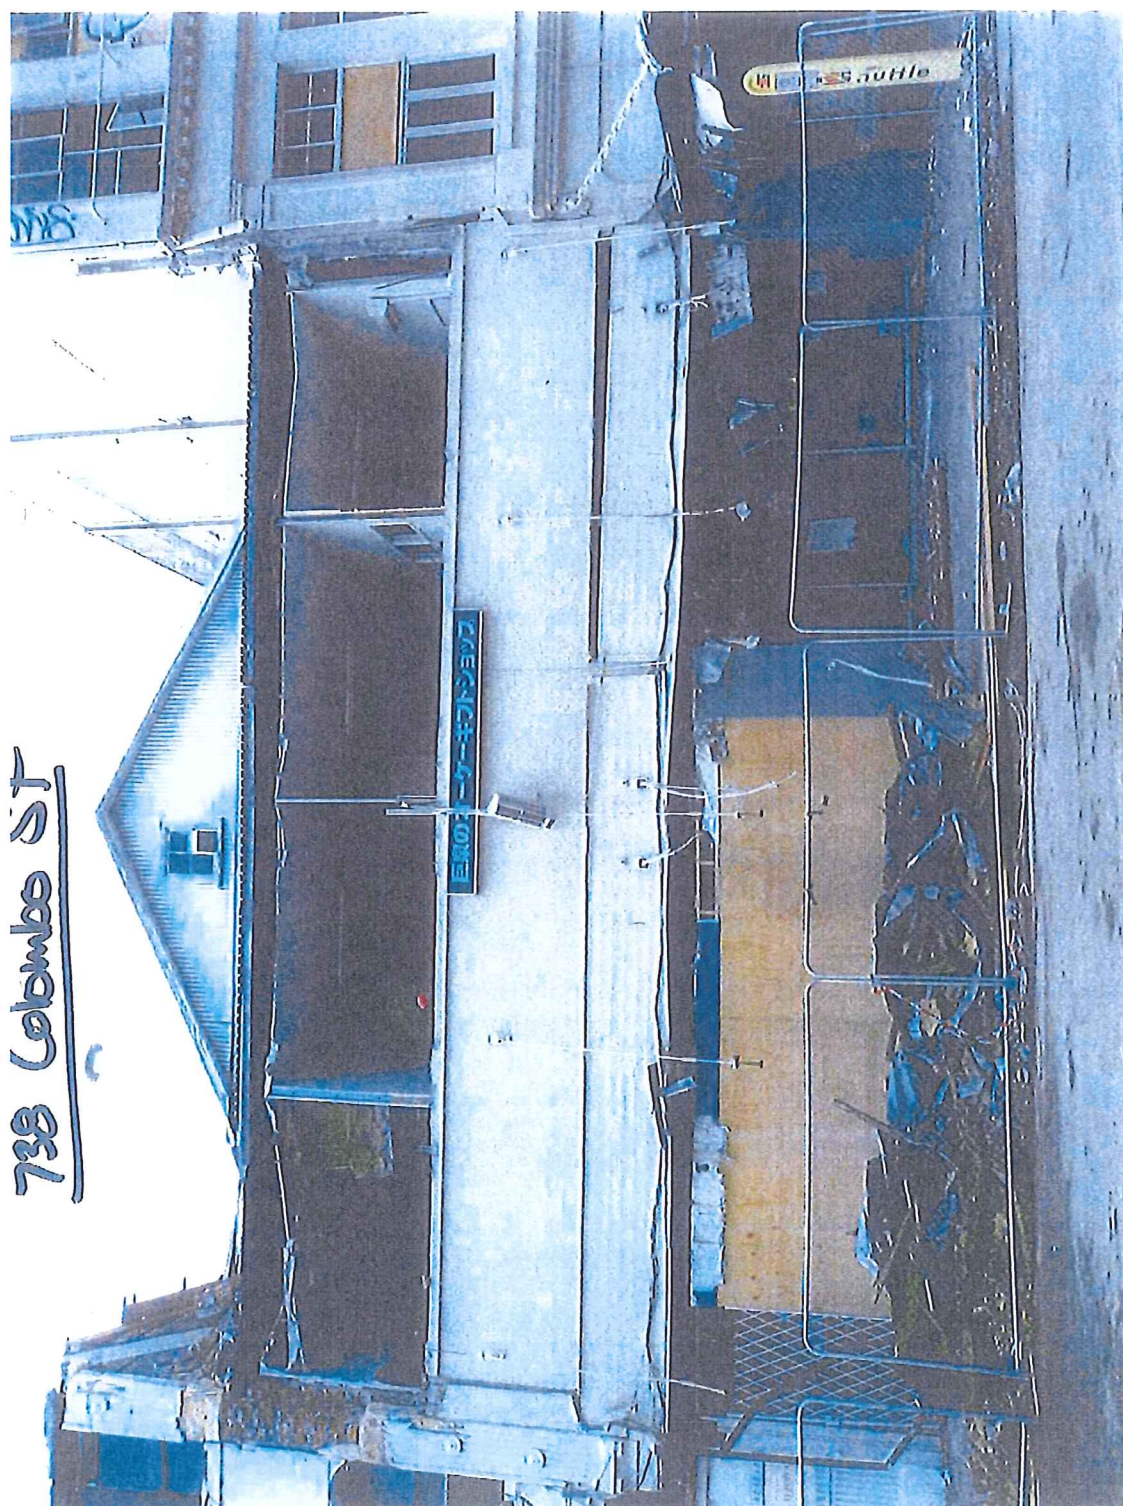
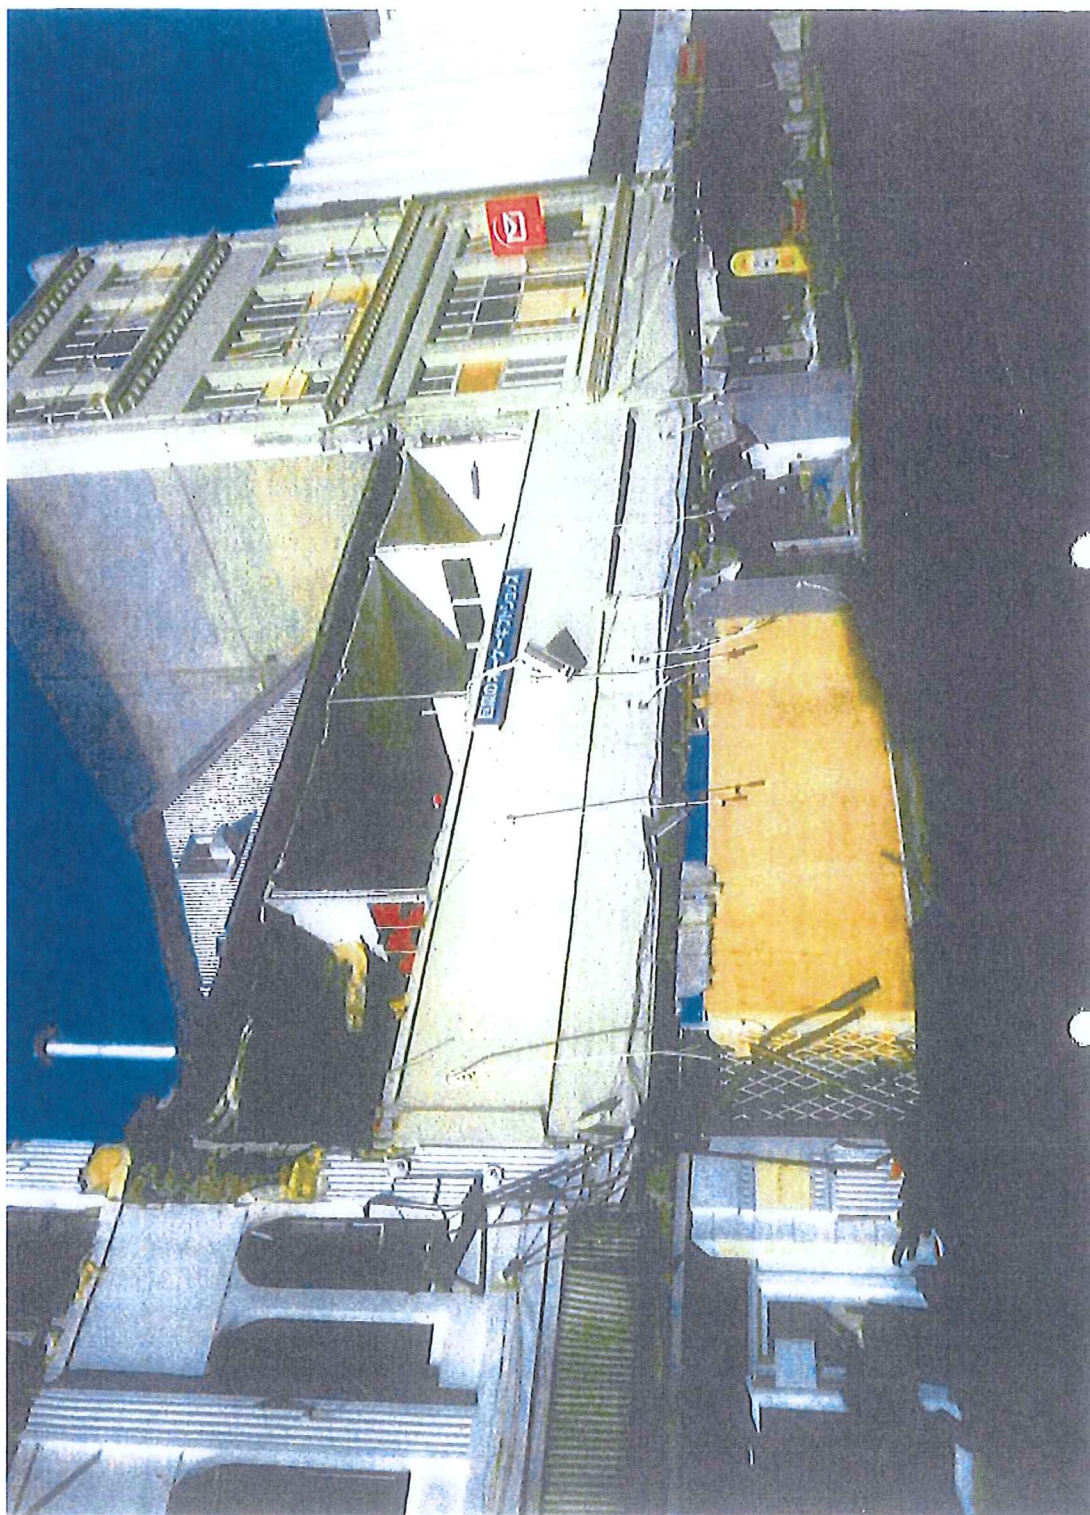
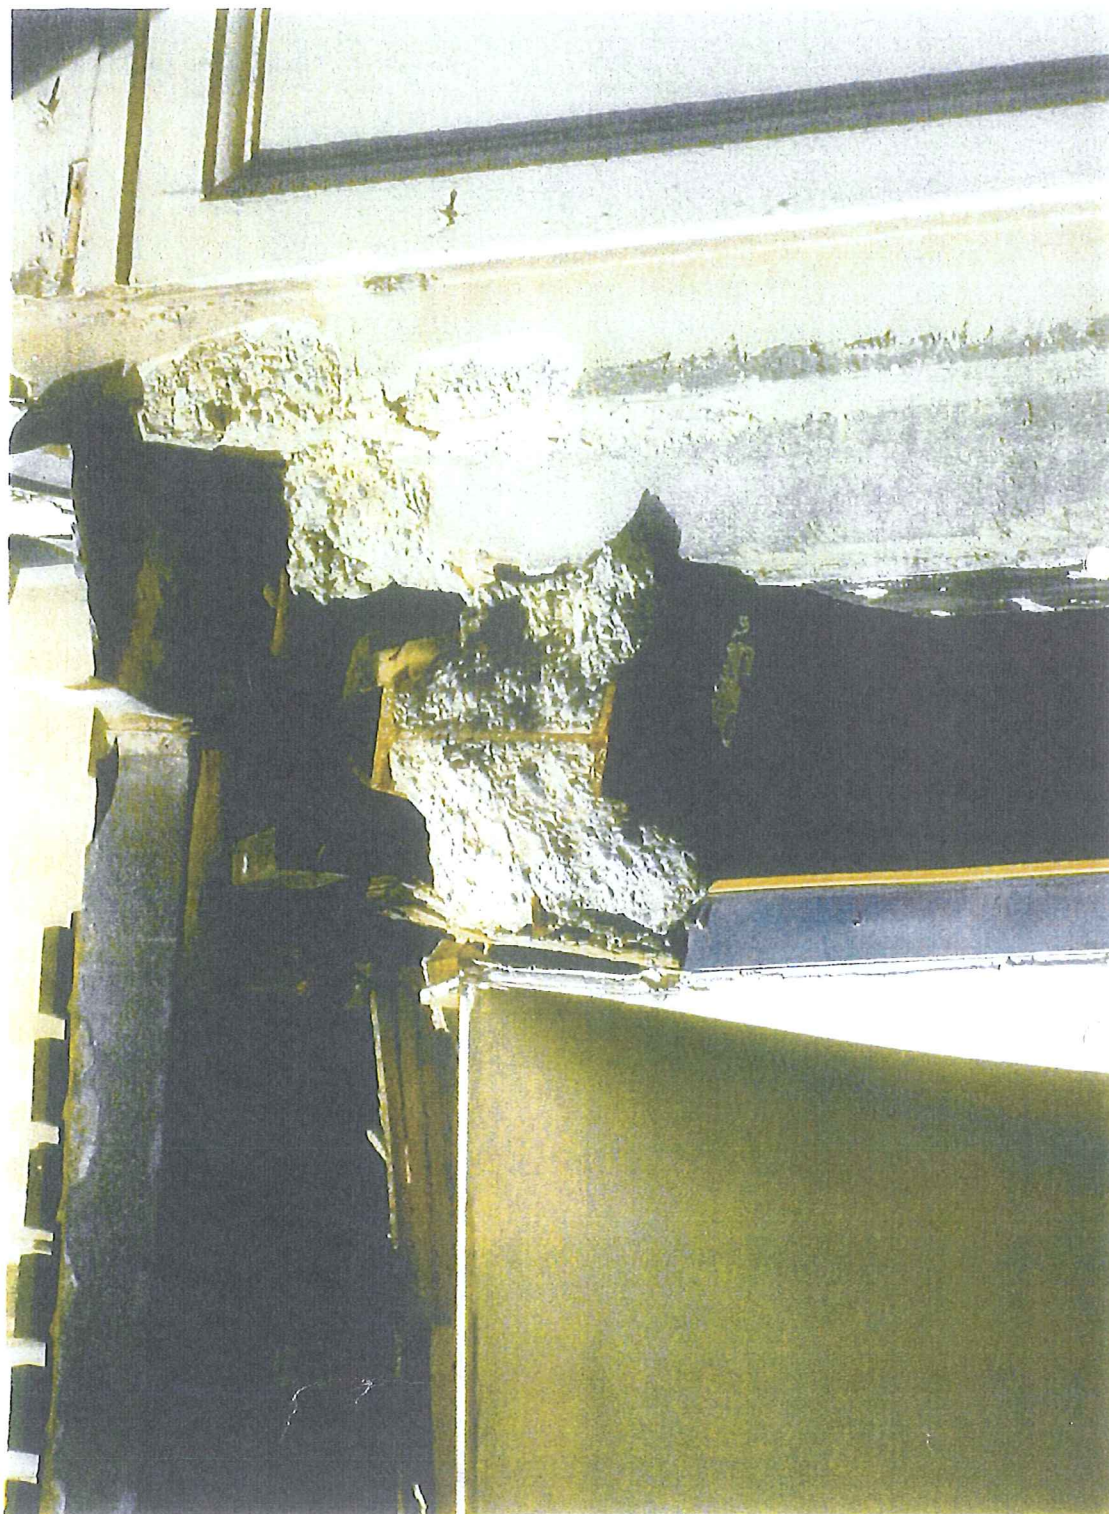
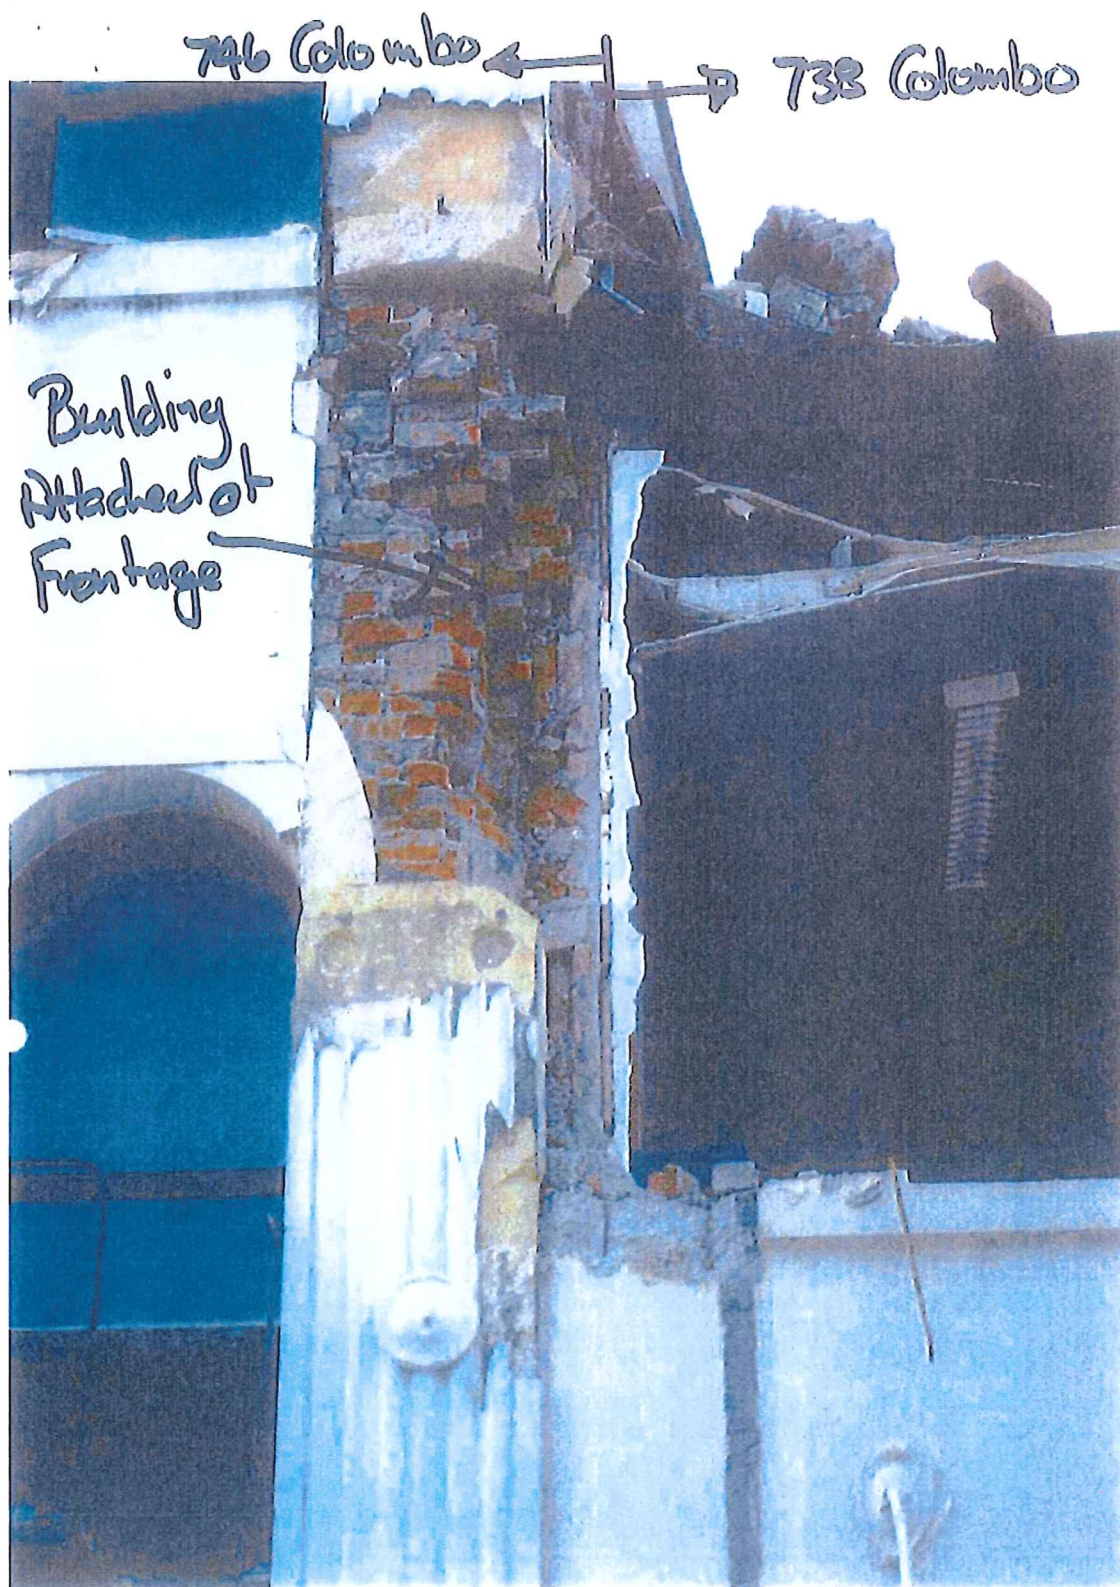
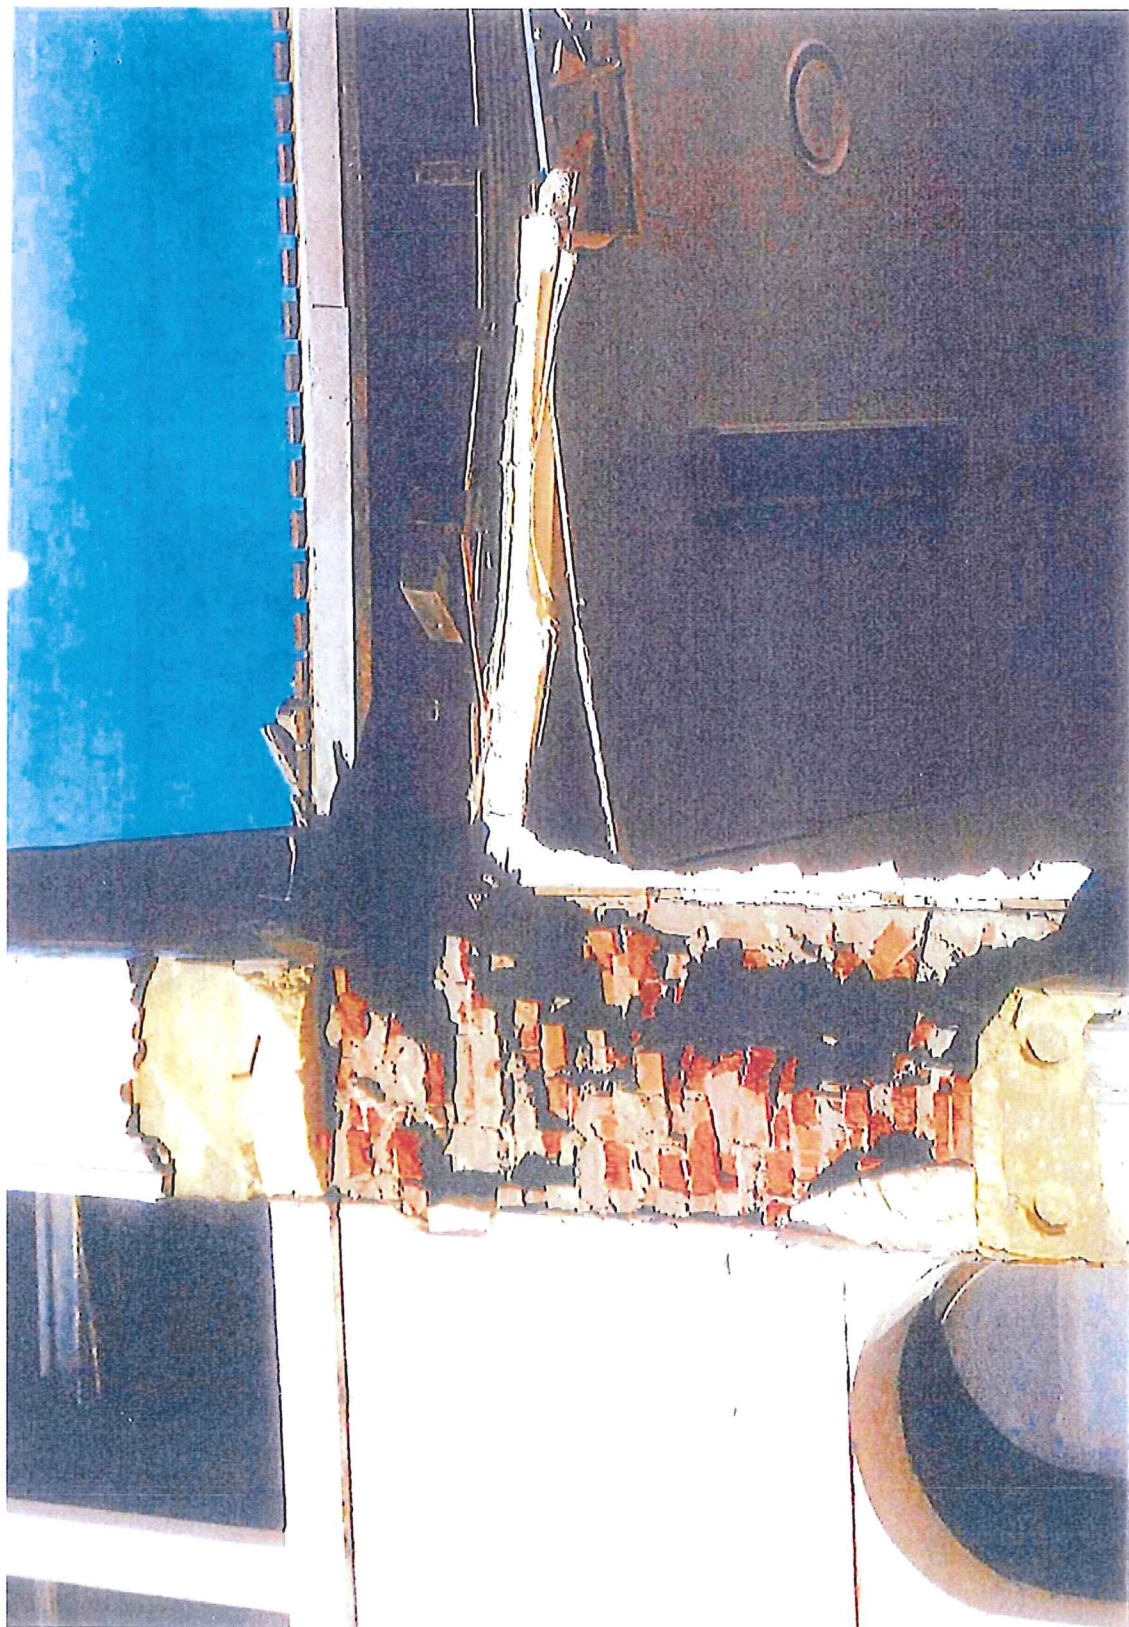
Photos of façade failure following the 4th September, 2010 earthquake

From the photographs it would appear that the front façade above first floor window sill level rotated outwards from the support at the window sill level, collapsing onto the footpath in Colombo Street as a result of the severe shaking experienced during the 22nd February, 2011 earthquake. It is also evident that there was significant damage to the wall of the building at 736 Colombo Street where it adjoined the wall of the building 738 Colombo Street. We are of the opinion that pounding of the two storey building by the four storey building may have contributed to the failure of the west wall façade to the two storey building.

The code lateral load coefficient for a façade to an elastic responding structure in Christchurch at the time of the earthquake sequence was 0.86g. Based on GNS Science records of measurements of accelerations in the Christchurch CBD during the 22nd February, 2011 earthquake, the building was likely to have been subjected to a ground accelerations of 0.9g. This level of ground acceleration equates to an acceleration of 1.25g at first floor level. In addition it is likely that the façade was subjected to vertical acceleration at the time the wall was subjected to the horizontal acceleration.

Although the wall had apparently been secured to the New Zealand National Society of Earthquake Engineering recommendations, the level of shaking experienced during the 22nd February, 2011 earthquake far exceeded this level of securing and failure of the wall was almost inevitable.

We suggest that due to the extensive damage and loss of life that occurred as a result of the failure of façades in the 22nd February, 2011 earthquake, consideration be given to reviewing the standards for securing the façades to un-reinforced masonry and early reinforced concrete buildings.
