**INDEPENDENT ASSESSMENT ON EARTHQUAKE PERFORMANCE
OF
246 High Street**

**FOR
Royal Commission of Inquiry into building failure
caused by the Canterbury Earthquakes**

Spencer Holmes Ltd

December 2011

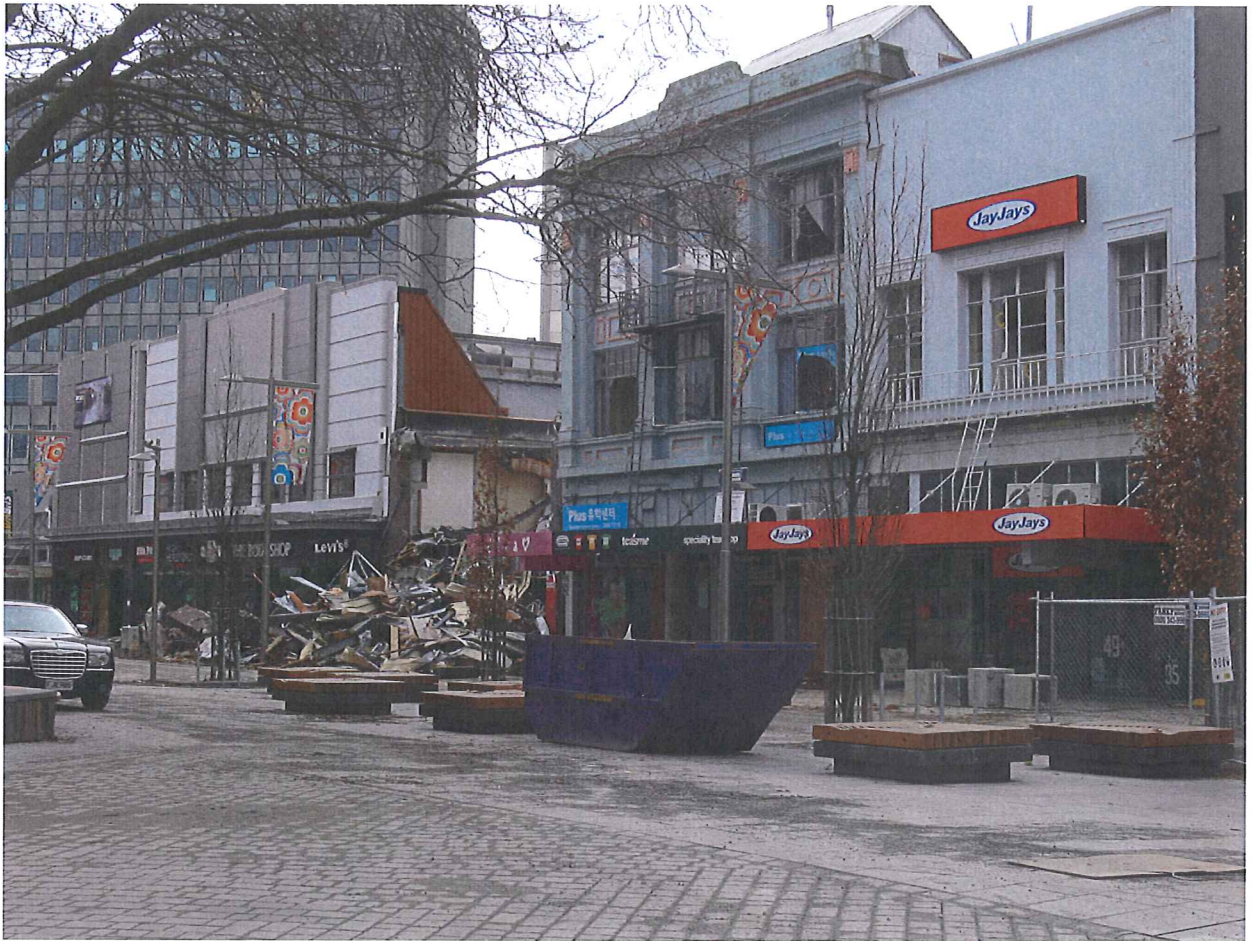
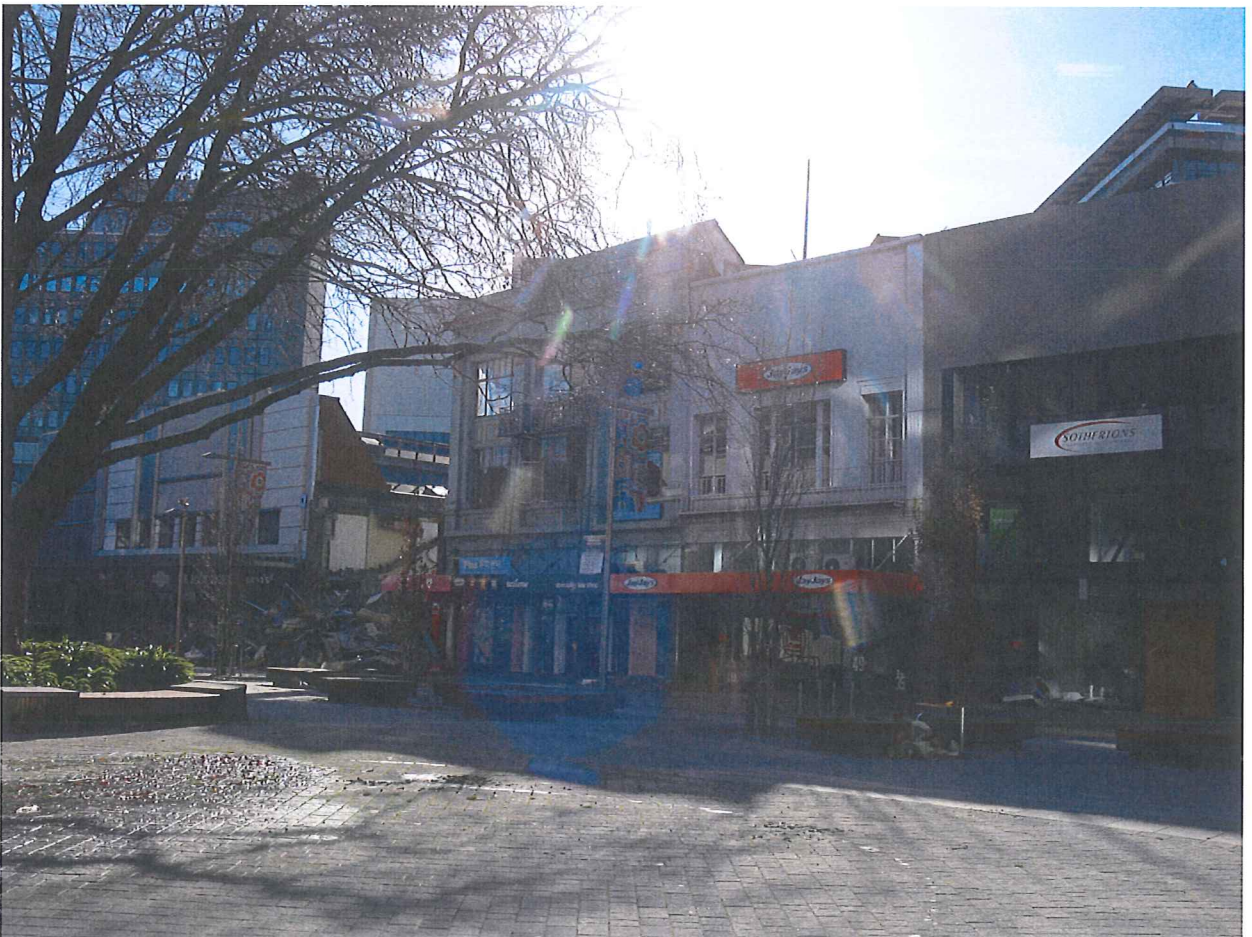
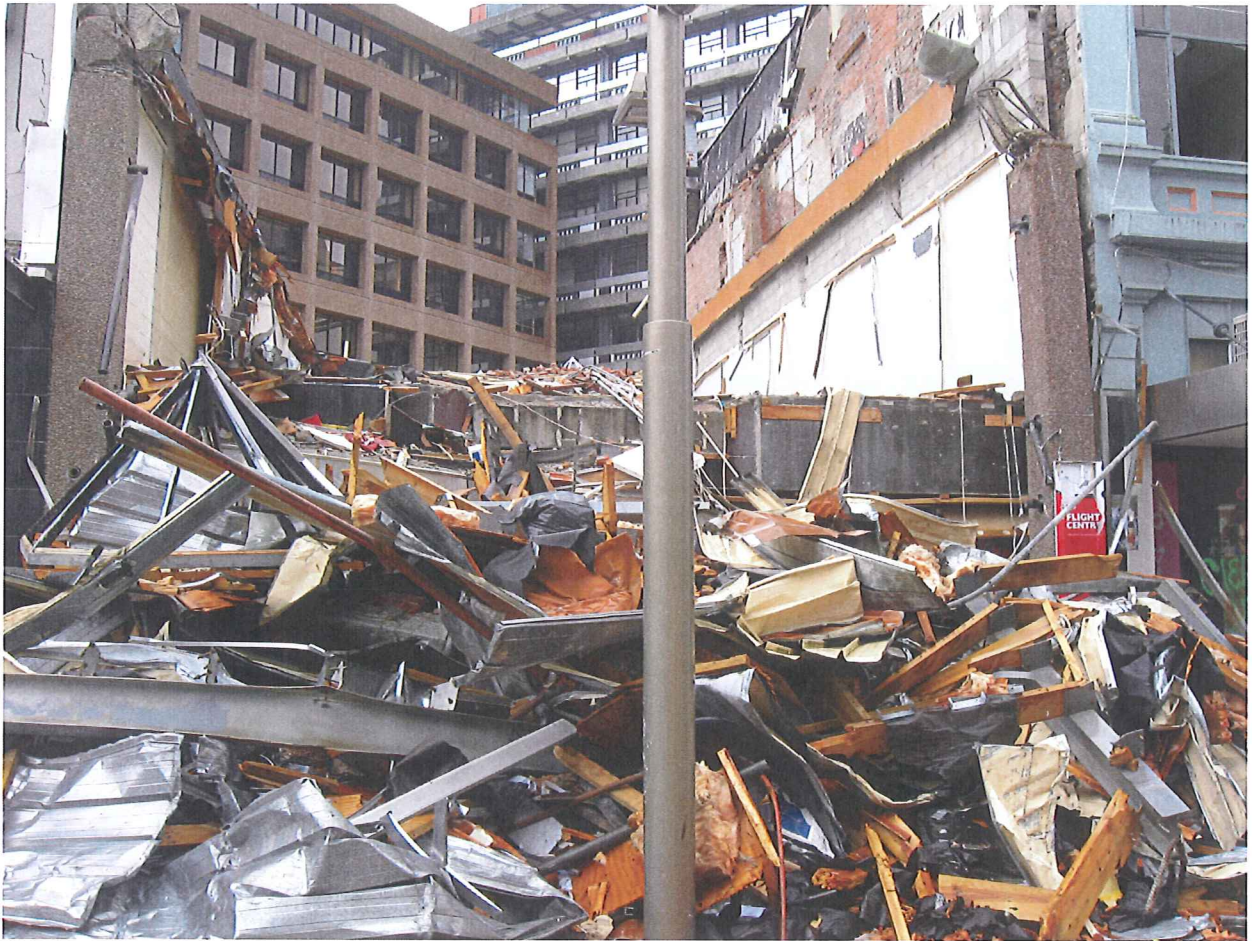
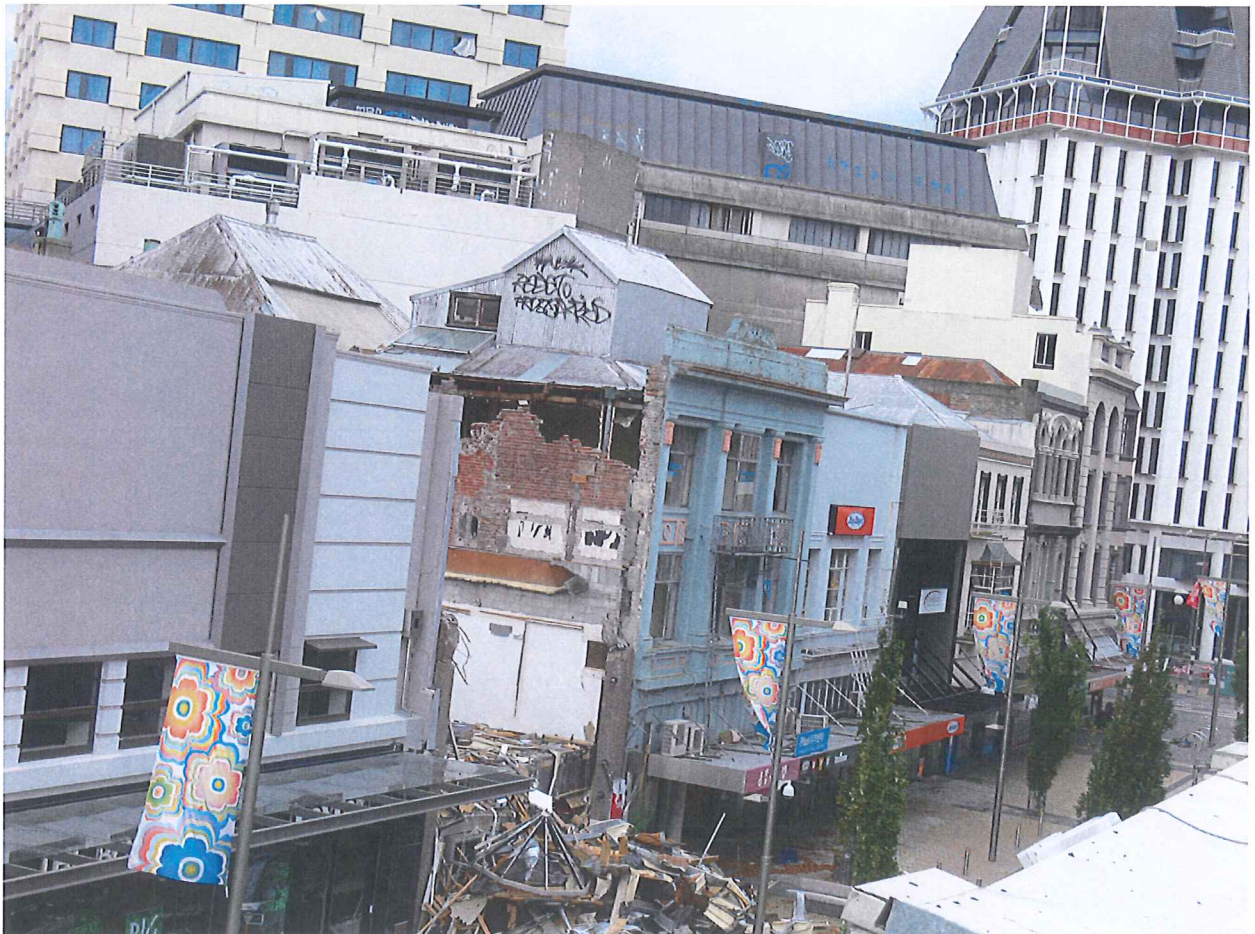
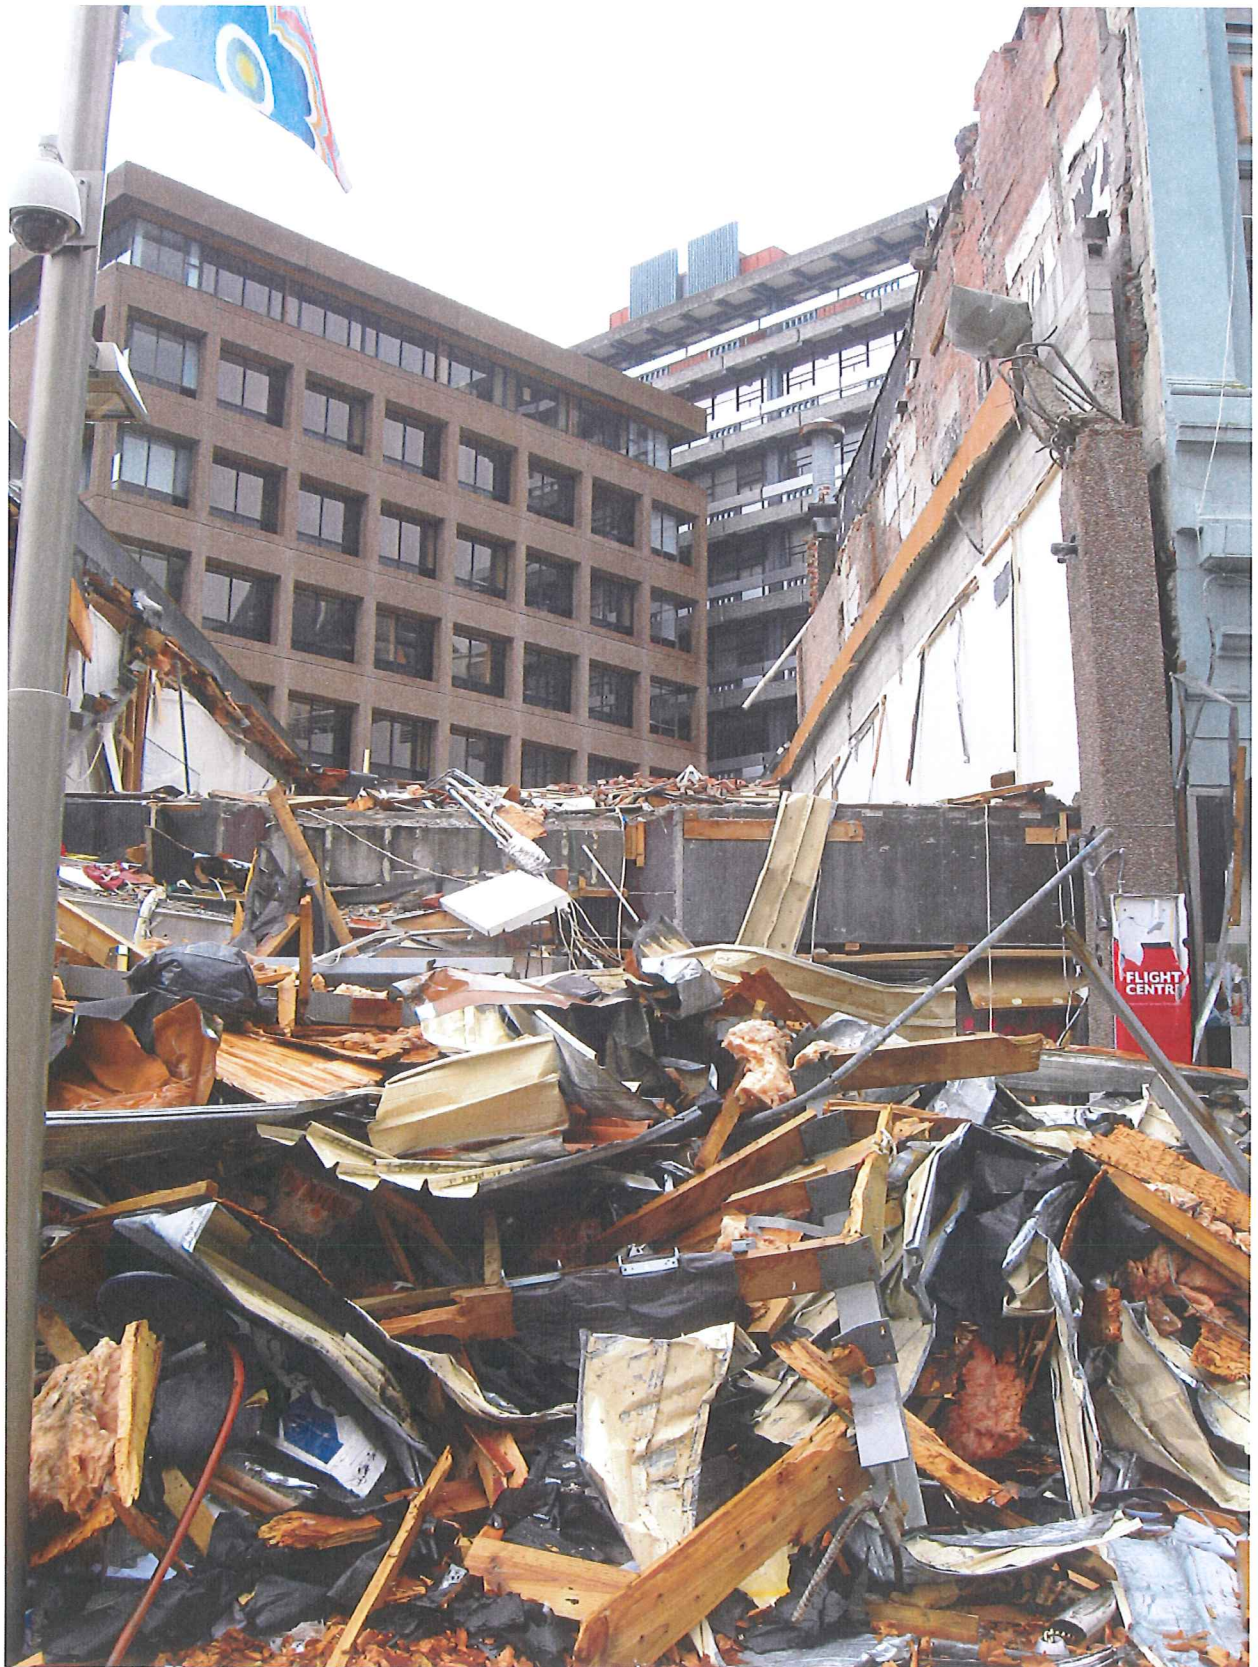
The building at 246 High Street was significantly damaged in the 22nd February, 2011 earthquake with the north-west wall collapsing on the Link Centre atrium at 152 High Street, causing a total collapse of the Link Centre atrium. (refer photos Appendix 2). The atrium structure to 152 Hereford Street was inspected by Allan Reay Consultants on 8th April, 2011. The atrium structure collapsed as a result of bricks falling from the adjacent buildings 246 High Street.

The upper levels of the north-west wall of the building at 246 High Street became disconnected from the roof and second floor structure and collapsed primarily outwards with masonry elements falling through the roof of the Link Centre atrium, which was a relatively new building at 152 Hereford Street.

Based on GNS Science records of measurements of accelerations in the Christchurch CBD during the 22nd February, 2011 earthquake, the building is likely to have been subjected to a ground acceleration of 0.9g. This level of ground acceleration equates to 1.68g acceleration at roof level. In addition, significant vertical accelerations are known to have occurred and it is probable that the façades were subjected to a vertical acceleration at the same time as being subjected to severe horizontal acceleration. Clearly failure of the poorly restrained third floor walls was almost inevitable in the severity of shaking that occurred during the 22nd February, 2011 earthquake.

Photographic record of damage following 22nd February 2011 earthquake
