**INDEPENDENT ASSESSMENT ON EARTHQUAKE PERFORMANCE
OF**

173 Gloucester Street(255-271 Manchester Street)

**Royal Commission of Inquiry into building failure
caused by the Canterbury Earthquakes**

January 2012

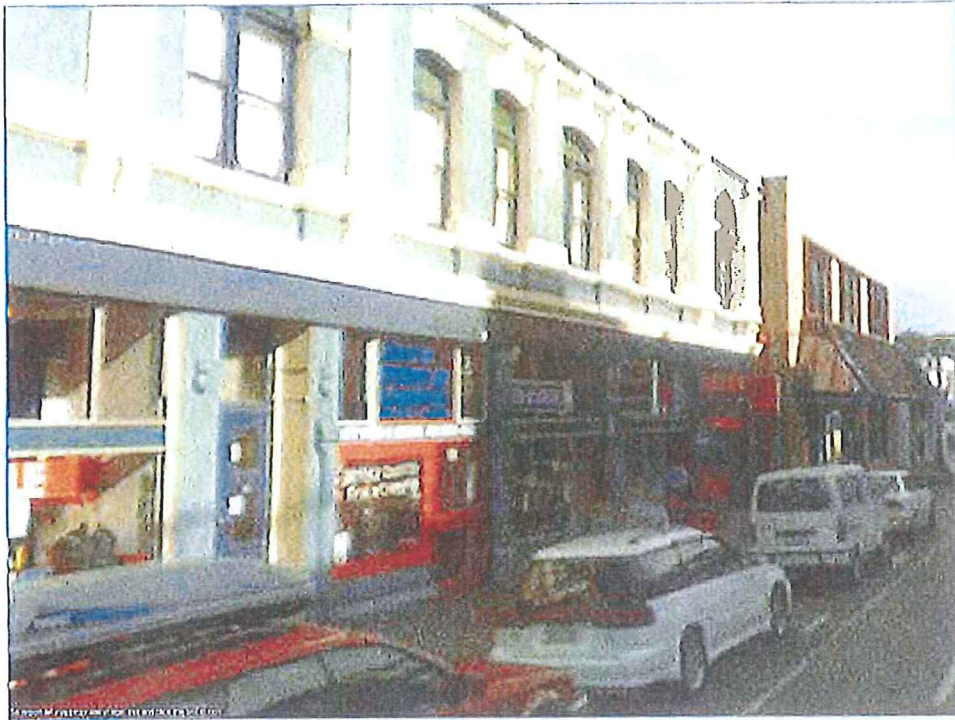
04

The Rapid Assessment form noted *some cracking to foundations. South wall brick parapet cracking and cracks to façade. Slight movement to internal lining of 10mm to back wall. Ceiling to NE parapet and + cracks to glass.*

A series of photographs were provided with the Rapid Assessment-Level 2 recording the extent and location of cracking.

The Rapid Assessment-Level 2 assigned a green placard and commented *fill cracks in parapet + bricks with epoxy resin once scaffold erected. Refix windows to brick work.*

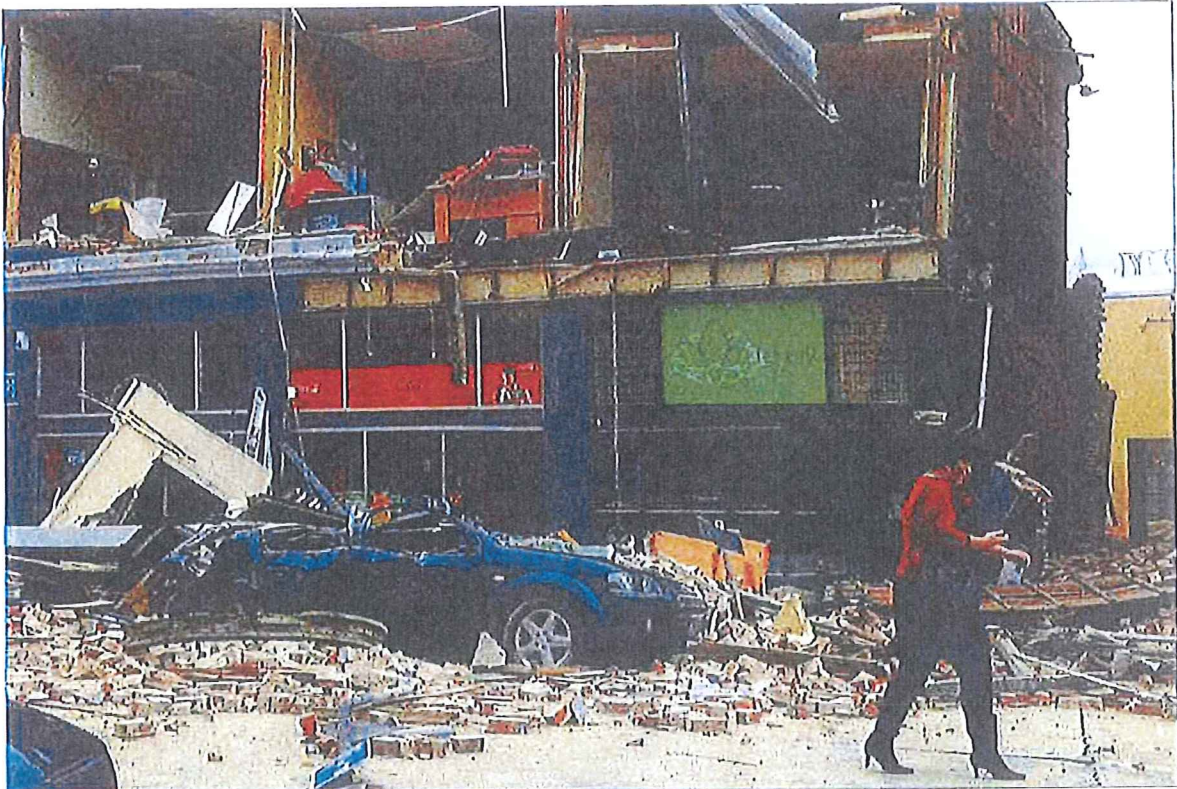
07

- 1. The un-reinforced masonry on the upper floor along the Manchester Street (East) façade has almost entirely collapsed from out of plane failure. (Refer to Photograph 1). The walls along the south façade (along Gloucester Street) have much less damage (photographs 3 and 4). This can probably be explained by the larger component of seismic shaking during the 22nd February, 2011 event being in the East-West direction.*

- 4. Significant damage to the walls and columns occurred on the ground floor of the building. One of the columns on the Manchester Street façade was damaged to the extent that this caused misalignment of the upper level floor (refer to photograph 1).*

The structural failure of the building has been described in some detail in Opus International Consultants report of the 1st April, 2011. This report identified that the un-reinforced masonry wall on the upper floor along the Manchester Street frontage almost entirely collapsed from out of plane failure. The walls to the south façade along Gloucester Street suffered less damage. There was greater damage at the west end of the south façade and the junction with the adjoining building.
