**IN THE MATTER OF
THE CANTERBURY EARTHQUAKES ROYAL COMMISSION**

BRIEF OF EVIDENCE OF DICK CUSIEL

Dated 2 February 2012

3. I am giving this evidence to the Canterbury Earthquakes Royal Commission in relation to a building at 43 Lichfield Street, known as the Anderson Building (“the building”).

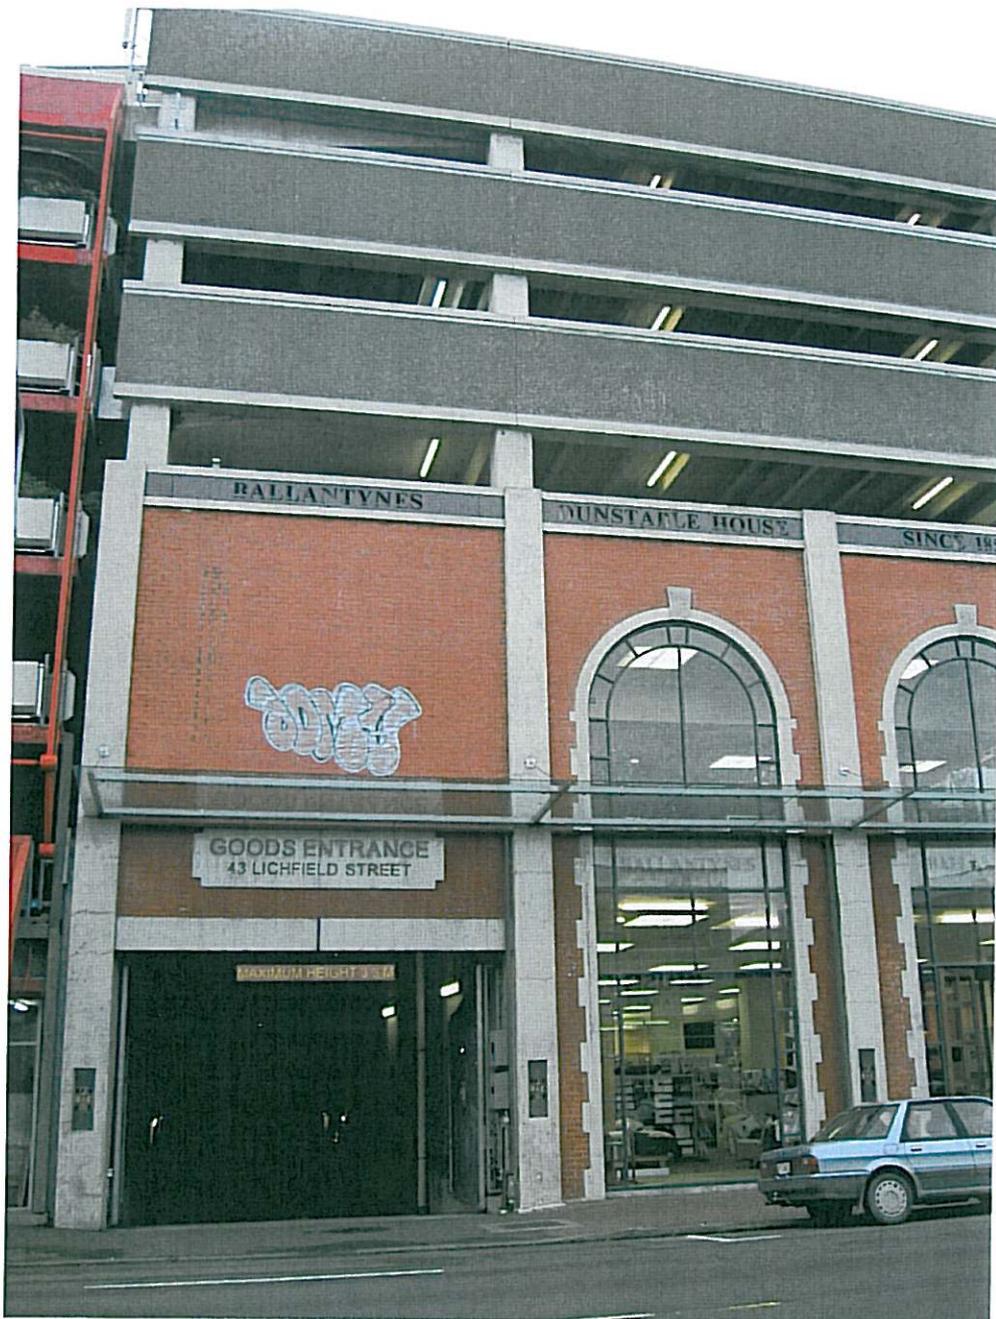
Photo 1

Building prior to earthquakes

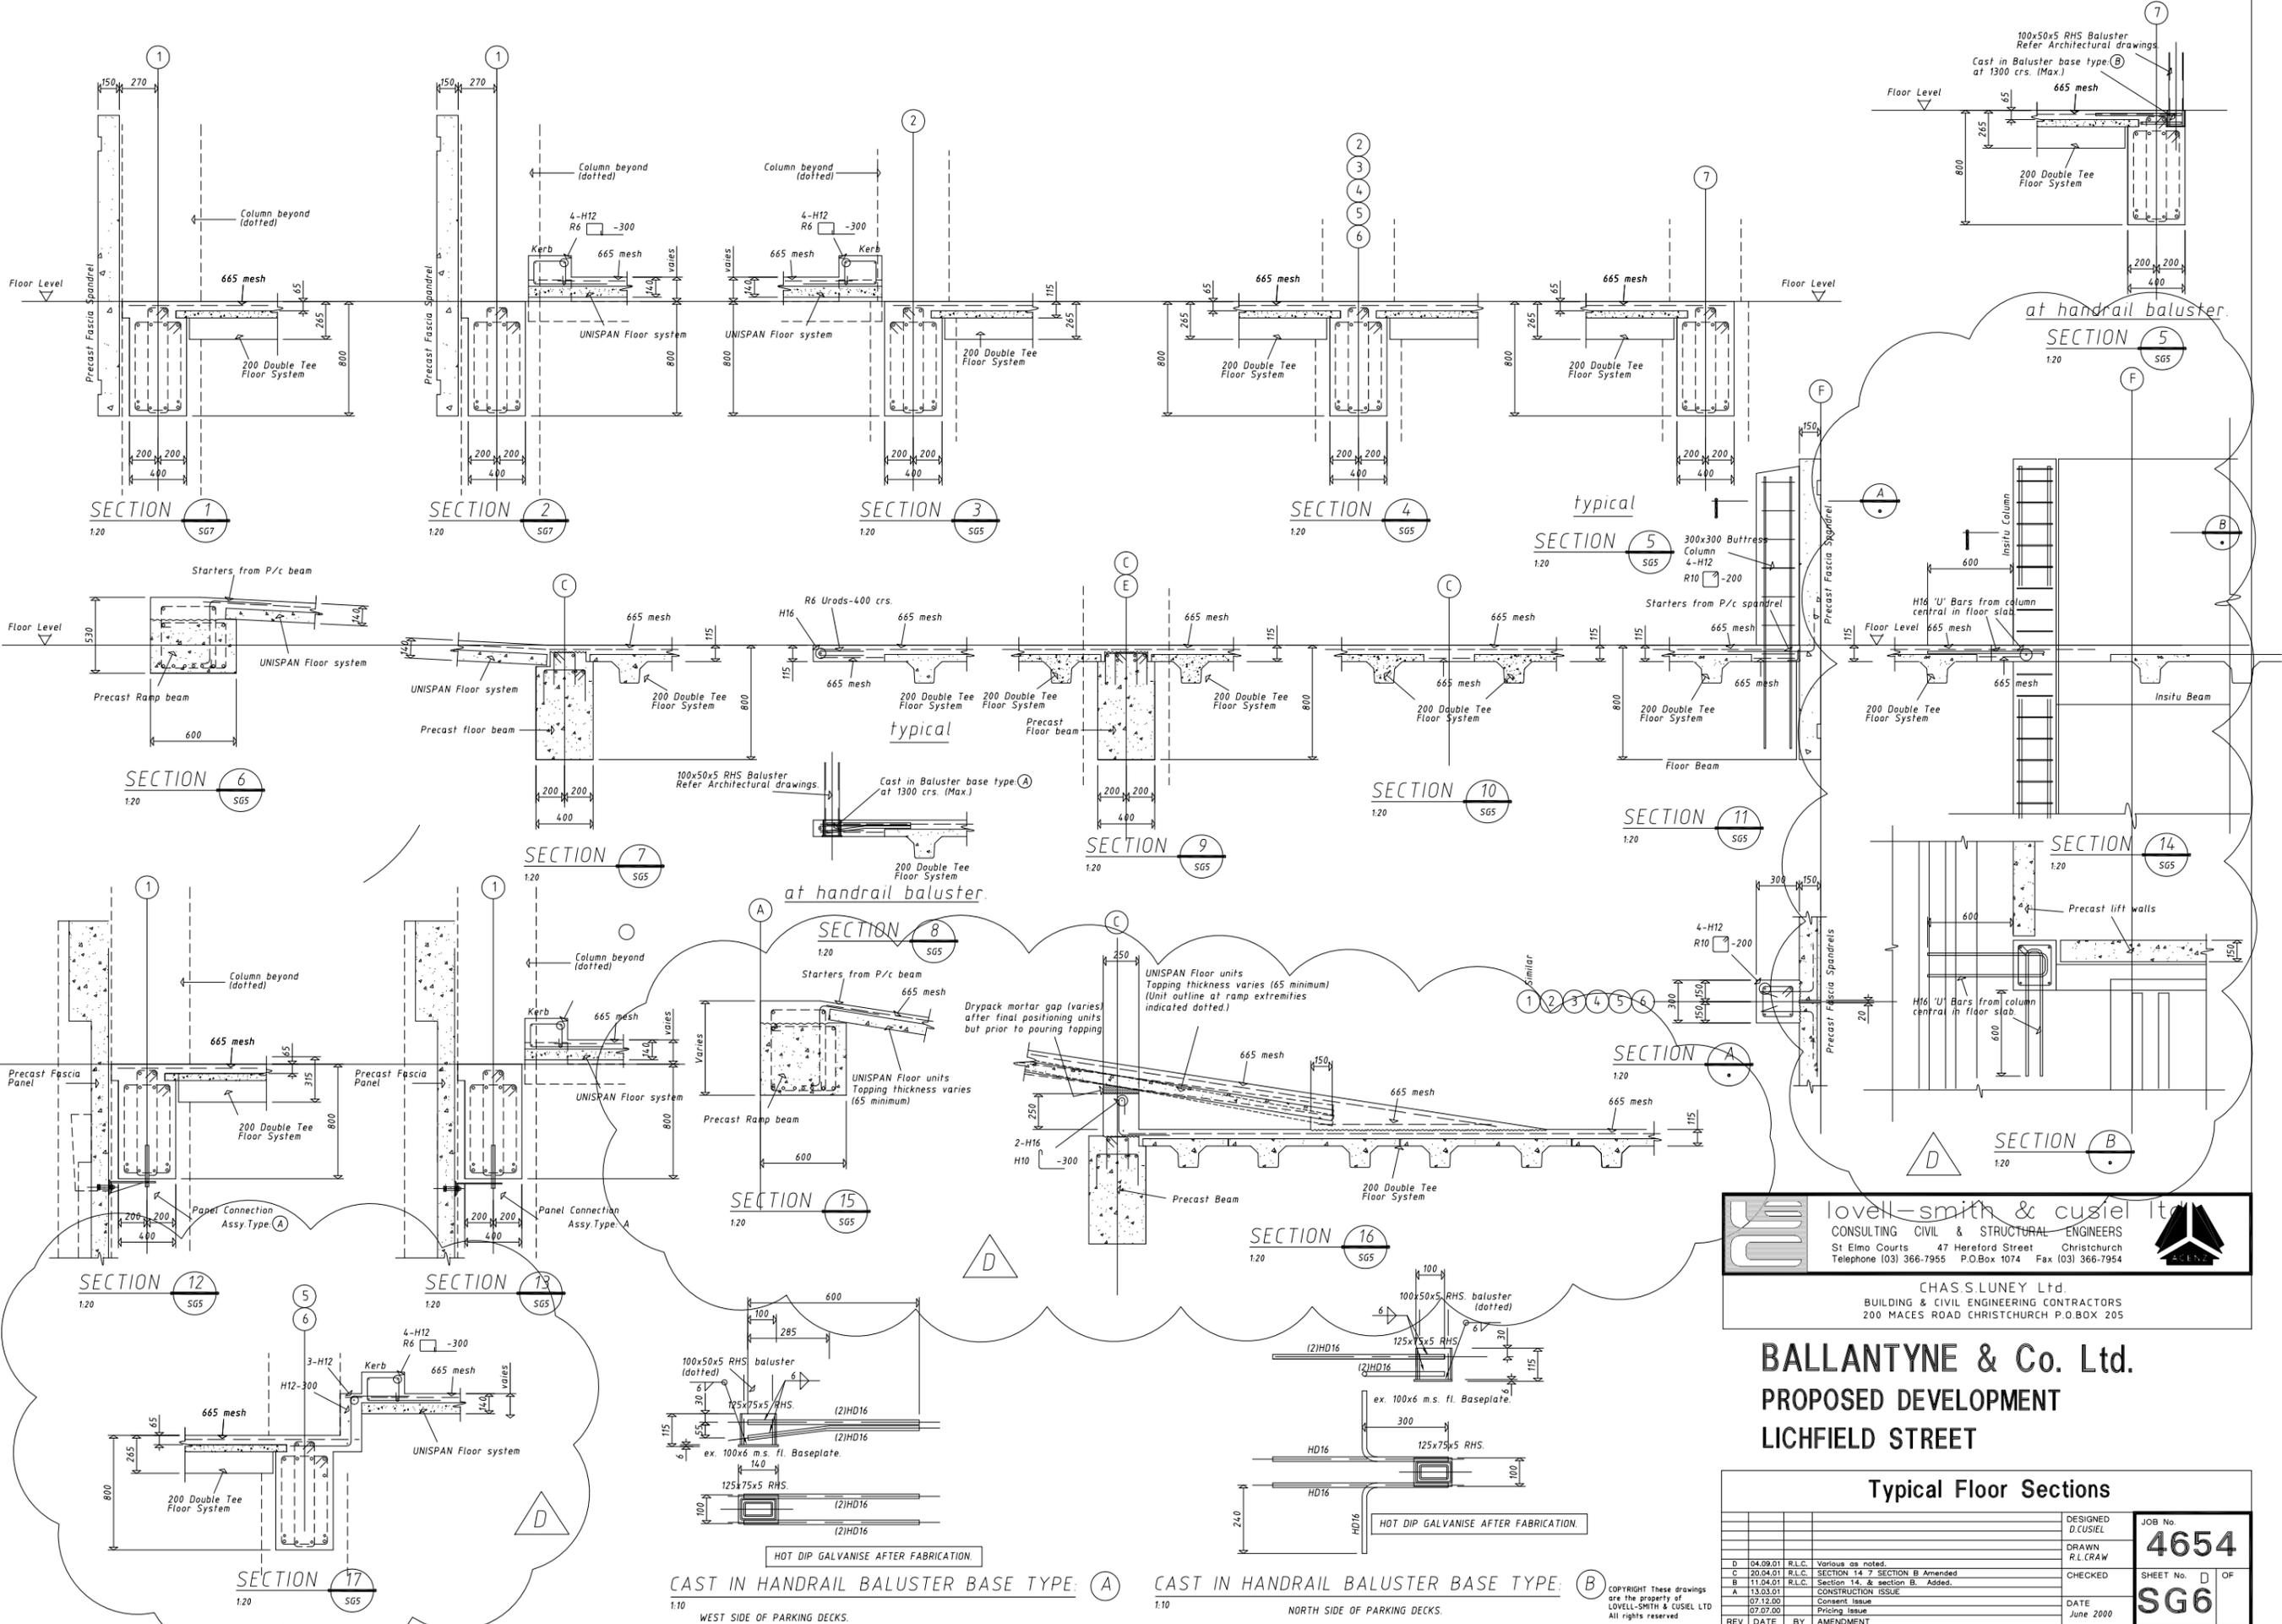
Typical Floor Sections			DESIGNED	JOB No.
			D.CUSIEL	4654
			R.L.CRAW	
			CHECKED	SHEET No. D OF
				SG6
			DATE	June 2000
REV	DATE	BY	AMENDMENT

26. This design concept is detailed in the drawing entitled “Typical Section Thru Precast Spandrel Panels” S1, S2 and S3 on drawing SP7 (bottom left-hand detail) (BUI.LIC43.0023.18). This construction method was carried out in relation to the corner spandrels which can be seen on Levels 3, 4 and 5 in the photos before the Commission (BUI.LIC43.0027.9 and BUI.LIC43.0024.5).

Section Thru Precast Spandrel Panels” S4, S5 and S6 (BUI.LIC43.0023.18). This is the drawing second from bottom left on SP7. What is not detailed, is the precast tie from the spandrel to the floor topping.

28. It is, regrettably, this omission which in my view has contributed, with the significant force of the earthquake, to the spandrel falling away from the structure. The panels were affixed with weld plates and angle cleats to the columns (BUI.LIC43.0024.5 and 24.8). However, they were primarily there for the purposes of construction to put the panels in place while the floor topping was poured. They were unlikely to have been sufficient to keep the panels in place in the event of a major earthquake.
