**INDEPENDENT ASSESSMENT ON EARTHQUAKE PERFORMANCE
OF
194 Gloucester Street**

**FOR
Royal Commission of Inquiry into building failure
caused by the Canterbury Earthquakes**

**Report prepared by Peter C Smith and Jonathan W Devine of
Spencer Holmes Ltd**

December 2011

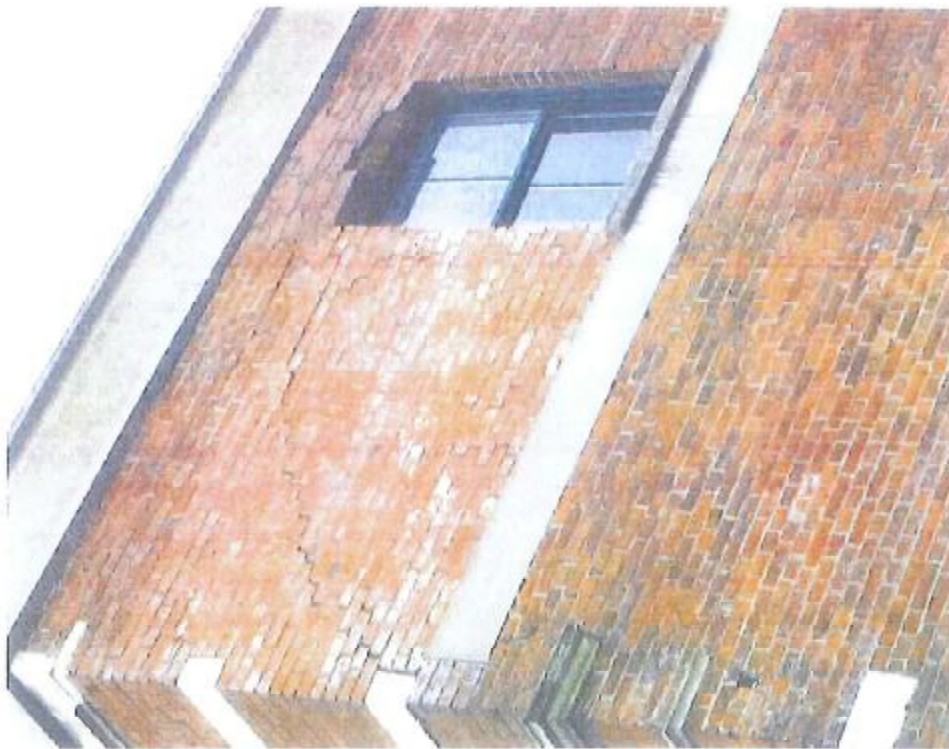
CLOSE UP VIEW SHOWING LINTEL
DAMAGE TO WINDOW ON WESTERN
FACE.

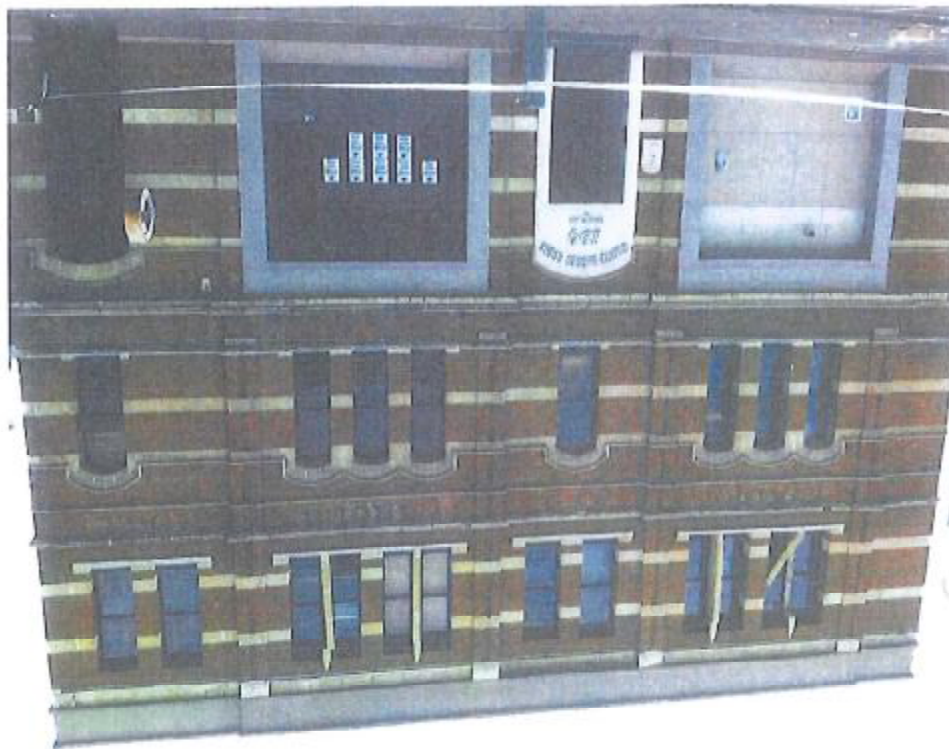
CLOSE UP VIEW SHOWING DISPLACEMENT
OF STONE WINDOW MULLION ON
NORTHERN FACE.

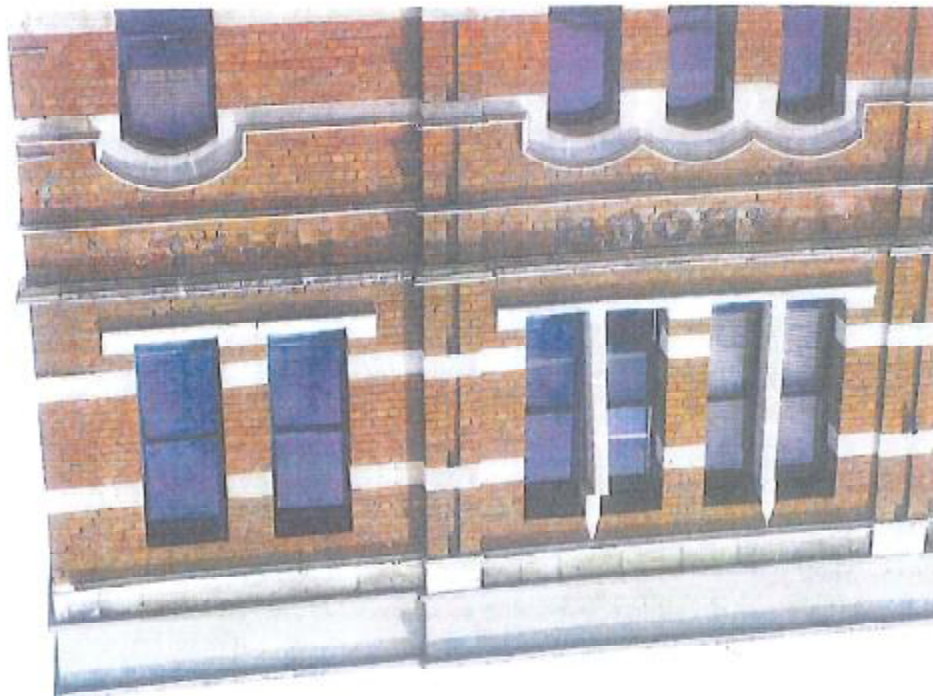
CLOSE UP VIEW SHOWING DISPLACEMENT
OF STONE WINDOW MULLION ON
NORTHERN FACE.
